YEAR 3 MONITORING and CLOSEOUT REPORT
for the
BARNHILL MITIGATION SITE
LITTLE IVY CREEK,
MADISON COUNTY, NORTH CAROLINA
EEP PROJECT NUMBER 92651

December 2008

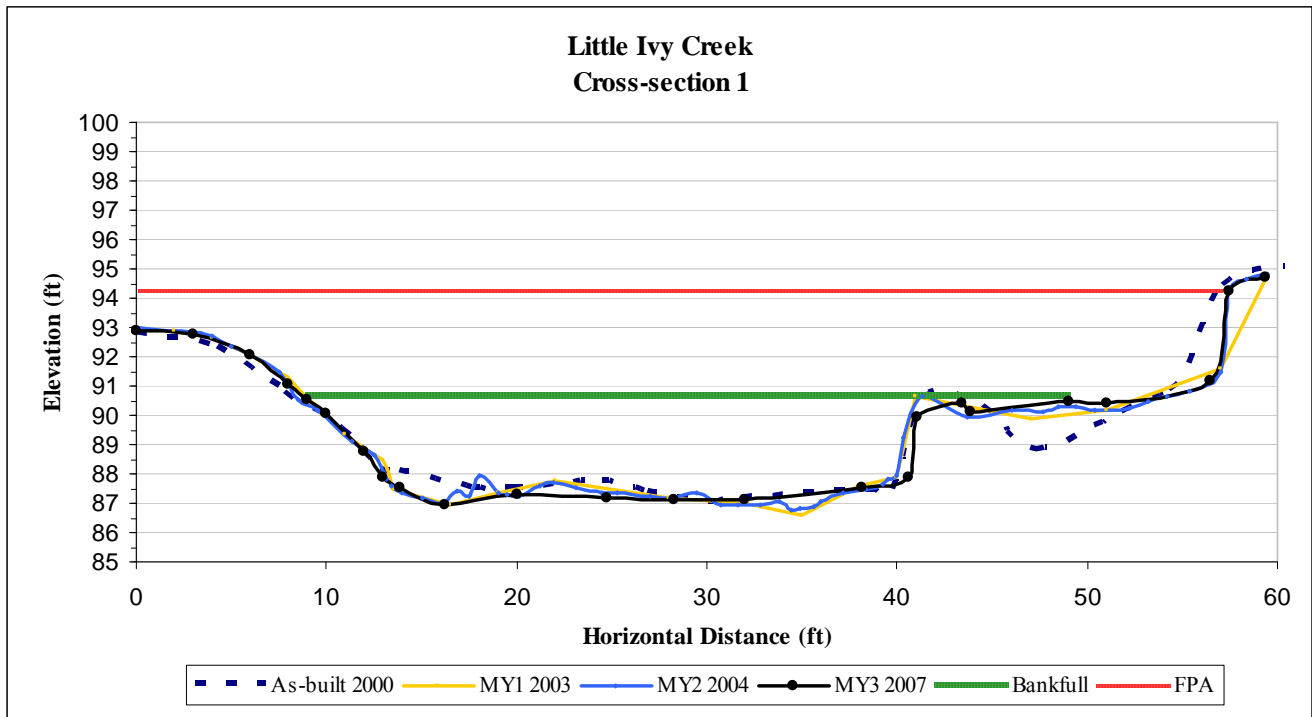
Cross-section 1, Glide (Appendix Table A.1.1.).—There has been little change in this cross-section since construction in 2000. This cross-section has remained stable with no lateral movement (bank erosion) observed along either streambank. The right bank has aggraded slightly between the constructed rock arm of the J-hook structure and the toe of the right bank terrace.

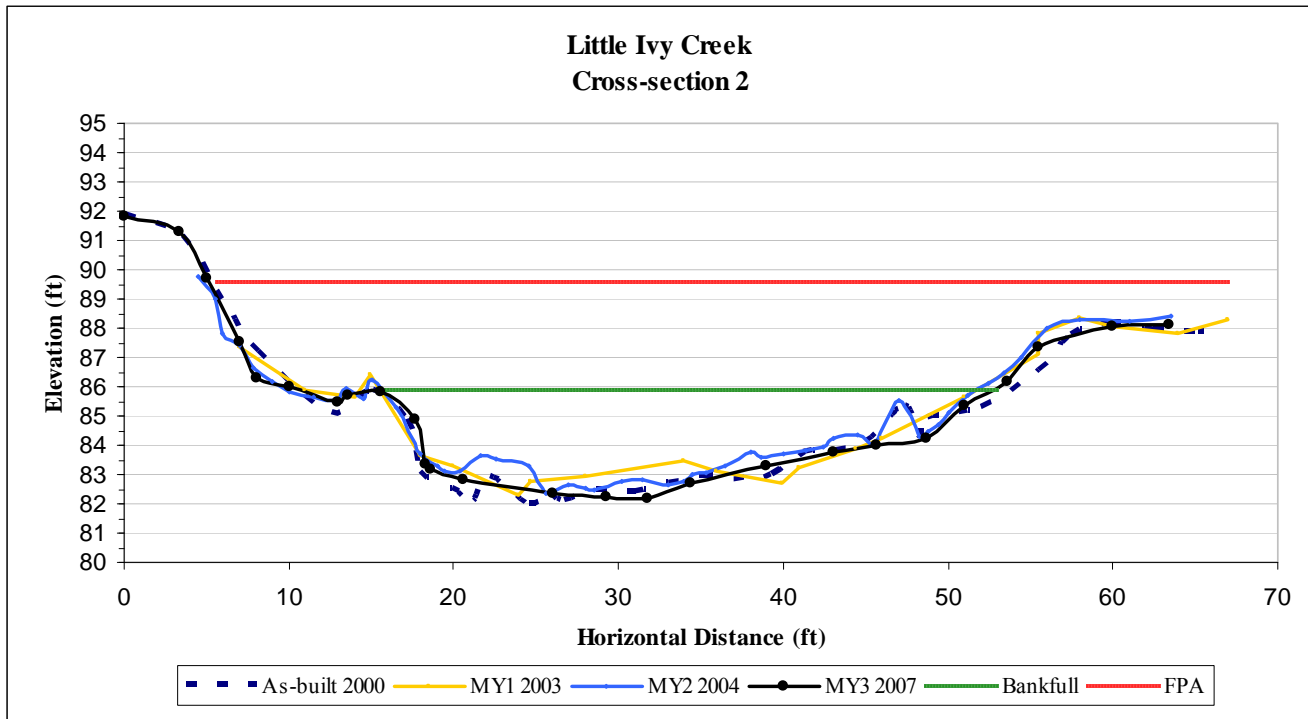
Cross-section 2, Pool (Appendix Table A.1.2.).—The left and right banks of this cross-section have remained stable during the seven years following construction. The vegetation on the left bank is well established; the riparian buffer on the right bank is well established with mature trees and a dense stand of non-native bamboo. The thalweg has experienced little to no change. Values presented in Appendix Table A.1.2. from Mulkey (2003) for MY1 do not come close to approximating values derived from the MY2 or MY3 survey data. It is suspected that the values for MY1 were derived from a bankfull estimation that was 2-3 ft lower than the actual bankfull elevation. This would have defined bankfull elevation as being at the toe of the constructed rock vane arm; whereas, the bankfull elevation at this cross-section is actually on top of the rocks that form the vane arm.

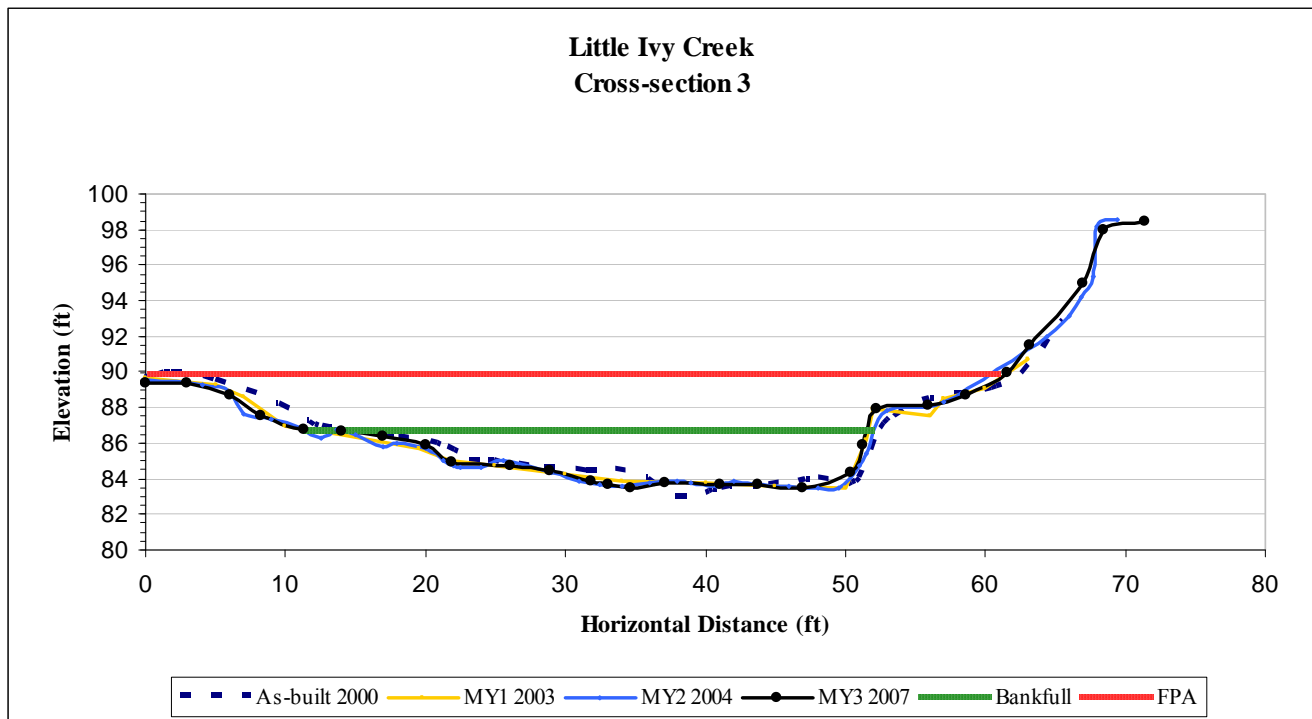
Cross-section 3, Riffle (Appendix Table A.1.3.).—The thalweg at cross-section 3 has shown no evidence of change over the seven years since project construction. Planted vegetation has helped to stabilize the right bank above the constructed rock toe revetment. The left bank is stable and well vegetated.

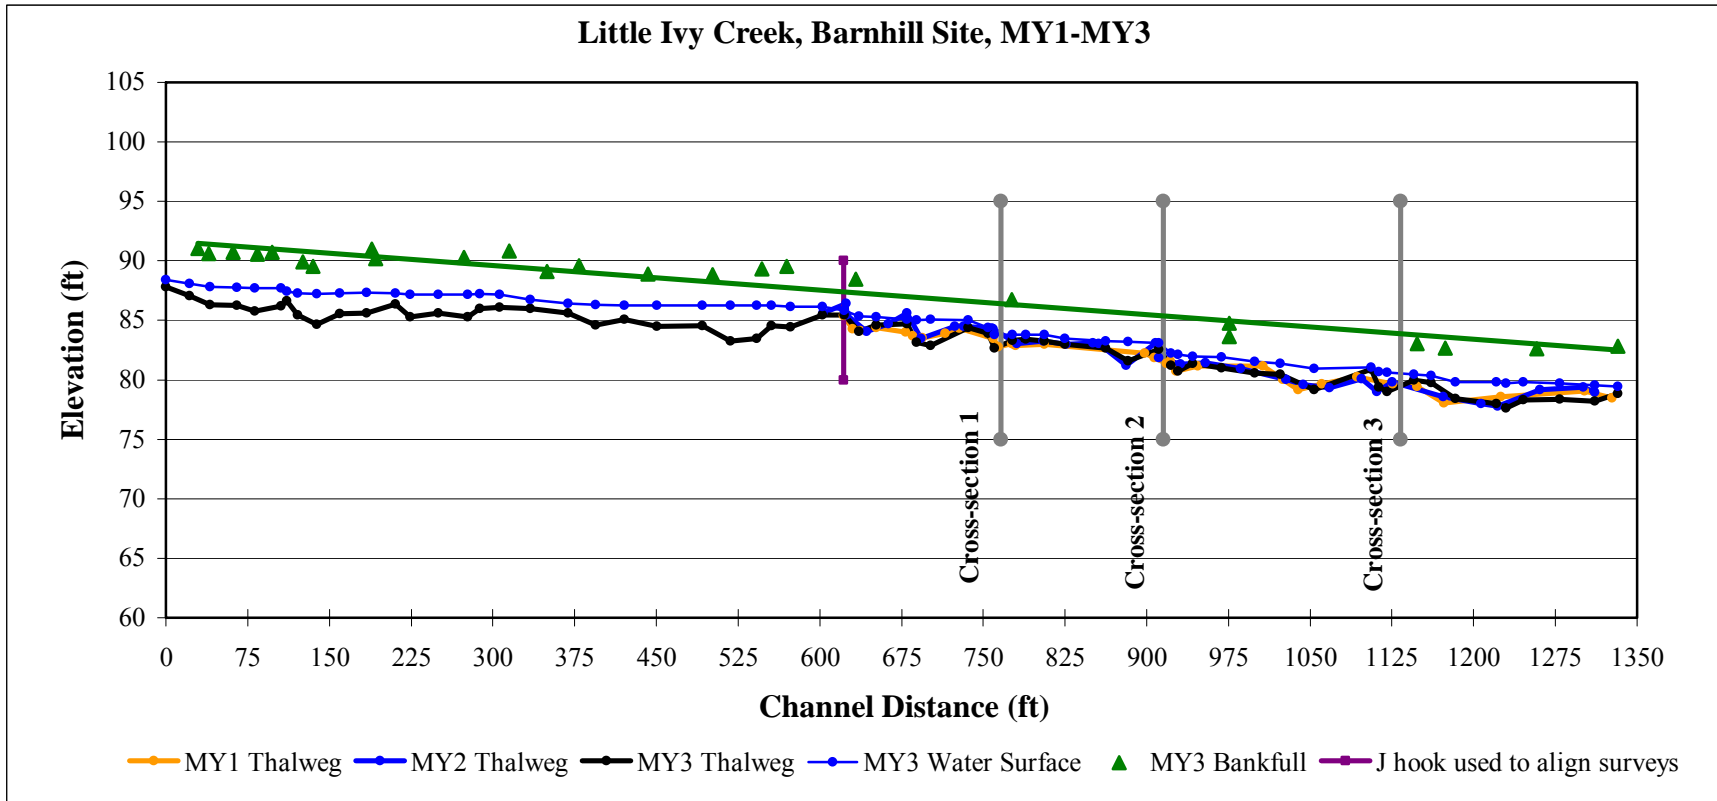
The longitudinal profile survey included the entire project reach (sta. 0+00 to sta. 13+38; Appendix A.2.). Elevations of the stream bed, water surface, bankfull indicators, and top of the low banks were recorded. Channel sinuosity was 1.1 and the average water surface slope was 0.009 ft/ft. Any change in thalweg depth or location of stream features when comparing the longitudinal profiles among monitoring years is likely due to natural year-to-year variation in stream bed movement and formation. The MY3 longitudinal profile survey found that the

thalweg was stable with minimal aggradation, degradation, or lateral movement occurring along the entire reach.

Longitudinal Profile.—Although sinuosity is on the low end for a C type channel (1.1), the water surface slope (0.009 ft/ft) is typical for a C stream type. Evidence of the channel attempting to increase its sinuosity (laterally extend) has not been observed. It is unlikely that lateral extension will occur given that the left and right bank vegetation is well established. Overall, the channel thalweg has and is expected to remain stable with little aggradation, degradation, or lateral movement under typical hydrologic conditions.

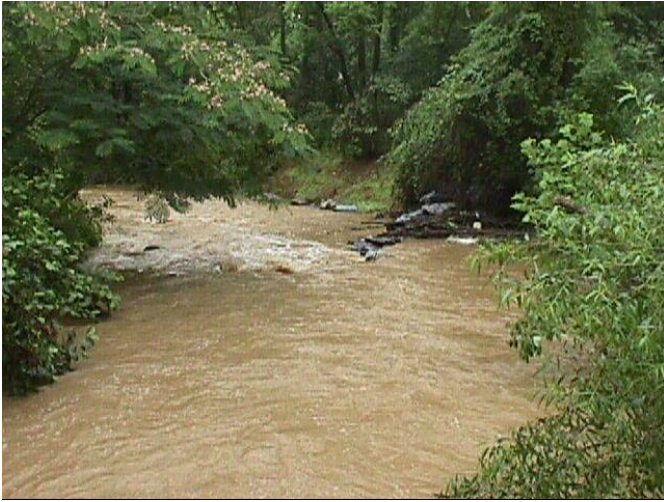
Bankfull photo, downstream at photo sta. 4, June 29, 2000.

Two of the bankfull events at the project site (June 29, 2000 and July 30, 2001) were photographically documented (Appendix A.5.). High flow discharges \geq 500 cfs recorded on consecutive days were counted as a single bankfull event.

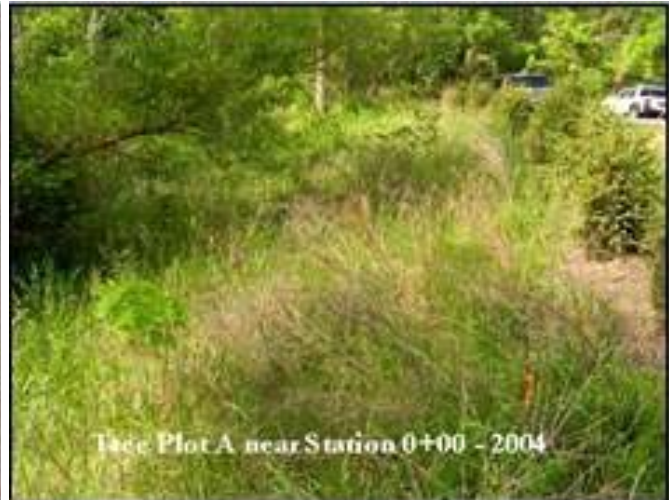
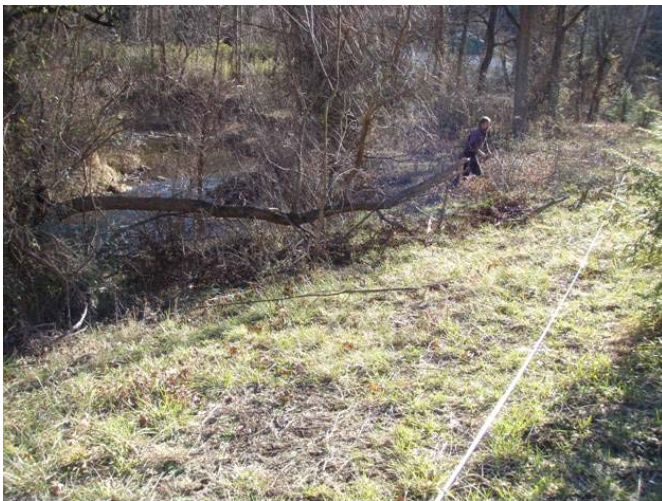
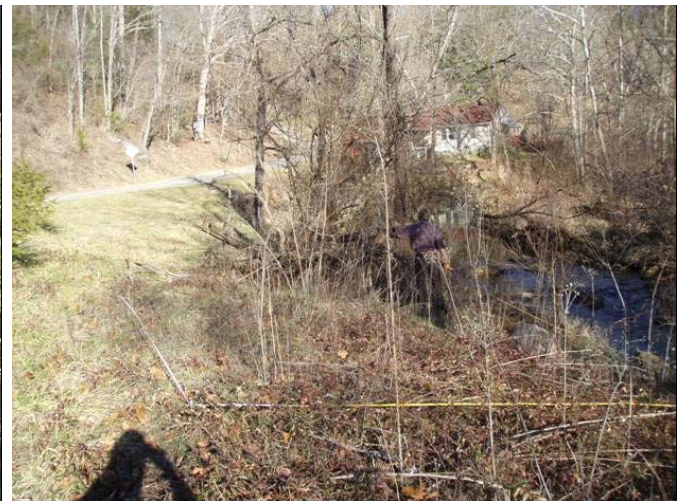
Tree Plot A.—The number of woody stems present in tree plot A decreased from 7 to 4 between MY2 and MY3 (Exhibit Table 5). Some of this decrease can be attributed to NCDOT roadside mowing during the fall of 2007. Tree plot A is adjacent to SR 1540; therefore, the plot is susceptible to right-of-way maintenance mowing. The mowed stems included two green ash *Fraxinus pennsylvanica* trees and a red maple *Acer rubra*. Moreover, of the three river birch *Betula nigra* stems noted in the MY1 survey, only one stem was found in MY2, whereas none was found in MY3. It is uncertain if the river birch stems succumbed to natural mortality or if mowing was the cause for their loss. Eastern gamagrass *Tripsacum dactyloides*, goldenrod *Solidago* sp., and blackberry *Rubus* sp. also were observed in tree plot A.

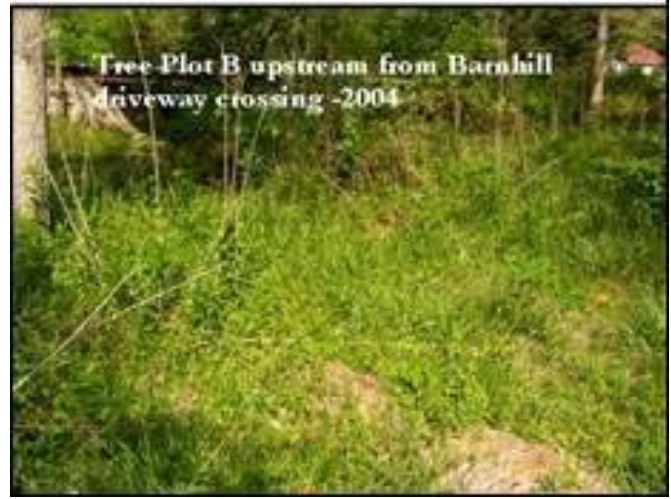
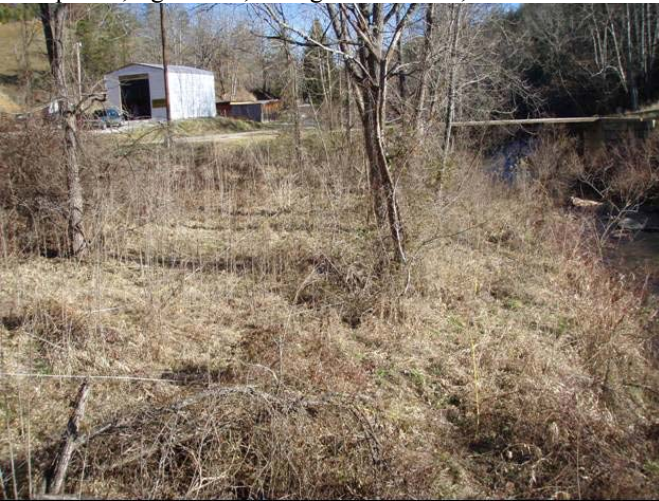
Tree Plot B.—The number of woody stems present in tree plot B increased from 5 to 12 between MY2 and MY3 (Exhibit Table 5). This is likely due to recruitment of new stems. In addition to the recruitment noted in the MY2 report (black walnut *Juglans nigra* and black cherry *Prunus serotina*), woody stems of staghorn sumac *Rhus typhina* (2) and persimmon *Diospyros virginiana* (1) were noted during the MY3 vegetation survey. The addition of recruited stems has helped to offset the loss of green ash stems. Seven green ash stems were noted in MY1; only three stems were noted in MY3. Herbaceous species included goldenrod, muscadine *Vitis rotundifolia*, and greenbrier *Smilax* sp.

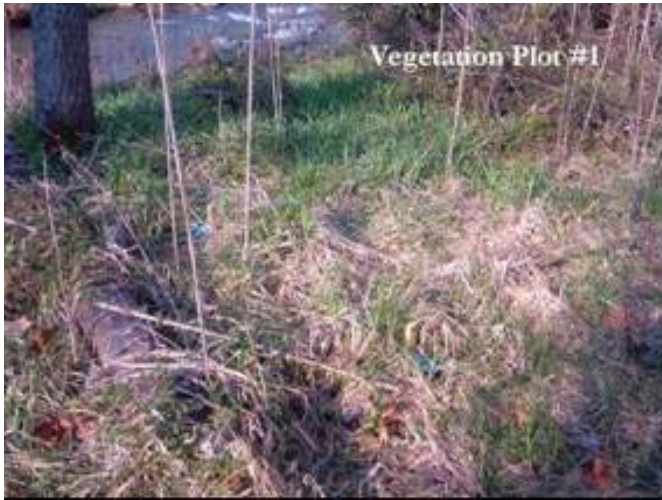
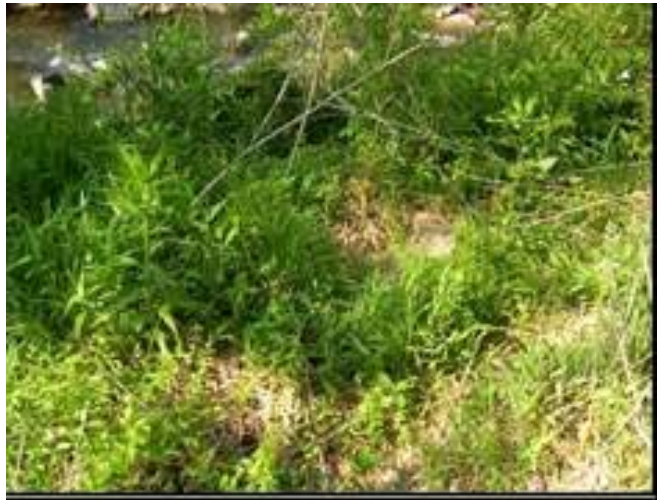
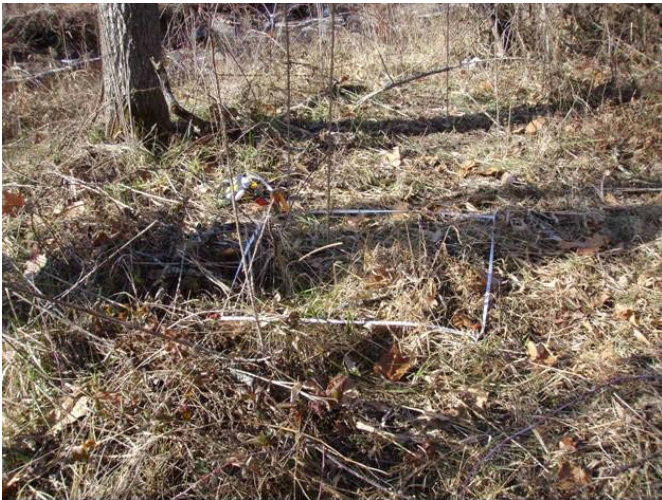
Vegetation Plot 1.—No woody stems were observed in vegetation plot 1, representing no change from past monitoring years. Eastern gamagrass was observed in the herbaceous layer, mixed in with tall fescue *Festuca* sp. Japanese honeysuckle *Lonicera japonica* also was present.

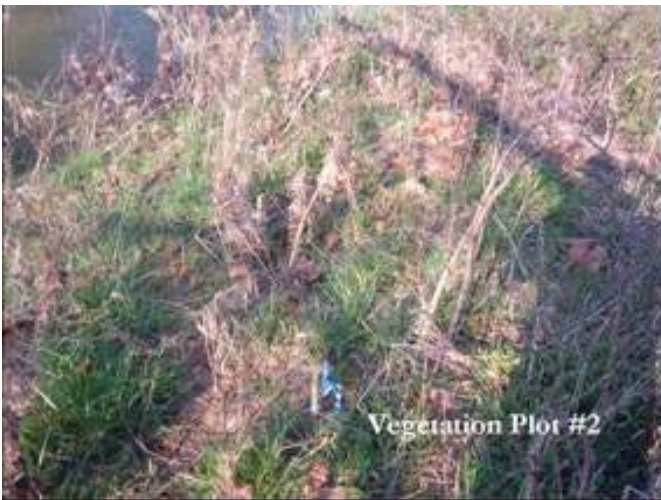
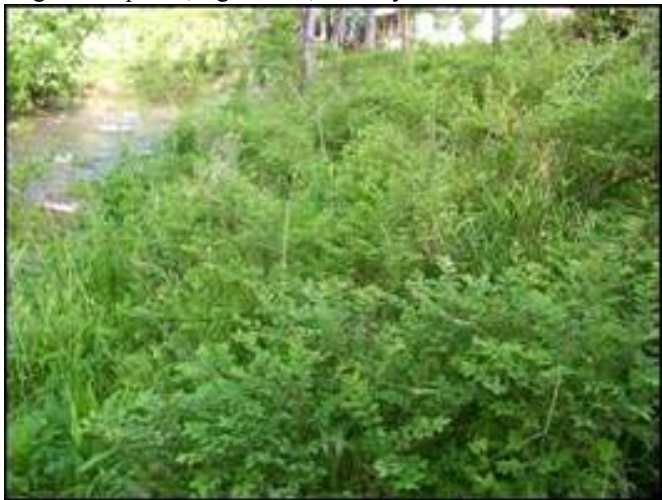
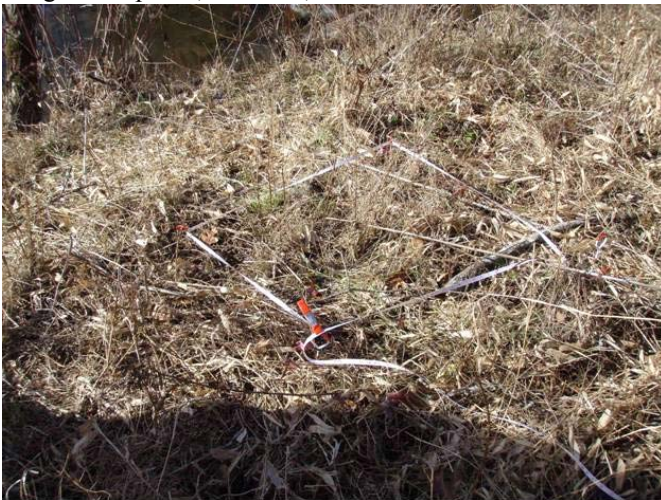
Vegetation Plot 2.—No woody stems have been observed in vegetation plot 2 during any of the three monitoring surveys. A mix of Eastern gamagrass and tall fescue was observed in the herbaceous layer. A small amount of Japanese honeysuckle was present.

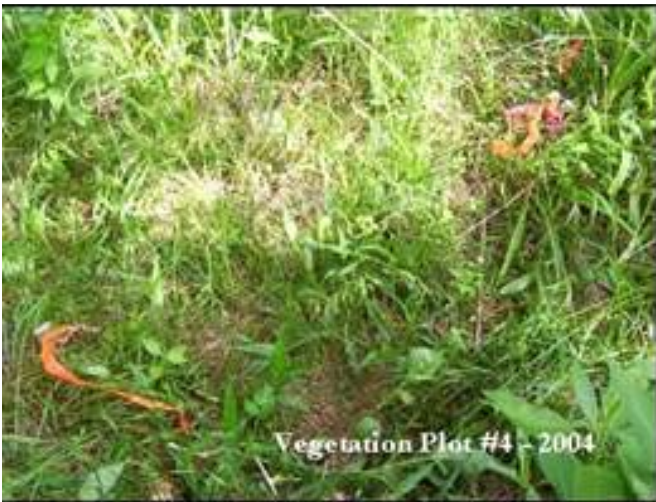
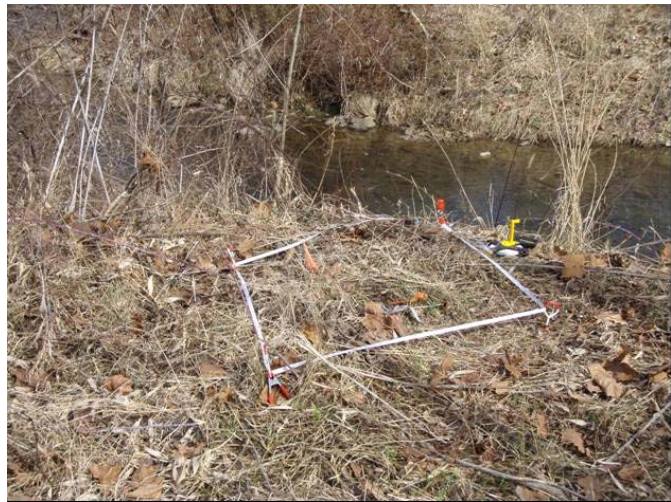
Vegetation Plot 4.—No woody stems have been observed in vegetation plot 4 during any of the three vegetation monitoring surveys. Tall fescue was the dominant species in the herbaceous layer, which also included wild onion *Allium canadense*, henbit deadnettle *Lamium amplexicaule*, and black berry.

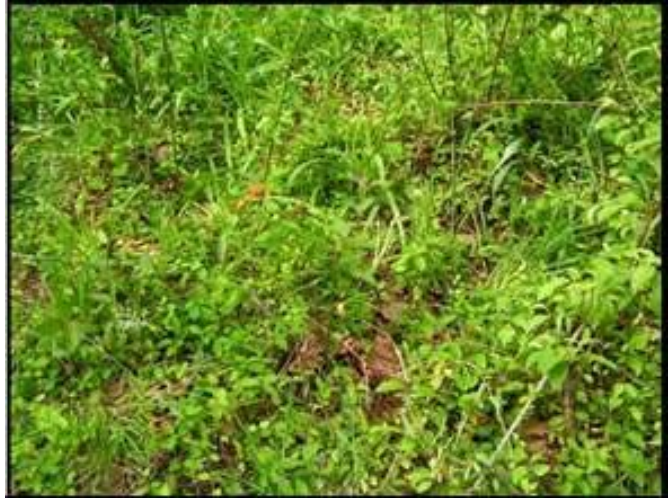
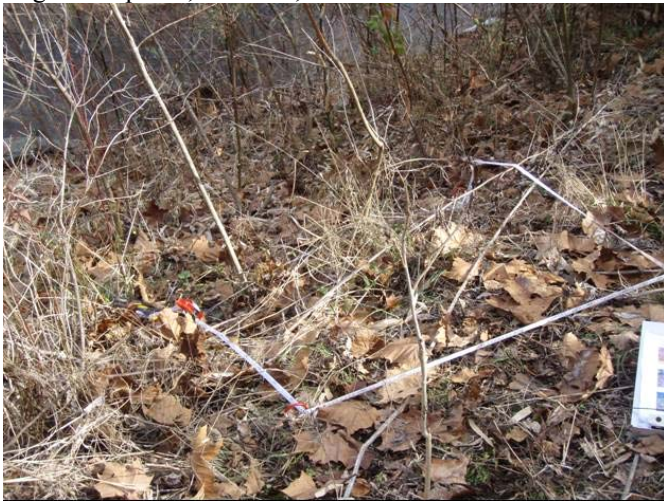
Vegetation Plot 5.—One silky dogwood *Cornus amomum* stem has been observed in vegetation plot 5 during each of the three vegetation monitoring surveys. Tall fescue was the dominant ground cover. Sparse sprigs of Japanese honeysuckle were present.

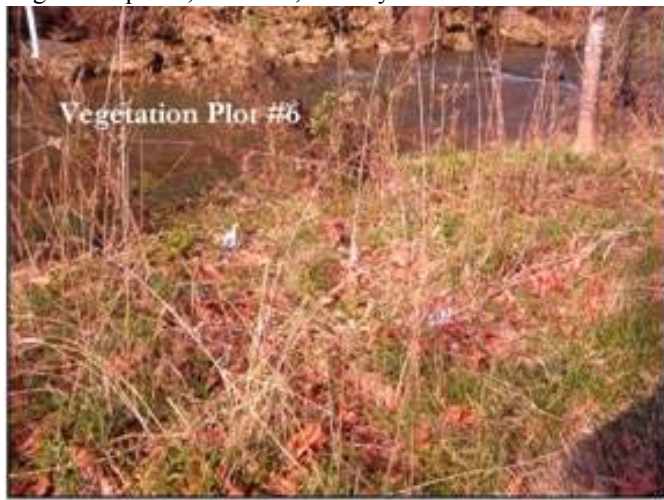
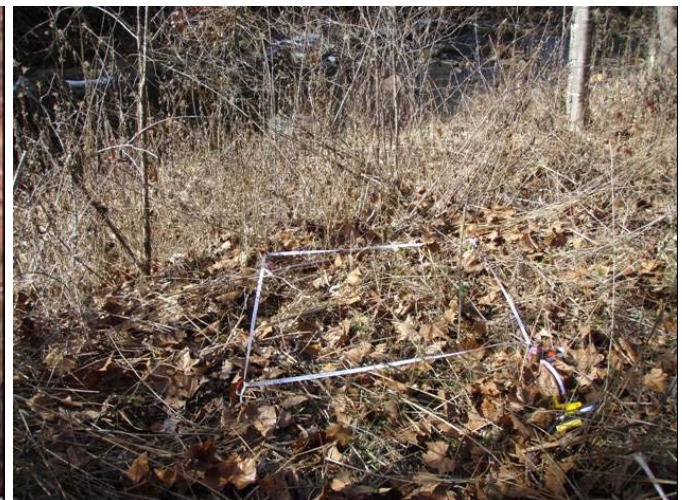
Vegetation Plot 6.—A single willow oak *Quercus phellos* stem was observed in MY3. A single woody stem also was noted during the MY1 and MY2 surveys, but the stem was identified as a cherrybark oak *Quercus pagoda* in MY2 and a willow oak in MY1. Tall fescue was the dominant herbaceous species; goldenrod and Japanese honeysuckle were observed, but less prevalent.
