BEAMON'S RUN BUFFER AND WETLAND RESTORATION SITE
(BARNHILL FARM)
MONITORING REPORT (2009)

Greene County, North Carolina
EEP Project No. 24

Status of Plan: Final
Submission Date: December 2009

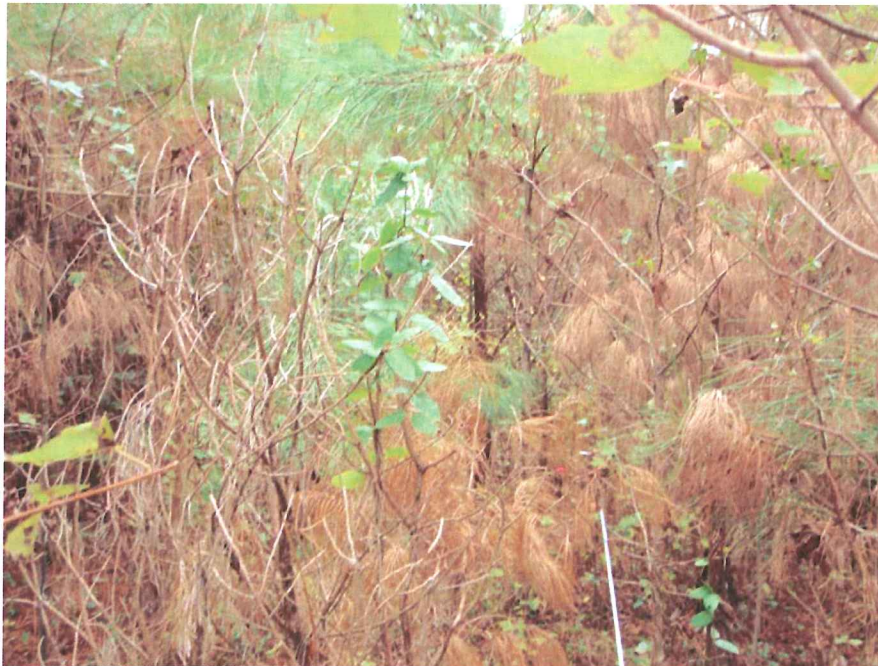
EXHIBIT TABLE A6. VEGETATION PROBLEM AREAS			
Feature/Issue	Station # / Range	Probable Cause	Photo #
Weak numbers of planted species	VP-3, VP-7, VP-10, VP-11A	Competition from volunteers, poor soil, early mortality	2
Weak numbers of planted Longleaf Pine	VP-4, VP-9	No management for Longleaf / competition from Loblolly Pine	1

Photo 1 – Dense loblolly pine recruitment in vicinity of Veg Plot 4 (10/7/09)

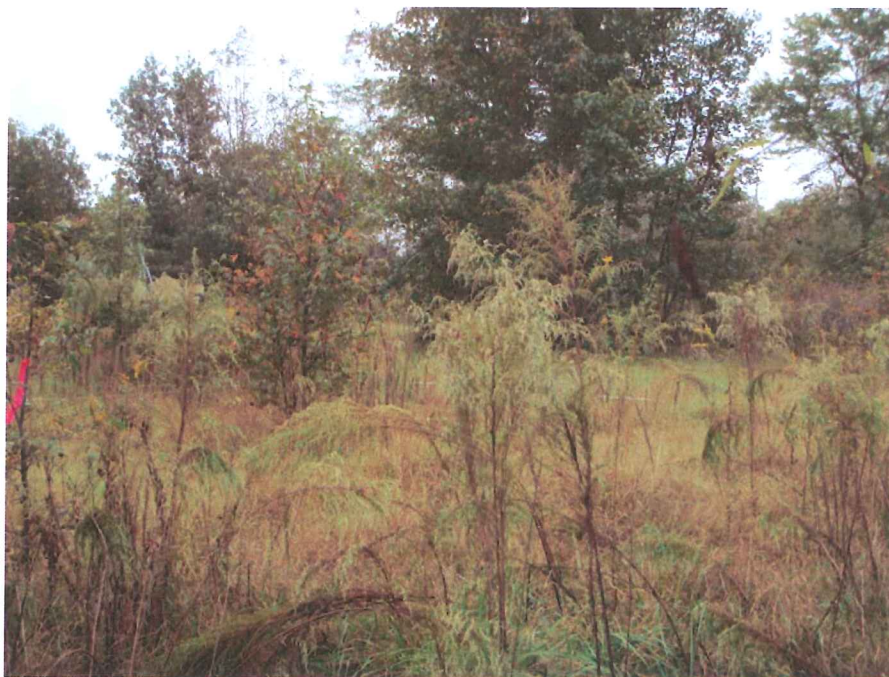
Photo 2 – Low planted species survival in vicinity of Veg Plot 7A (10/7/09)

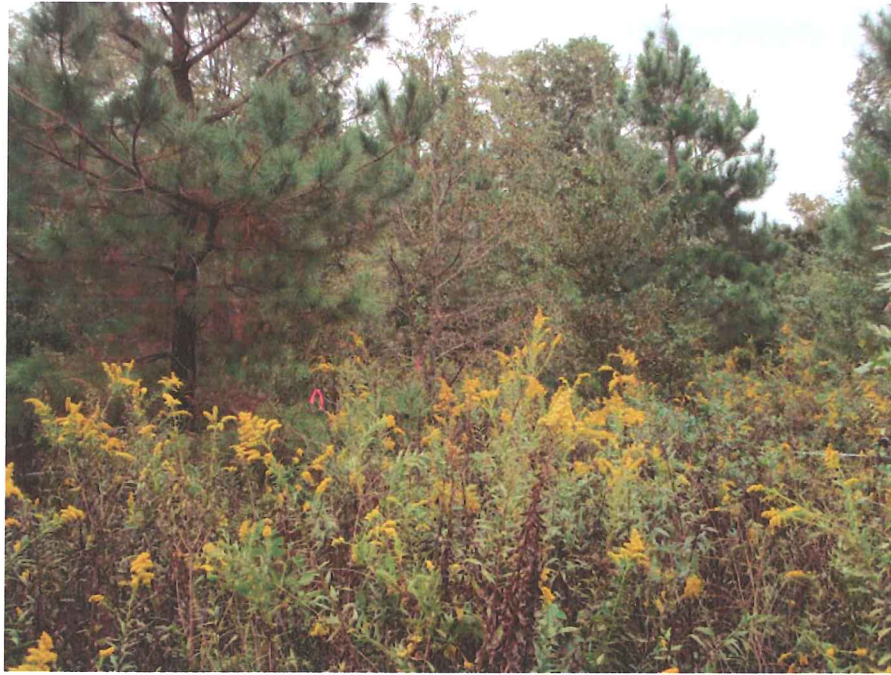
Photo Station 3 - Vegetation Plot 3 (10/6/09)

Monitoring revealed that 6 of the 12 plots (50%) met the vegetative success criteria of 320 planted stems or greater per acre. The remaining 6 plots failed to meet the success criteria (plots 3, 4, 7, 9, 10 and 11A). There are a number of issues causing the failure of these plots. Vegetation Plots 4 and 9 (VP-4, VP-9) exhibited poor survival of planted longleaf likely resulting from high densities of volunteer loblolly recruitment. This may be an issue related to a lack of forest management for longleaf pines after planting. VP-7 was located in an area that appeared to have poor soil due to residual debris from the site's history of being a tire dump. It could have been attributed to early mortality of oak species after planting. It is difficult to discern the exact reasons for poor planted species survival in the vegetation plots and elsewhere on the site since it has been 9 years since vegetation installation. Seedlings may have been shaded out, eaten by wildlife, affected by recent droughts, or in some cases affected by mowing.
