BEAMON'S RUN BUFFER AND WETLAND RESTORATION SITE  
(BARNHILL FARM)  
MONITORING REPORT (2012)

Greene County, North Carolina  
EEP Project No. 24

Status of Plan: Final  
Project Planted: 2000  
Data Collected: October 2012  
Submission Date: November 2012

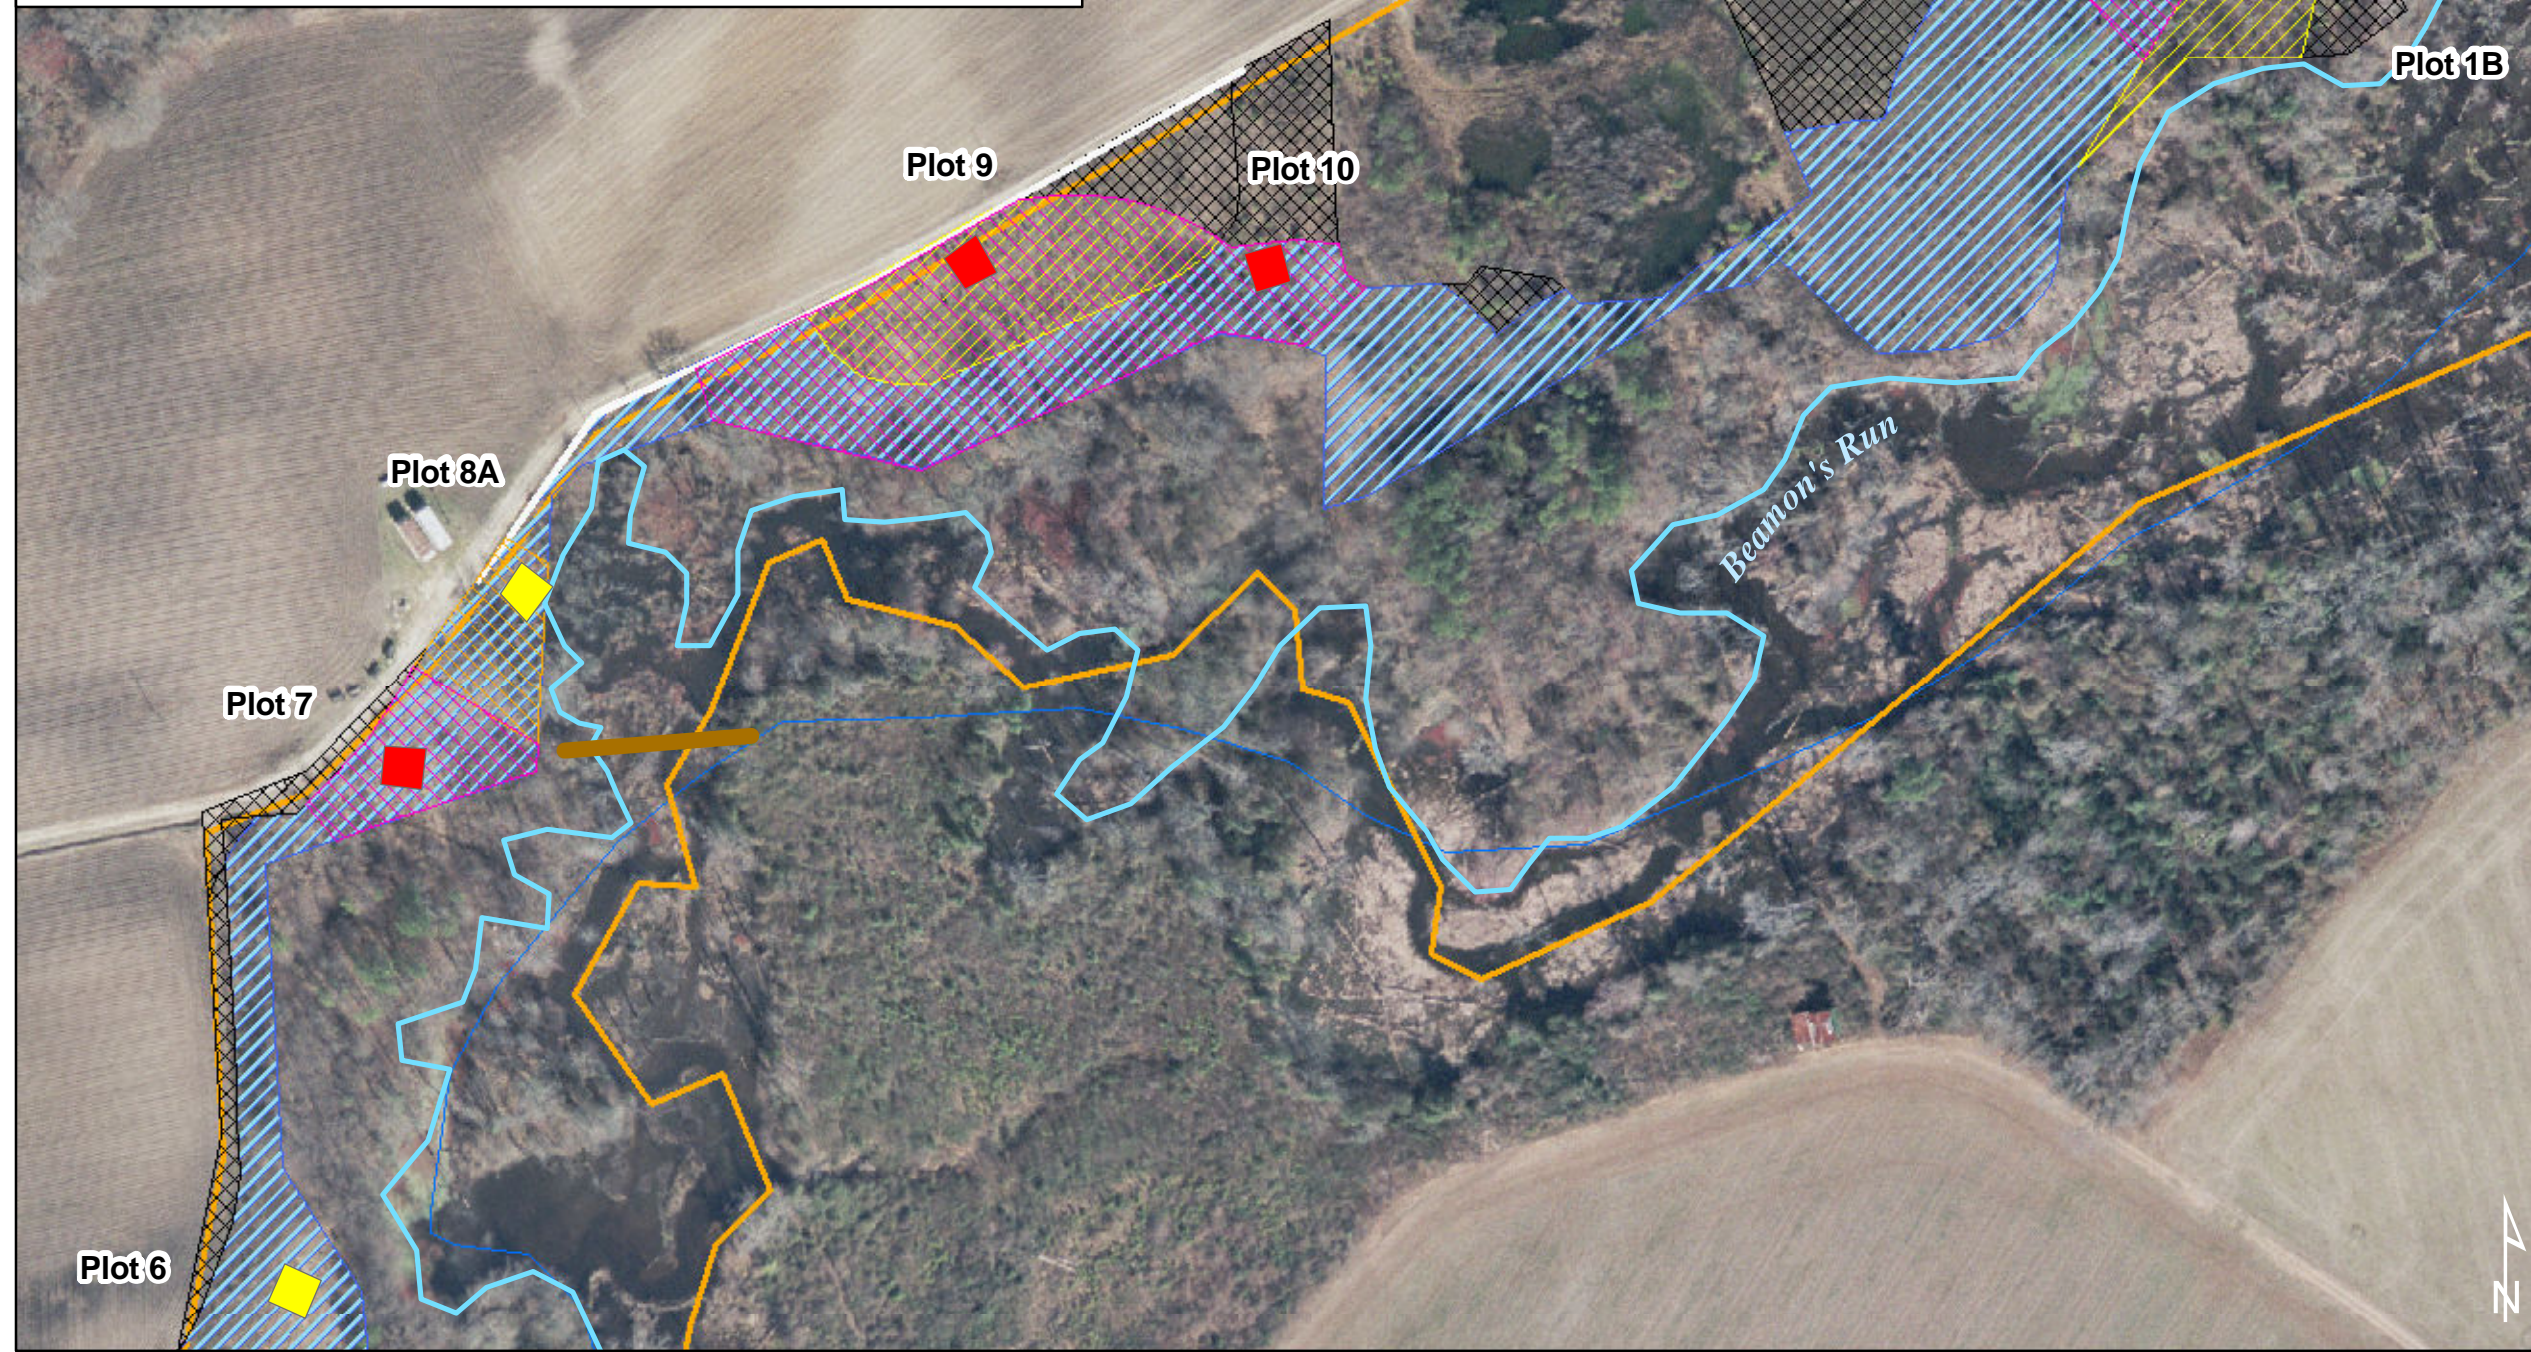
Figure 2 - Sheet 3

Note:  
The area on this sheet depicted in the planting plan as river birch is actually bigger than originally shown. The entirety of Plot 1B is planted with River Birch.

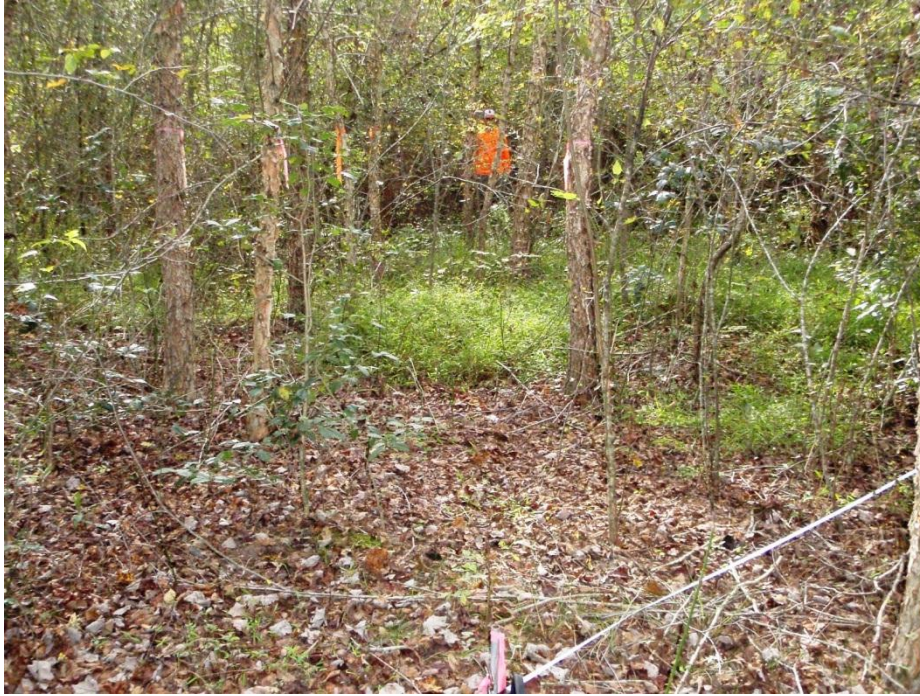
**Photo Station 1 – Vegetation Plot 1B**

<b>Table 7. Veg Plot Criteria Attainment</b>		
<b>Beamon's Run Buffer and Wetland Restoration Site/EEP Project No. 24</b>		
Vegetation Plot ID	Vegetation Survival Threshold Met?	Tract Mean
VP1B	Y (688)	50%
VP2	Y (364)	
VP3	N (202)	
VP4	N (0)	
VP5	Y (445)	
VP6	Y (526)	(331 stems/acre)
VP7	N (81)	
VP8A	Y (567)	
VP9	N (0)	
VP10	N (162)	
VP11A	N (81)	
VP12A	Y (728)

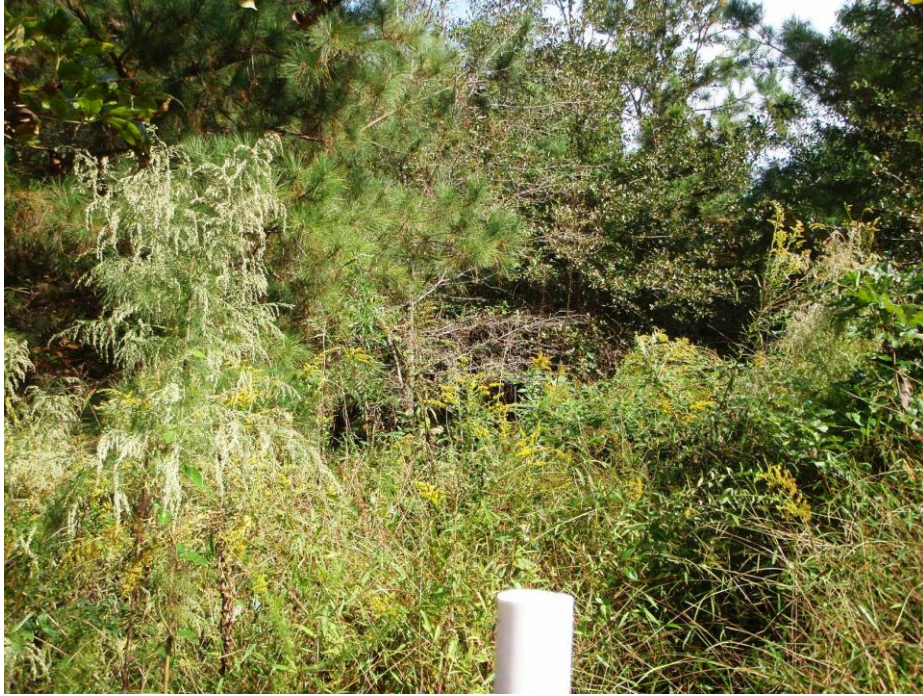
**Photo Station 3 – Vegetation Plot 3**

During the previous monitoring field visit conducted in August 2011, several beaver dams were observed on-site near vegetation plots 3, 8A, and 12A. Despite the presence of the beaver dams no recent signs of beaver activity were observed in the vegetation plots; in fact areas that previously exhibited extensive beaver damage have rebounded considerably in 2012. Plants that were resprouting from stumps as well as numerous small saplings of desired species were observed. It was also noted during the annual monitoring that vegetation in areas that had been previously mowed and/or sprayed prior to 2009 are continuing to

The annual vegetation monitoring occurred on October 17<sup>th</sup>, 2012 and found that little change has occurred since the previous monitoring visit in August 2011. The beaver dams are still in place near vegetation plots 3, 8A, and 12A with no recent beaver damage in the vegetation plots. Wind damage previously documented in the 2011 monitoring report was still evident particularly in vegetation plot 7. The two planted species affected by a windblown tree have survived and are growing without incident. Common invasive species onsite still include *Lespedeza* and Japanese honeysuckle but have not expanded since 2011 and do not seem to be a major concern for desirable vegetation establishment. *Ligustrum sinense* was also observed in 2012 near vegetation plot 2. *Lespedeza* occurs along the field edges while Japanese honeysuckle is prevalent across the entire site. A few areas, particularly in the eastern portions of the site, the honeysuckle is dense and could cause problems in the future. Currently the invasive vegetation is not affecting planted woody vegetation. It is recommended that the invasive vegetation continue to be monitored for potential issues in the future.

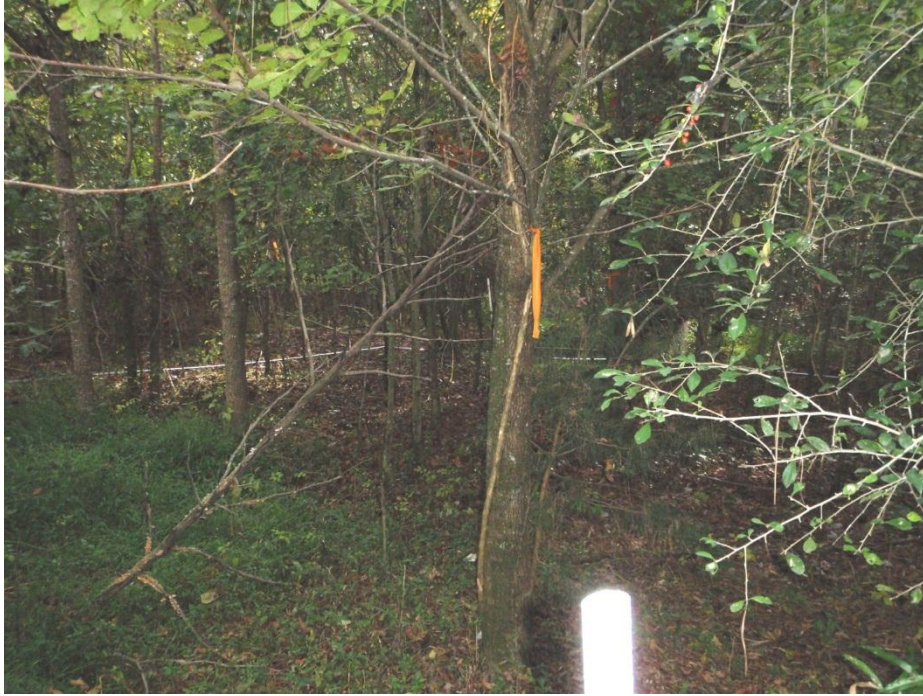
**Photo Station 5 – Vegetation Plot 5**

regenerate, and additional mowing and/or spraying has not occurred in 2012. There was an ATV path observed inside the conservation easement between vegetation plots 6 and 5.
