**Bear Basin Restoration Site  
Monitoring Report MY08  
DMS Project # 95362  
DMS Contract # 004741**

**Onslow County, NC  
CU# 03030001  
DWR# 2013-0456  
SAW# 2012-01391**

**Construction Completed: February 2015  
Data Collection: 2022  
Submitted: January 2023**

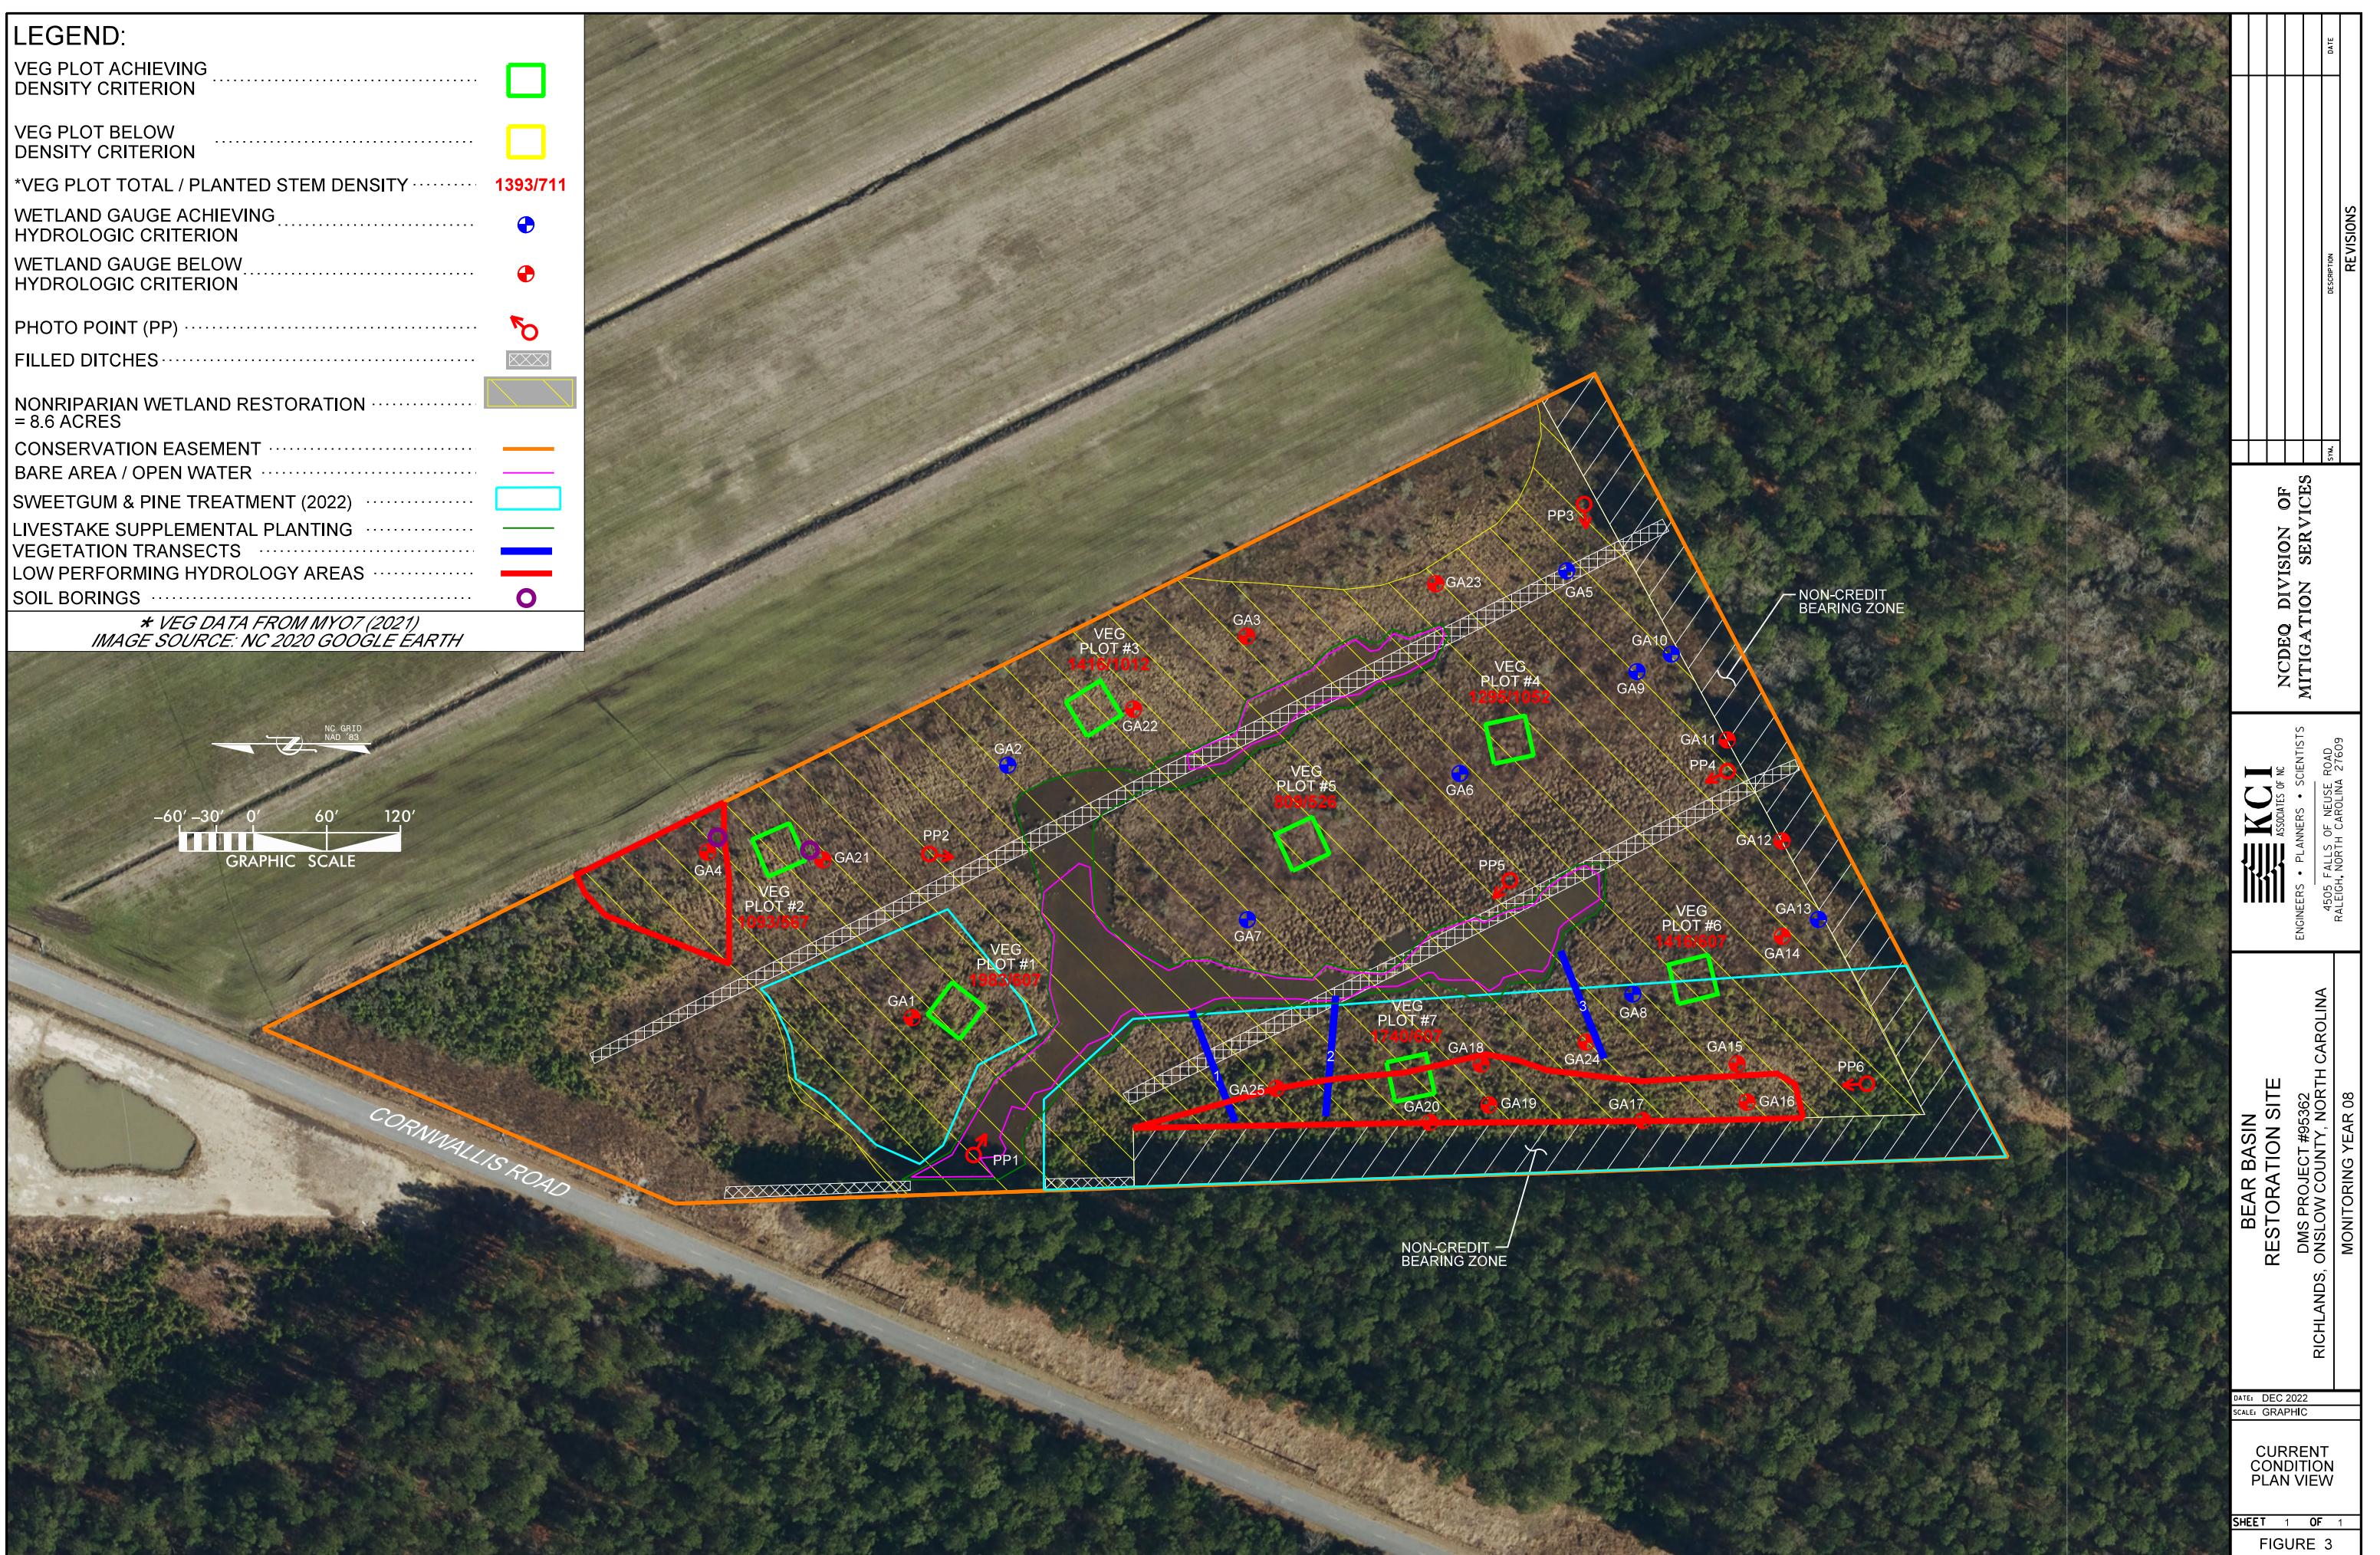
The majority of the gauges that have not met the success criteria in more than 50% of the years that they were installed are located near the western edge of the site. This area of the site is bordered by a large ditch that was not filled in as part of the project because it is located on a different parcel than the project. When the mitigation plan was prepared, the potential horizontal drainage influence of this ditch was modeled using Lateral Effect and determined to be 85 feet. It was assumed that other on-site modifications, such as filling other ditches and surface roughening, would increase the surface and groundwater across the entire site and decrease the effect of this ditch. For this reason, the non-credit bearing area associated with this ditch was set at half of the area of influence of this ditch (42.5 feet from the ditch). Based on the data obtained from the gauges during monitoring, it was determined that the extent of influence of this ditch was greater than originally estimated. To determine the exact extent of the area of influence of this ditch, an analysis of the soils and vegetation in this area was completed on December 5, 2022. This analysis also looked at the area around Gauge 4, which has only achieved the success criteria in 2 of the 8 years that it has been installed. This analysis identified the soils on the site as having a dark mineral surface underlain by a lighter E or Bt horizon, consistent with the site's mapped soil series of Stallings and Rains. In areas of the site that had consistently met the hydrologic success criteria, this Bt horizon generally began at a shallower depth, had a lower chroma, and showed stronger evidence of redoximorphic features than in areas that had failed to meet the success criteria consistently. F3 – Depleted Matrix and A11 – Depleted Below Dark Surface were the predominant hydric soil indicator used during this delineation. There were also some areas of A12 – Thick Dark Surface, but in general, areas with thick dark surfaces failed to meet the chroma or redox requirements for the underlying layer that this indicator requires. A representative description of both soil types is presented in Appendix A – Visual Assessment Data. After identifying the main difference between the "wet" and "dry" soils, a detailed delineation of the extent of each was completed in the areas that had shown less than ideal hydrology. Based on this analysis, 0.642 acres have been designated as low performing hydrology areas and KCI is proposing to remove these areas from crediting.

While the site hydrology has been below the success criteria in the areas as described above and there is an area of open water that is not ideal, this restoration site brings significant wetland functions back to this system and this part of the river basin. The open water and variable hydrology wetlands create a complex habitat with varied niches throughout the site. While some of the gauge data did not meet the hydrology success criteria, there were many years that some gauges were close to achieving. Additionally, one of the gauges in a non-credit area (Gauge 12) routinely met the success criteria, indicating that some non-credit portions of the site may have achieved wetland hydrology. This site also placed some adjacent non-credit upland acreage into the conservation easement that has developed into a diverse well vegetated buffer to the wetlands on-site. For these reasons, and as documented above, KCI would like to close out the low hydrology and open water areas at a 2:1 ratio.
