**Bear Basin Restoration Site
Monitoring Report MY06
DMS Project # 95362
DMS Contract # 004741**

**Onslow County, NC
CU# 03030001
DWR# 2013-0456
SAW# 2012-01391**

**Construction Completed: February 2015
Data Collection: 2020
Submitted: December 2020**

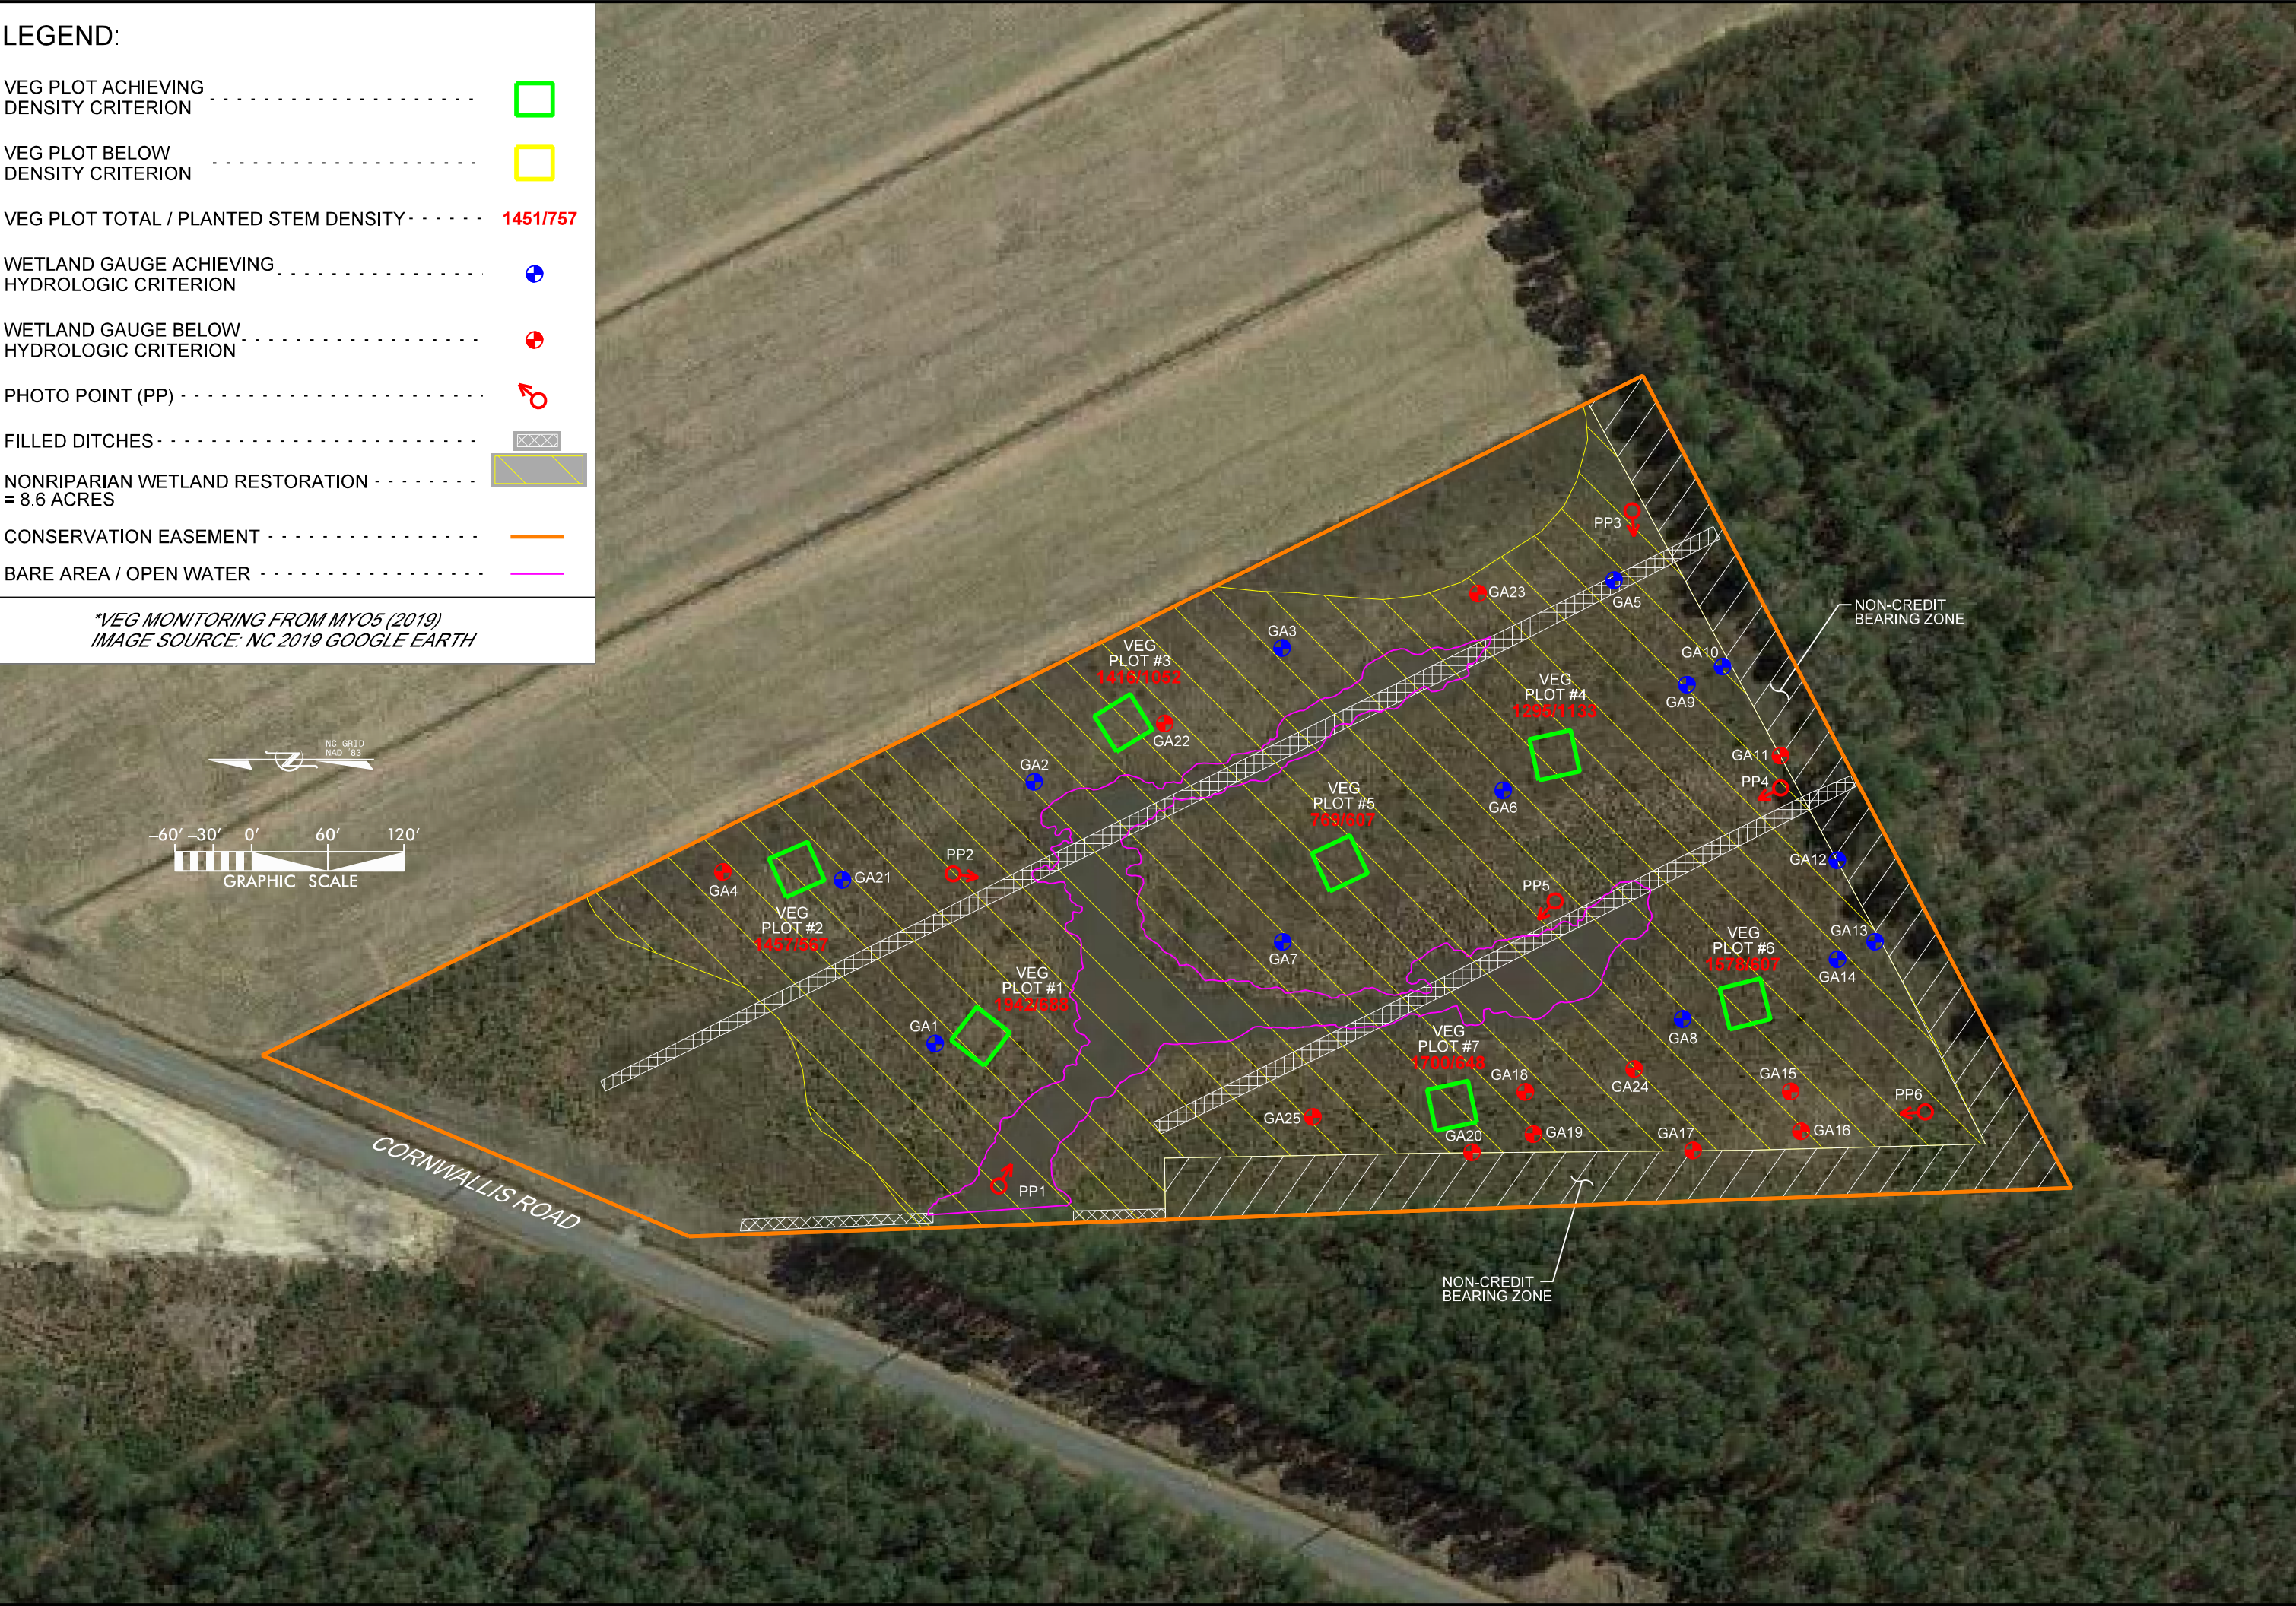
During the sixth monitoring year, vegetation monitoring did not occur, as stipulated in the mitigation plan. In general the site is well vegetated, with widespread herbaceous coverage and healthy planted stems. There is an area of open water that does not have significant vegetation. Over the course of the year, this area expands and shrinks with the seasons so that it reaches its fullest extent in the winter and its lowest during the summer. This results in areas around the edge that, while inundated during the winter, support vegetation during the summer. Species such as *Juncus effuses*, *Scirpus cyperinus*, *Scirpus atrovirens*, *Carex comosa*, *Carex vulpinodea*, and *Schoenoplectus tabernaemontani* are abundant in these areas. In December 2018, KCI used GPS to map the extent of the area that is inundated to the point of excluding vegetation year round and found it to be 0.87 acres. See Appendix B – Visual Assessment Data for more information.

1. Bare Areas	Very limited cover of both woody and herbaceous material.	0.1 acres	Pattern and Color	1	0.87	7.3%
2. Low Stem Density Areas	Woody stem densities clearly below target levels based on MY3, 4, or 5 stem count criteria.	0.1 acres	Pattern and Color	0	0.00	0.0%
Total				1	0.87	7.3%
