FINAL
YEAR 5 (2018) ANNUAL MONITORING REPORT
BEAR CREEK (PHILLIPS SITE) RESTORATION PROJECT

Chatham County, North Carolina
DMS Project No. 26 (Contract No. 5715)
DWR Project No. 0713-94
SCO No. 09-07726-01A

Data Collection – January-September 2018

RE: Bear Creek (Phillips) Monitoring (DMS Project # 26, Contract #5715)
Final MY5 (2018) Annual Monitoring Report

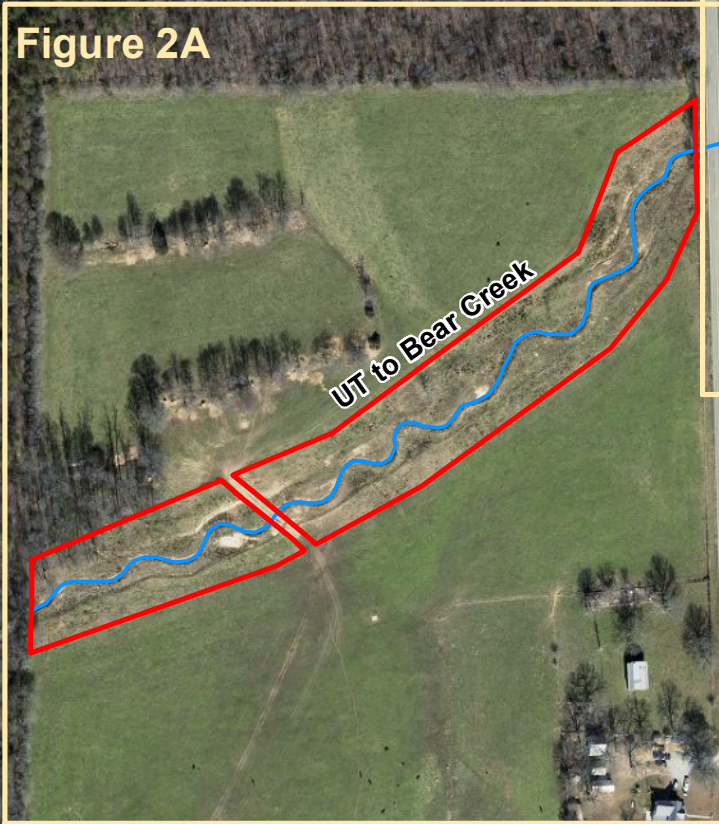
Two stream areas of concern were observed during monitoring year 5 (2018). They are depicted on Figure 2A in Appendix B. Area of Concern #1 was observed during the previous four monitoring years, and it has remained relatively unchanged. The right bank of the Unnamed Tributary to Bear Creek has failed causing the water to leave the stream channel and scour a new, smaller channel during storm events. Area of Concern #2 consists of bank scour in the inner bend of a pool caused by instream vegetation that has altered the flow path causing undercutting of the stream bank. Both areas have changed little from previous monitoring years, and both appear relatively stable with herbaceous vegetation becoming well-established.

Shortly after construction was complete, several large rain events caused flooding that scoured the floodplain, leaving it bare. Vegetation has established throughout much of the floodplain, but there are still a few small bare areas. These scoured areas have been depicted on Figures 2A-2B in Appendix B.

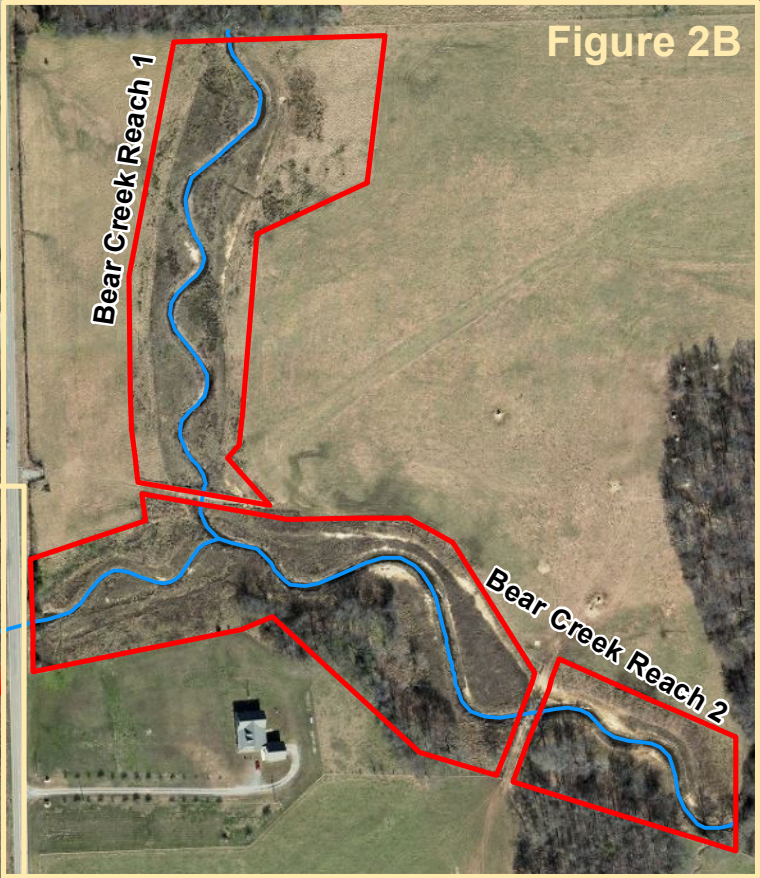
Figure 2B

- b. Figure 2B: Show damage to fence cause by remnants of Hurricane Florence on crossing at downstream end of Bear Creek Reach 1.
Callout text was inserted on figure 2B explaining that the fence had been damaged during the remnants of hurricane Florence.

One area of easement encroachment was observed during year 5 (2018) monitoring. Due to a scoured hole within the crossing on the upstream portion of the unnamed tributary, making it impassable to livestock, the adjacent landowner had removed a section of fencing within the crossing in order to walk cattle to the next pasture. The cattle were walking through a small corner of the easement. This area is depicted on Figure 2A (Appendix B) and has been addressed by NCDMS. The landowner has made necessary repairs to the fence, and the easement encroachment has ceased.

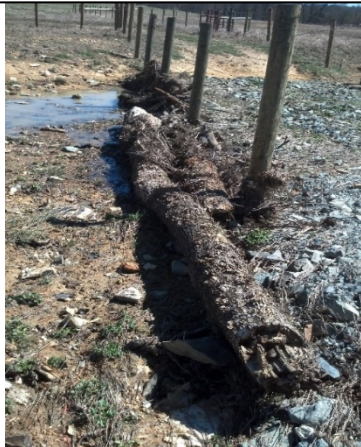
Bankfull Photo 1: Wrack on fence

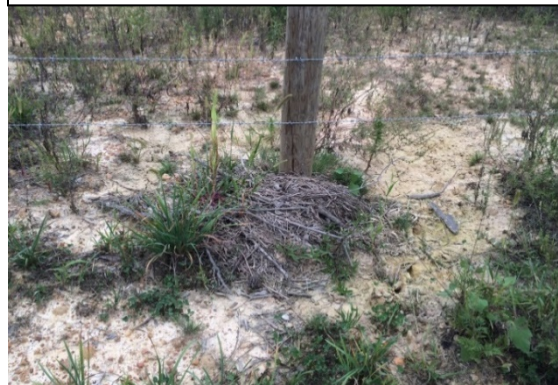
Bankfull Photo 2: Wrack piled on fencepost

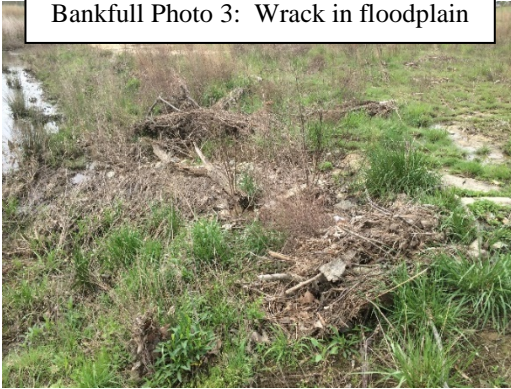
Bankfull Photo 3: Wrack in floodplain

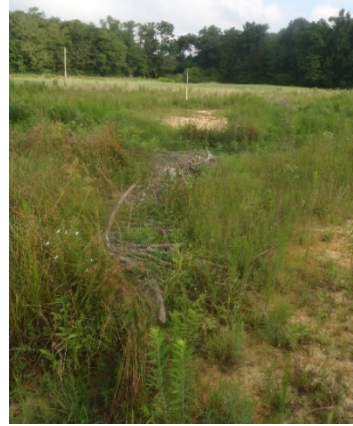
Bankfull Photo 4: Wrack in floodplain

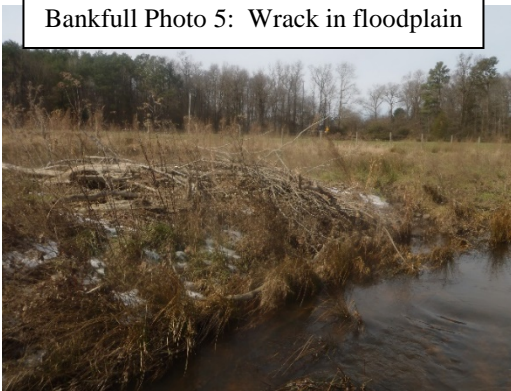
Bankfull Photo 5: Wrack in floodplain

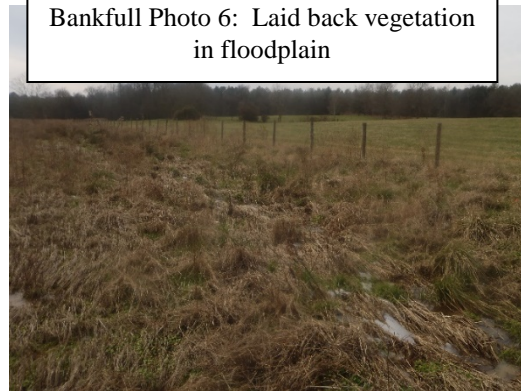
Bankfull Photo 6: Laid back vegetation in floodplain

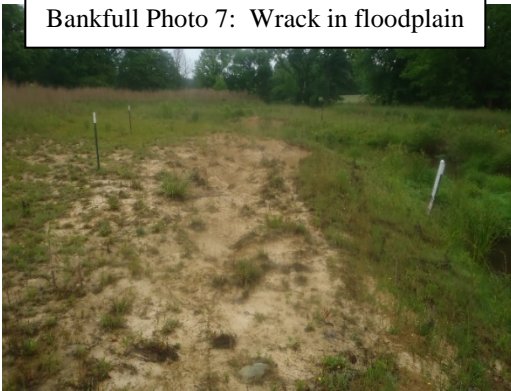
Bankfull Photo 7: Wrack in floodplain

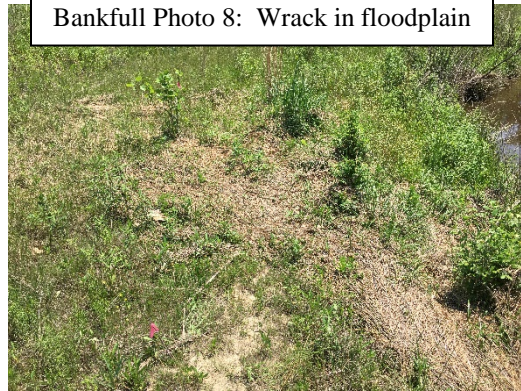
Bankfull Photo 8: Wrack in floodplain

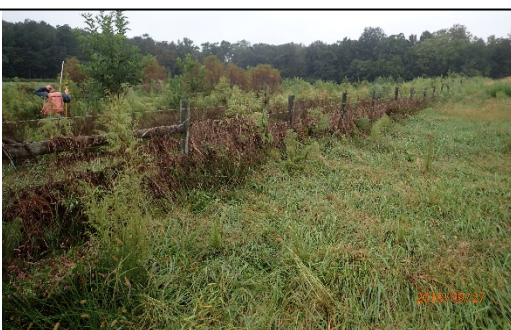
Bankfull Photo 9: Wrack on easement fencing

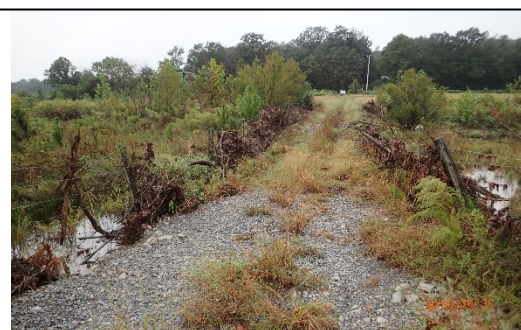
Bankfull Photo 10: Wrack on easement fencing

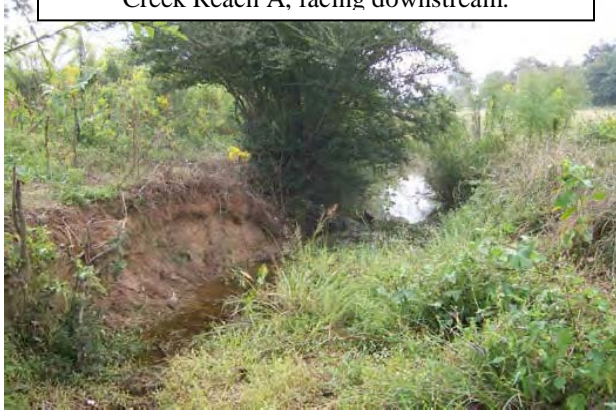
Photo 1-View of left bank erosion along Bear Creek Reach A, facing downstream.

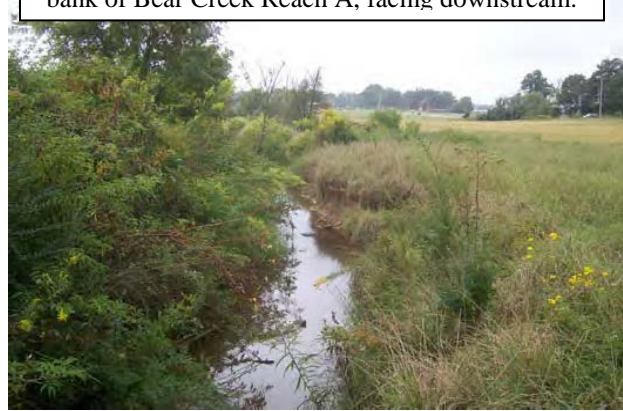
Photo 2-View of severe bank erosion along right bank of Bear Creek Reach A, facing downstream.

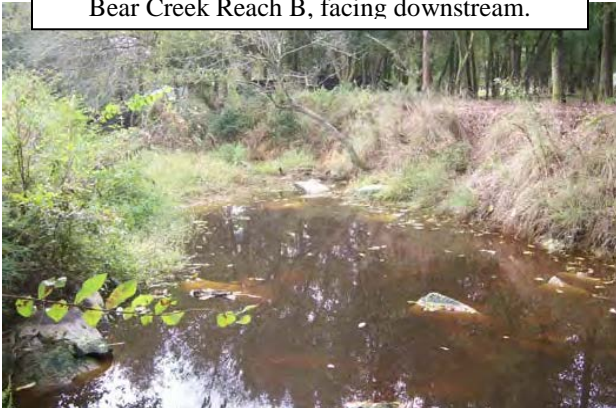
Photo 5- View of erosion along right bank of Bear Creek Reach B, facing downstream.

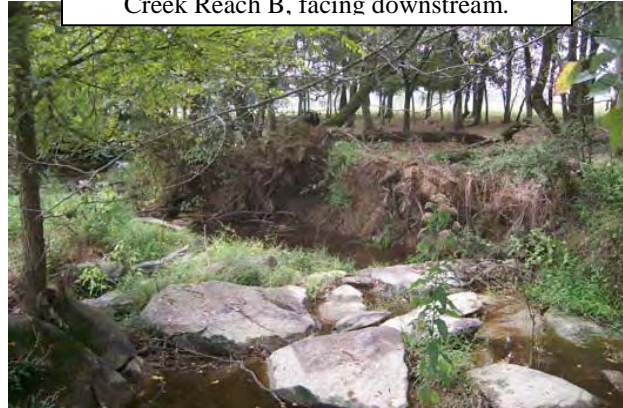
Photo 6-View of right bank erosion on Bear Creek Reach B, facing downstream.

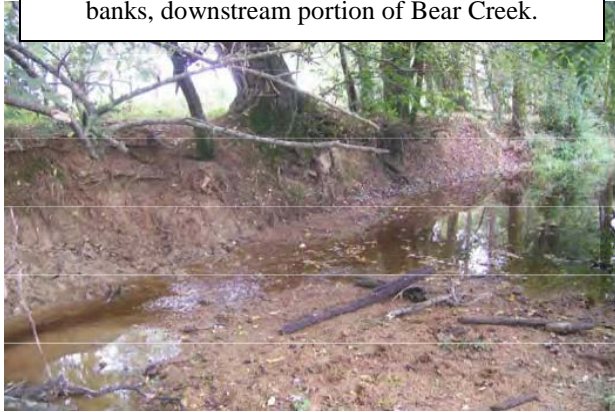
Photo 7-View of sediment deposition and vertical banks, downstream portion of Bear Creek.

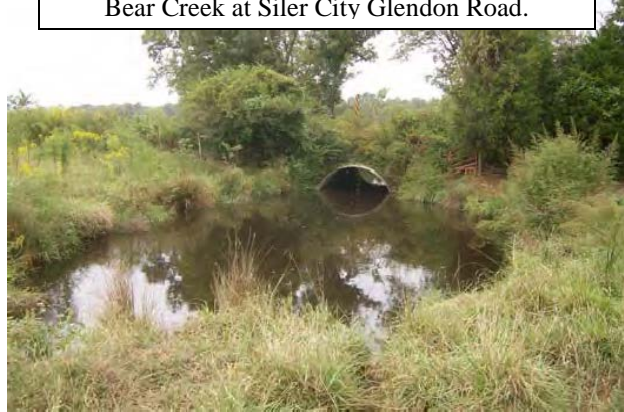
Photo 8-View of over-wide section of UT to Bear Creek at Siler City Glendon Road.
