FINAL
YEAR 1 (2014) ANNUAL MONITORING REPORT
BEAR CREEK (PHILLIPS SITE) RESTORATION PROJECT

Chatham County, North Carolina
EEP Project No. 26 (Contract No. 5715)
DWR Project No. 0713-94
SCO No. 09-07726-01A

Data Collection – May-October 2014

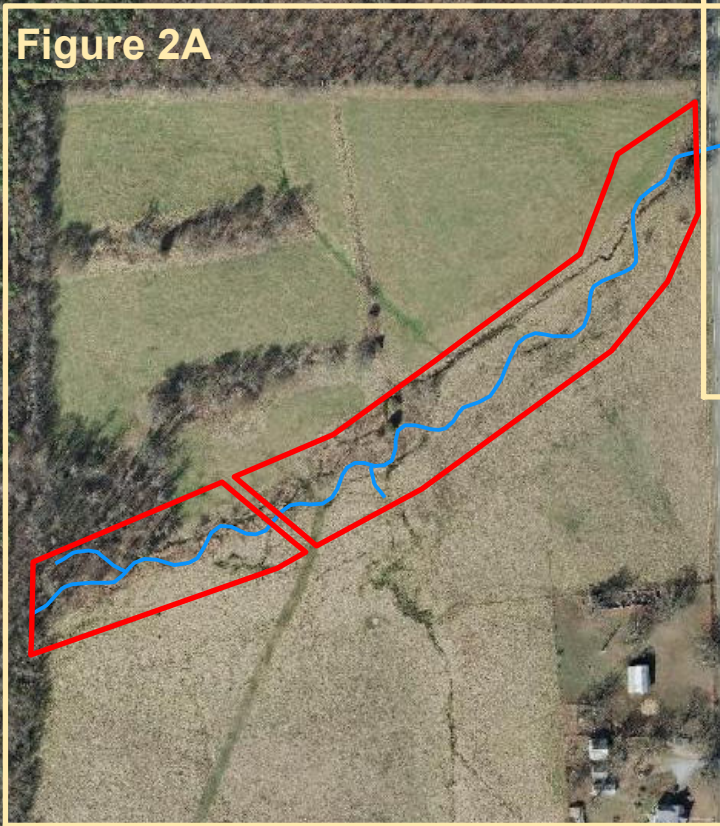
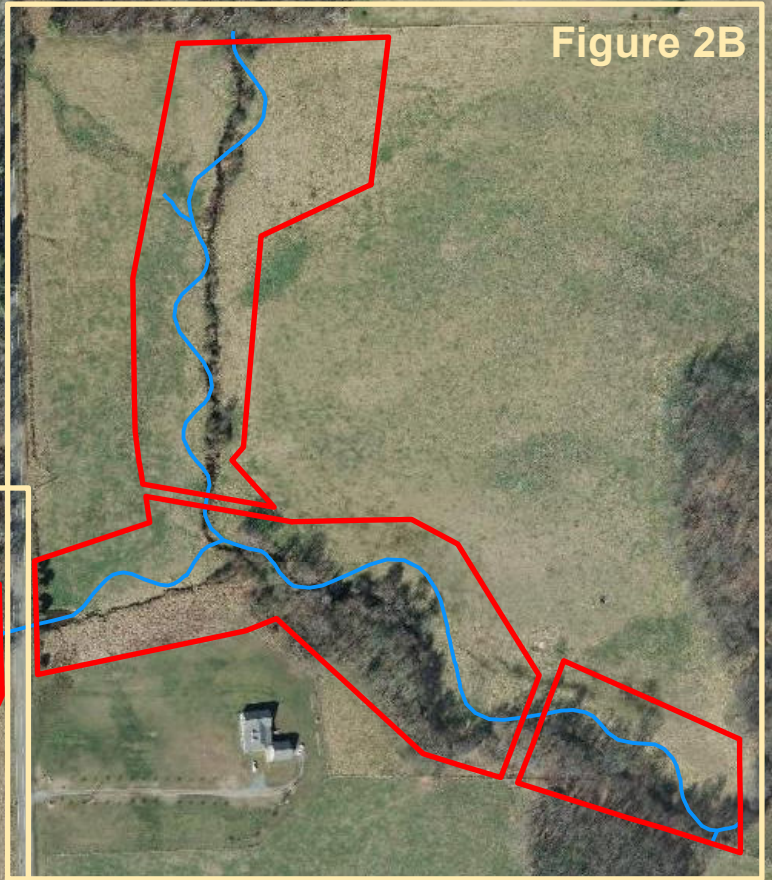
During monitoring year 1 (2014), two stream areas of concern were observed. An outer bend on the Unnamed Tributary to Bear Creek has been severely scoured (Area of Concern #1). The bank appears unstable and is void of all vegetation. One additional area of concern is the upstream culverted crossing on Bear Creek (Area of Concern #2). Rain events since construction have caused a significant amount of debris to block the culverts. Efforts to remove debris manually have been unsuccessful. During storm events the stream is bypassing the culvert and scouring the crossing. These areas of concern are depicted on Figures 2A-2B in Appendix B.

monitored include species composition and species density. Visual observations of the percent cover of shrub and herbaceous species will also be documented by photograph. Vegetation plot information can be found in Appendix C. MY1 (2014) stem count measurements indicate an average of 314 planted stems per acre (excluding livestock) across the Site, which is slightly below success criteria for monitoring year 1 (2014). Additionally, six of the twelve vegetation monitoring plots met success criteria. The lack of vegetation survival can be attributed to poor soils in the graded floodplain throughout the site. Also, just after construction was complete, several large rain events caused flooding that scoured the floodplain, leaving it bare. Vegetation is slowly establishing, but there are still many bare areas. These scoured areas have been depicted on Figures 2A-2B in Appendix B.

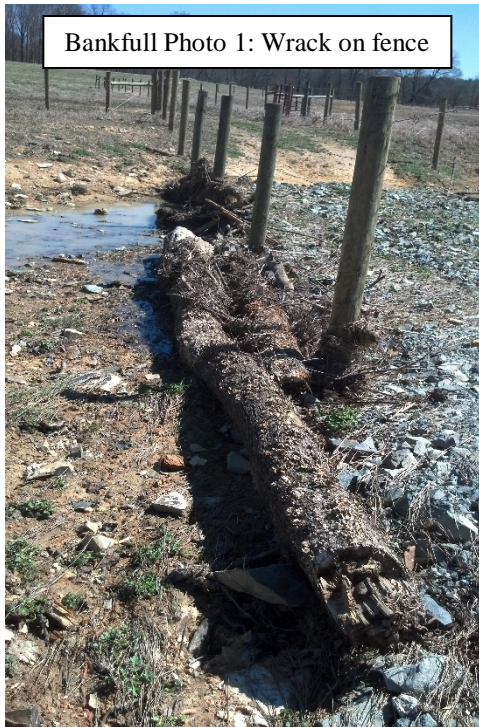
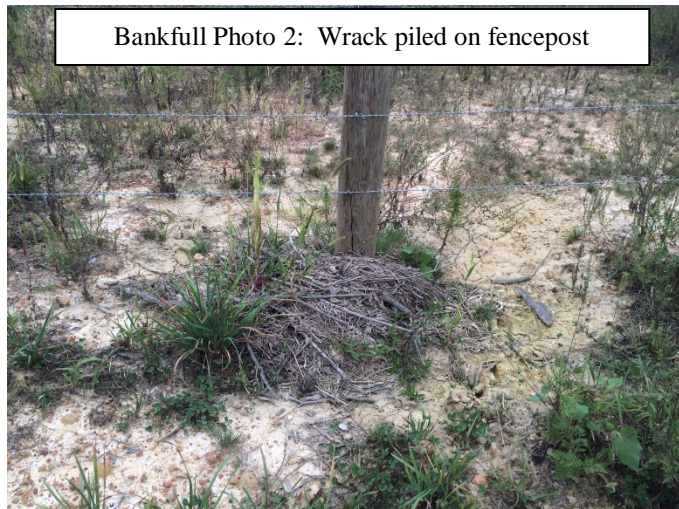
Date of Data Collection	Date of Occurrence	Method	Photo (if available)
March 13, 2014	March 7, 2014	Wrack on floodplain and crest gauge data indicate a bankfull event after 1.59 inches* of rain in one day.	1
August 22, 2014	May 15, 2014	Crest gauge data indicate a bankfull event after 2.08 inches* of rain in one day.	--
September 23, 2014	September 4, 2014	Wrack on floodplain and crest gauge data indicate bankfull event after 1.95 inches rain* in three days.	2
