FINAL
YEAR 2 (2015) ANNUAL MONITORING REPORT
BEAR CREEK (PHILLIPS SITE) RESTORATION PROJECT

Chatham County, North Carolina
DMS Project No. 26 (Contract No. 5715)
DWR Project No. 0713-94
SCO No. 09-07726-01A

Data Collection – May-September 2015

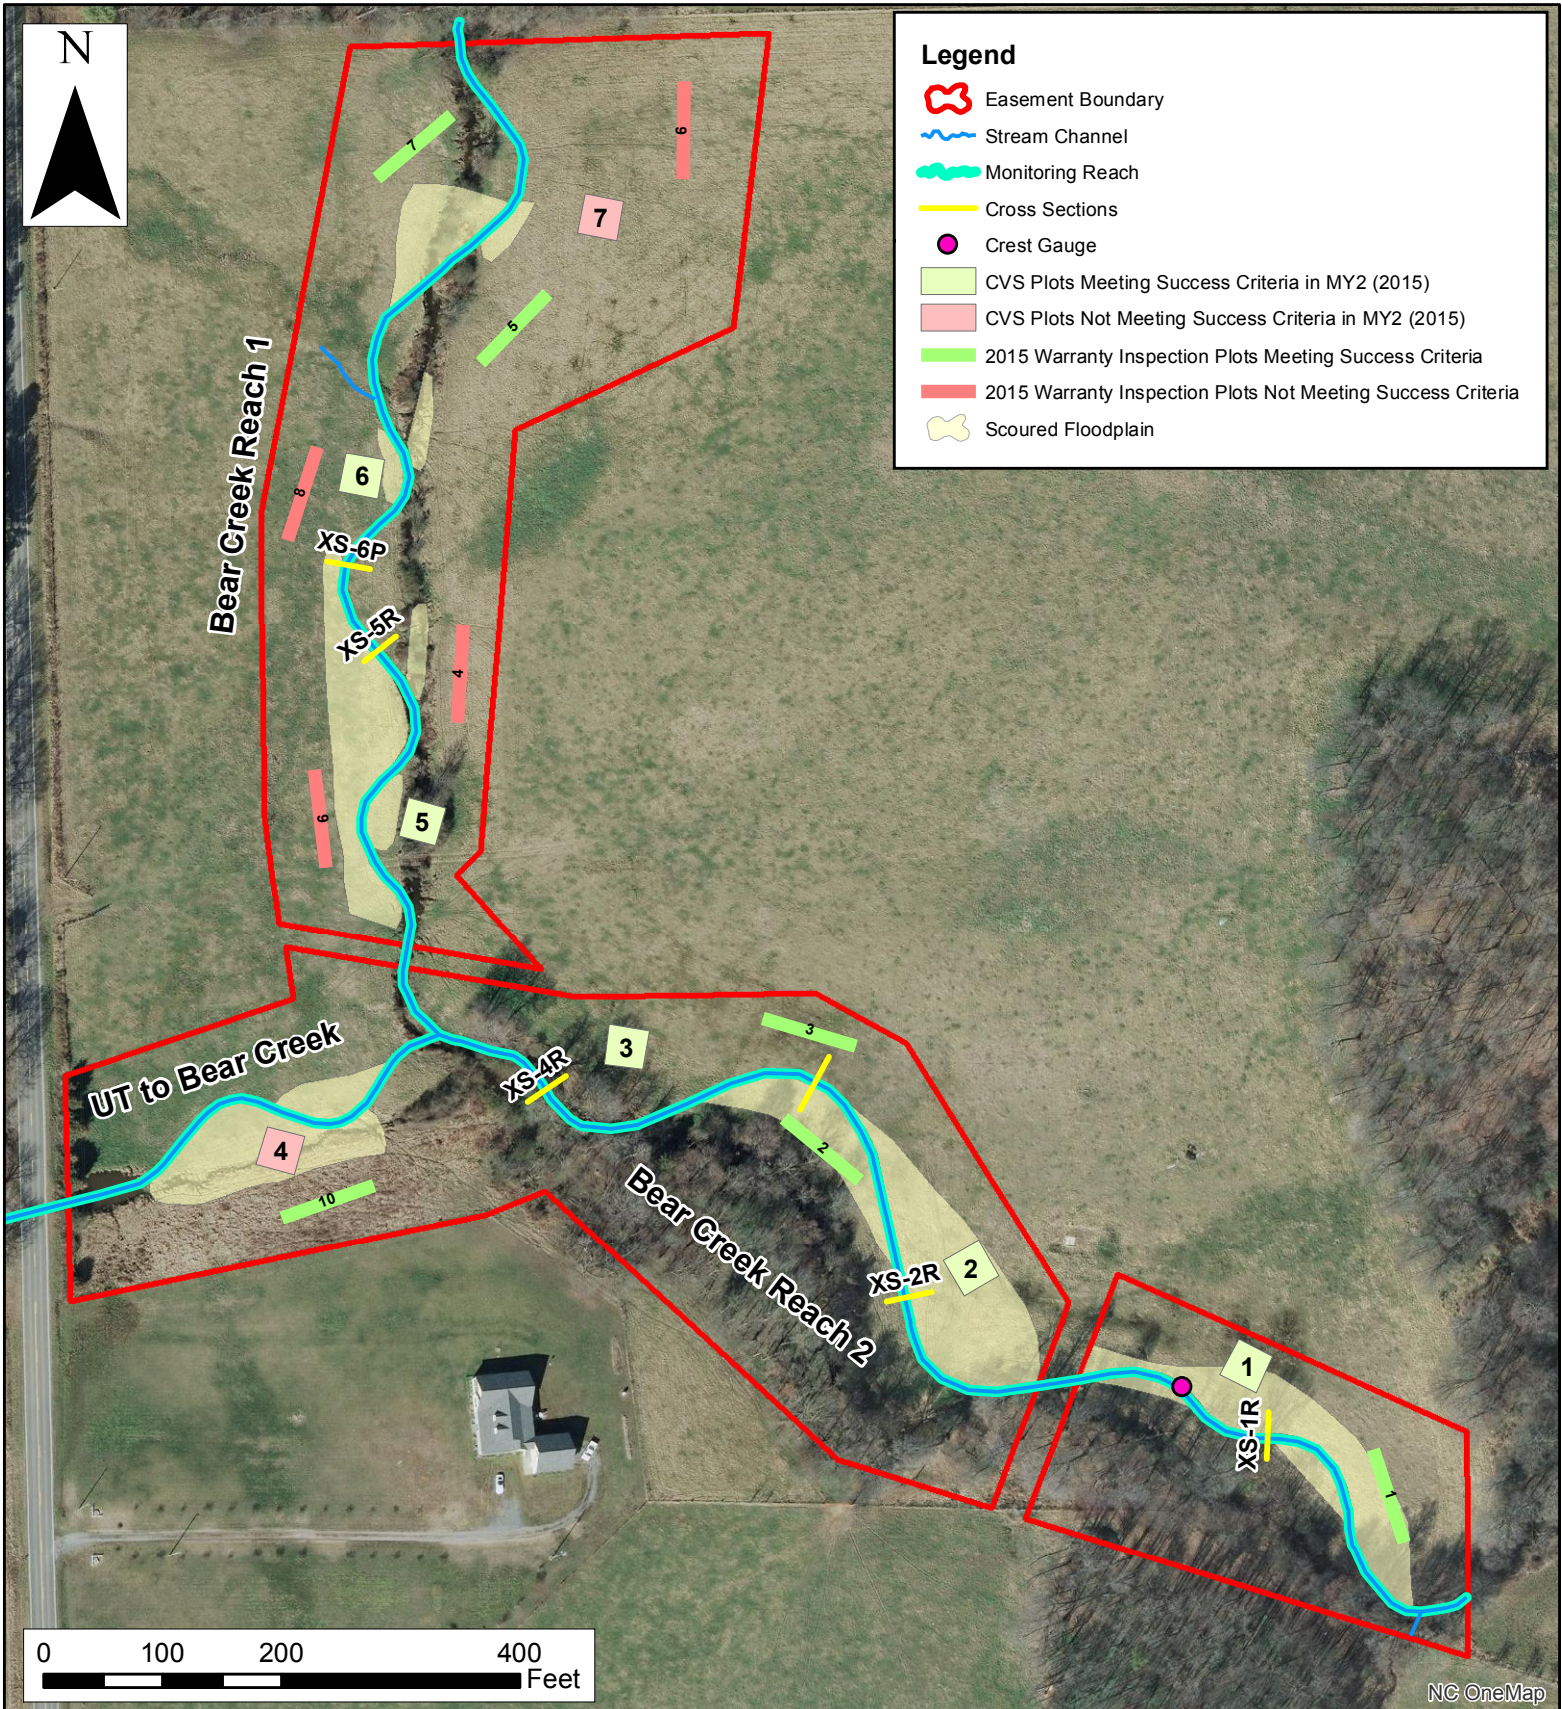
During monitoring year 1 (2014), two stream areas of concern were observed; one remains during monitoring year 2 (2015). An outer bend on the Unnamed Tributary to Bear Creek has been severely scoured (Area of Concern #1). The bank appears unstable and is void of all vegetation. This area of concern is depicted on Figure 2A in Appendix B.

Stream Area of Concern #1

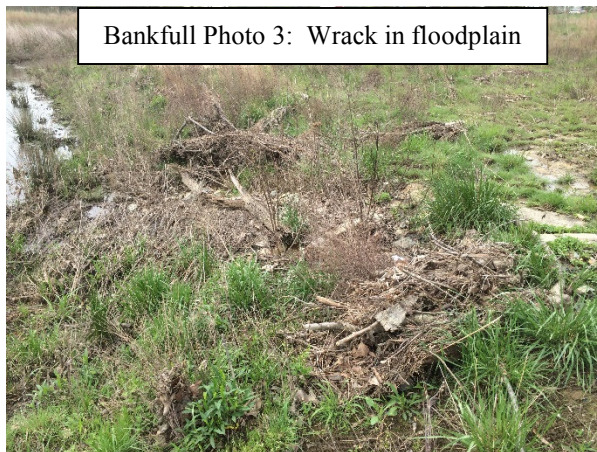
Bankfull Photo 4: Wrack in floodplain

Date of Data Collection	Date of Occurrence	Method	Photo (if available)
March 13, 2014	March 7, 2014	Wrack on floodplain and crest gauge data indicate a bankfull event after 1.59 inches* of rain in one day.	1
August 22, 2014	May 15, 2014	Crest gauge data indicate a bankfull event after 2.08 inches* of rain in one day.	--
September 23, 2014	September 4, 2014	Wrack on floodplain and crest gauge data indicate bankfull event after 1.95 inches rain* in three days.	2
April 20, 2015	April 17, 2015	Wrack and standing water on floodplain and crest gauge data indicate bankfull event after 2.13 inches rain* in three days.	3
July 14, 2015	June 19, 2015	Wrack on floodplain and crest gauge data indicate bankfull event after 1.95 inches rain* in two days.	4
September 21, 2015	August 20, 2015	Wrack on floodplain and crest gauge data indicate bankfull event after 2.11 inches rain* in two days.	--
