**FINAL**  
**YEAR 3 (2016) ANNUAL MONITORING REPORT**  
**BEAR CREEK (PHILLIPS SITE) RESTORATION PROJECT**

Chatham County, North Carolina  
DMS Project No. 26 (Contract No. 5715)  
DWR Project No. 0713-94  
SCO No. 09-07726-01A

**Data Collection – January-September 2016**

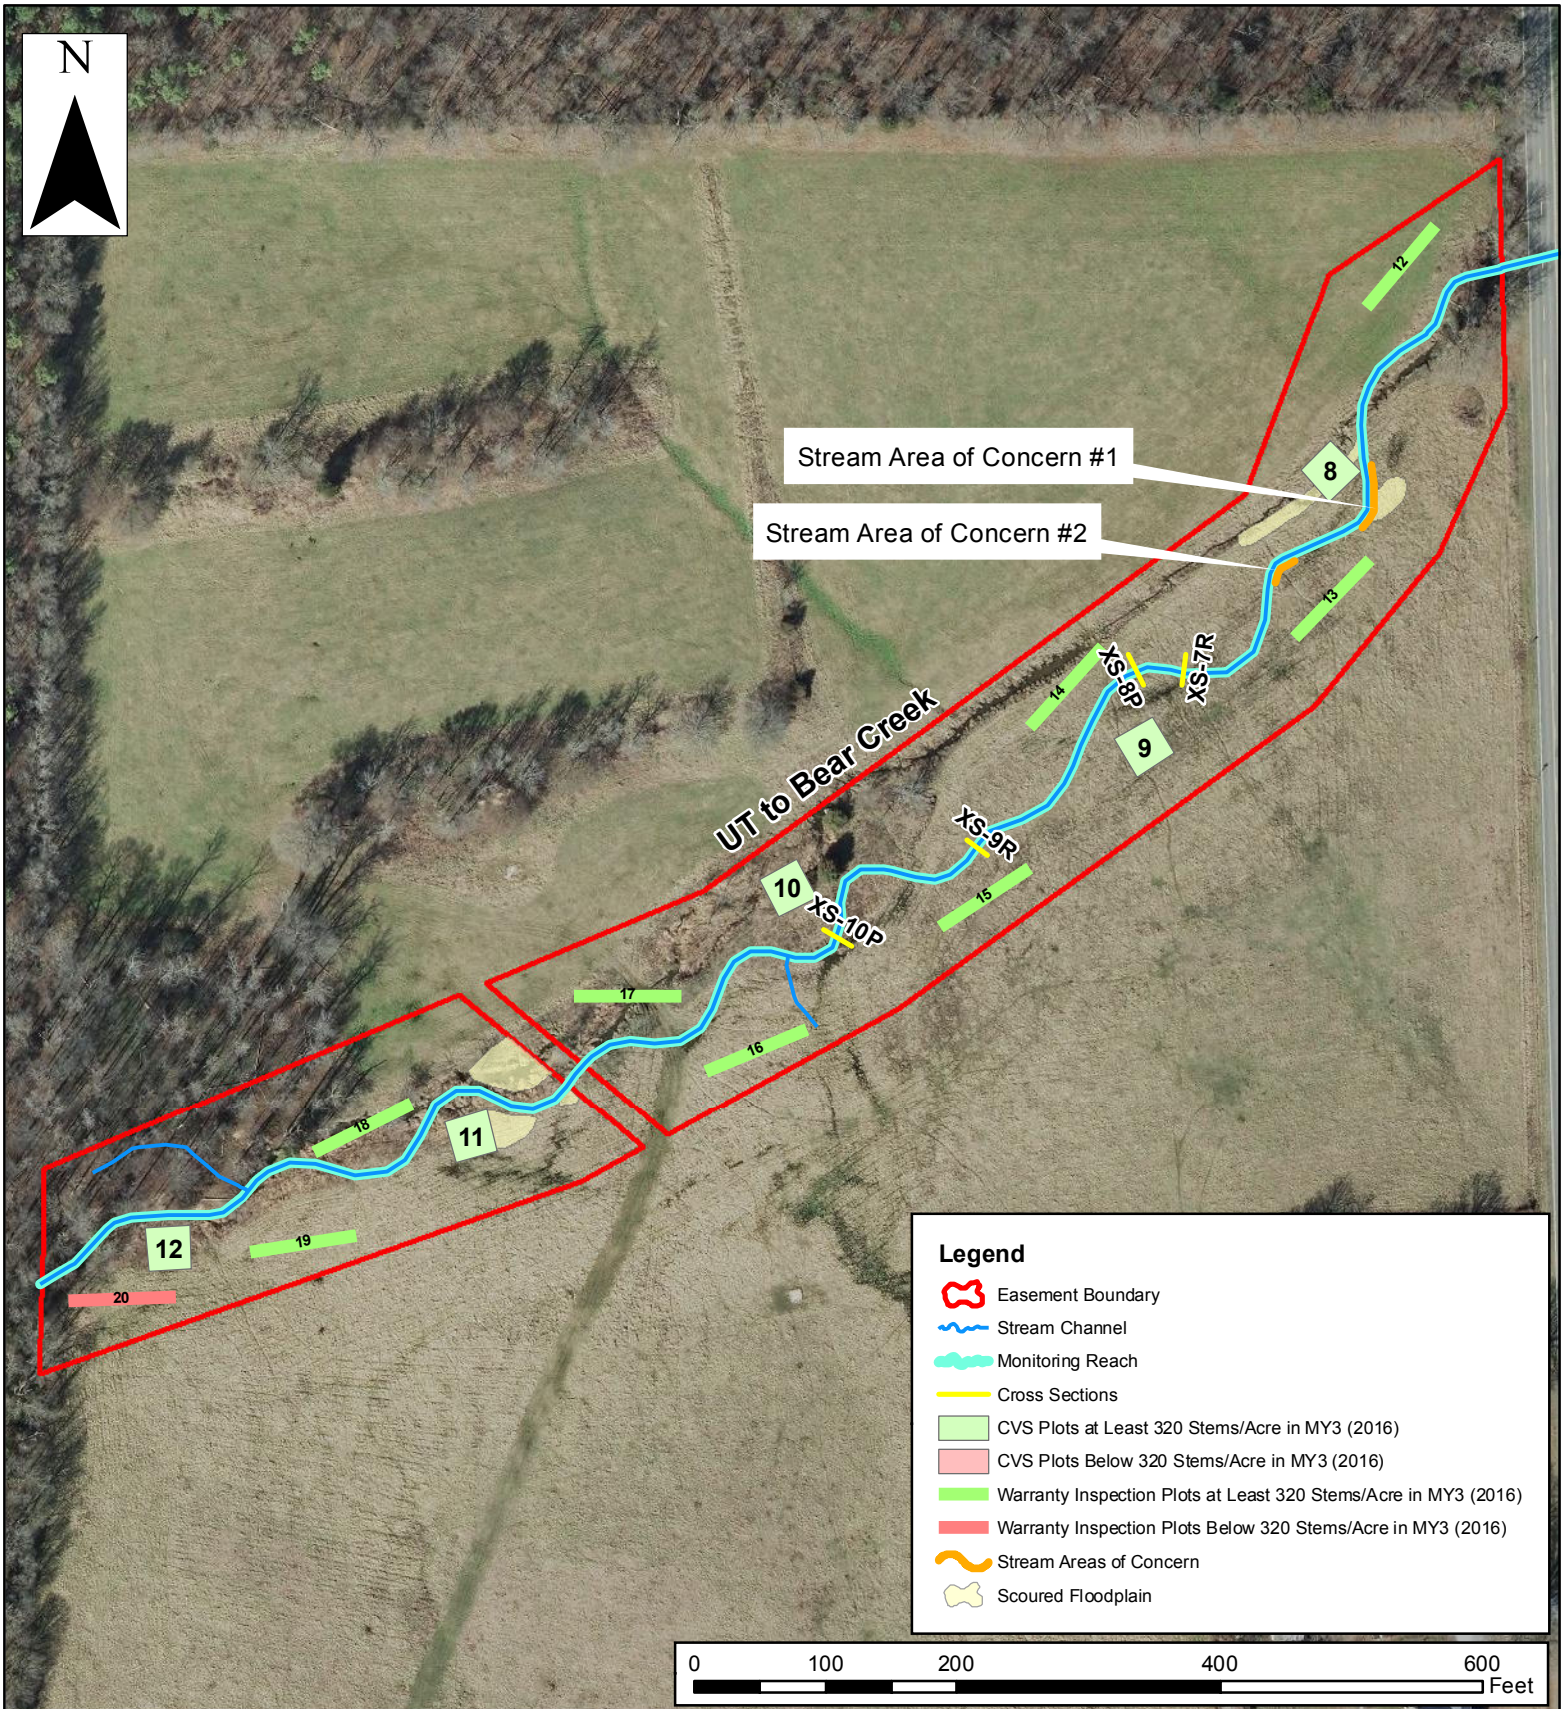
FIGURE

construction was complete, several large rain events caused flooding that scoured the floodplain, leaving it bare. Vegetation has established throughout much of the floodplain, but there are still some bare areas. These scoured areas have been depicted on Figures 2A-2B in Appendix B.

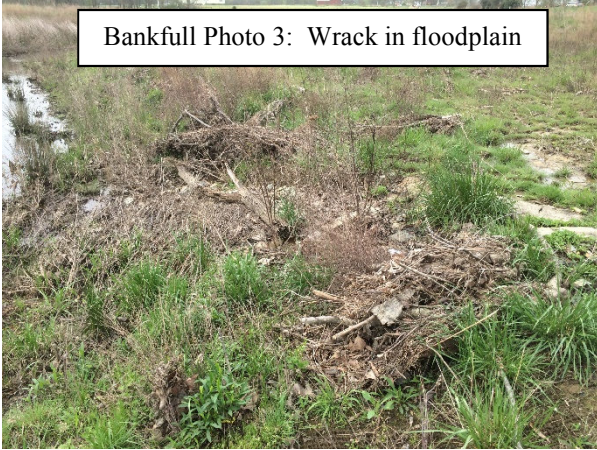
Bankfull Photo 3: Wrack in floodplain

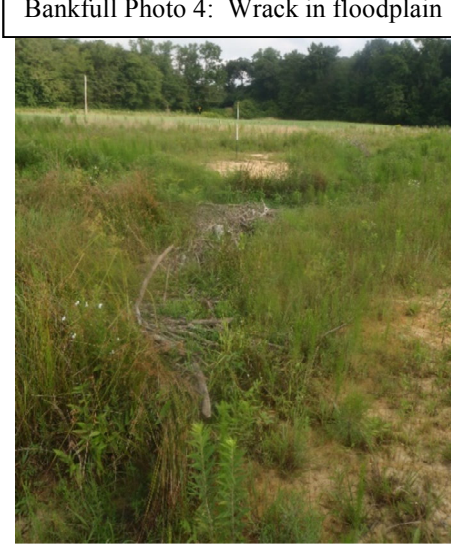
Bankfull Photo 4: Wrack in floodplain

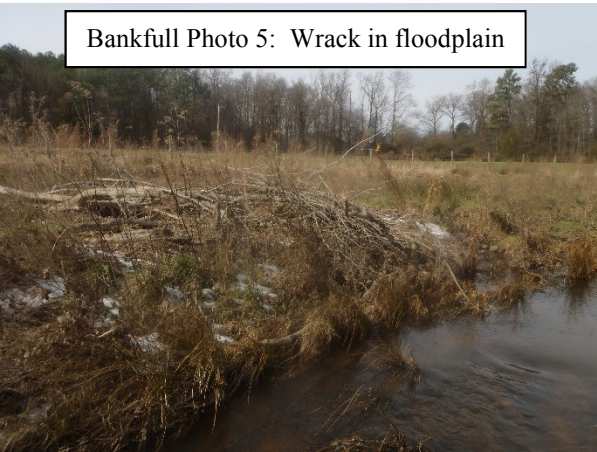
Bankfull Photo 5: Wrack in floodplain

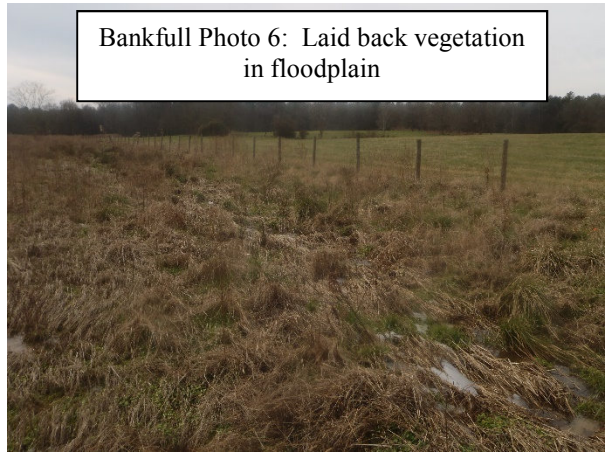
Bankfull Photo 6: Laid back vegetation in floodplain

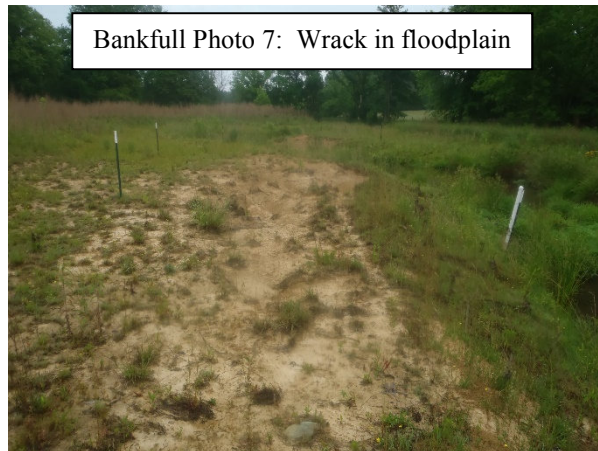
Bankfull Photo 7: Wrack in floodplain
