Year One Monitoring Report

Unnamed Tributary to Bear
Swamp Creek

North Carolina Department of the
Environment and Natural Resources
Ecosystem Enhancement Program

January 2004

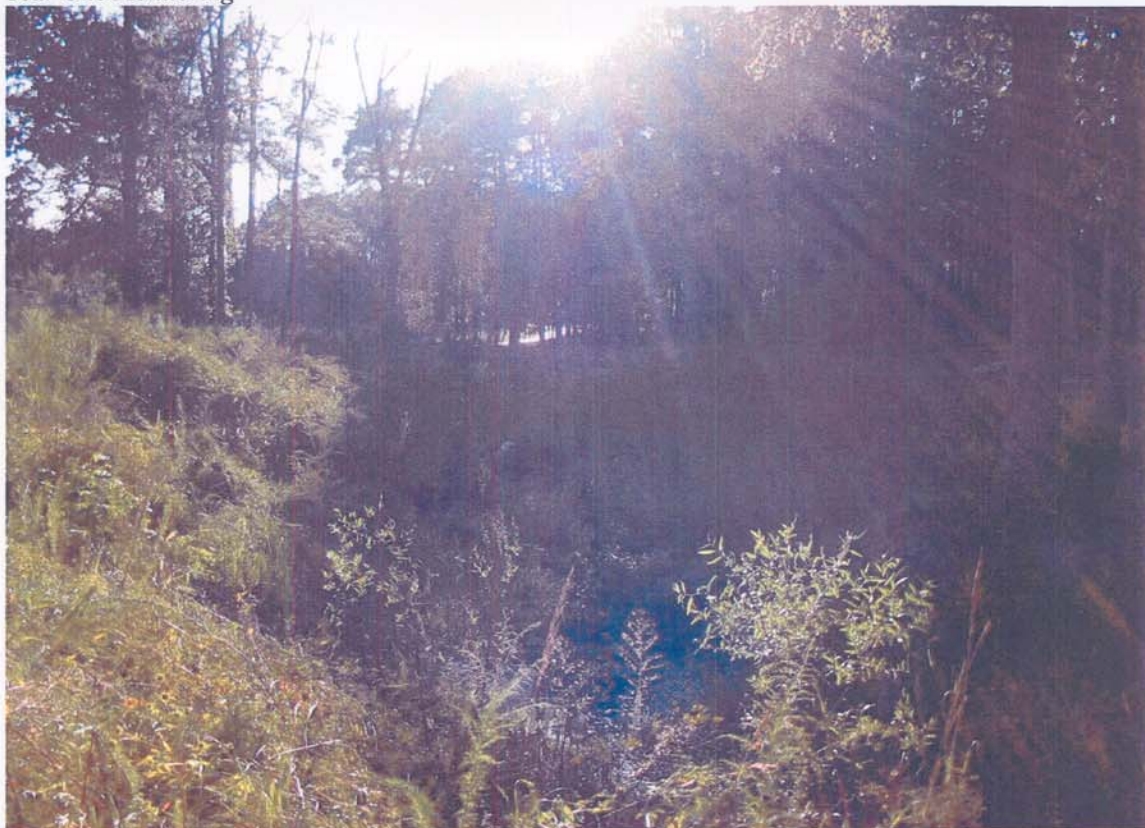
Photograph Point #1 Looking downstream. 9/24/03

The photographs show thick, healthy, early succession vegetation establishing throughout the easement area. No significant changes to the new channel or to in-stream structures are observed. All photographs are shown in Appendix A.

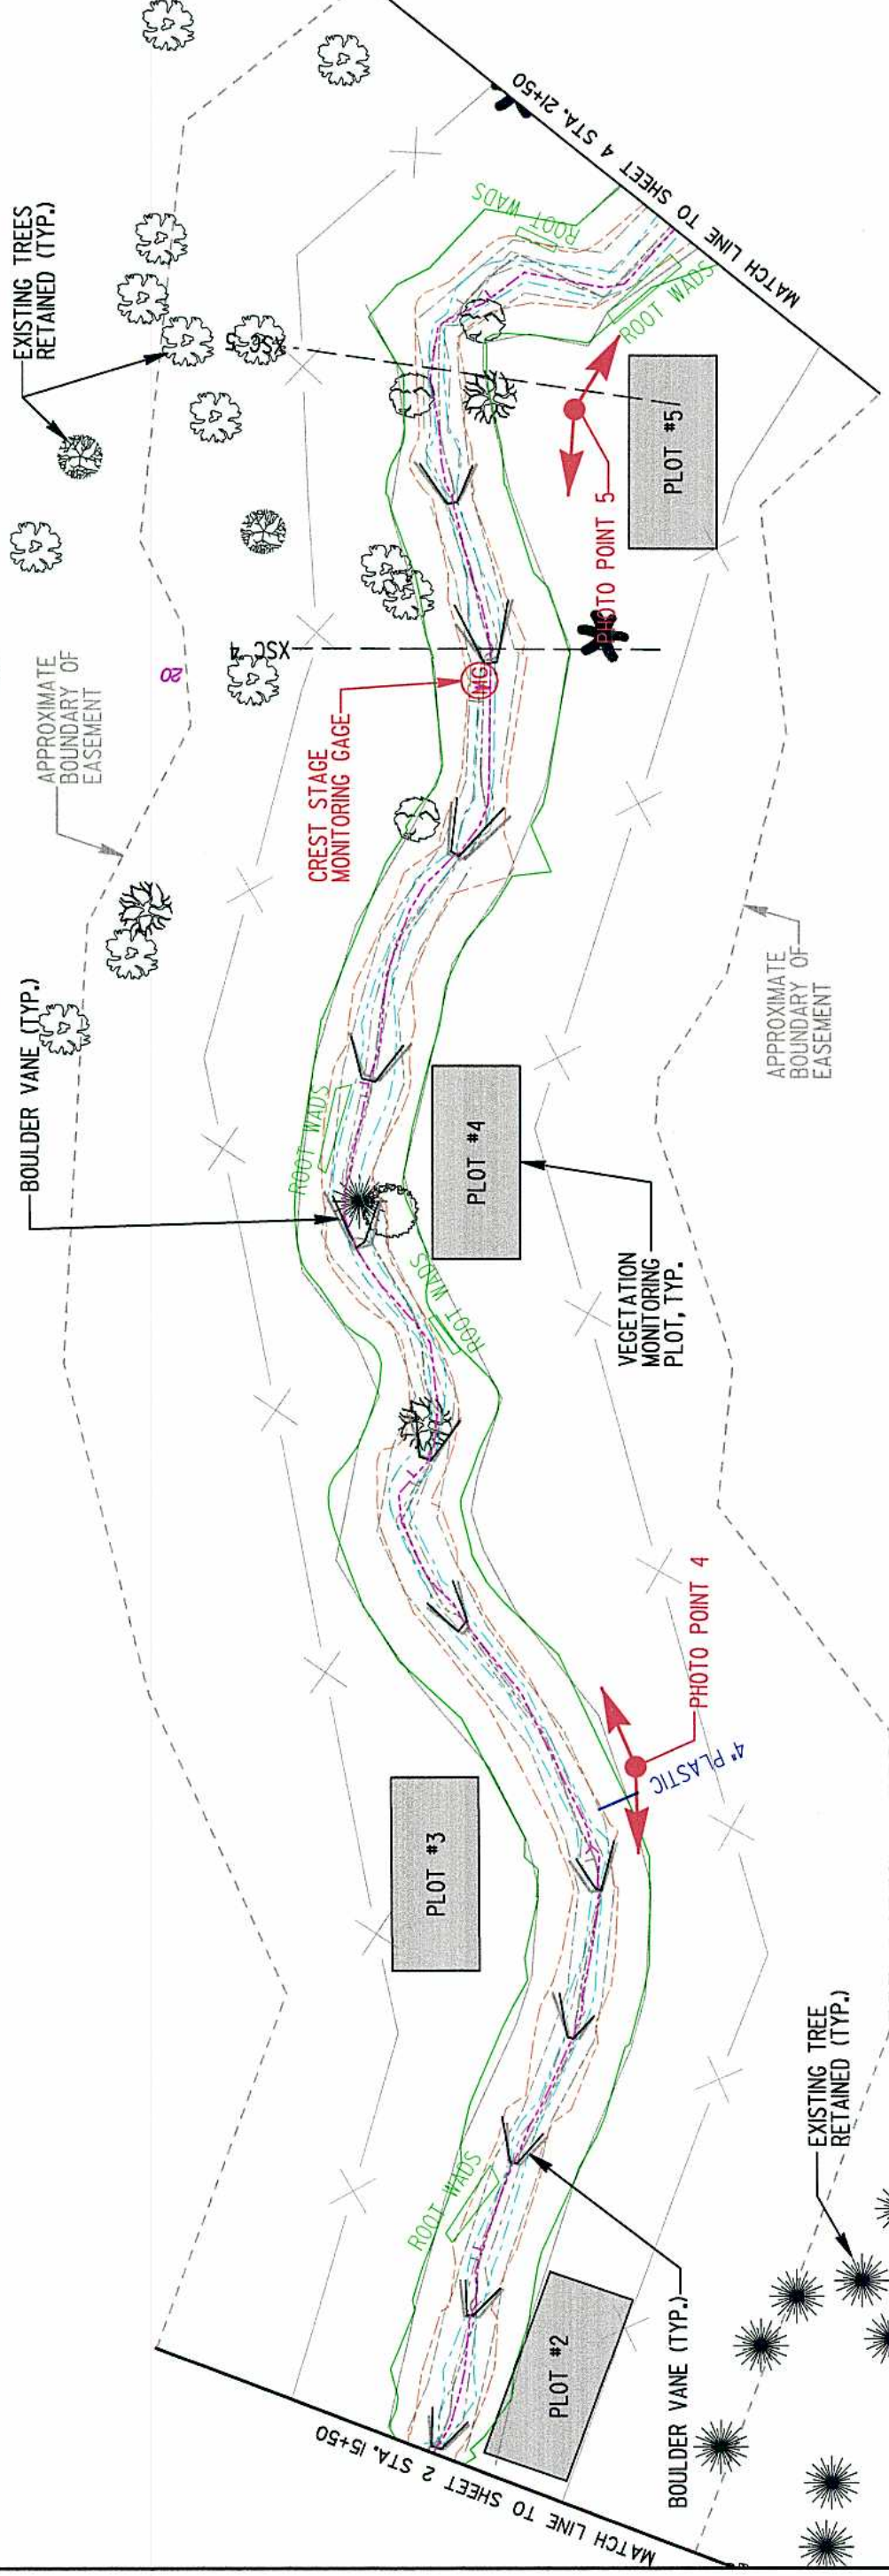
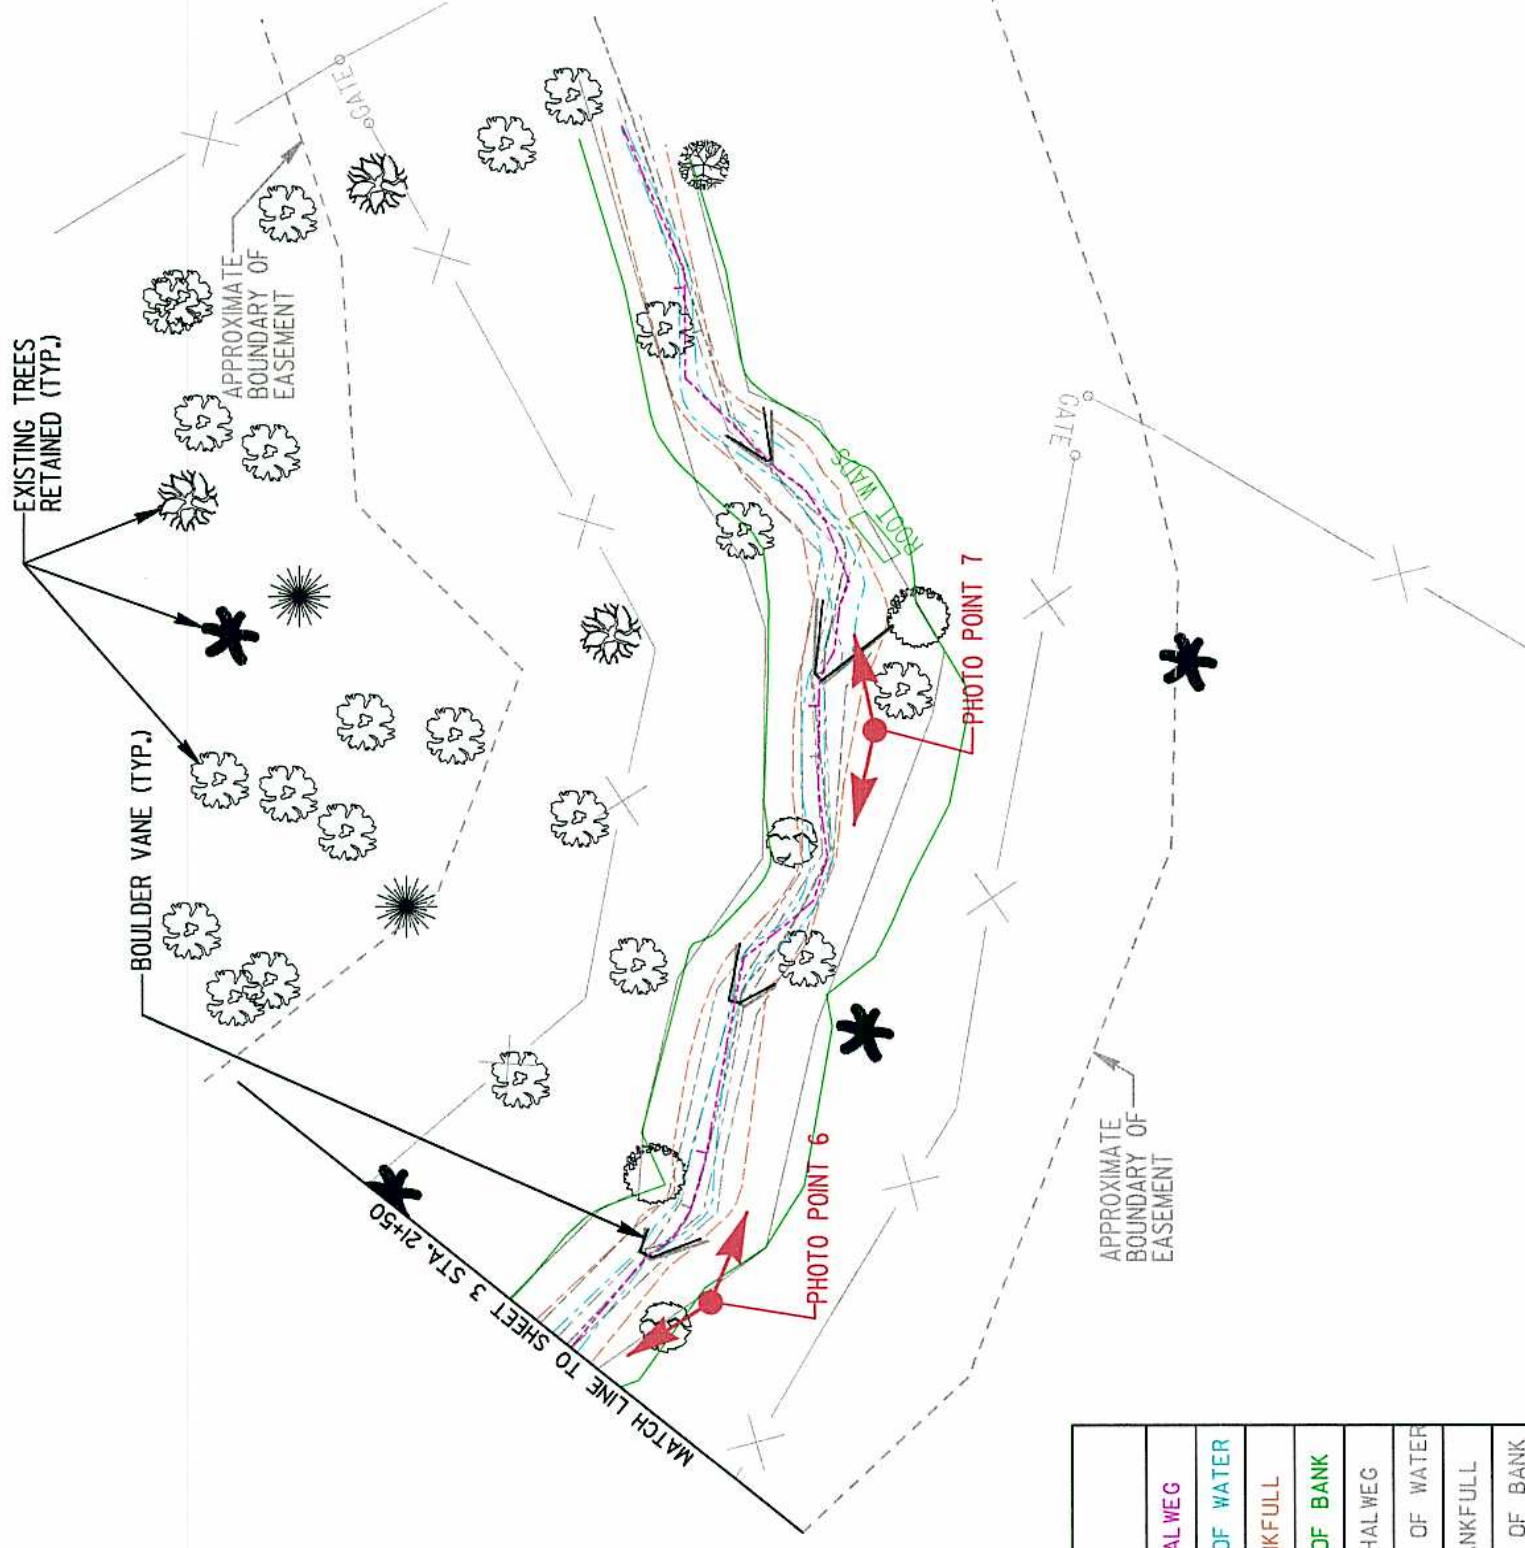
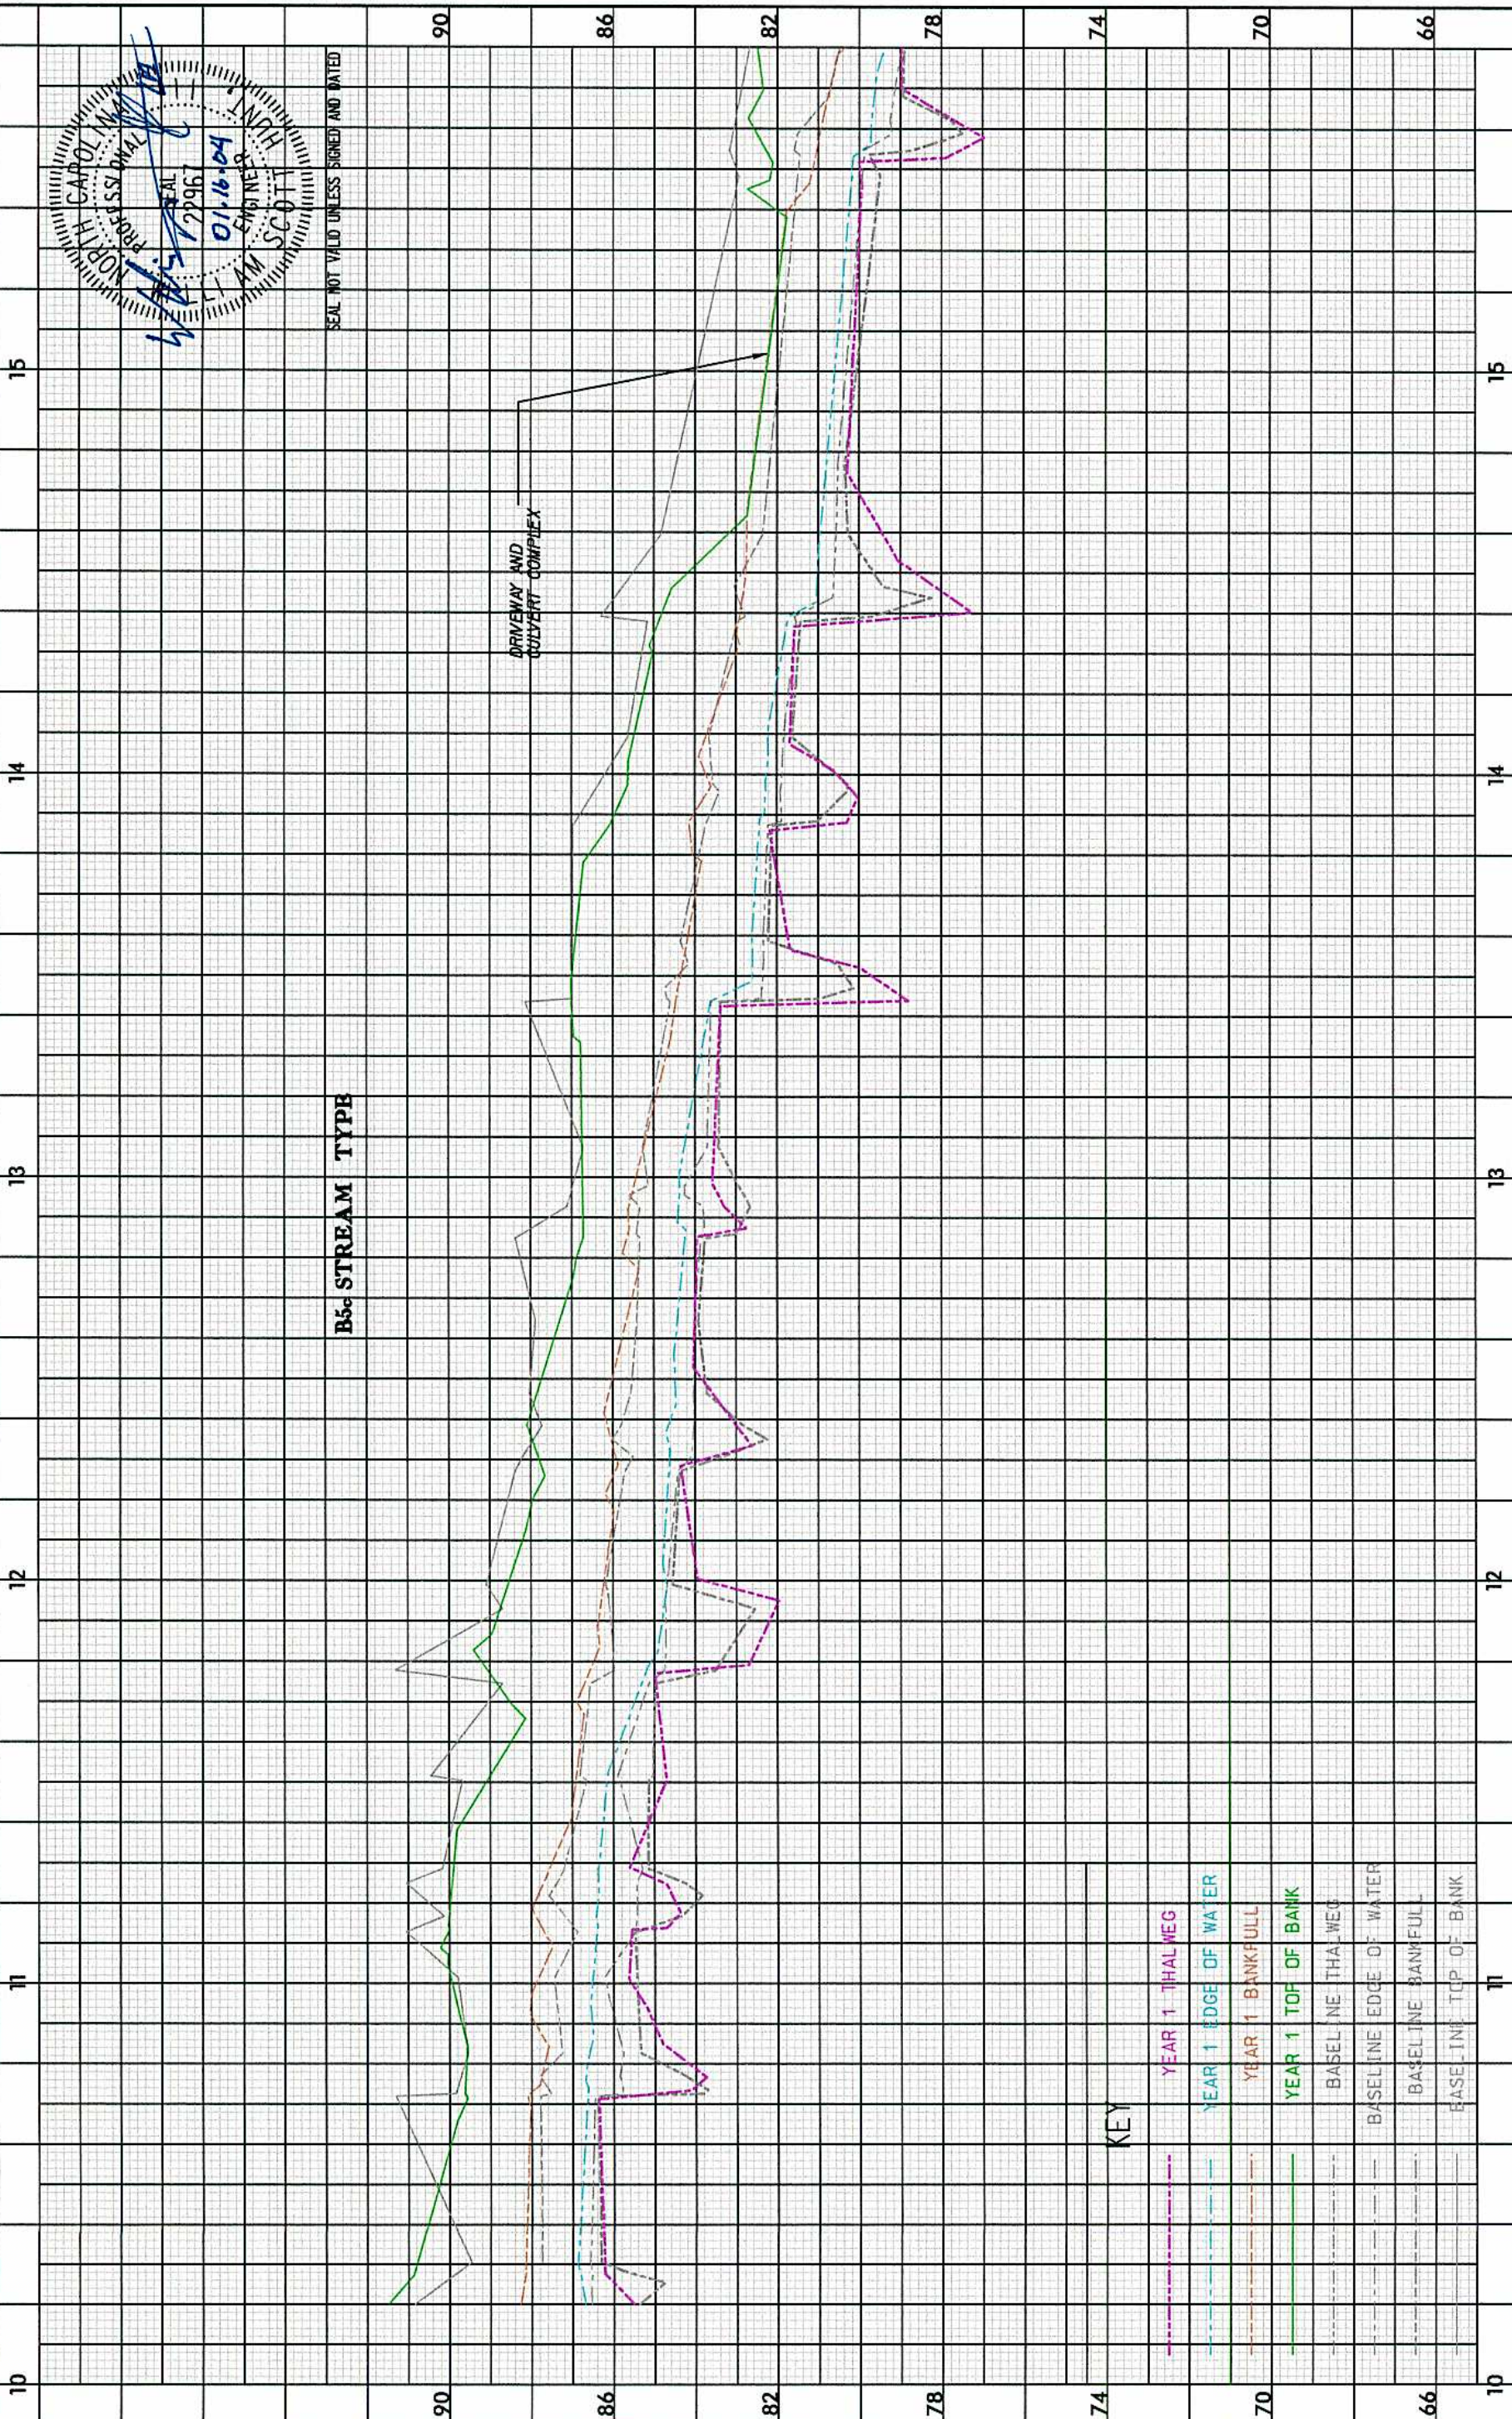
The channel sinuosity did not change from design to baseline to year-one survey. Plan sheets 2-4 show the year-one channel overlaid with the baseline channel. No significant difference is observed. Table 1 shows a change in the channel meander length, radius of curvature, and belt width between proposed reach, baseline channel and year-one monitoring. The change is attributed to the difference in the method of measuring these parameters and not a change in the stream pattern. As mentioned above, the channel plan view shows no significant change in the channel pattern.

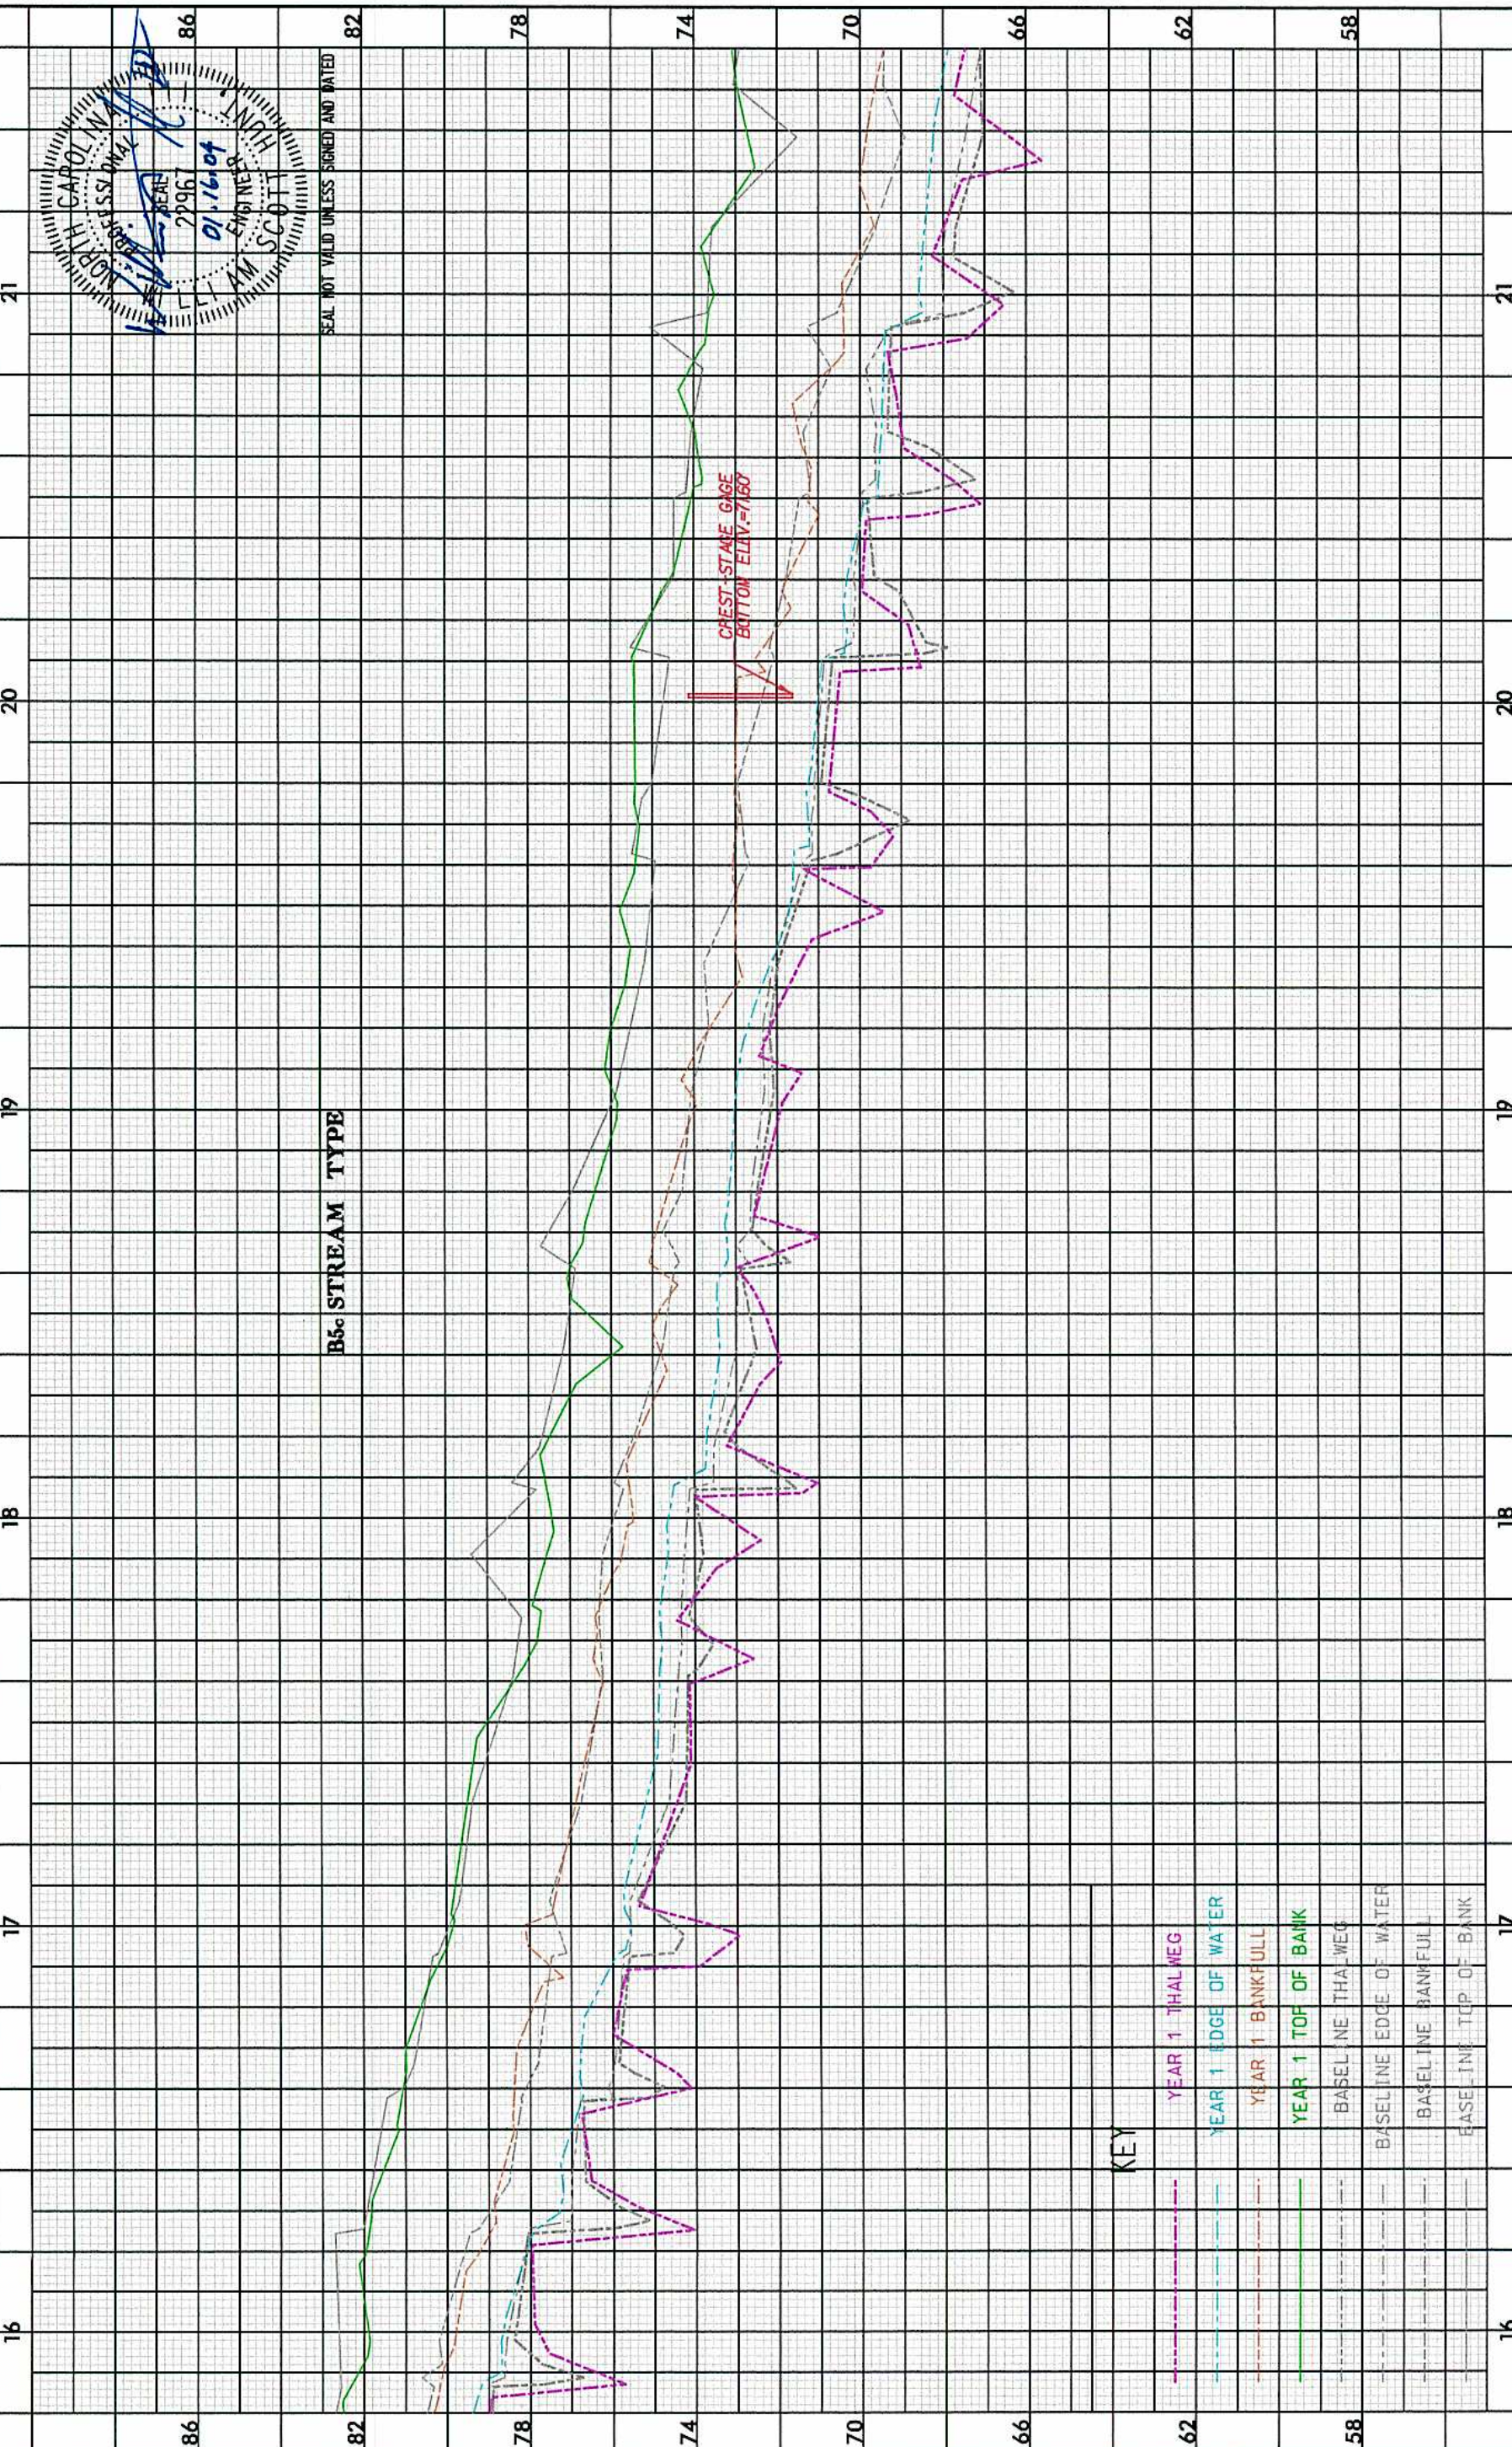
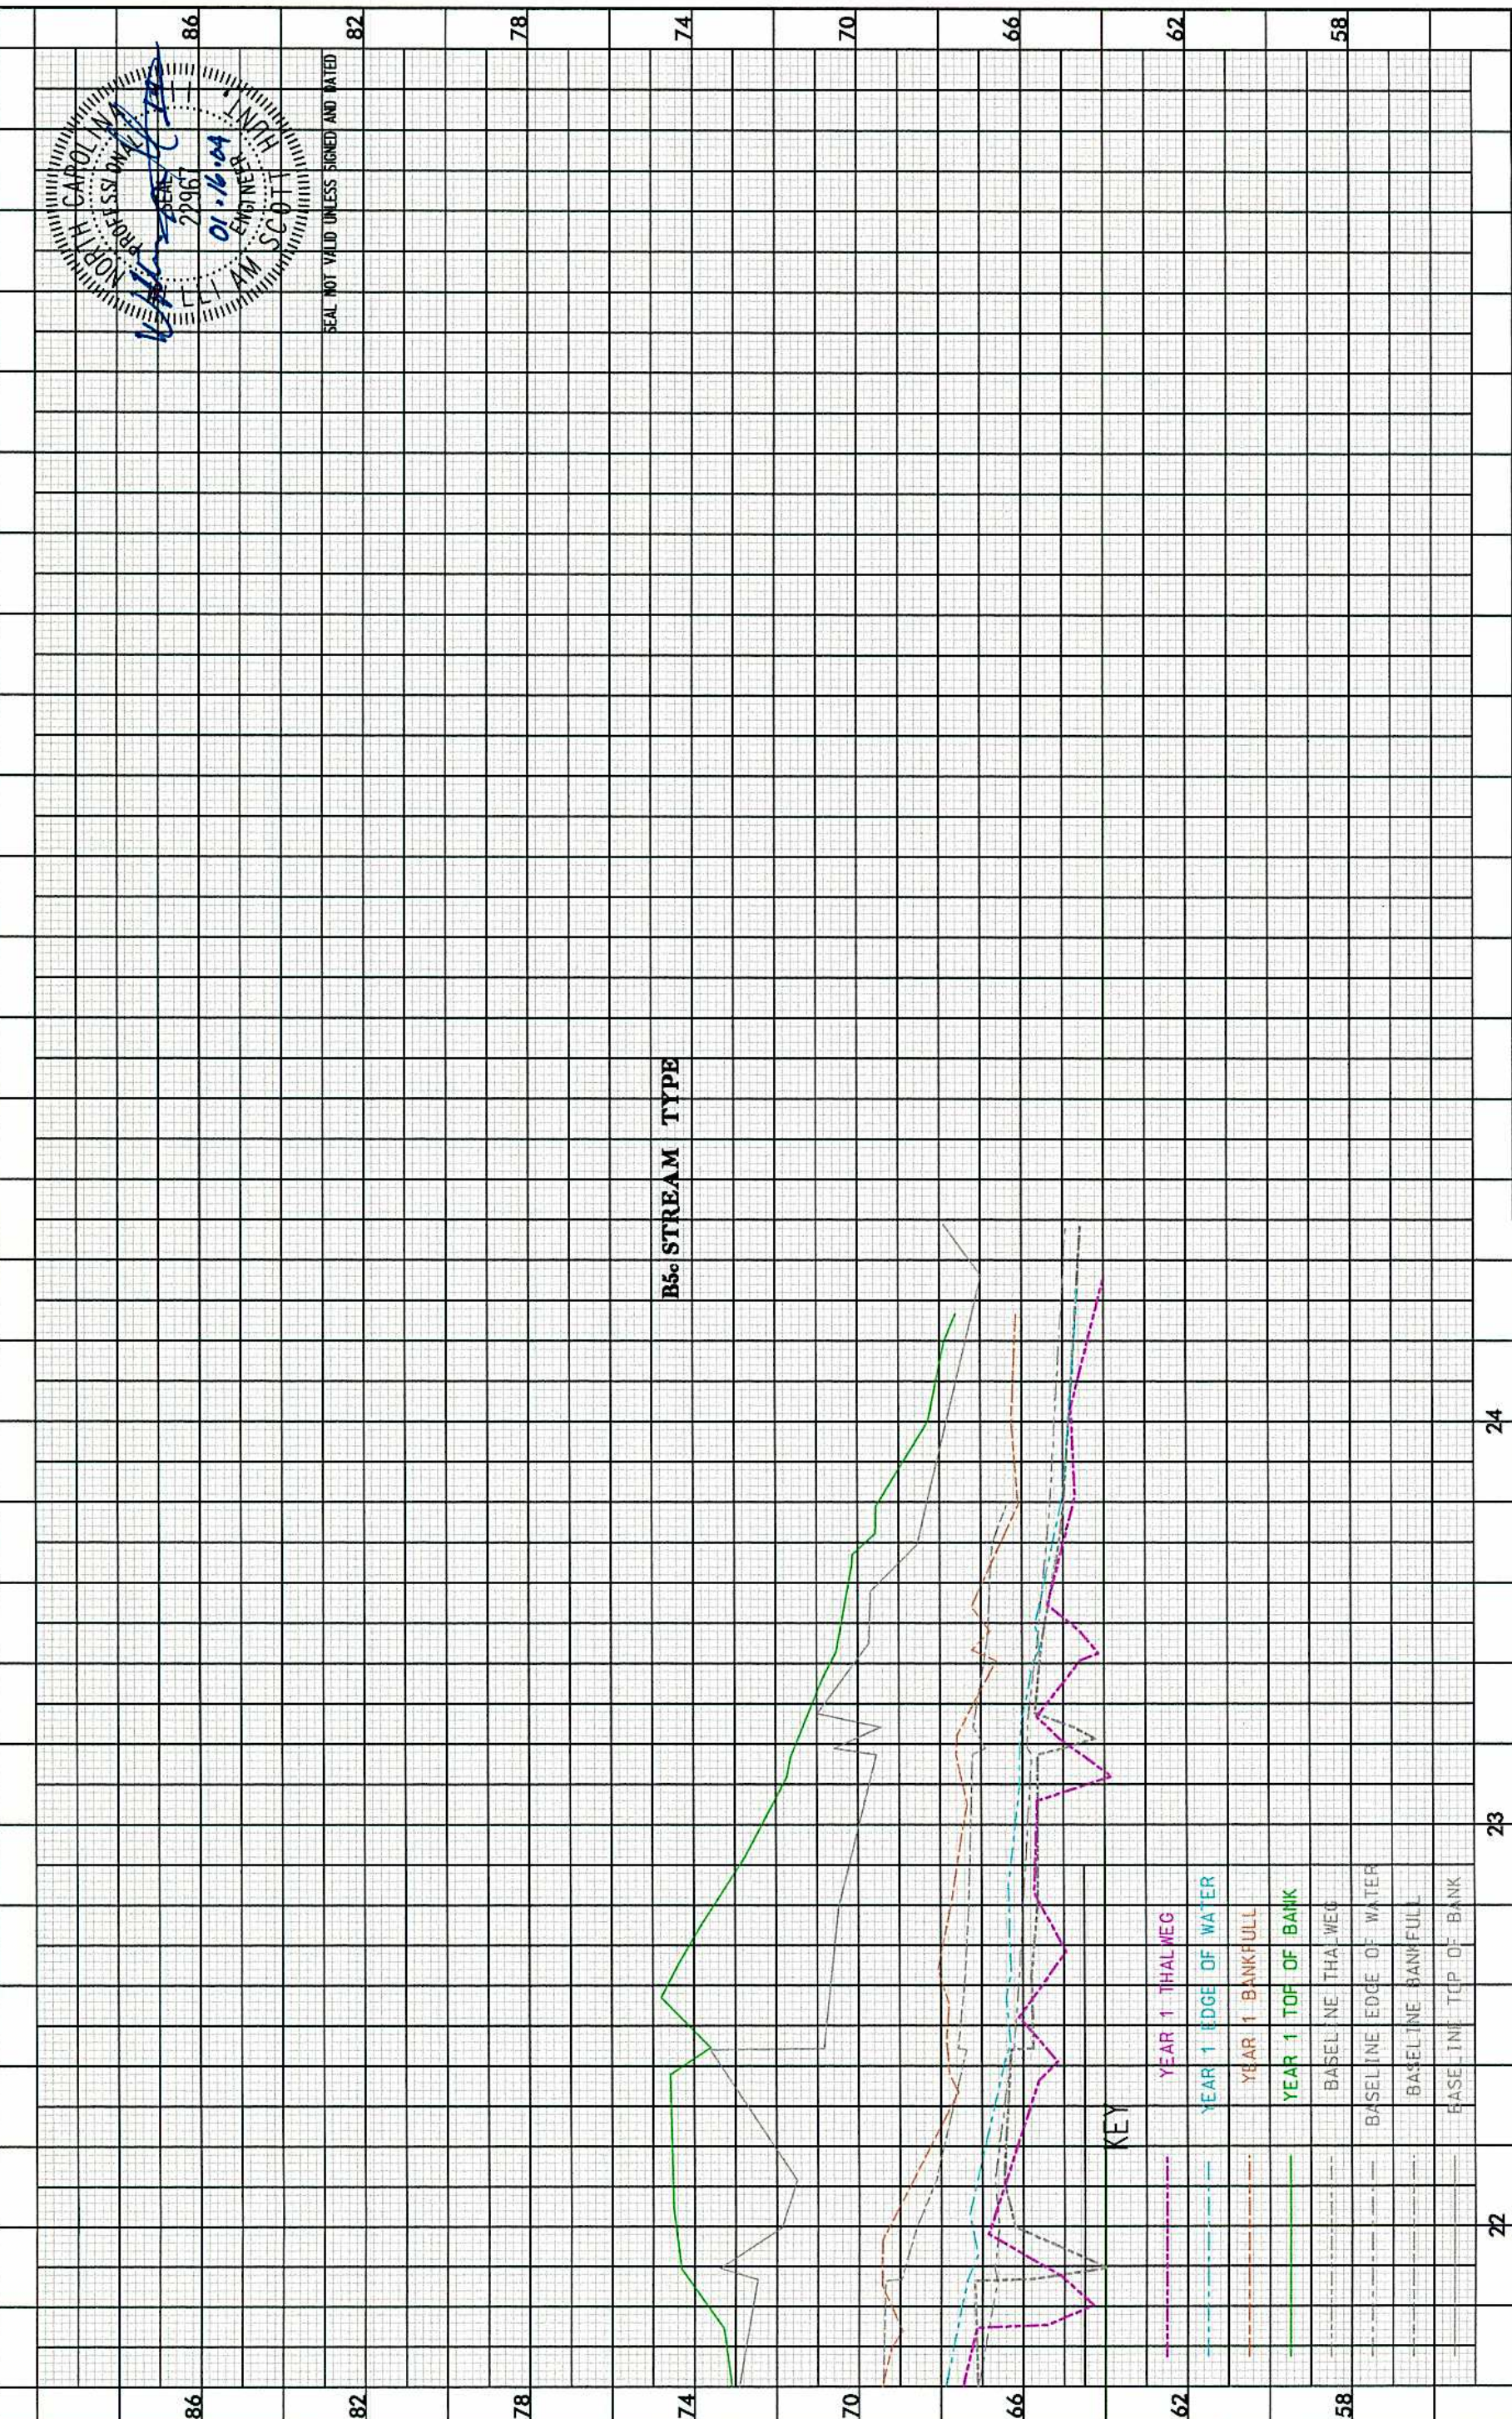
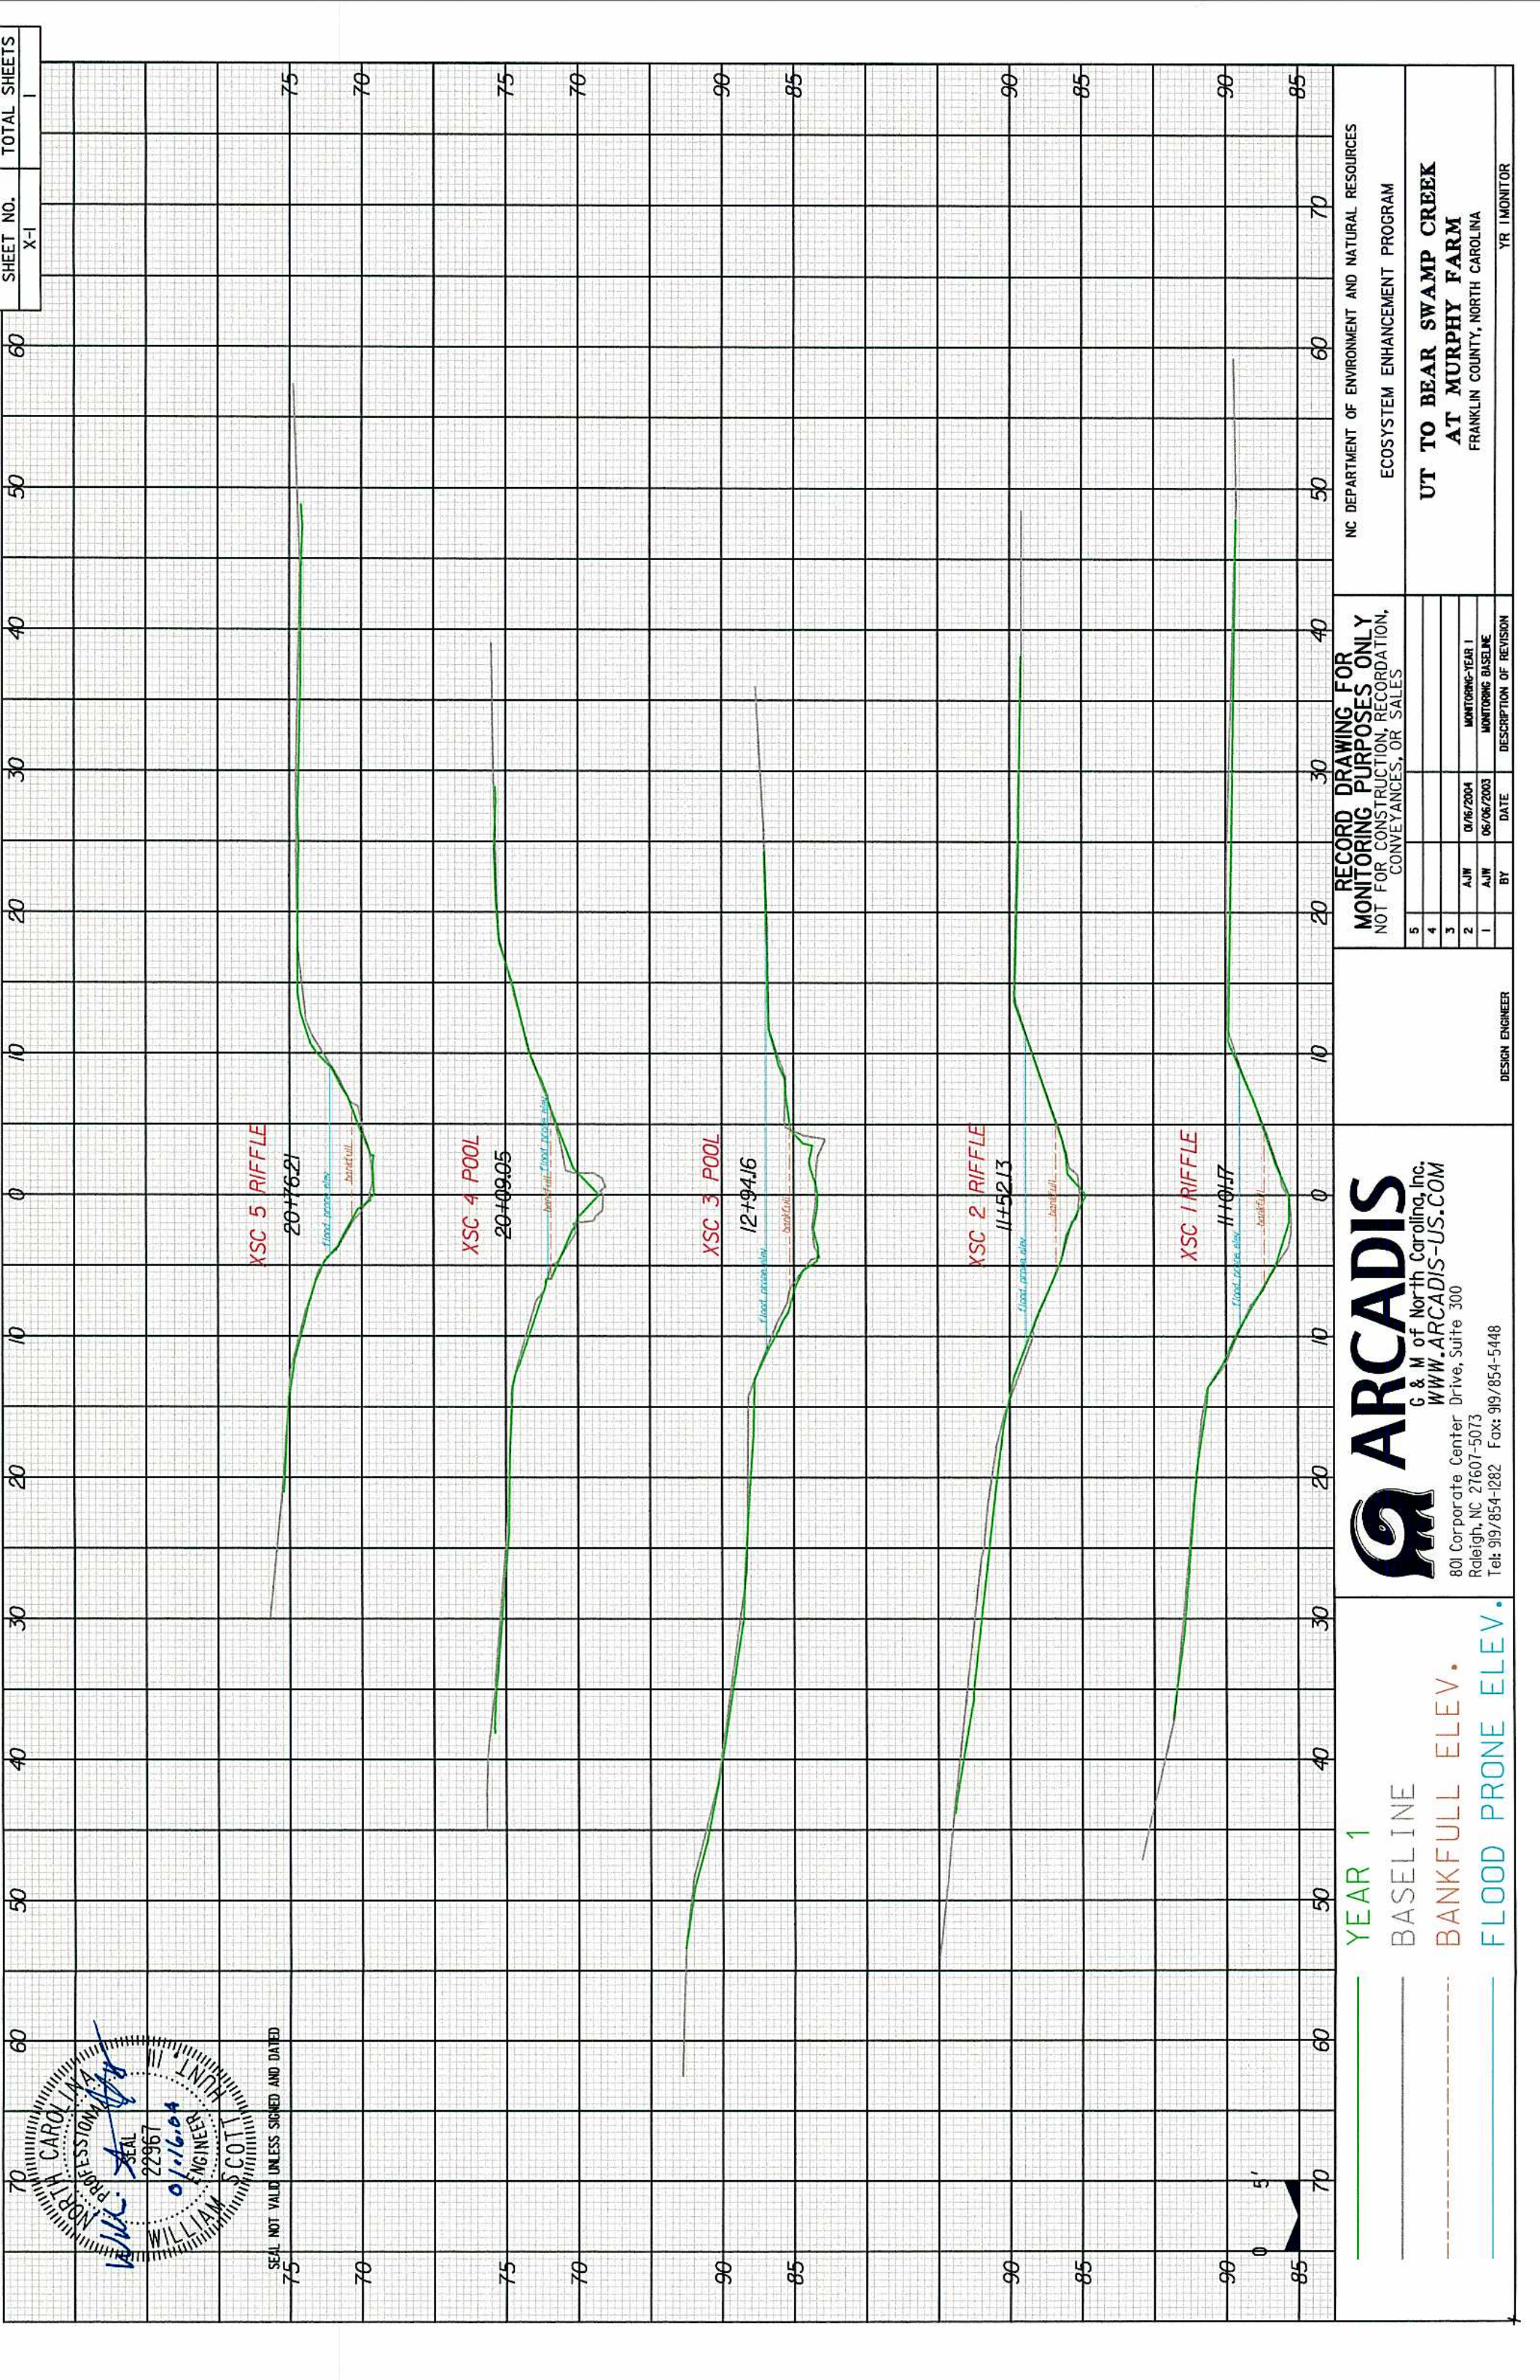
The average water slope for the length of the reach is 0.0161 ft/ft, with a range from 0.0161 – 0.0164 ft/ft; pool-to-pool spacing (measured from head of pool to head of next pool) ranged from 17.7 ft to 69.3 ft, with an average of 41.6 ft.

The average water-surface slope of the bankfull channel increased slightly. The increase is not considered significant and is more than likely the result of channel measurements not taken in the exact locations used for the baseline survey. For example, on Sheet 7, the baseline survey shows a structure at station 23+86. The year-one survey shows the same structure at station 23+75. The same shift can be seen at other locations on the profile. The structure did not move 11 feet upstream. The length of the survey was shorter. This slight difference in stream length is the cause of the increase in average water-surface slope.

The pool-to-pool spacing decreased from the baseline survey but is in line with the design spacing. During construction, some of the pools filled with sediment and could not be cleaned out with construction equipment. It appears that the pools have cleaned themselves out. The spacing is not exactly the design spacing due to the development of small pools upstream of two boulder cross vane structures (stations 18+06 and 19+60). The establishment of these pools is not considered significant, since they are not compromising the boulder structures and the pool-to-pool spacing is still close to the design ranges.
