UT to Bear Swamp Stream Restoration 2004 Annual Monitoring Report

March, 2005

2004 UT to Bear Swamp Creek Monitoring Abstract

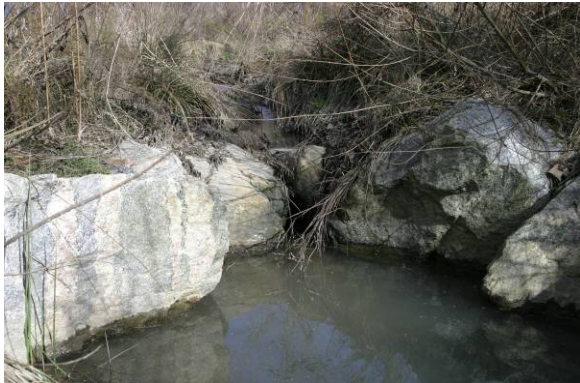
- At station 3+25 the rock cross vane has water piping under the invert rock with a head loss of 4 inches due to the piping. At this point the structure is not at risk of complete failure due to the boulder size used for the vane construction, the total number of vanes in the project, and the existing vegetation

Issue Photo 1. Piping under Structure STA: 3+25

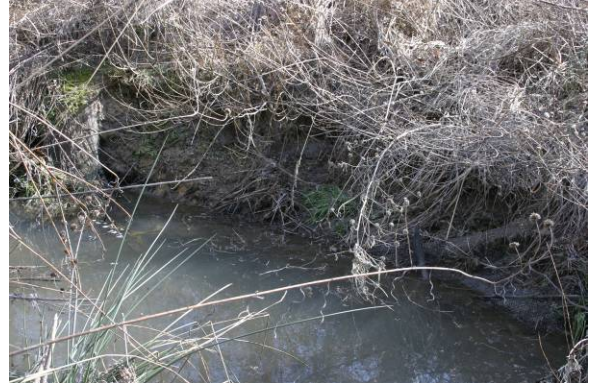
Issue Photo 2. Bank Erosion STA: 9+30

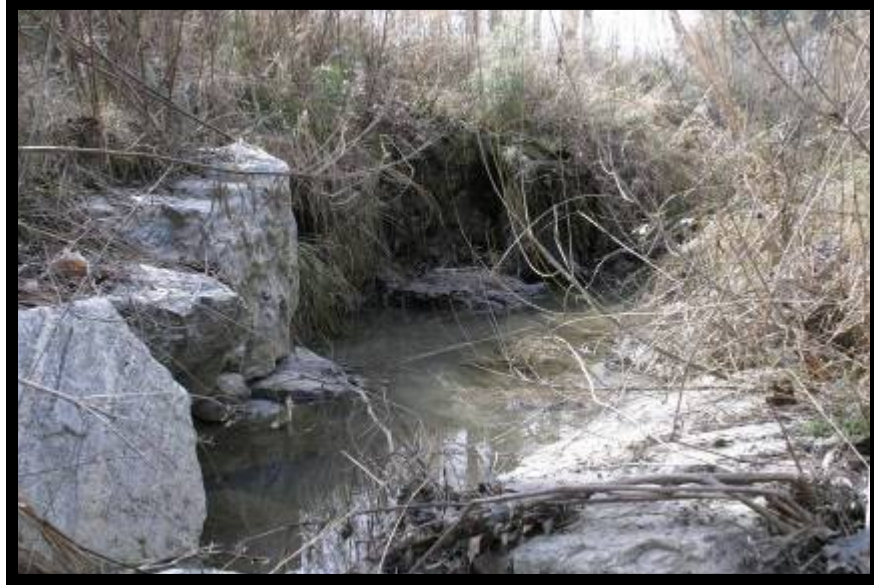
- At station 1+60 the rock cross vane has water piping under the invert rock with a head loss of 4 inches due to the piping. At this point the structure is not at risk of complete failure due to the boulder size used for the vane construction, the total number of vanes in the project, and the existing vegetation

Station 01+60 Root Wad Vane Failure

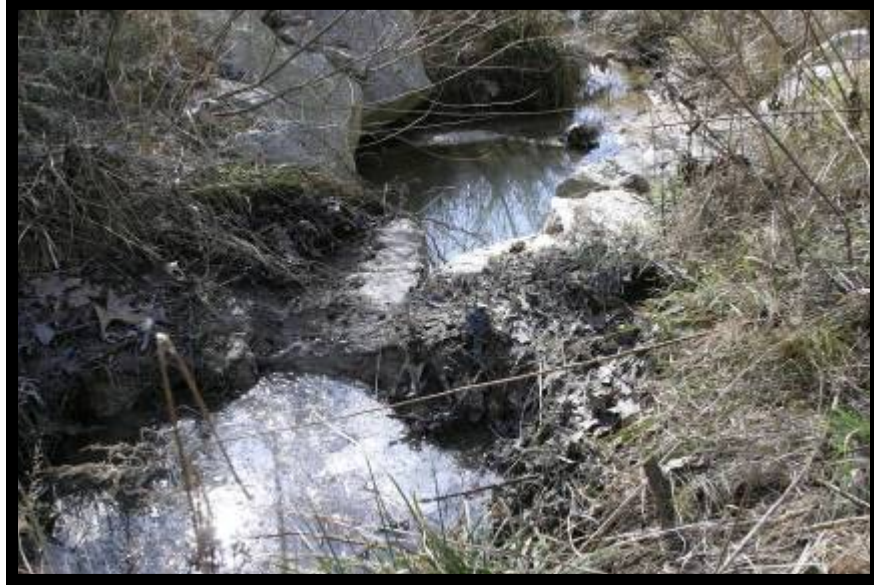
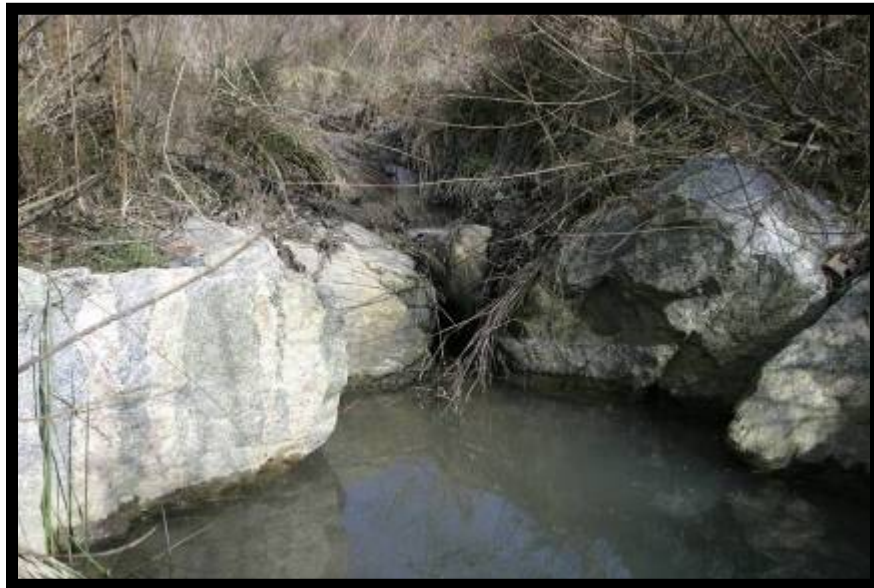
Station 03+40 Piping Vane Downstream

Station 03+40 Piping Vane Upstream

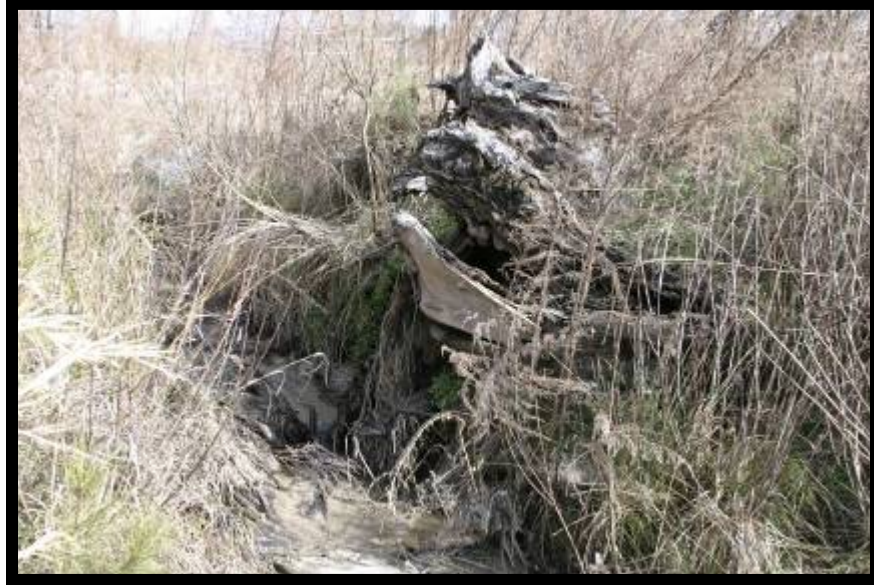
Station 06+20 High Root Wad

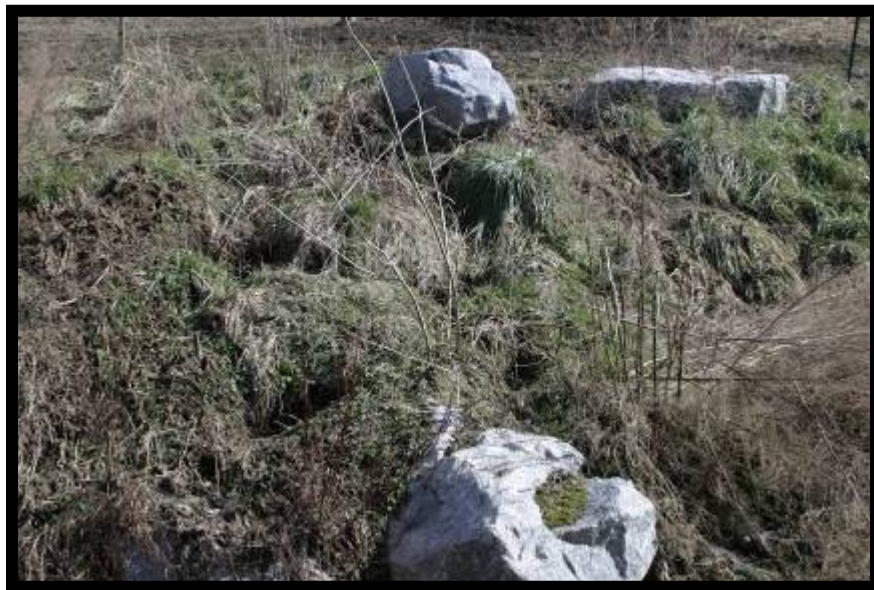
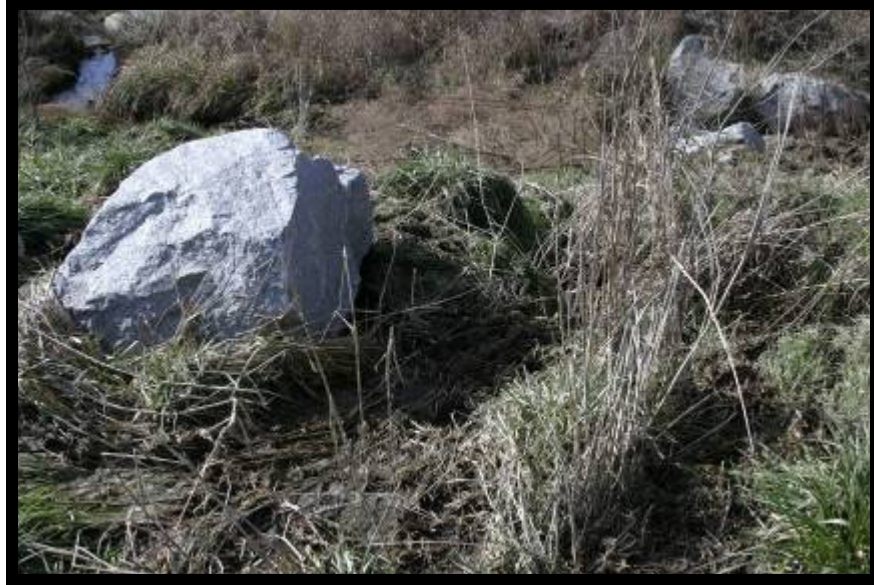
Station 07+70 Runoff Gulley

Station 07+70 Runoff Gulley from Fence

- Some banks near root wads also have some localized bank erosion
 - There are two areas of major bank erosion due to the overland flow and seepage at station 7+45 on the left bank and station at 8+45 on the left bank Possible repairs would include regarding the gully, preparing this area and seeding with a tackafier and straw mulch

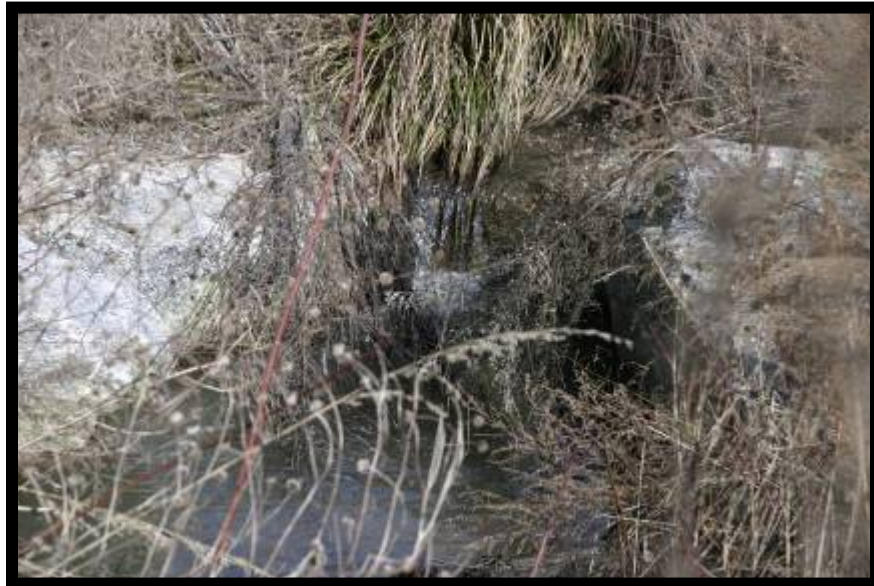
Station 08+20 Big Drop

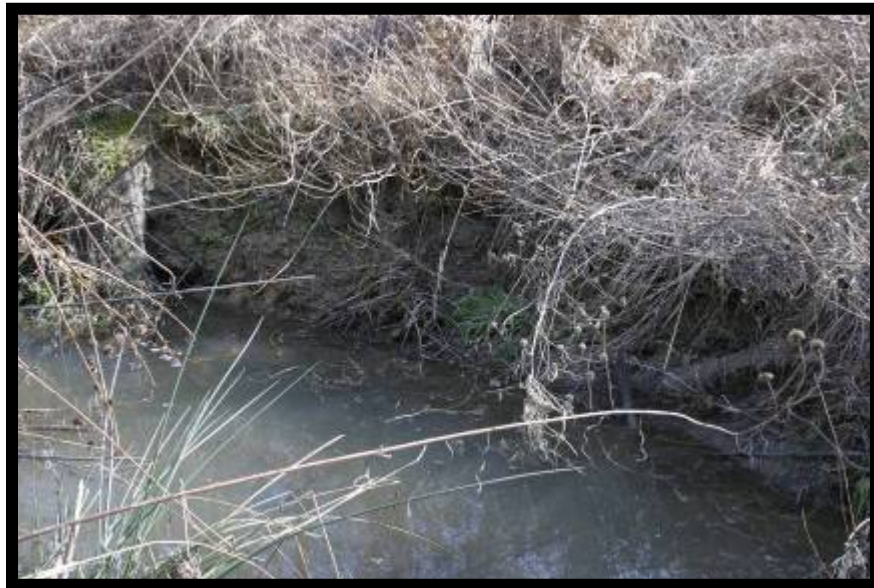
Station 09+40 Bank Slump

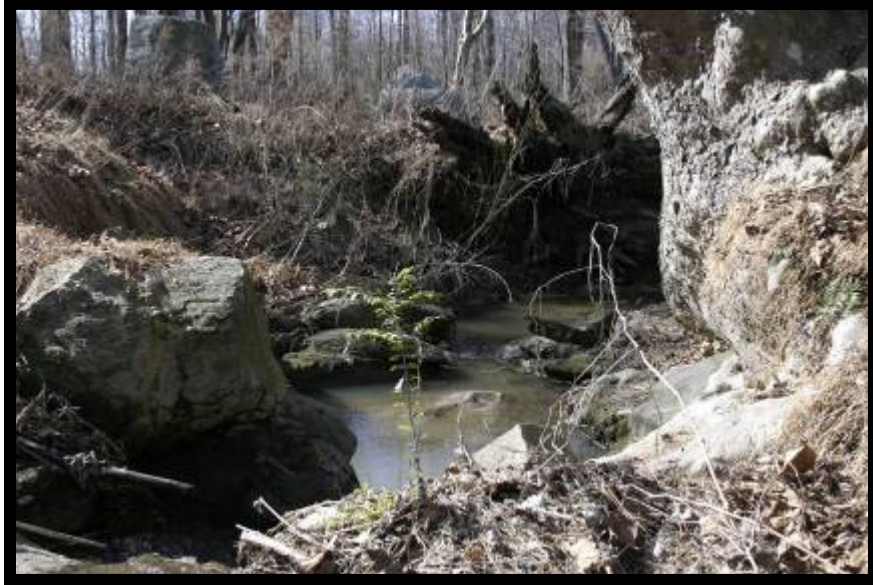
Station 11+00 High Root Wads

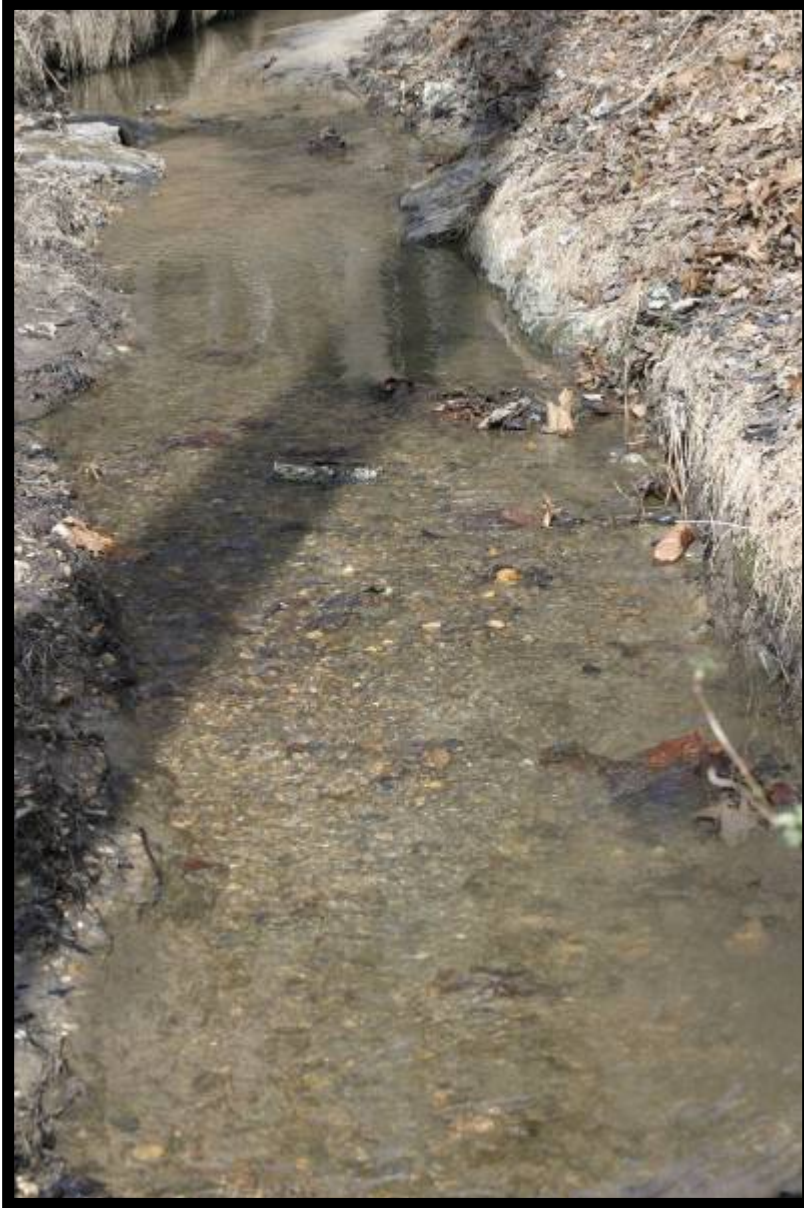
Station 13+50 Unnecessary Vane
