**UNNAMED TRIBUTARY TO BEAR SWAMP CREEK  
STREAM RESTORATION SITE  
2005 Annual Monitoring Report (Year 3)**

**Franklin County  
EEP Project No. 27  
Design Firm: Arcadis G&M of North Carolina, Inc.**

**February, 2006**

**Prepared by: ECOSCIENCE CORPORATION  
1101 Haynes Street, Suite 101  
Raleigh, NC 27604**

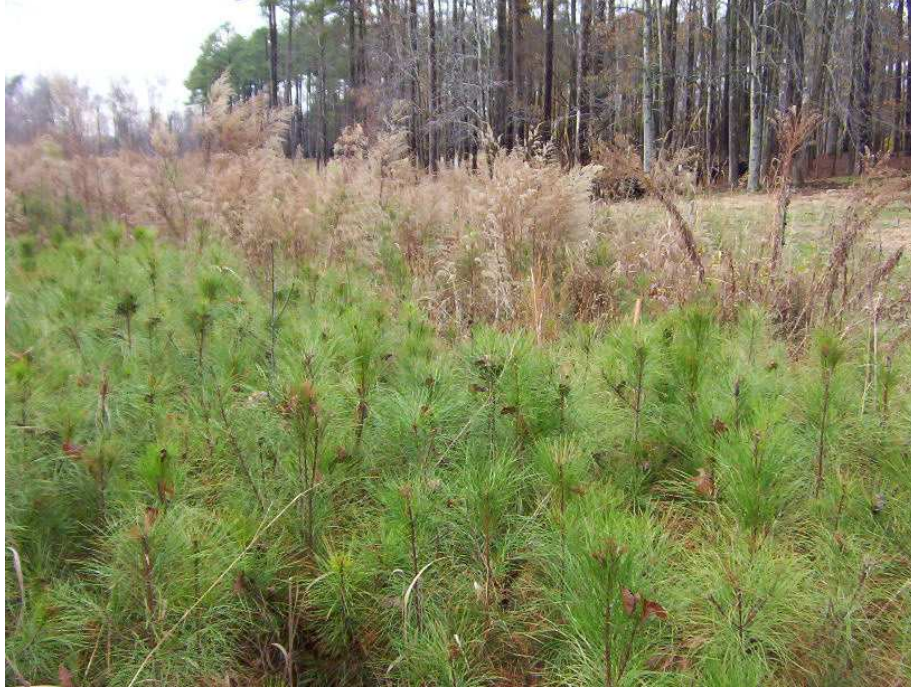
Photo 1. Heavy loblolly pine colonization near Station 1+00.

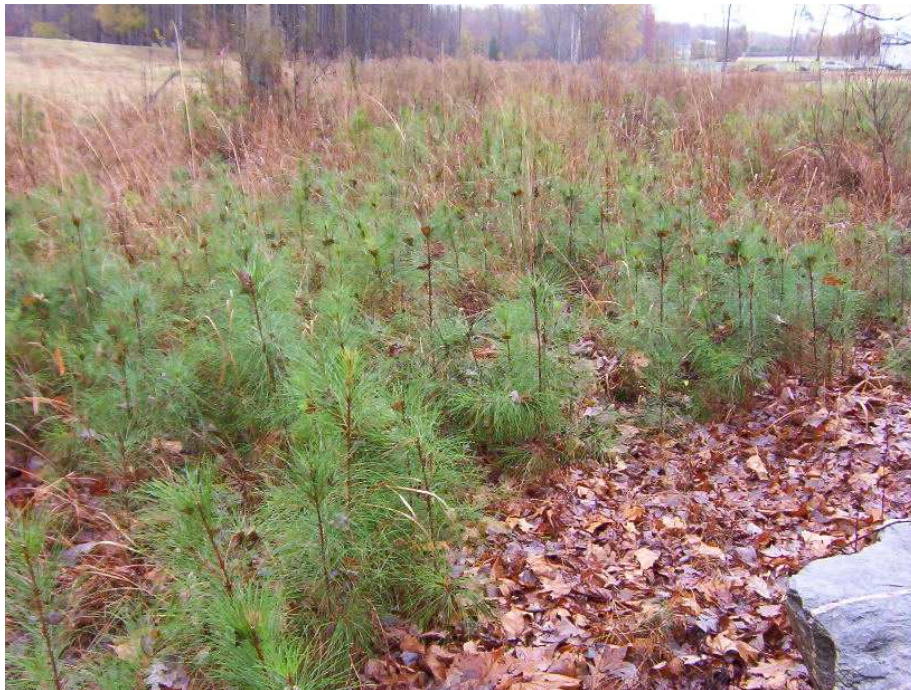
Photo 2. Heavy loblolly pine colonization near Station 10+00.

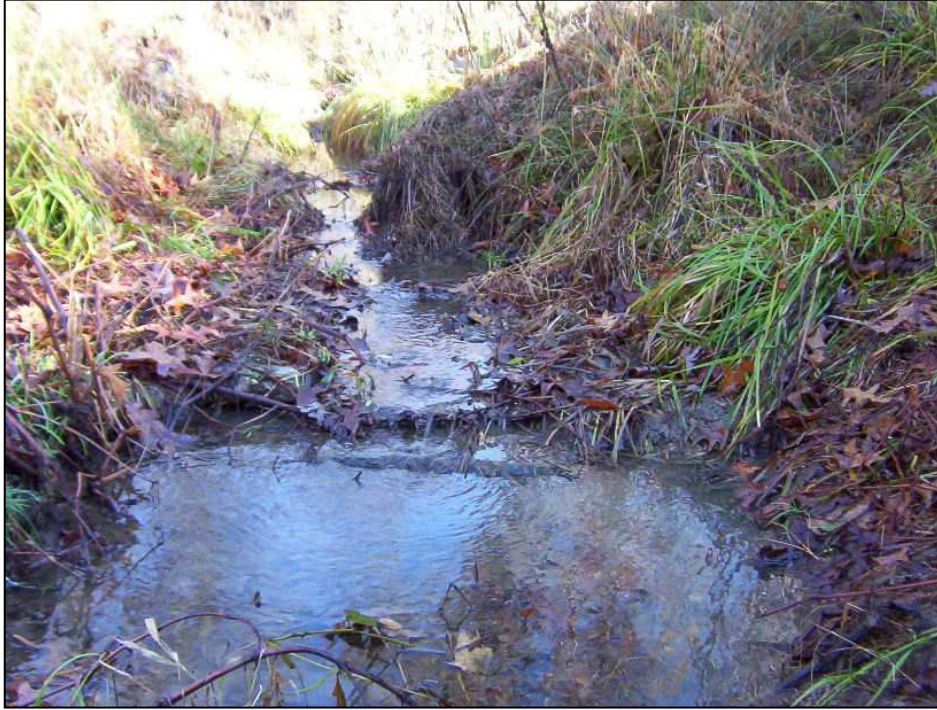
Photo 1. Rock Vane 2 has filled in with sediment but stream remains stable.

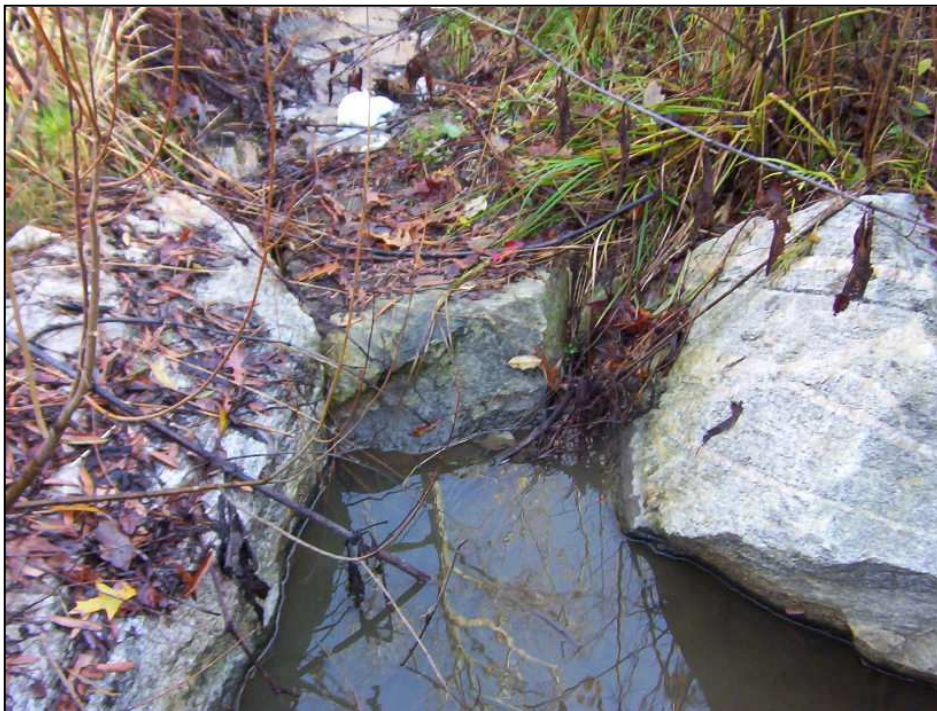
Photo 2. Piping of flow behind Rock Vane 3.

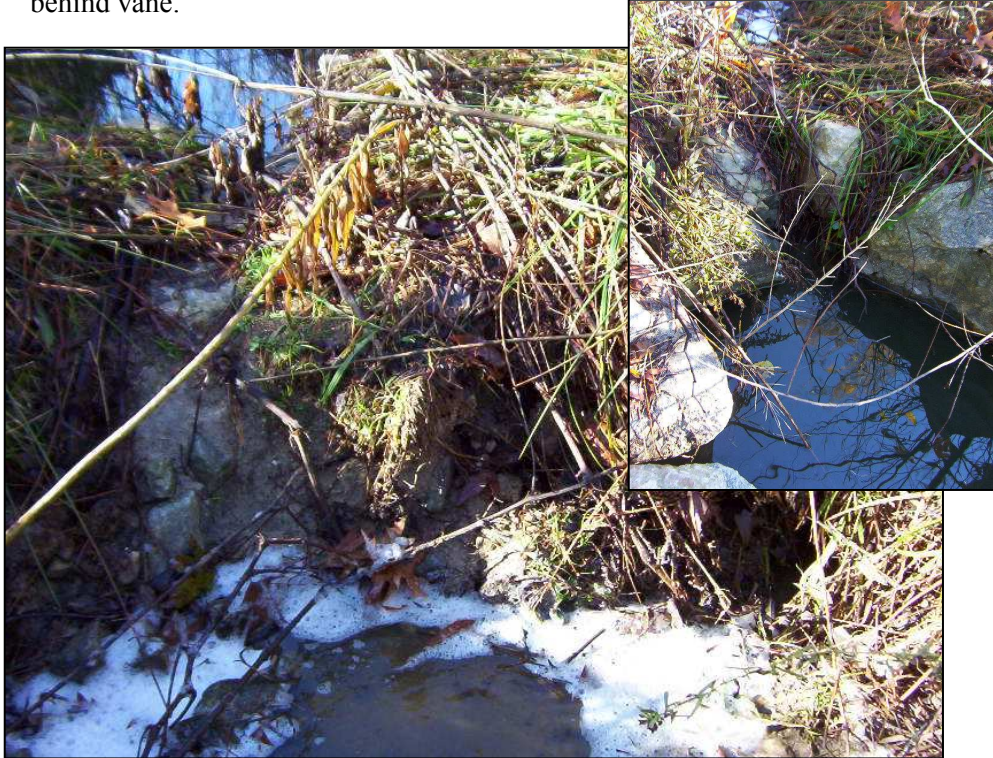
Photo 3. Piping of flow behind Rock Vane 3, causing moderate degradation of channel behind vane.

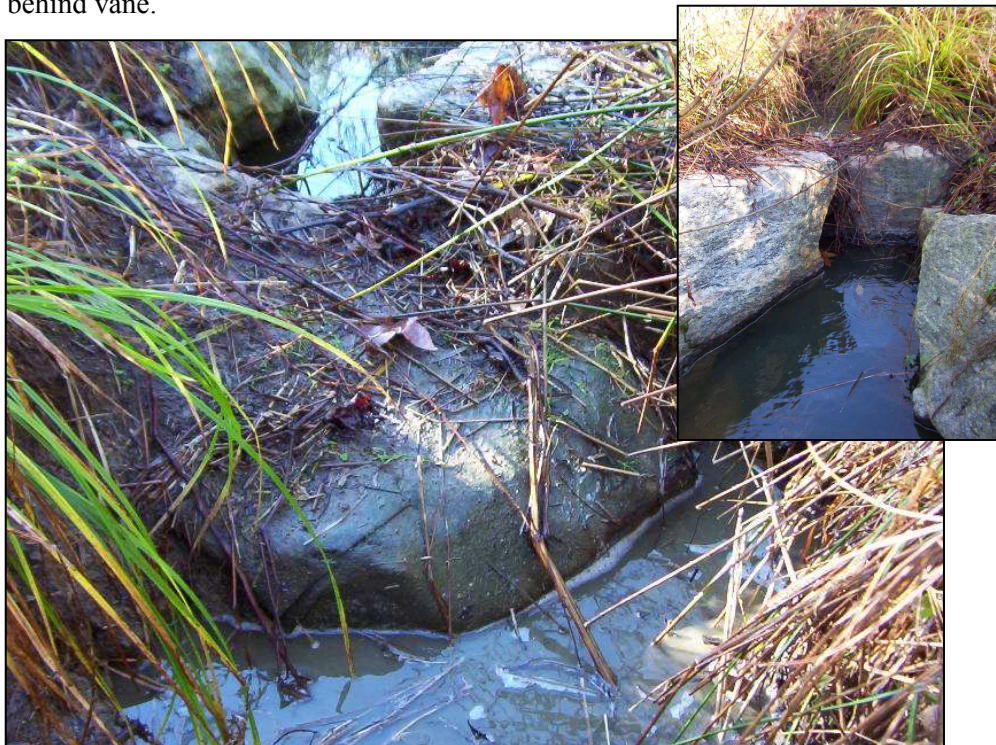
Photo 4. Piping of flow behind Rock Vane 3, causing moderate degradation of channel behind vane.

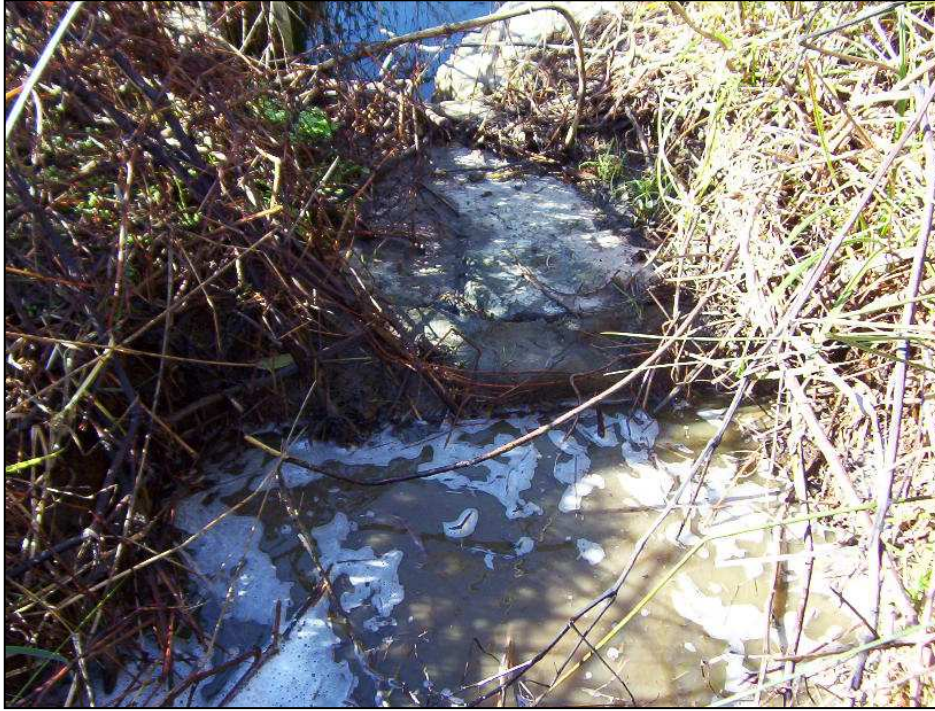
Photo 5. Piping of flow behind Rock Vane 10.

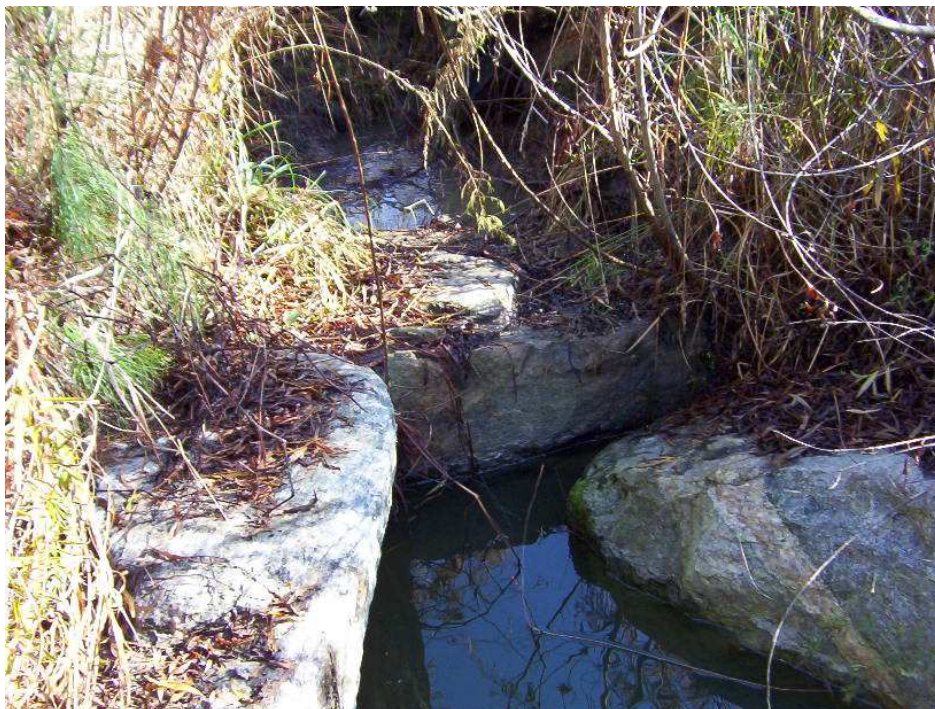
Photo 6. Piping of flow behind Rock Vane 11.

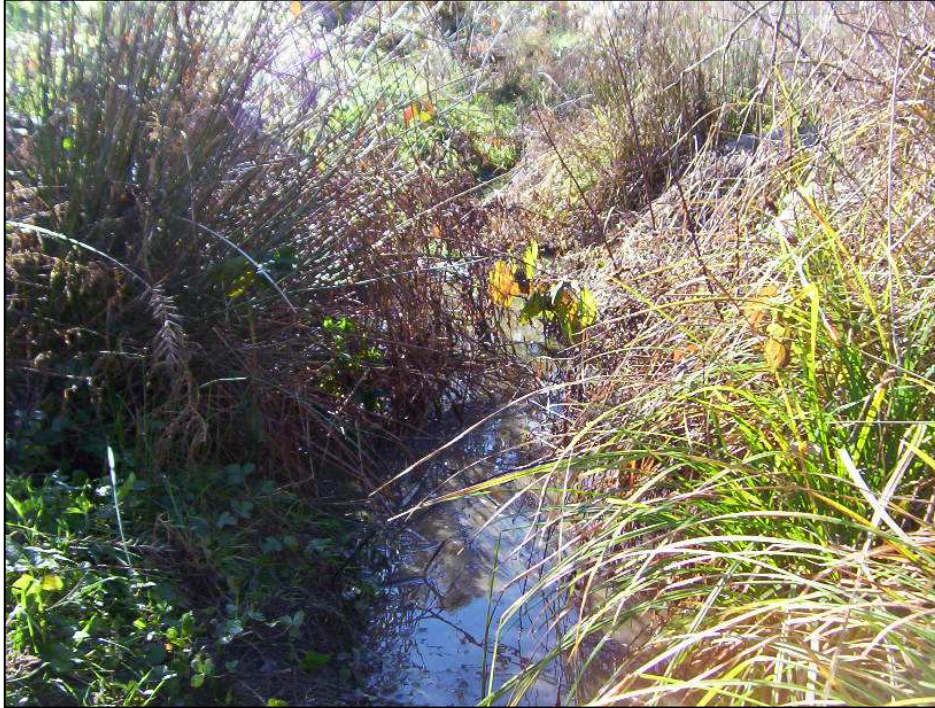
Photo 7. Rock Vane 14 has filled in with sediment but stream remains stable.

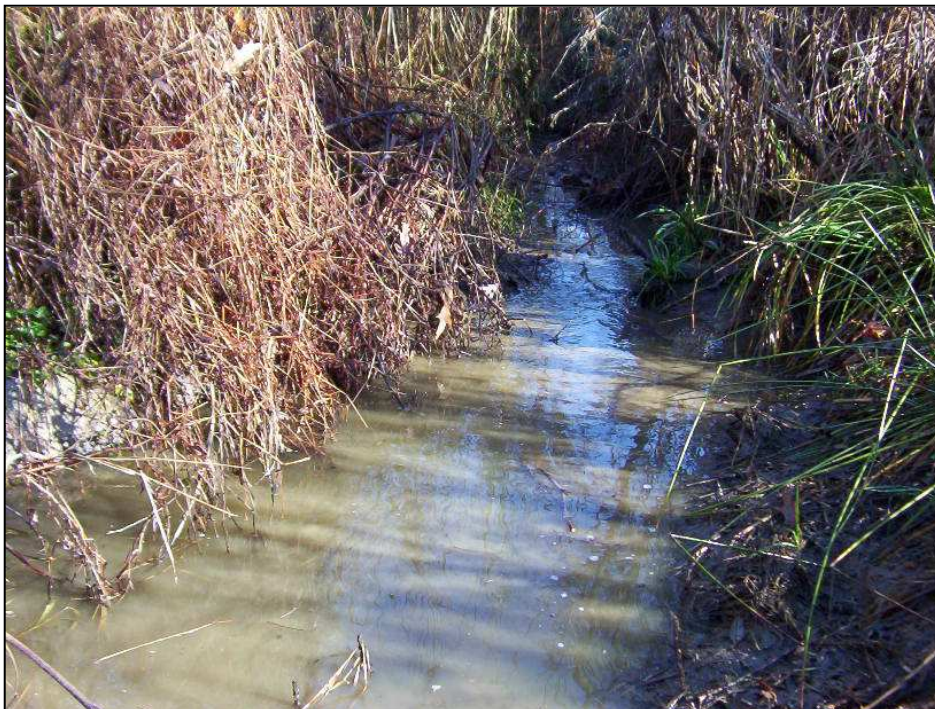
Photo 8. Rock Vane 17 has filled in with sediment but stream remains stable.

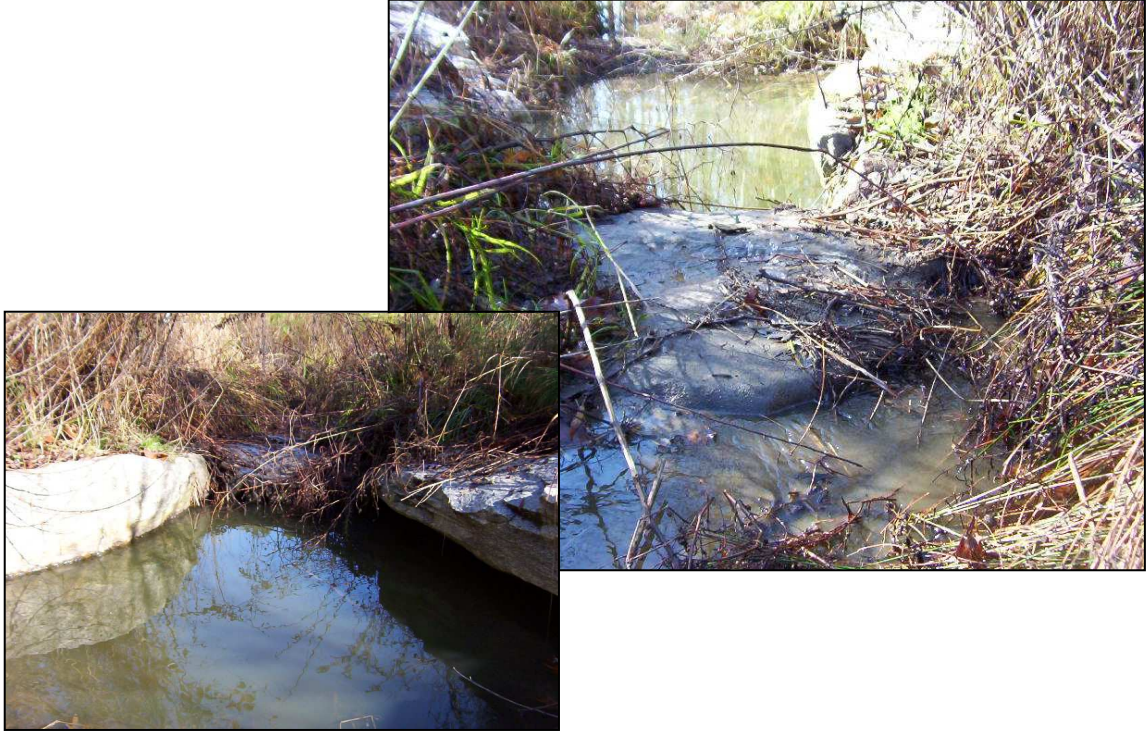
Photo 9. Piping of flow behind Rock Vane 11.

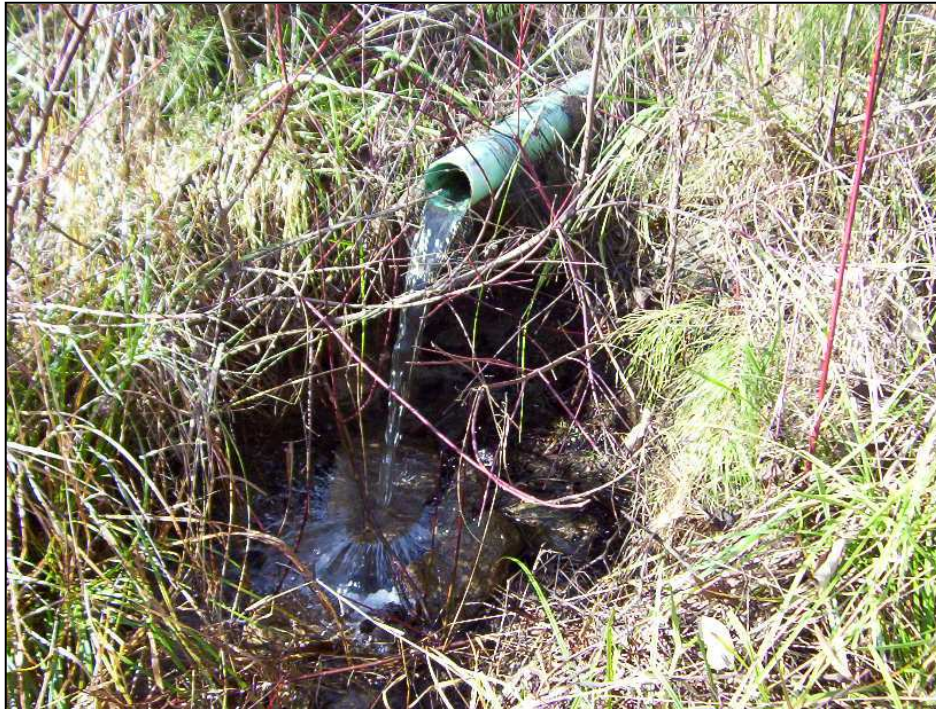
Incoming 4-inch pipe		No energy dissipater	10
Slight Bank Erosion		Floodplain restriction	11

Photo 10. Erosion directly adjacent to stream from incoming 4-inch pipe.

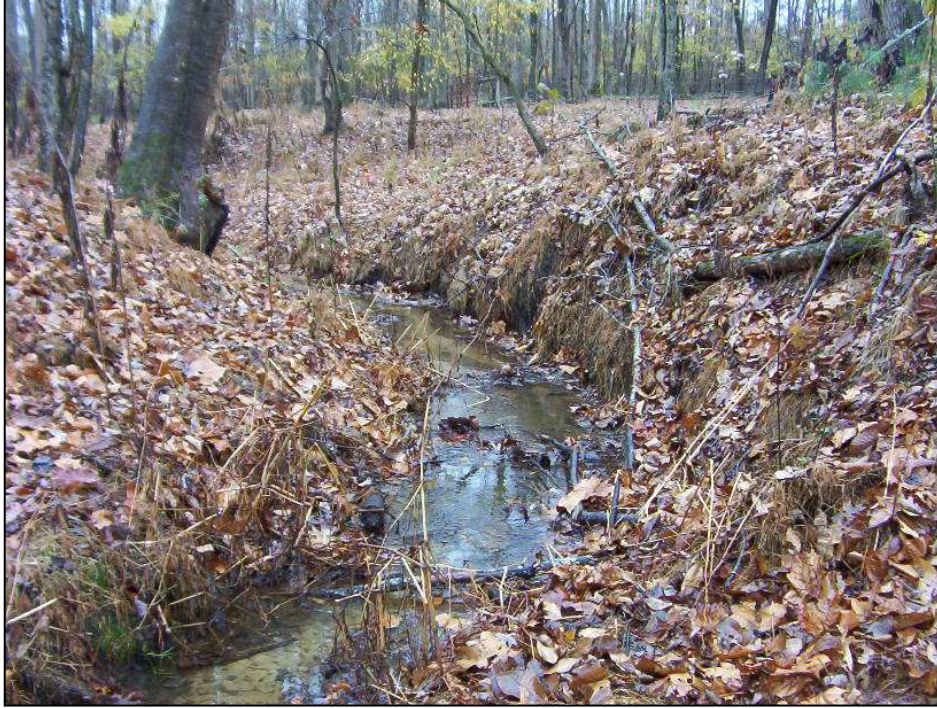
Photo 11. Minor erosion along outside bend where channel is pinched.
