# UNNAMED TRIBUTARY TO BEAR SWAMP CREEK STREAM RESTORATION SITE

2006 Annual Monitoring Report (Year 4)

Franklin County  
EEP Project No. 27  
Design Firm: Arcadis G&M of North Carolina, Inc.

January, 2007

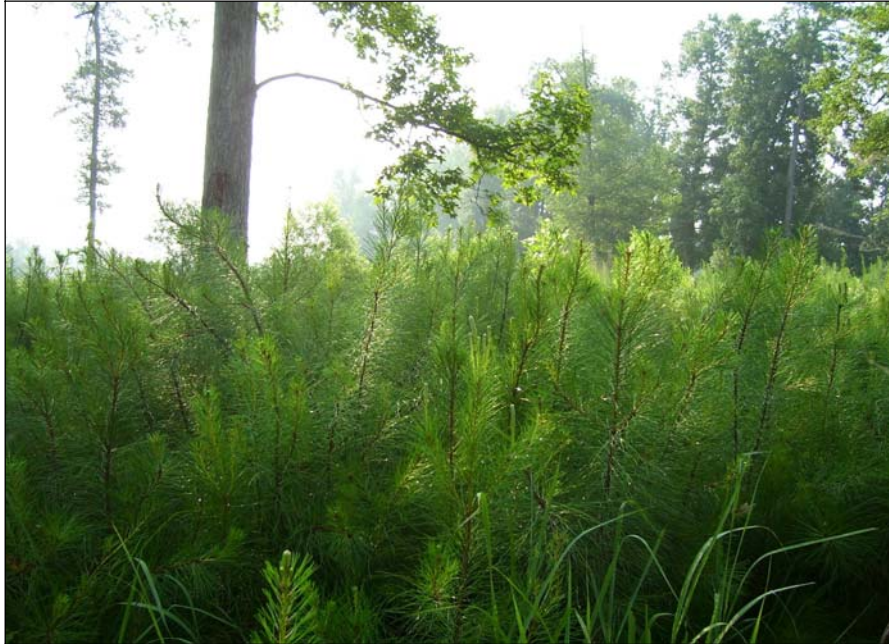
Photo 1. Heavy loblolly pine colonization near Station 1+00.

Exhibit Table VI. Vegetative Problem Areas UT to Bear Swamp Creek Stream Restoration Site / EEP Project No. 27			
Feature / Issue	Station # / Range	Probable Cause	Photo #
Invasive Populations	Throughout, but especially at Vegetation Plot 1	<i>Pinus taeda</i> : seeding from adjacent stands	1 and 2

Aggressive recruitment of *Pinus taeda* continues at the site, especially at the northeastern end (Appendix B). A mixed pine-hardwood woodlot near this area provides a nearby source of pine propagules. The northeastern end of the Site, near Plot 1, also features abundant *Rhus* shrubs, principally *Rhus glabra*. While these are abundant, they do not generate the dense shade found under pine saplings. The unbranched stems and weak vegetative growth result in an open understory where grasses and herbs flourish. It was noted that the *Rhus* thickets were used by deer as a bedding area.

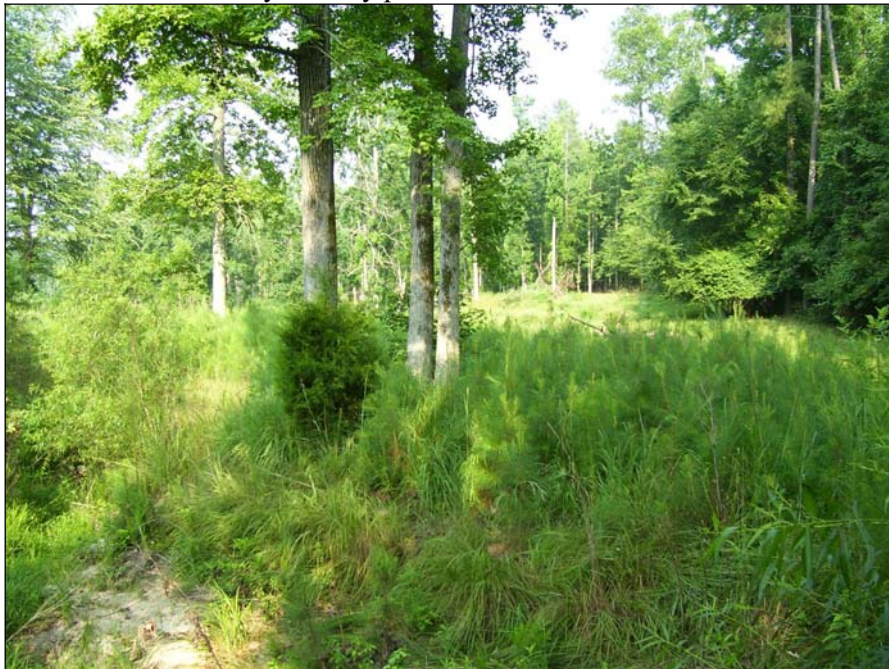
Photo 2. Heavy loblolly pine colonization near Station 1+50.

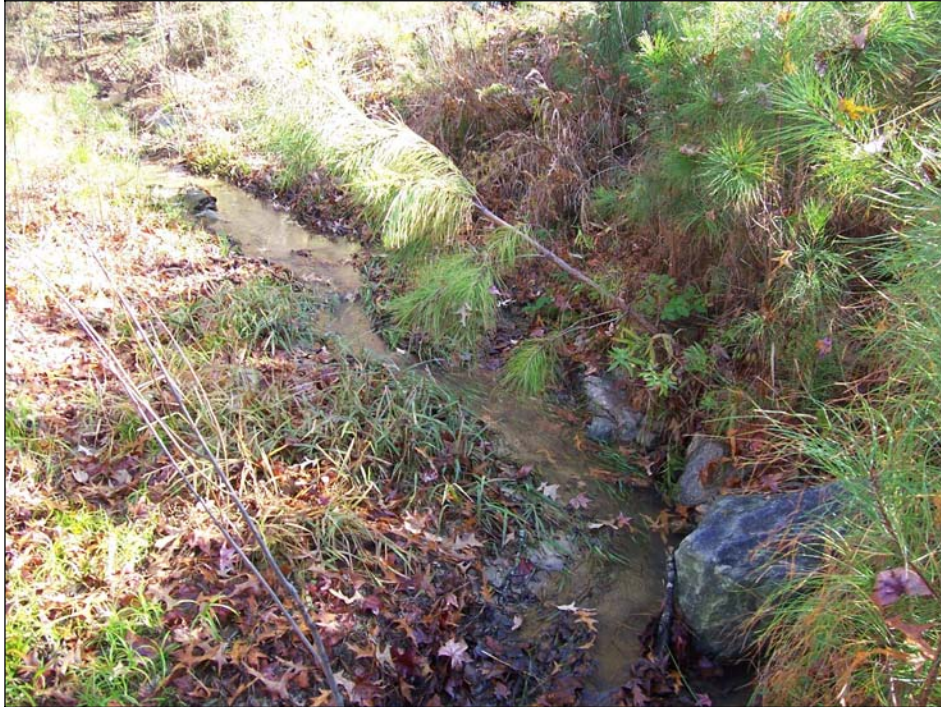
Photo 1. Rock Vane 2 has filled in with sediment but stream remains stable.

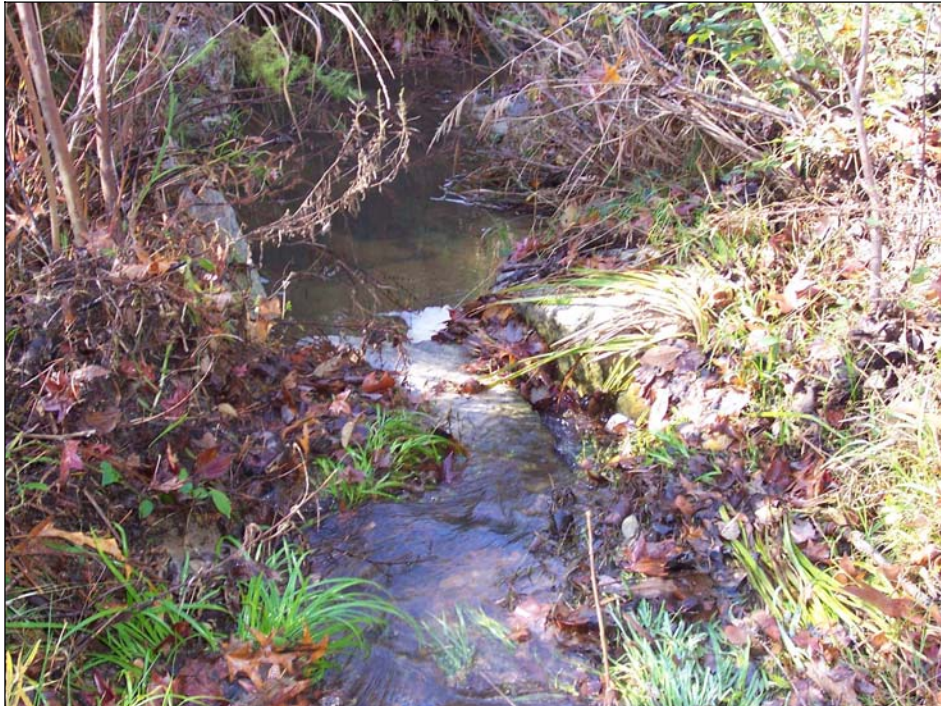
Photo 2. Piping of flow behind Rock Vane 3.

Exhibit Table X. Stream Problem Areas UT to Bear Swamp Creek Stream Restoration Site / EEP Project No. 27			
Feature Issue	Station Numbers	Suspected Cause	Photo Number
Vane 2, filled in		low slope, excess sediment	1
Vane 3, structure failure		Piping, inadequate use of filter fabric, steep vane arms	2
Vane 4, filled in		low slope, excess sediment	3
Vane 6, structure failure		Piping, inadequate use of filter fabric, steep vane arms	4
Vane 8, structure failure		Piping, inadequate use of filter fabric, steep vane arms	5
Vane 10, structure failure		Piping, inadequate use of filter fabric, steep vane arms	6
Vane 11, structure failure		Piping, inadequate use of filter fabric, steep vane arms	7
Vane 14, filled in		low slope, excess sediment	8
Vane 16, filled in		low slope, excess sediment	9
Vane 17, filled in		low slope, excess sediment	10
Vane 19, structure failure		Piping, inadequate use of filter fabric, steep vane arms	11

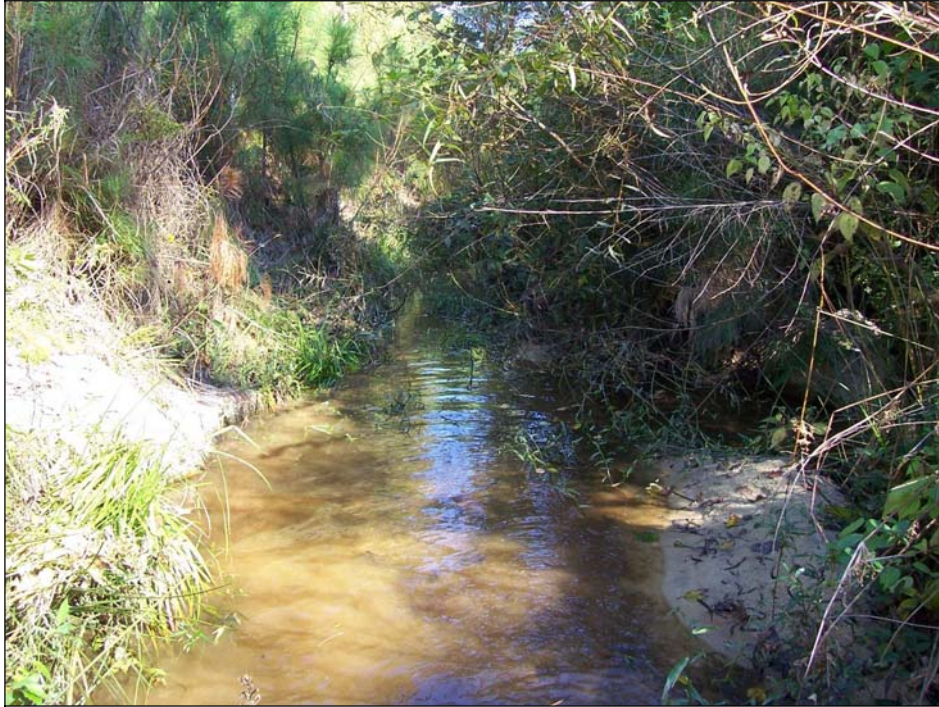
Photo 3. Rock Vane 4 has accrued sediment but stream remains stable.

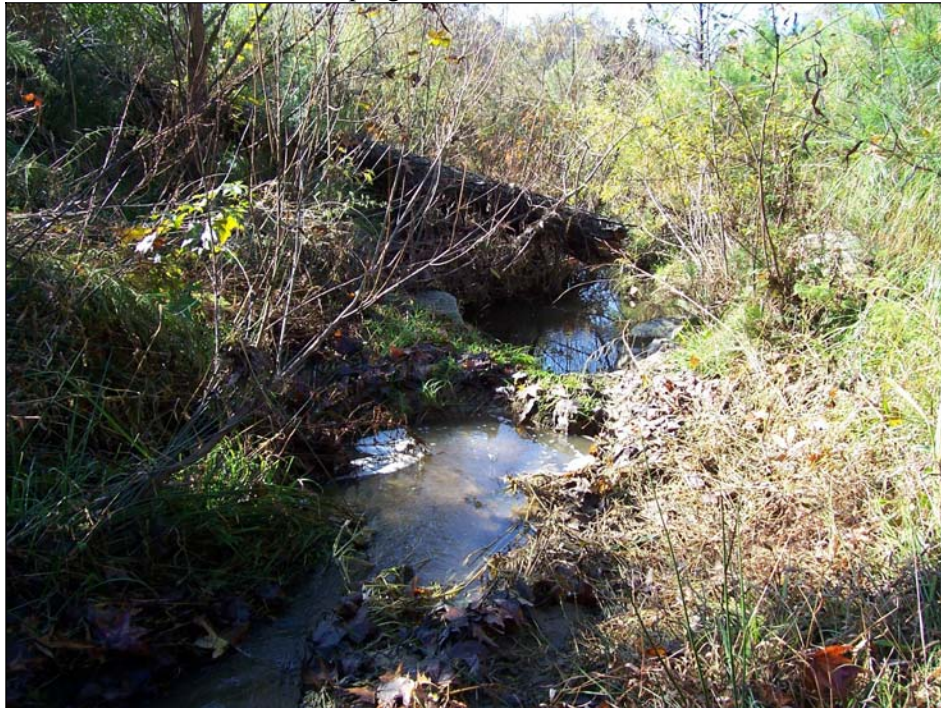
Photo 4. Piping of flow behind Rock Vane 6.

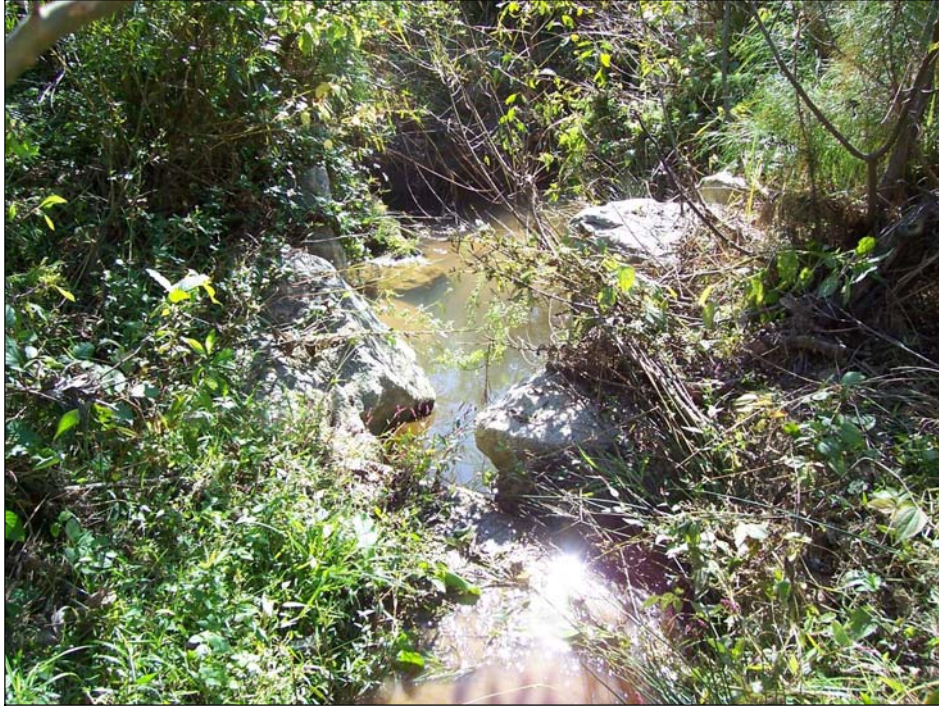
Photo 5. Piping of flow behind Rock Vane 8.

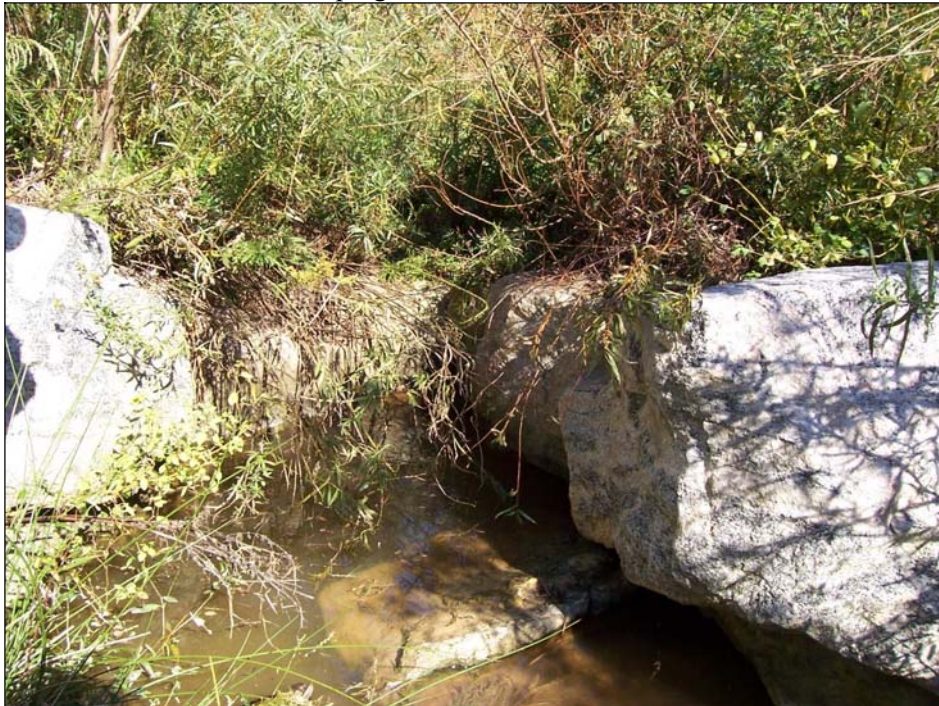
Photo 6. Piping of flow behind Rock Vane 10.

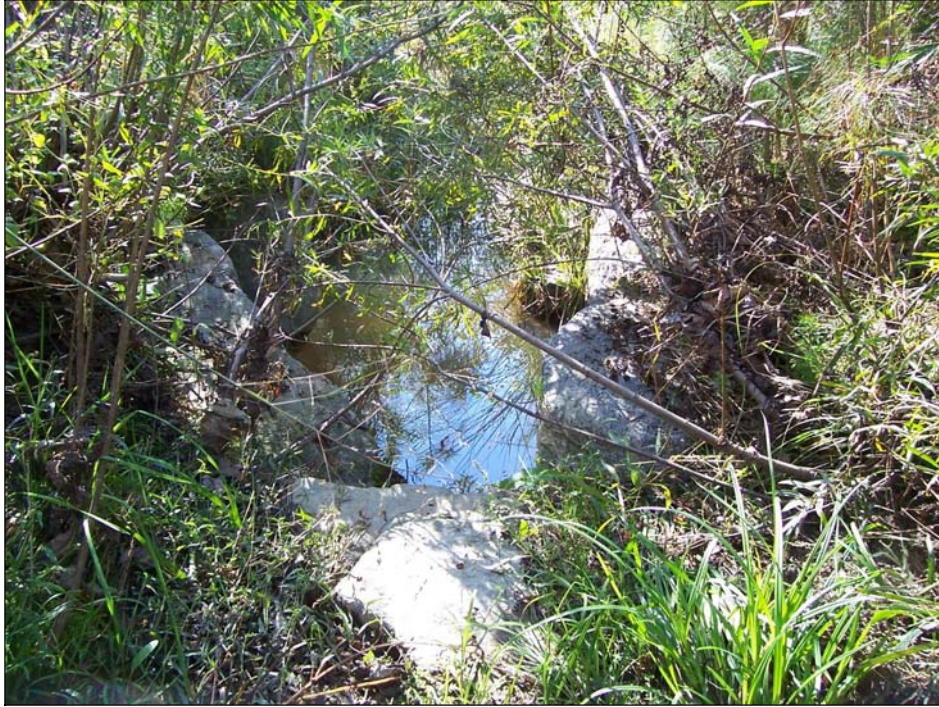
Photo 7. Piping of flow behind Rock Vane 11.

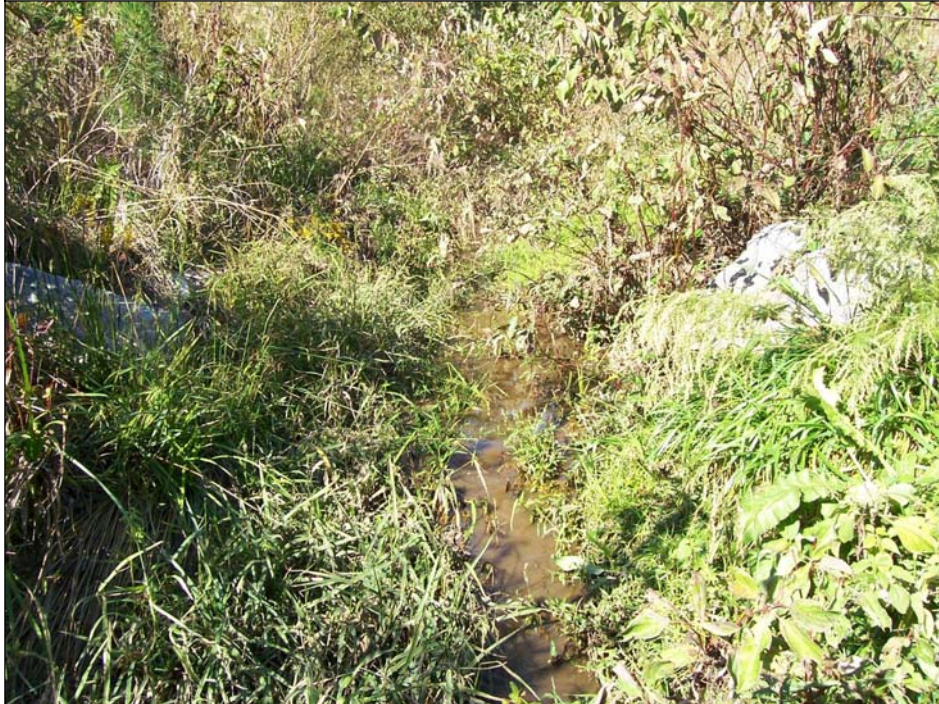
Photo 8. Rock Vane 14 has filled in with sediment but stream remains stable.

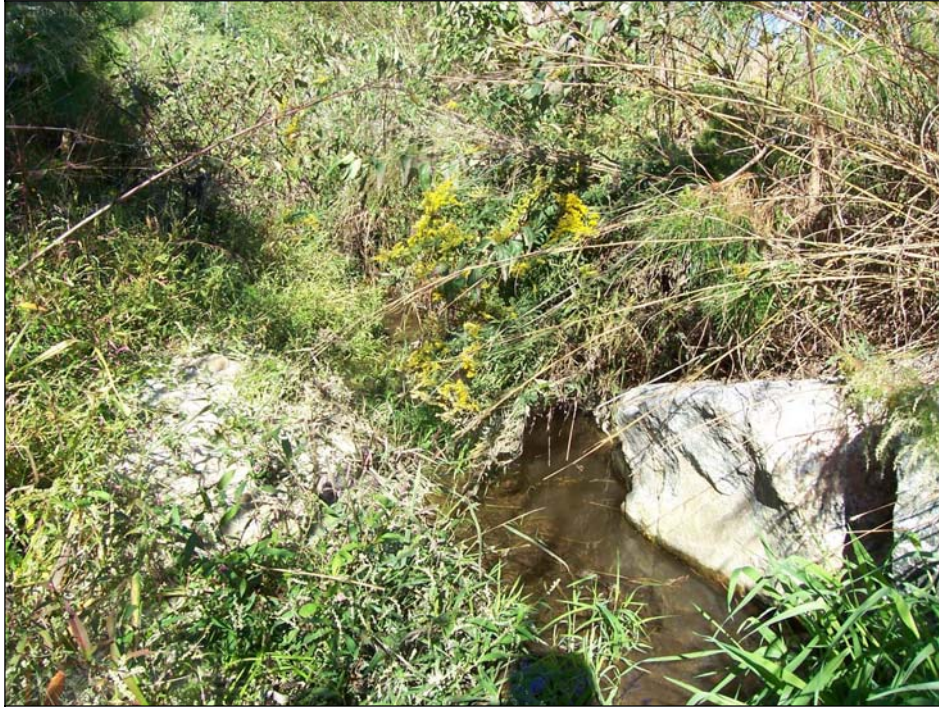
Photo 9. Rock Vane 16 has accrued sediment but stream remains stable.

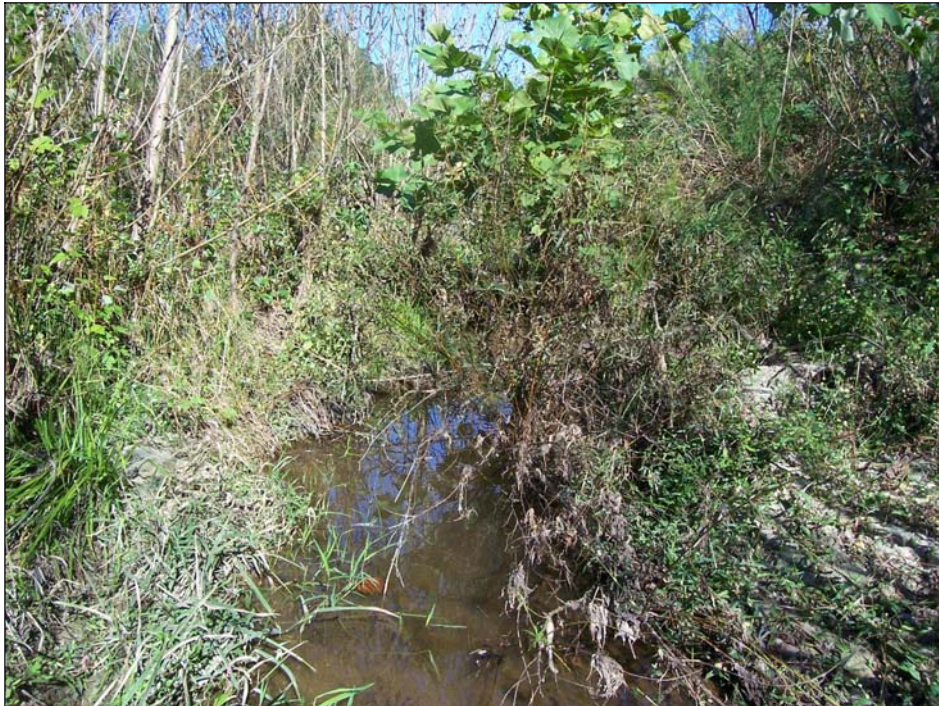
Photo 10. Rock Vane 17 has filled in with sediment but stream remains stable.

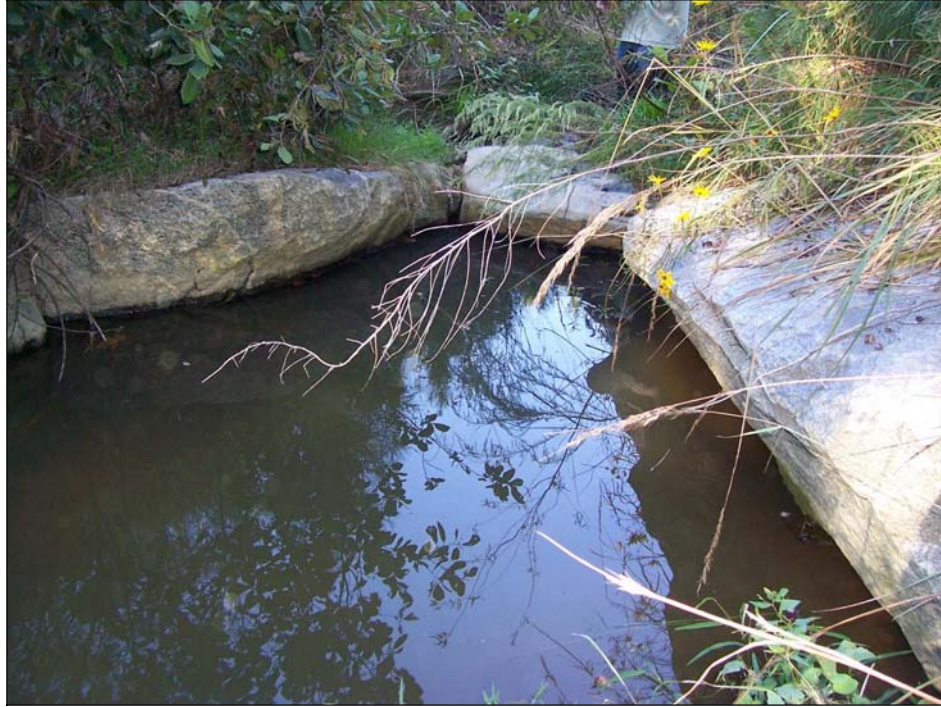
Photo 11. Piping of flow behind Rock Vane 19.

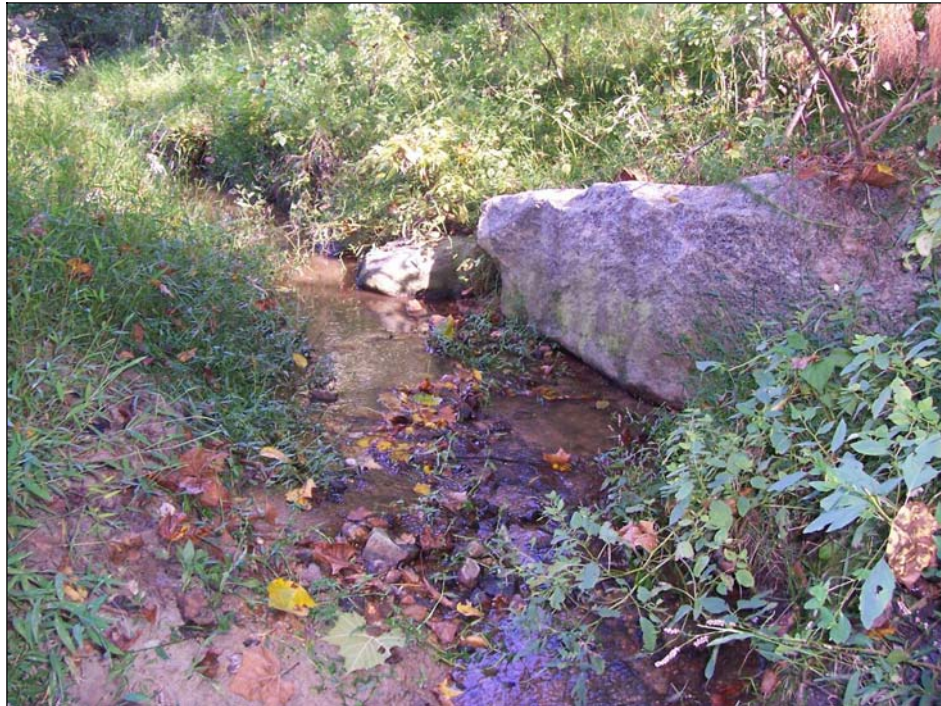
Photo 12. Rock Vane 22 has accrued sediment but stream remains stable.

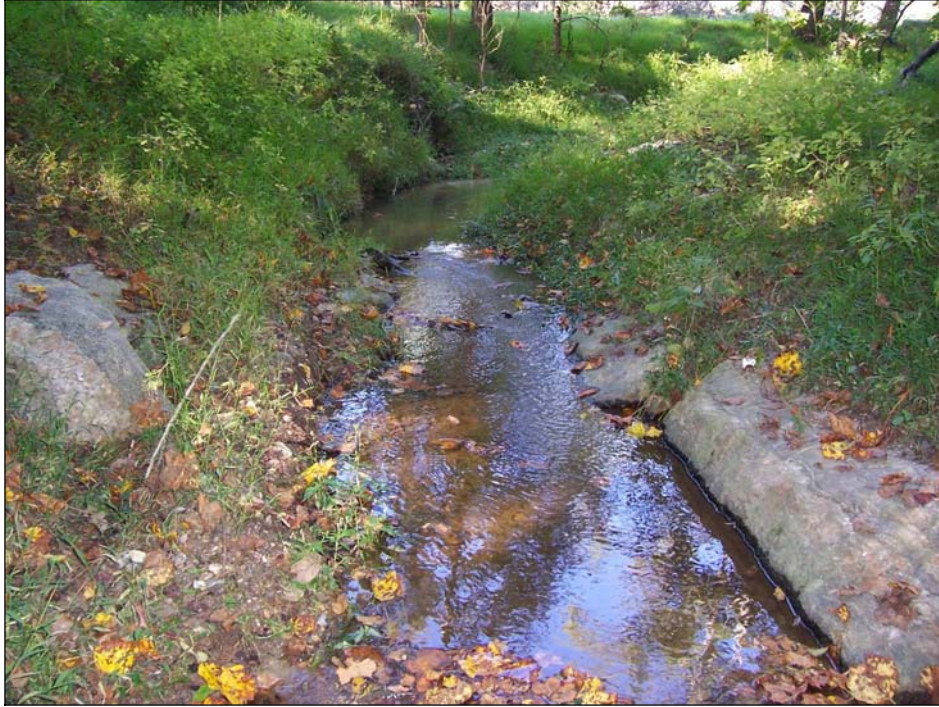
Photo 13. Rock Vane 24 has filled accrued sediment but stream remains stable.
