**UNNAMED TRIBUTARY TO BEAR SWAMP CREEK  
STREAM RESTORATION SITE**

**2007 Annual Monitoring Report (Year 5)**

**Franklin County  
EEP Project No. 27  
Design Firm: Arcadis G&M of North Carolina, Inc.**

**February 2008**

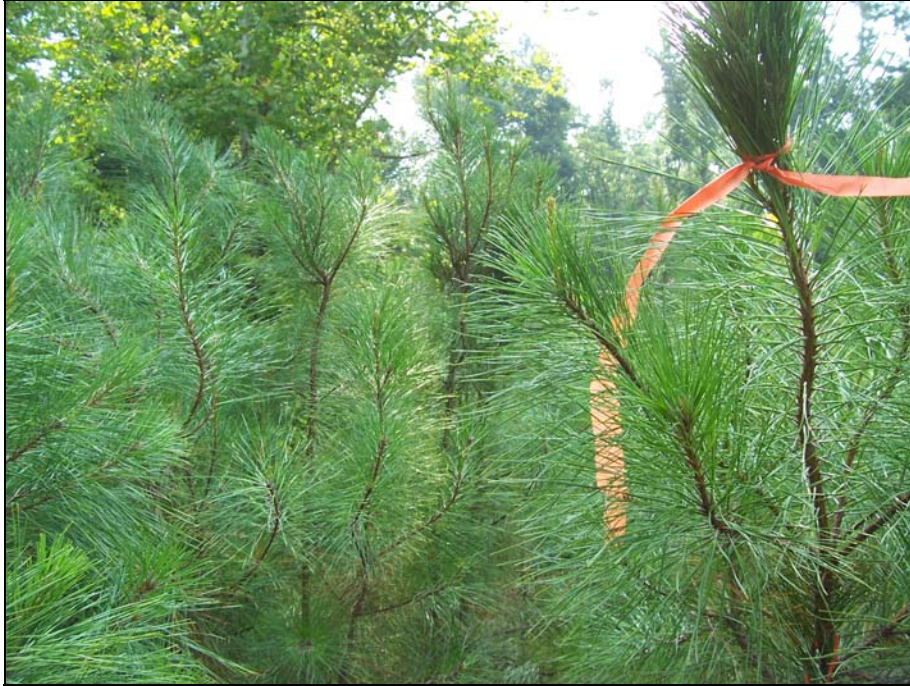
<b>Exhibit Table VI. Vegetative Problem Areas</b> <b>UT to Bear Swamp Creek Stream Restoration Site / EEP Project No. 27</b>			
<b>Feature / Issue</b>	<b>Station # / Range</b>	<b>Probable Cause</b>	<b>Photo #</b>
Invasive Populations	Throughout, but especially at Vegetation Plot 1	loblolly pine ( <i>Pinus taeda</i> ): seeding from adjacent stands	1 and 2 (Appendix B)

Photo 1. Heavy loblolly pine colonization near Station 1+00.

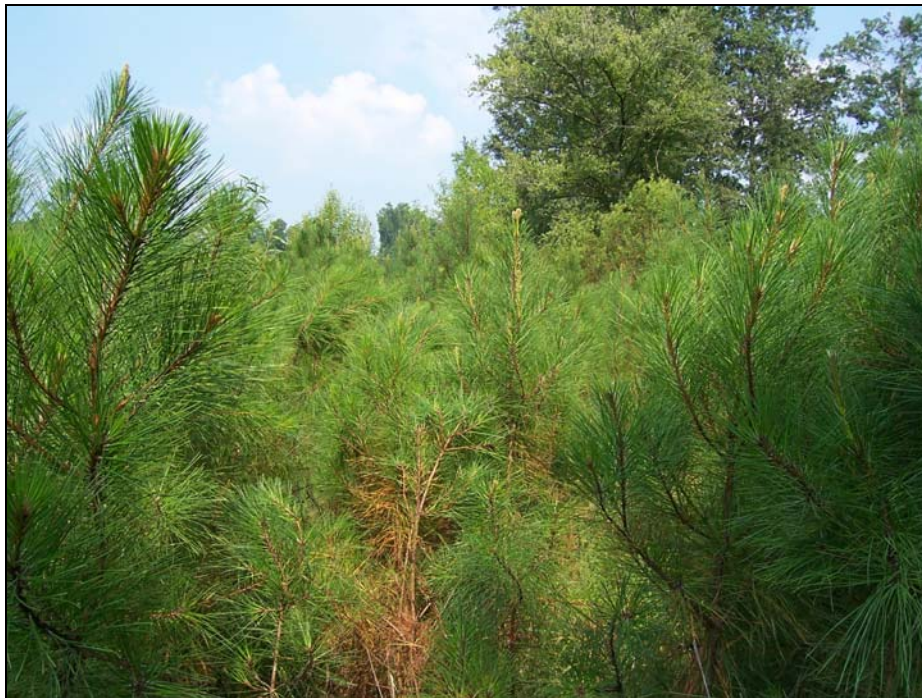
Photo 2. Heavy loblolly pine colonization near Station 10+00.

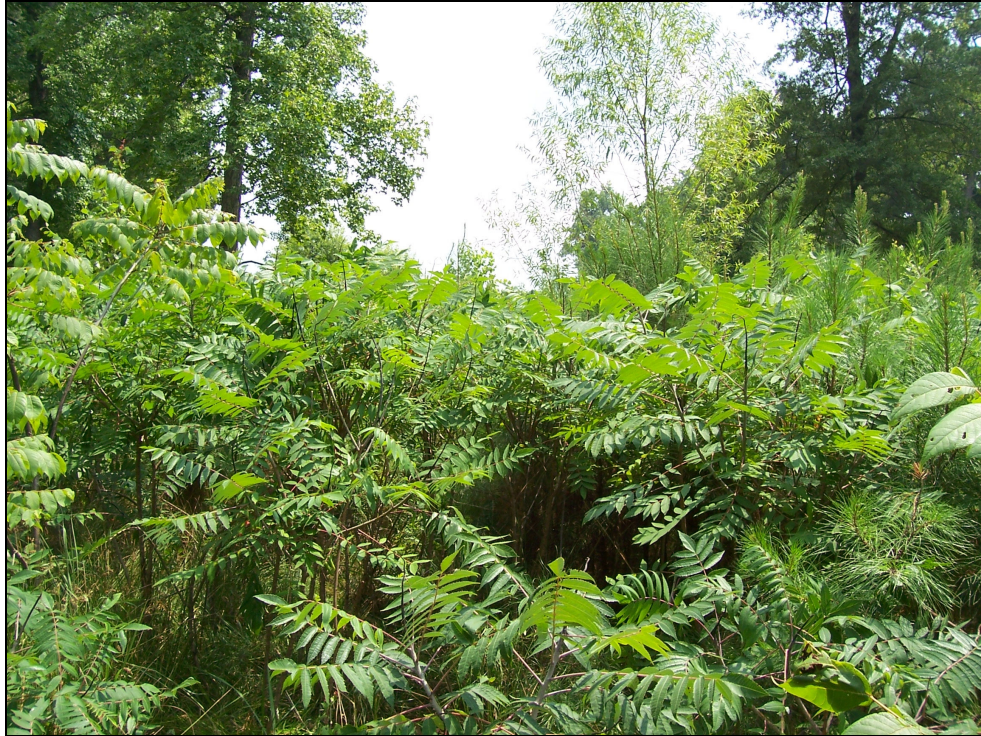
Photo 3. Plot 1 taken July 31, 2007 from the northwest corner looking southeast.

A total of 29 stems of planted species were counted in the four plots. Stem density per acre for Plots 1, 2, 3, and 5 are 728, 364, 40, and 40 stems per acre. The average density for planted species in all plots is 293 stems per acre, which exceeds the established success criteria of 260 stems per acre for vegetation at year 5.

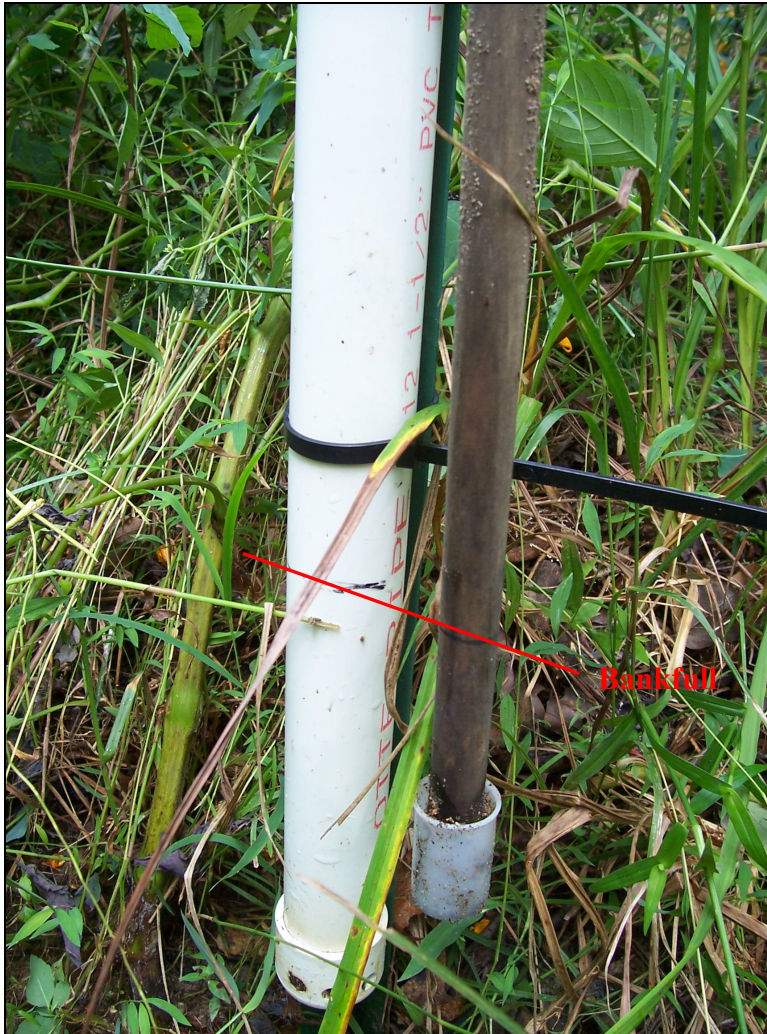
Exhibit Table VIII. Verification of Bankfull Events UT to Bear Swamp Creek Stream Restoration Site / EEP Project No. 27			
Date of Data Collection	Date of Occurrence	Method	Photo Number
08/28/2007	July 2007	Crest Gauge (Water level was 6-8 inches above bankfull)	7 (Appendix C)

Photo 7. Crest gauge showing particulate deposited 6-8 inches above bankfull during a storm event in July 2007.

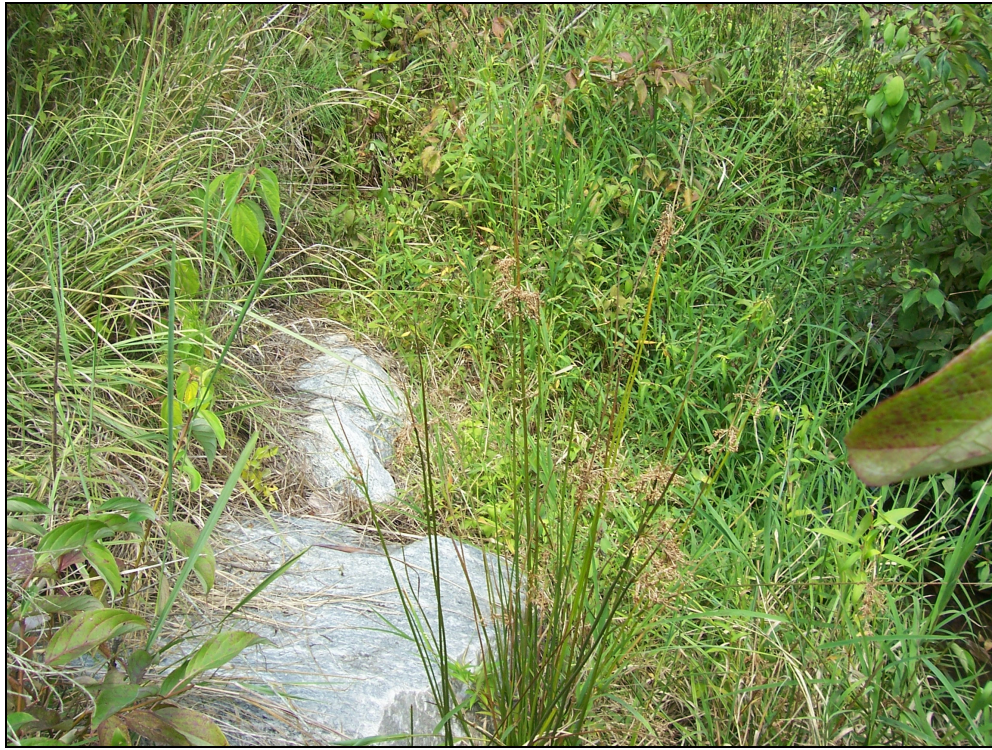
<b>Exhibit Table X. Stream Problem Areas</b>			
<b>UT to Bear Swamp Creek Stream Restoration Site / EEP Project No. 27</b>			
<b>Feature Issue</b>	<b>Station Numbers</b>	<b>Suspected Cause</b>	<b>Photo Number</b>
Vane 2, filled in		Low slope, excess sediment	8**
Vane 3, structure failure		Piping, steep vane arms	
Vane 4, filled in		Low slope, excess sediment	
Vane 5, filled in		Low slope, excess sediment	
Vane 6, structure failure		Piping, steep vane arms	
Vane 8, structure failure		Piping, steep vane arms	
Vane 11, flooded		Beaver dam downstream of structure*	9**
Vane 14, filled in		Low slope, excess sediment	
Vane 15, flooded		Beaver dam downstream of structure*	
Vane 16, flooded		Beaver dam downstream of structure*	
Vane 17, flooded		Beaver dam downstream of structure*	
Vane 18, flooded		Beaver dam downstream of structure*	
Vane 19, flooded		Beaver dam downstream of structure*	
Vane 20, flooded		Beaver dam downstream of structure*

Photo 8. Rock vane 14 has filled in with sediment but stream remains stable.

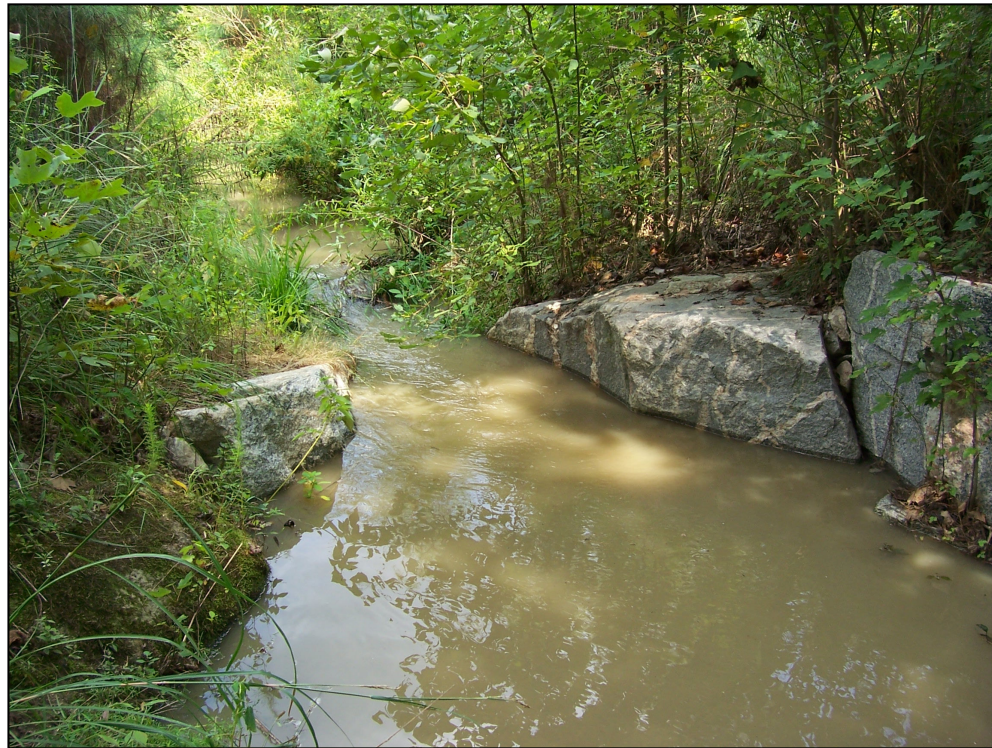
\* Beaver trapping and removal was carried out at the Site in late 2007.

Photo 9. Rock vane 20 flooded from downstream beaver dams.
