Beaver Creek Stream Restoration Annual Monitoring Report

Monitoring Year: 2004

NCEEP Project Number: 00005

BEAVER CREEK STREAM RESTORATION 2004 MONITORING REPORT

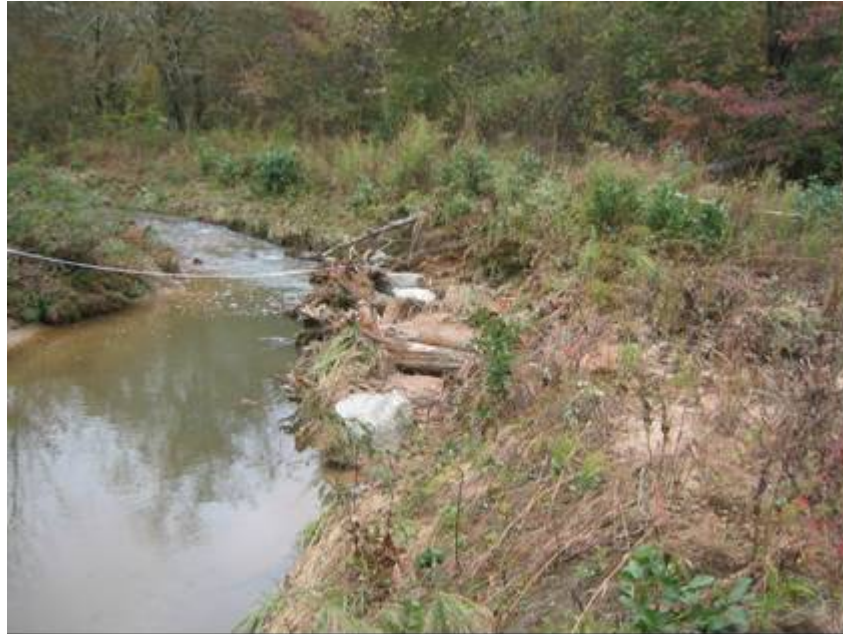
SP1. Station 3+60 to 4+20
Erosion and scour around root wads

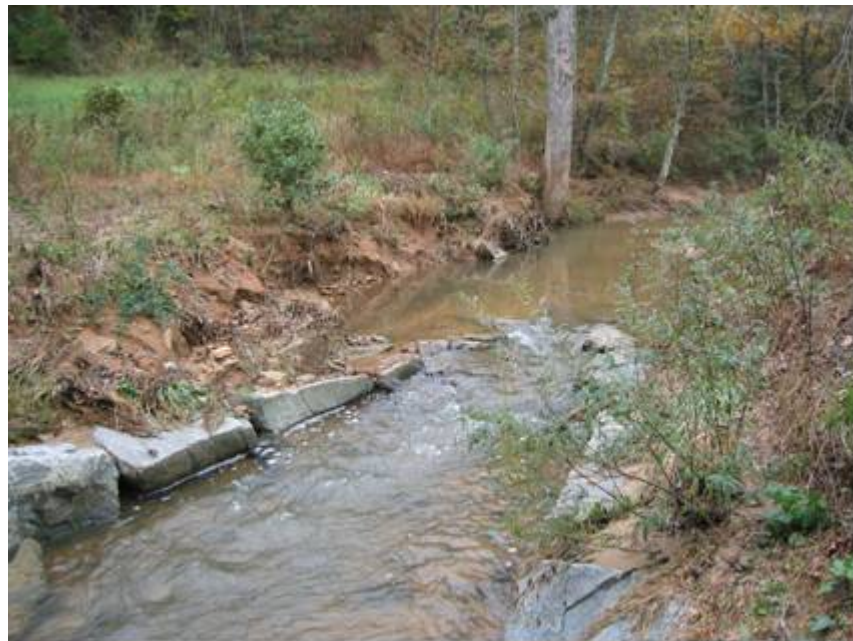
SP2. Station 8+10 to 8+30
Bank scour

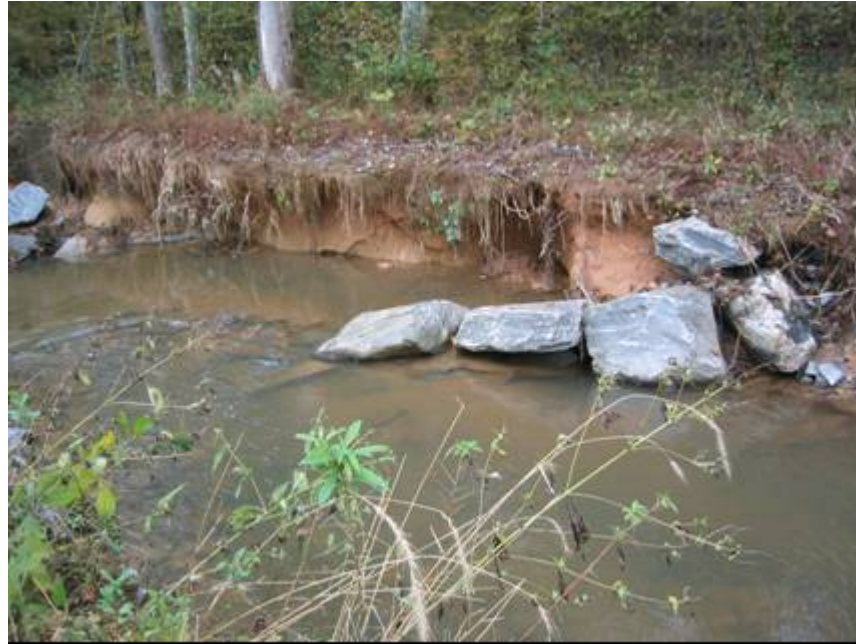
SP3. Station 8+80 to 9+20
Erosion and scour around root wads

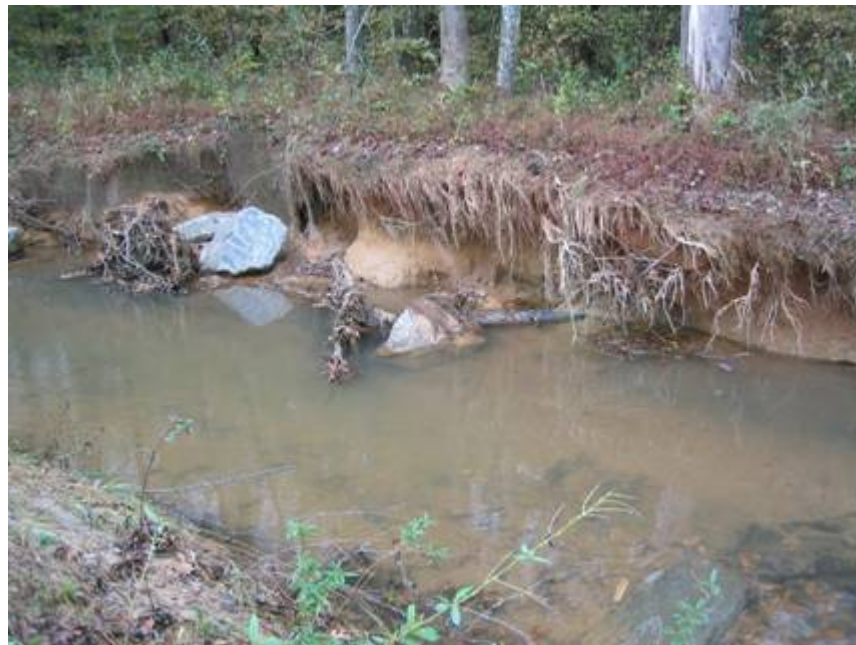
SP4. Station 8+80 to 9+20
Erosion and scour around root wads

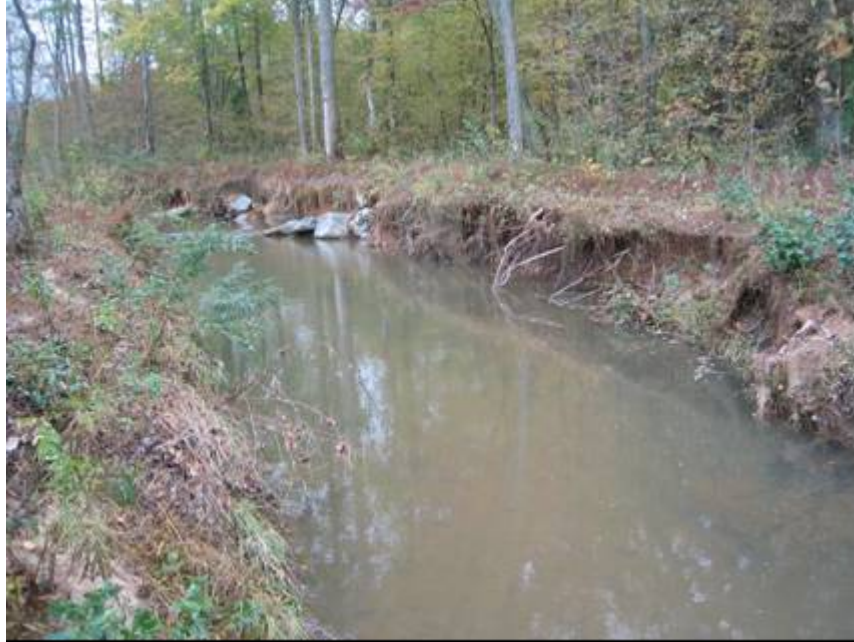
SP5. Station 8+80 to 9+20
Erosion and scour around root wads

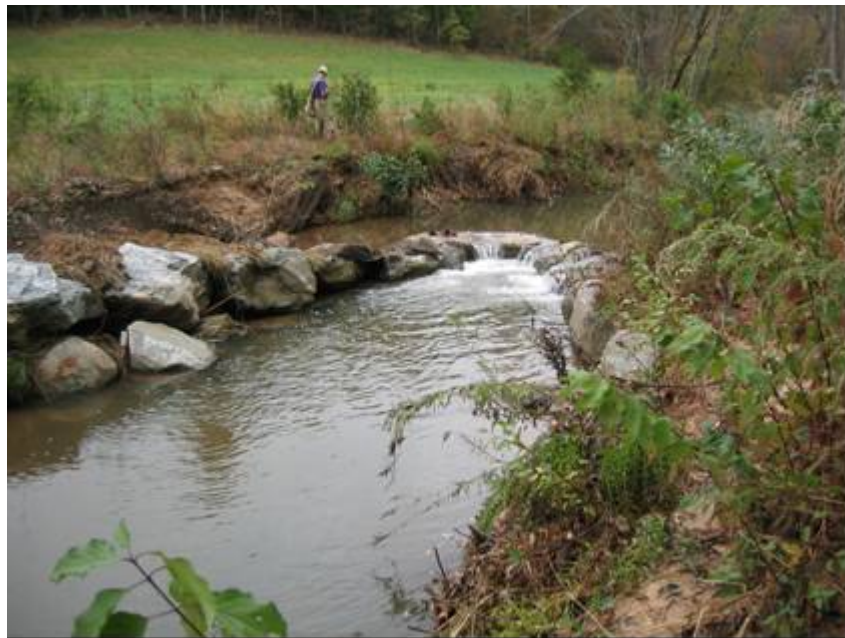
SP6. Station 10+60
Piping through cross vane

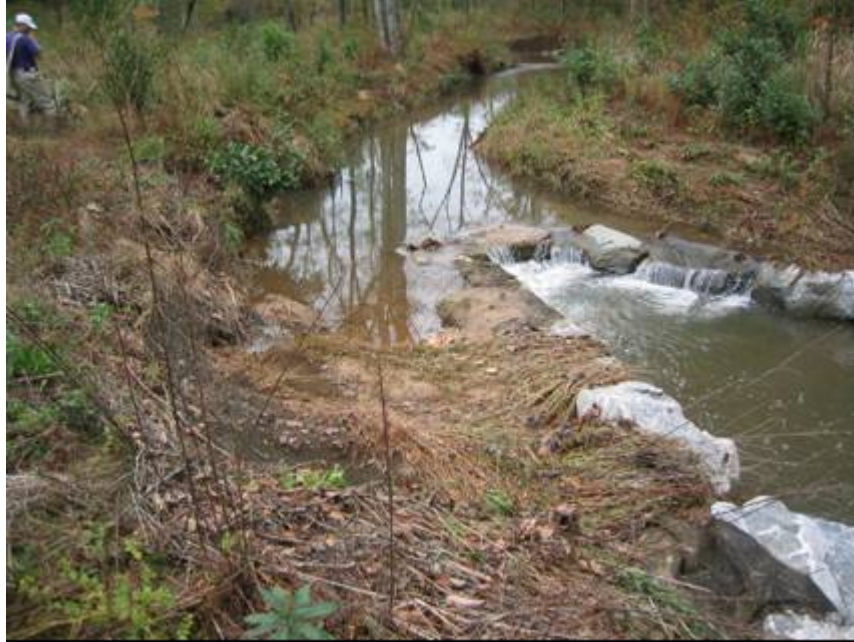
SP7. Station 11+10 to 11+30
Scour downstream of cross vane

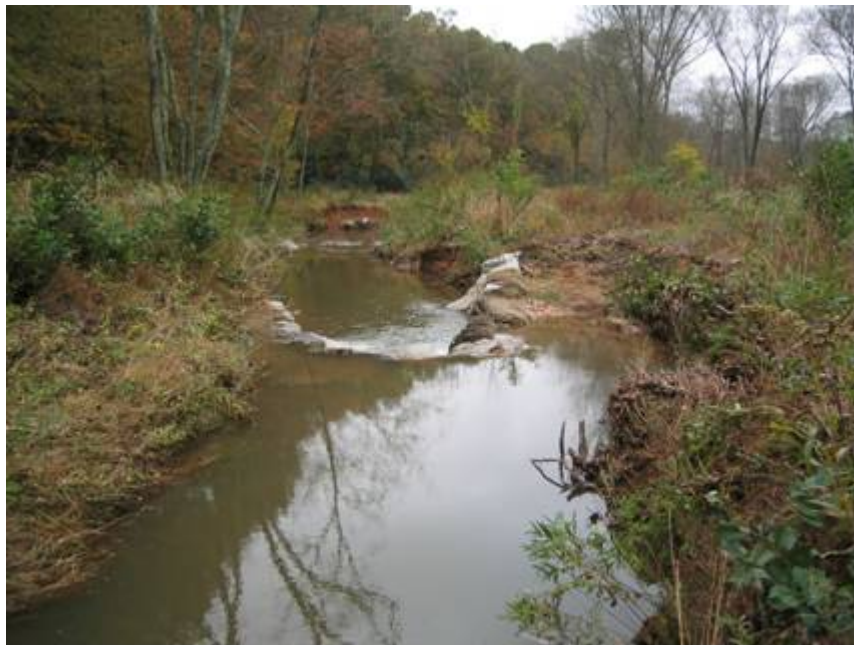
SP8. Station 11+10 to 11+30
Scour downstream of cross vane

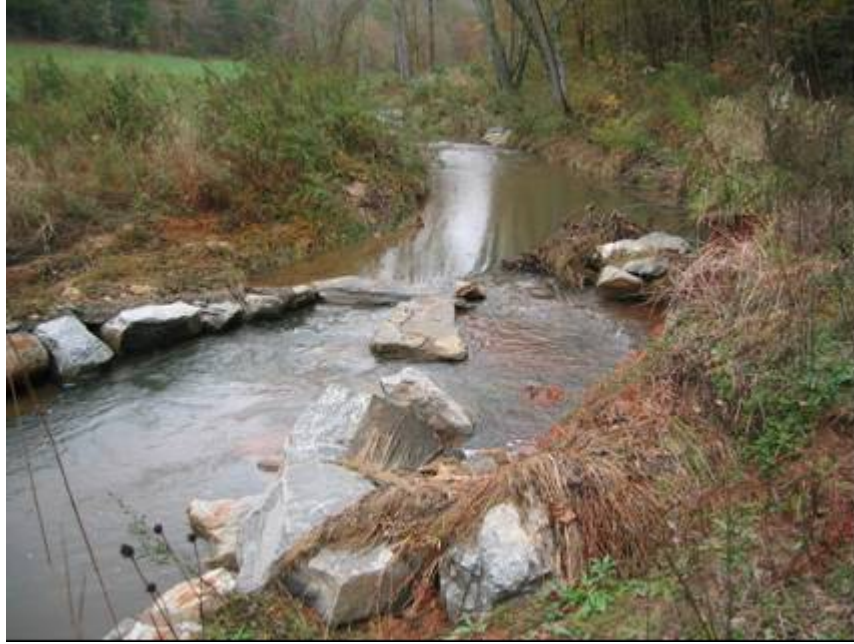
SP9. Station 12+00 to 12+60
Blowout around root wad and cross vane

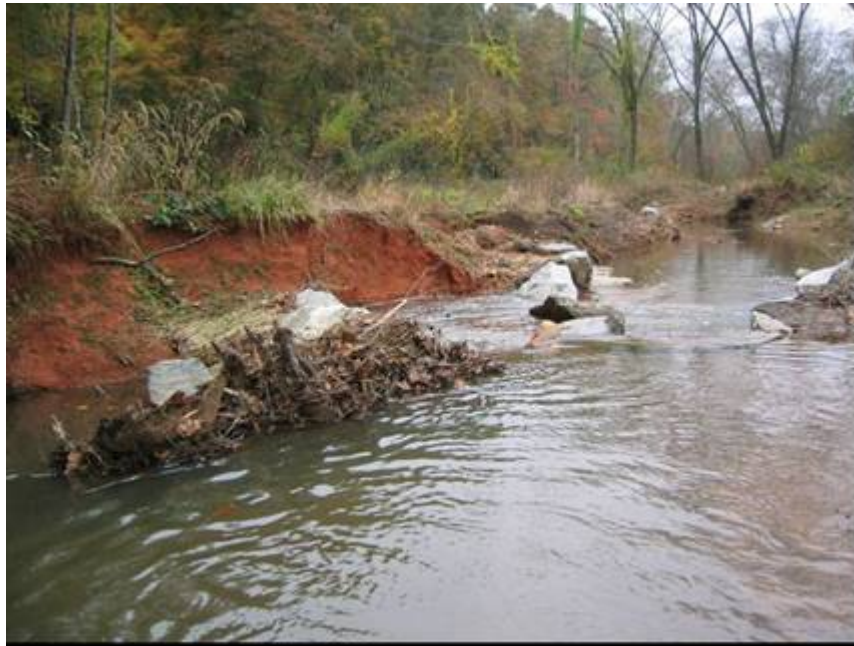
SP10. Station 12+00 to 12+60
Blowout around root wad and cross vane

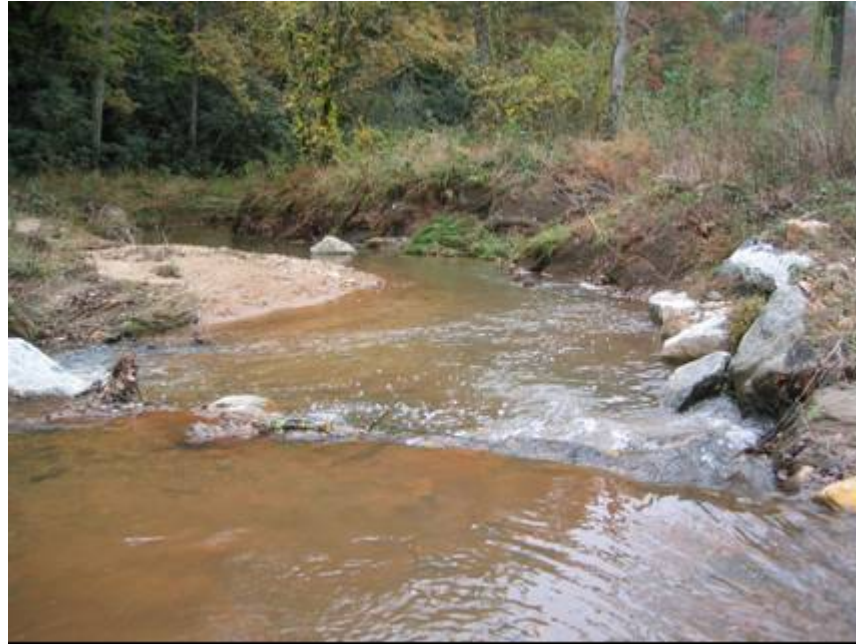
SP11. Station 13+50 to 13+80
Cutting around cross vane

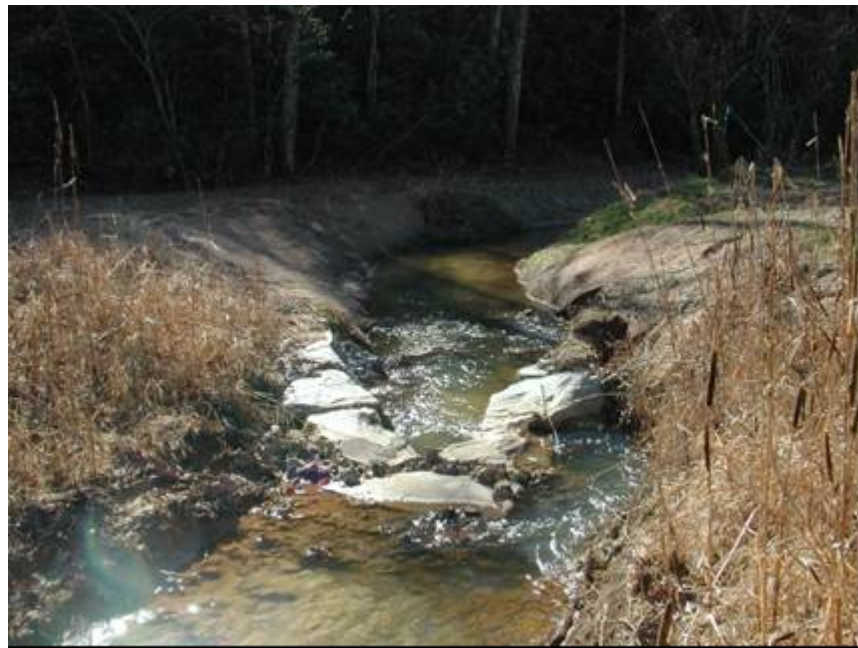
SP12. 2002 Photo Station 13+50 to 13+80
Cutting around cross vane

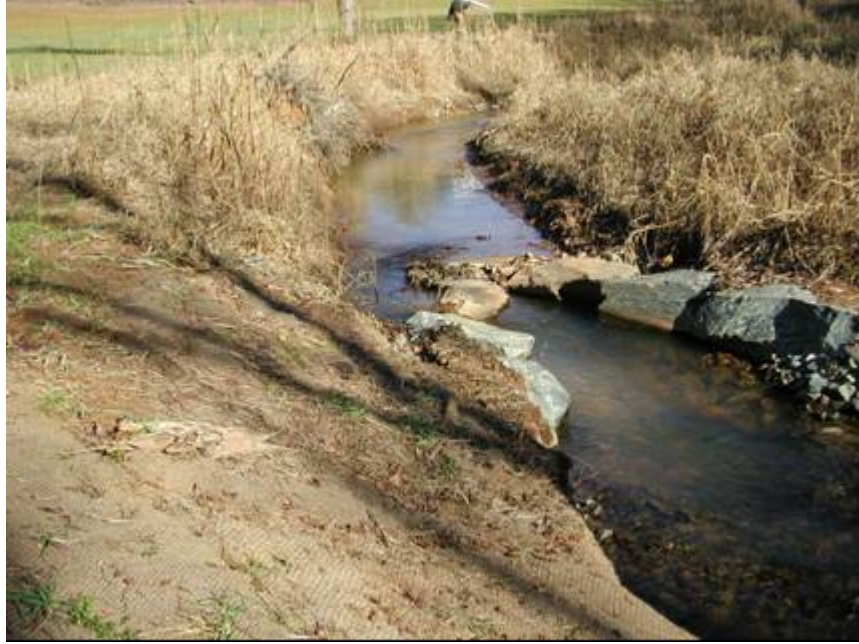
SP13. 2002 Station 13+50 to 13+80
Cutting around cross vane

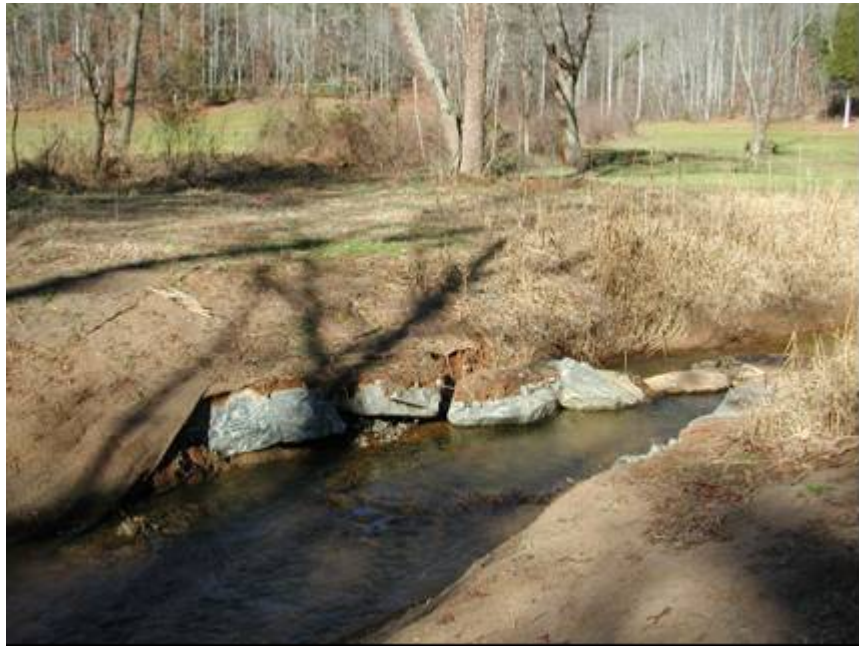
SP14. 2002 Station 13+50 to 13+80
Cutting around cross vane

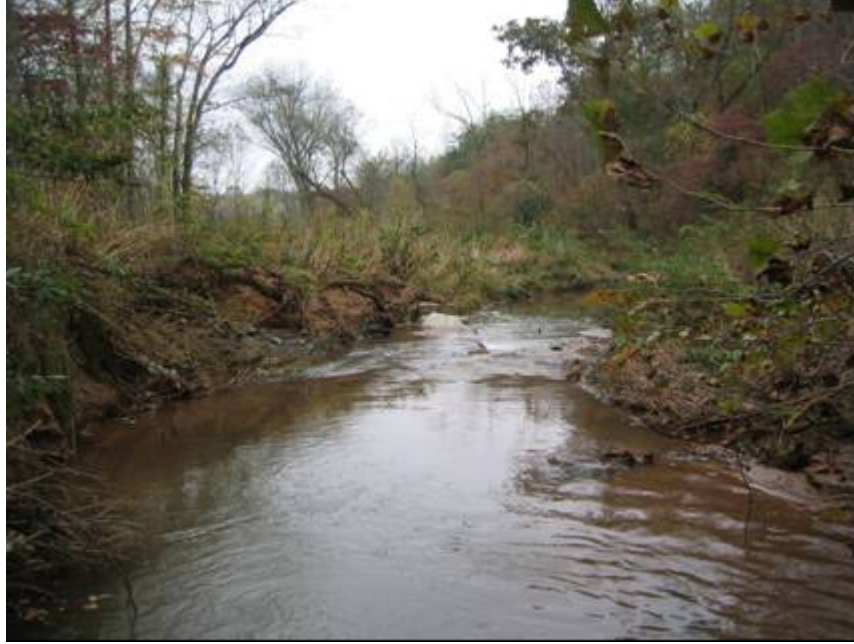
SP15. Station 14+30 to 14+60
Cutting around cross vane

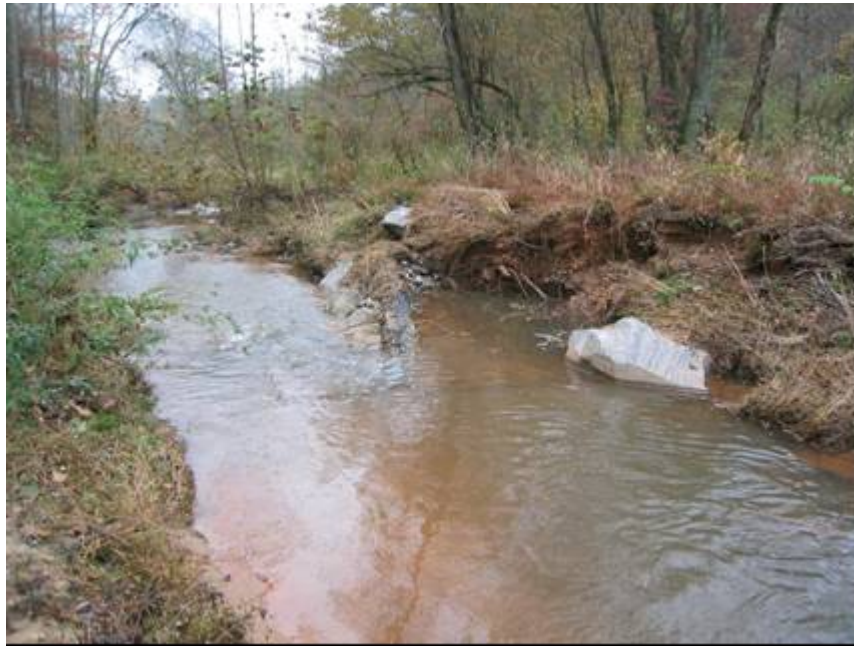
SP16. Station 17+00 to 17+20
Cutting around log cross vane

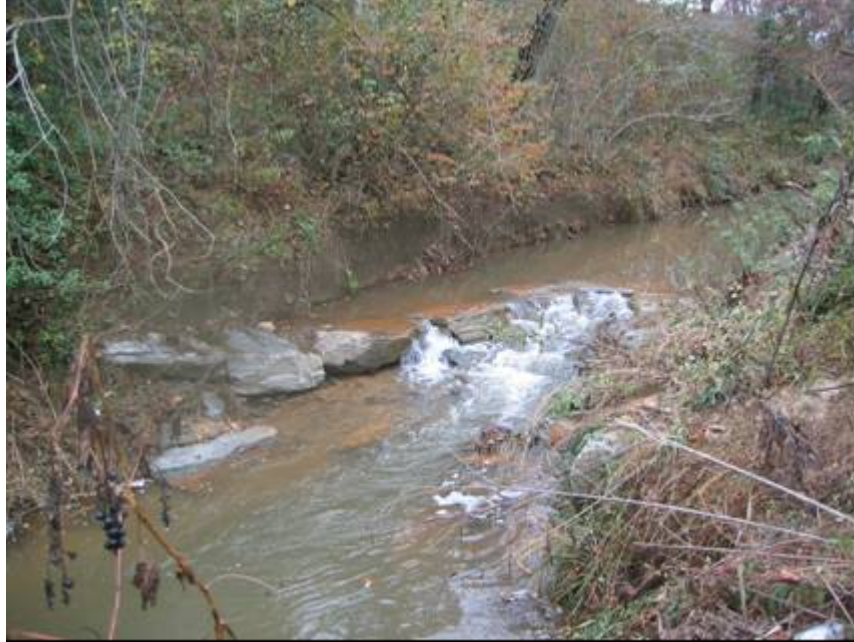
SP17. Station 20+10 to 20+40
Bank scour and erosion

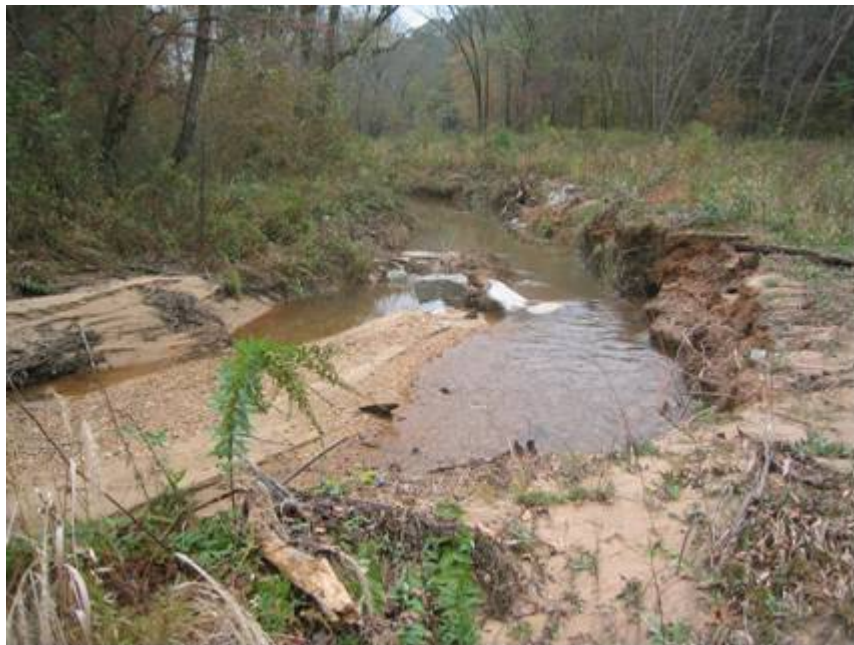
SP18. Station 22+20 to 22+80
Blowout around vane

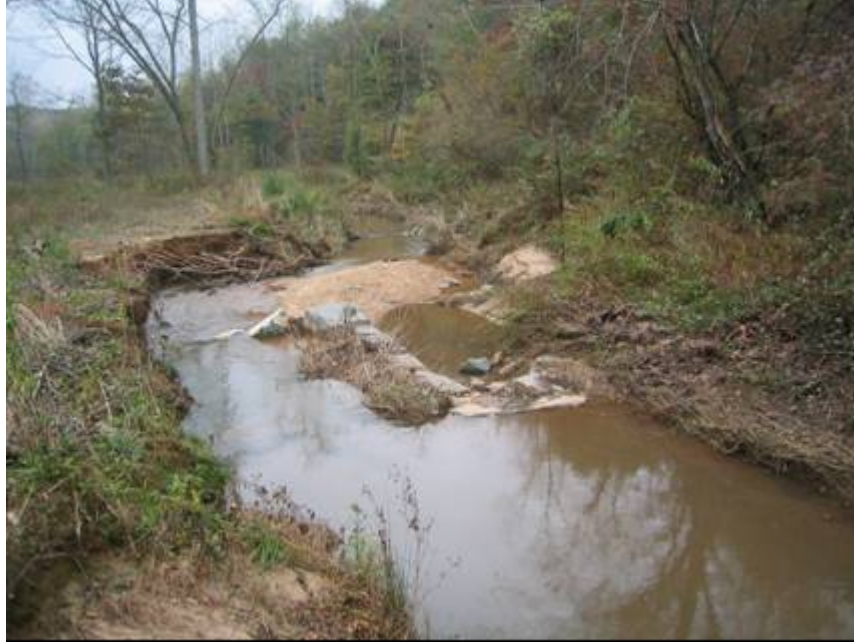
SP19. Station 22+20 to 22+80
Blowout around vane

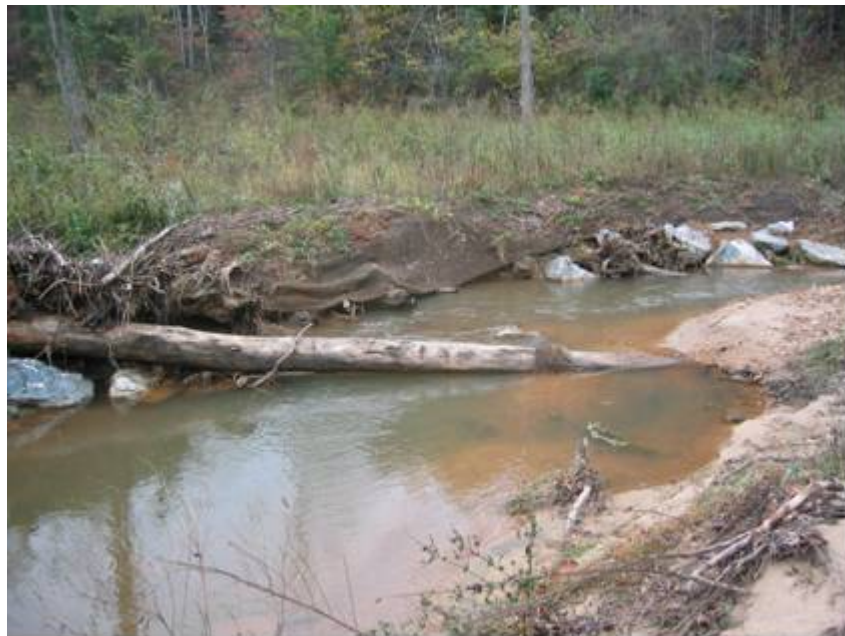
SP20. Station 24+80 to 25+10
Log vane moved

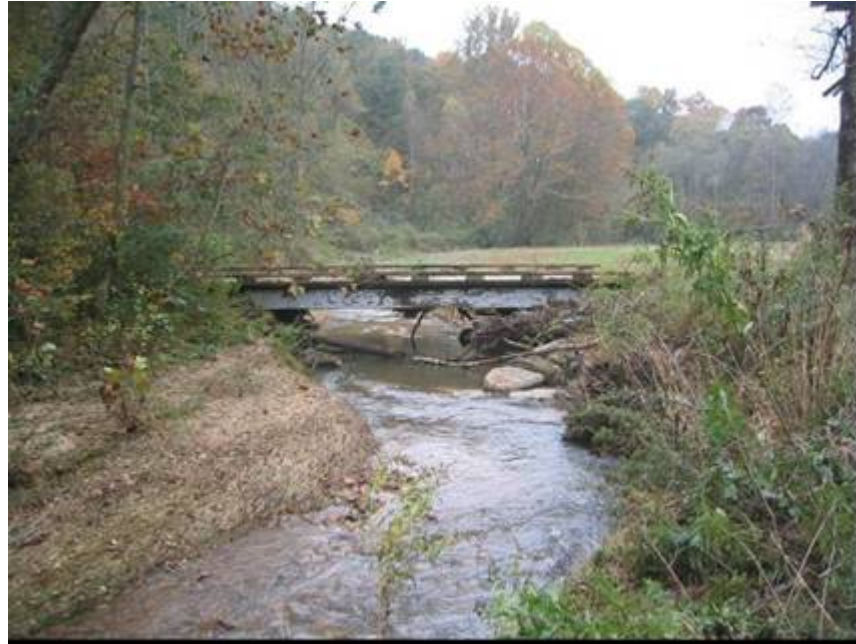
PA 19	Bank scour from debris jam	28+90 to 29+10	Debris jam directing flows into bank	SP23
PA 20	Scour in front of root wad	30+50 to 30+60	Inadequate number of root wads	SP24
PA 21	Bank erosion	30+80 to 31+00	Floodplain constriction	SP24
PA 22	Over wide	35+40 to 35+80	Poor construction	SP25
PA 23	Lower bank scour	37+20 to 37+40	Poor vegetation establishment	Similar to SP26
PA 24	Bare lower bank	39+20 to 39+40	Poor vegetation establishment	SP26
PA 25	Piping around vane	40+30 to 40+50	Poor soils Backwater from Fisher River	SP27-28
PA 26	Cutting around vane	40+90 to 41+10	Poor soils Backwater from Fisher River Poor vegetation establishment	SP29
PA 27	Bank scour Bank slumping	41+80 to 41+95	Poor soils Backwater from Fisher River Poor vegetation establishment	Similar to SP30
PA 28	Bank scour Bank slumping	42+00 to 42+30	Poor soils Backwater from Fisher River Poor vegetation establishment	SP30

SP24. Station 30+50 to 31+00
Scour in front of root wad and bank erosion

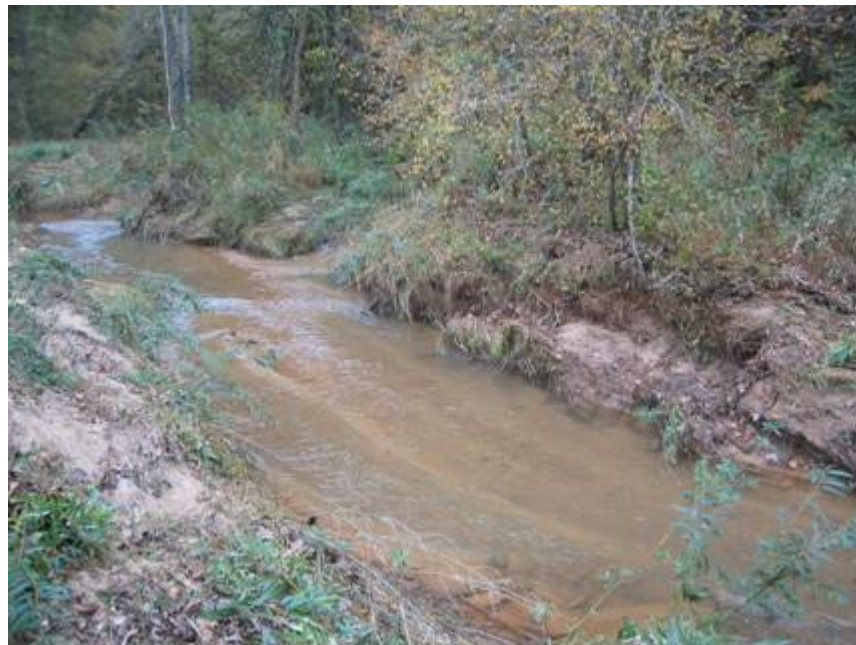
SP25. Station 35+40 to 35+80
Over wide

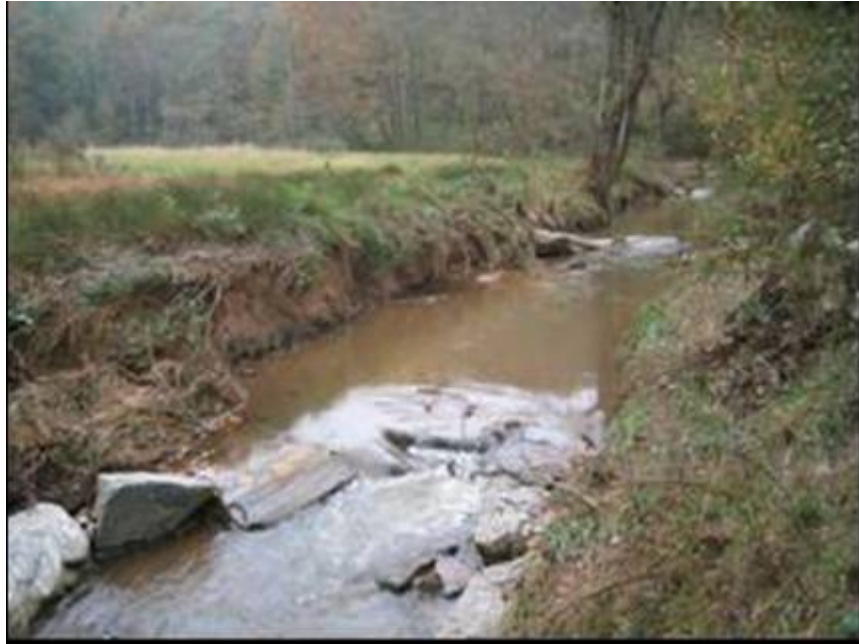
SP26. Station 39+20 to 39+40
Bare lower bank

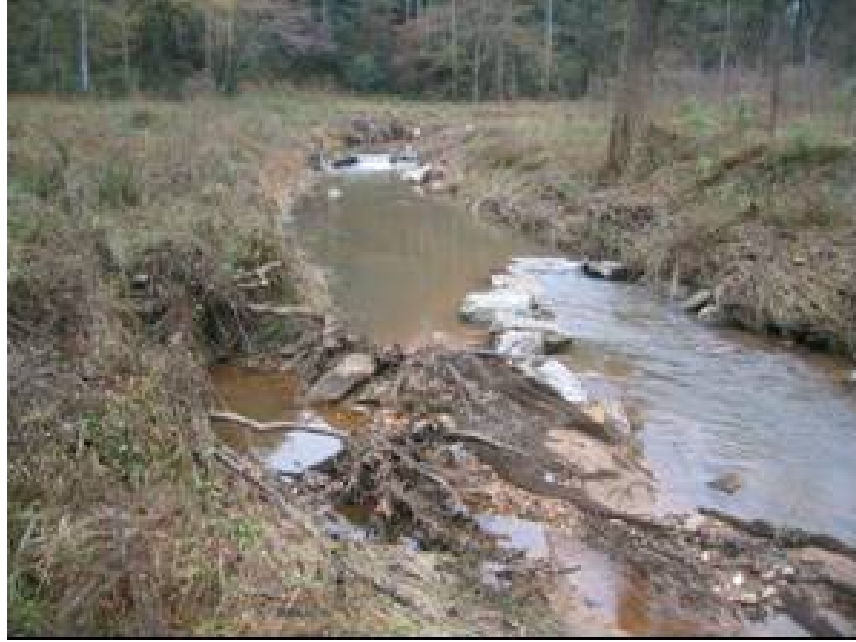
SP29. Station 40+90 to 41+10
Cutting around vane

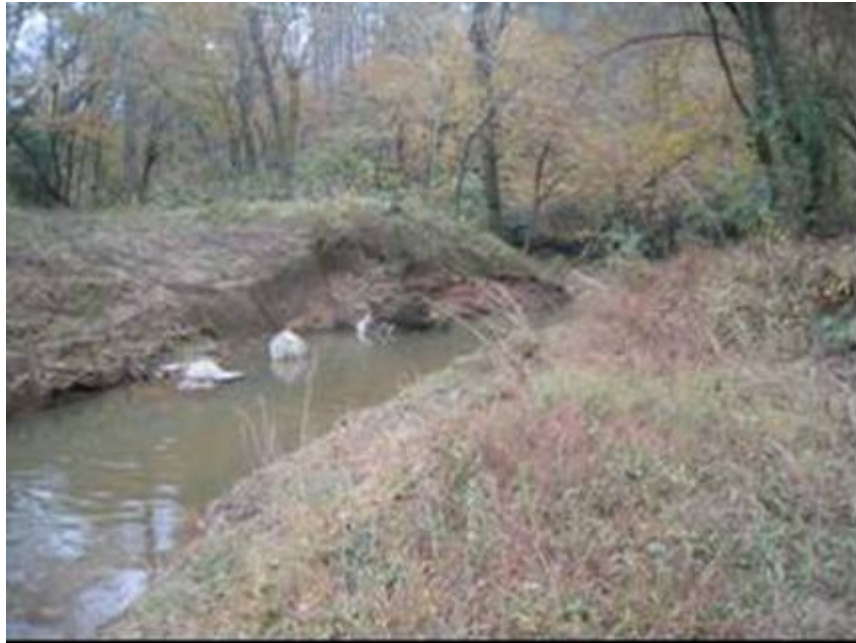
SP30. Station 42+00 to 42+30
Bank scour and bank slumping
