Beaver Creek Stream Restoration 2005 Monitoring Report Year Two of Monitoring

Ecosystem Enhancement Program Project Number 00028

Prepared by: EcoLogic Associates, P.C.
4321-A S. Elm-Eugene St.
Greensboro, NC 27406

Submitted: March, 2006

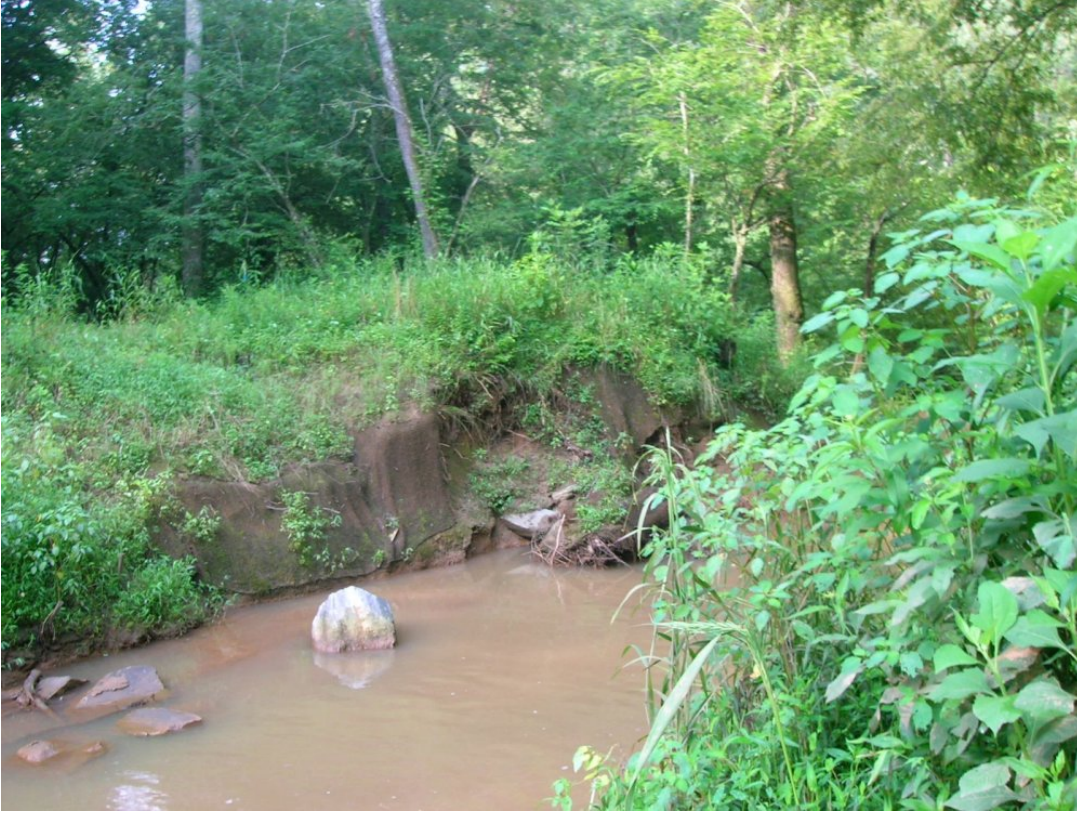
PA 1

Feature Issue	Station	Suspected Cause	Photo	Severity
Density	42+00	Bank erosion	PA1	Red
Density	22+50	Bank erosion	PA18	Red

Recommendations include replanting larger containerized trees to obtain mitigation requirements and staking in areas where erosion is problematic. Measures should be taken to prevent deer browse of planted vegetation. Although invasive vegetation is not a major issue on this project site, exotic invasive species present include *Microstegium vimineum* (Japanese grass), *Lonicera japonica* (Japanese honeysuckle), *Puerariaia montana* var. *lobata* (Kudzu) and *Paulownia tomentosa* (Princess tree). Control measures may be necessary if these species become dense.
