# Beaver Creek Stream Restoration 2008 Final Monitoring Report

Construction Completed January 2003 - 5 Years Elapsed (MY5)  
Third Year of Measurement - Measurement Suspended in MY3 and MY4 Due to Repair

Ecosystem Enhancement Program Project Number 00028

**Beaver Creek Stream Restoration  
2008 Final Monitoring Report  
Monitoring Year Five**

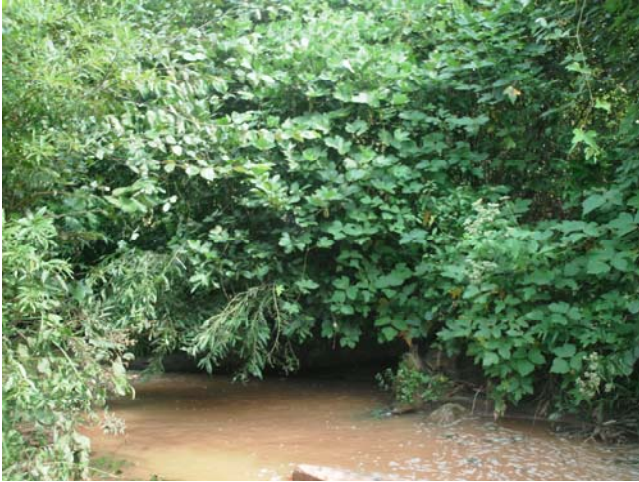
Beaver Creek EEP Project Number 00028				
Feature #	Feature/Issue	Station # / Range	Probable Cause	Photo #
VPA1	Exotic population	3+00	Kudzu	VPA1
VPA2	Exotic population	5+00	Kudzu	VPA2
VPA3	No woody survival	8+00 to 13+00	Maintenance and repairs	VPA3
VPA4	No woody survival	15+00 to 19+00	Maintenance and repairs	VPA4
VPA5	No woody survival	25+00 to 26+00	Maintenance and repairs	VPA5
VPA6	Bare floodplain	25+00 to 25+50	Maintenance and repairs	VPA6
VPA7	Bare banks	37+00 to 37+25	Bank erosion	VPA7

VPA1 facing left bank

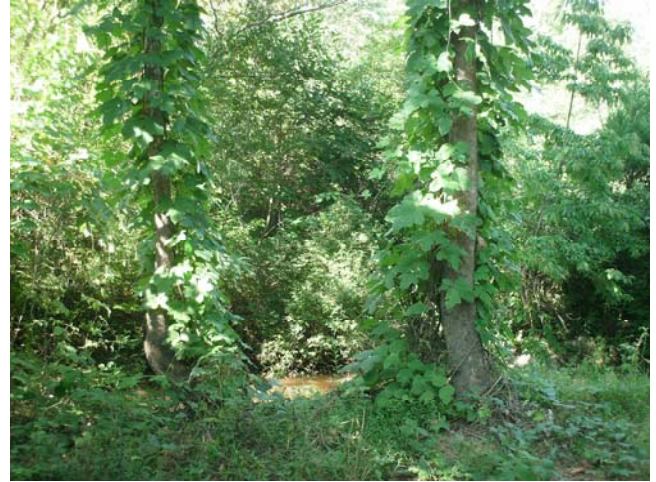
VPA2 facing right bank

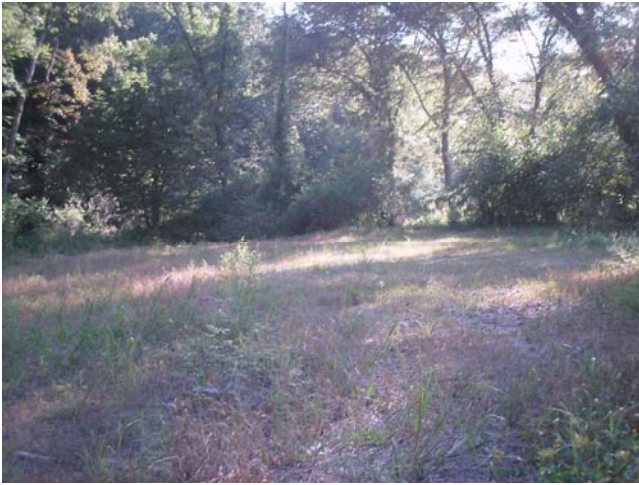
VPA3 facing right bank

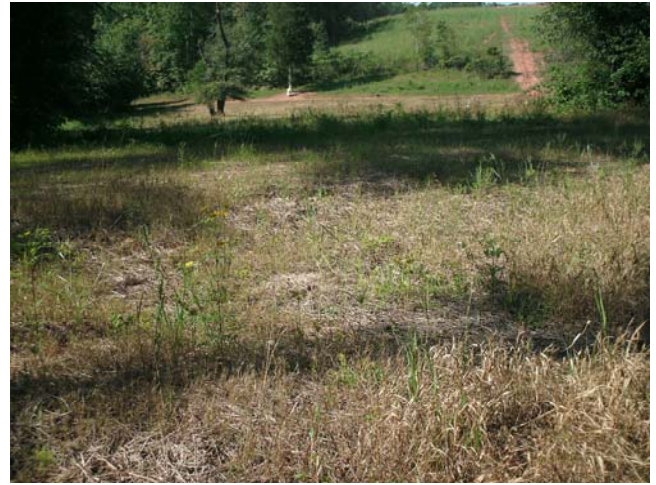
VPA4 facing upstream

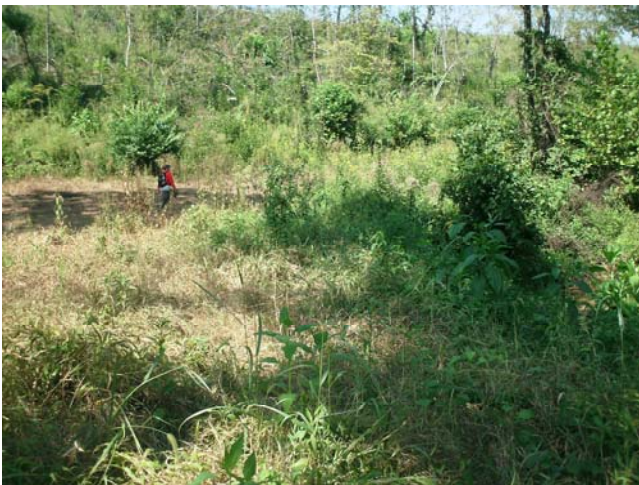
VPA5 facing upstream

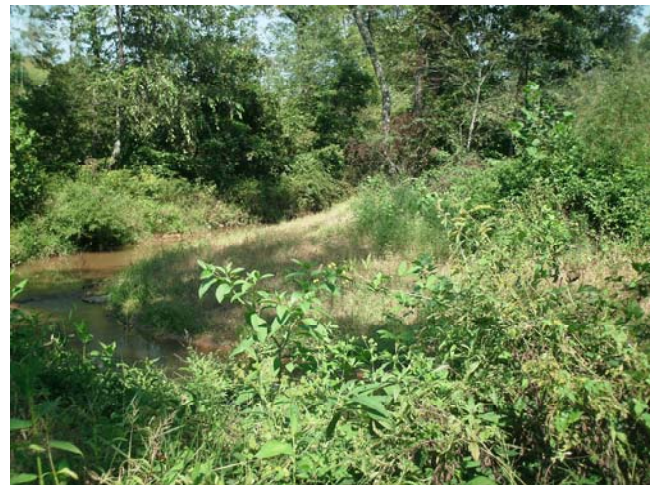
VPA6 facing upstream

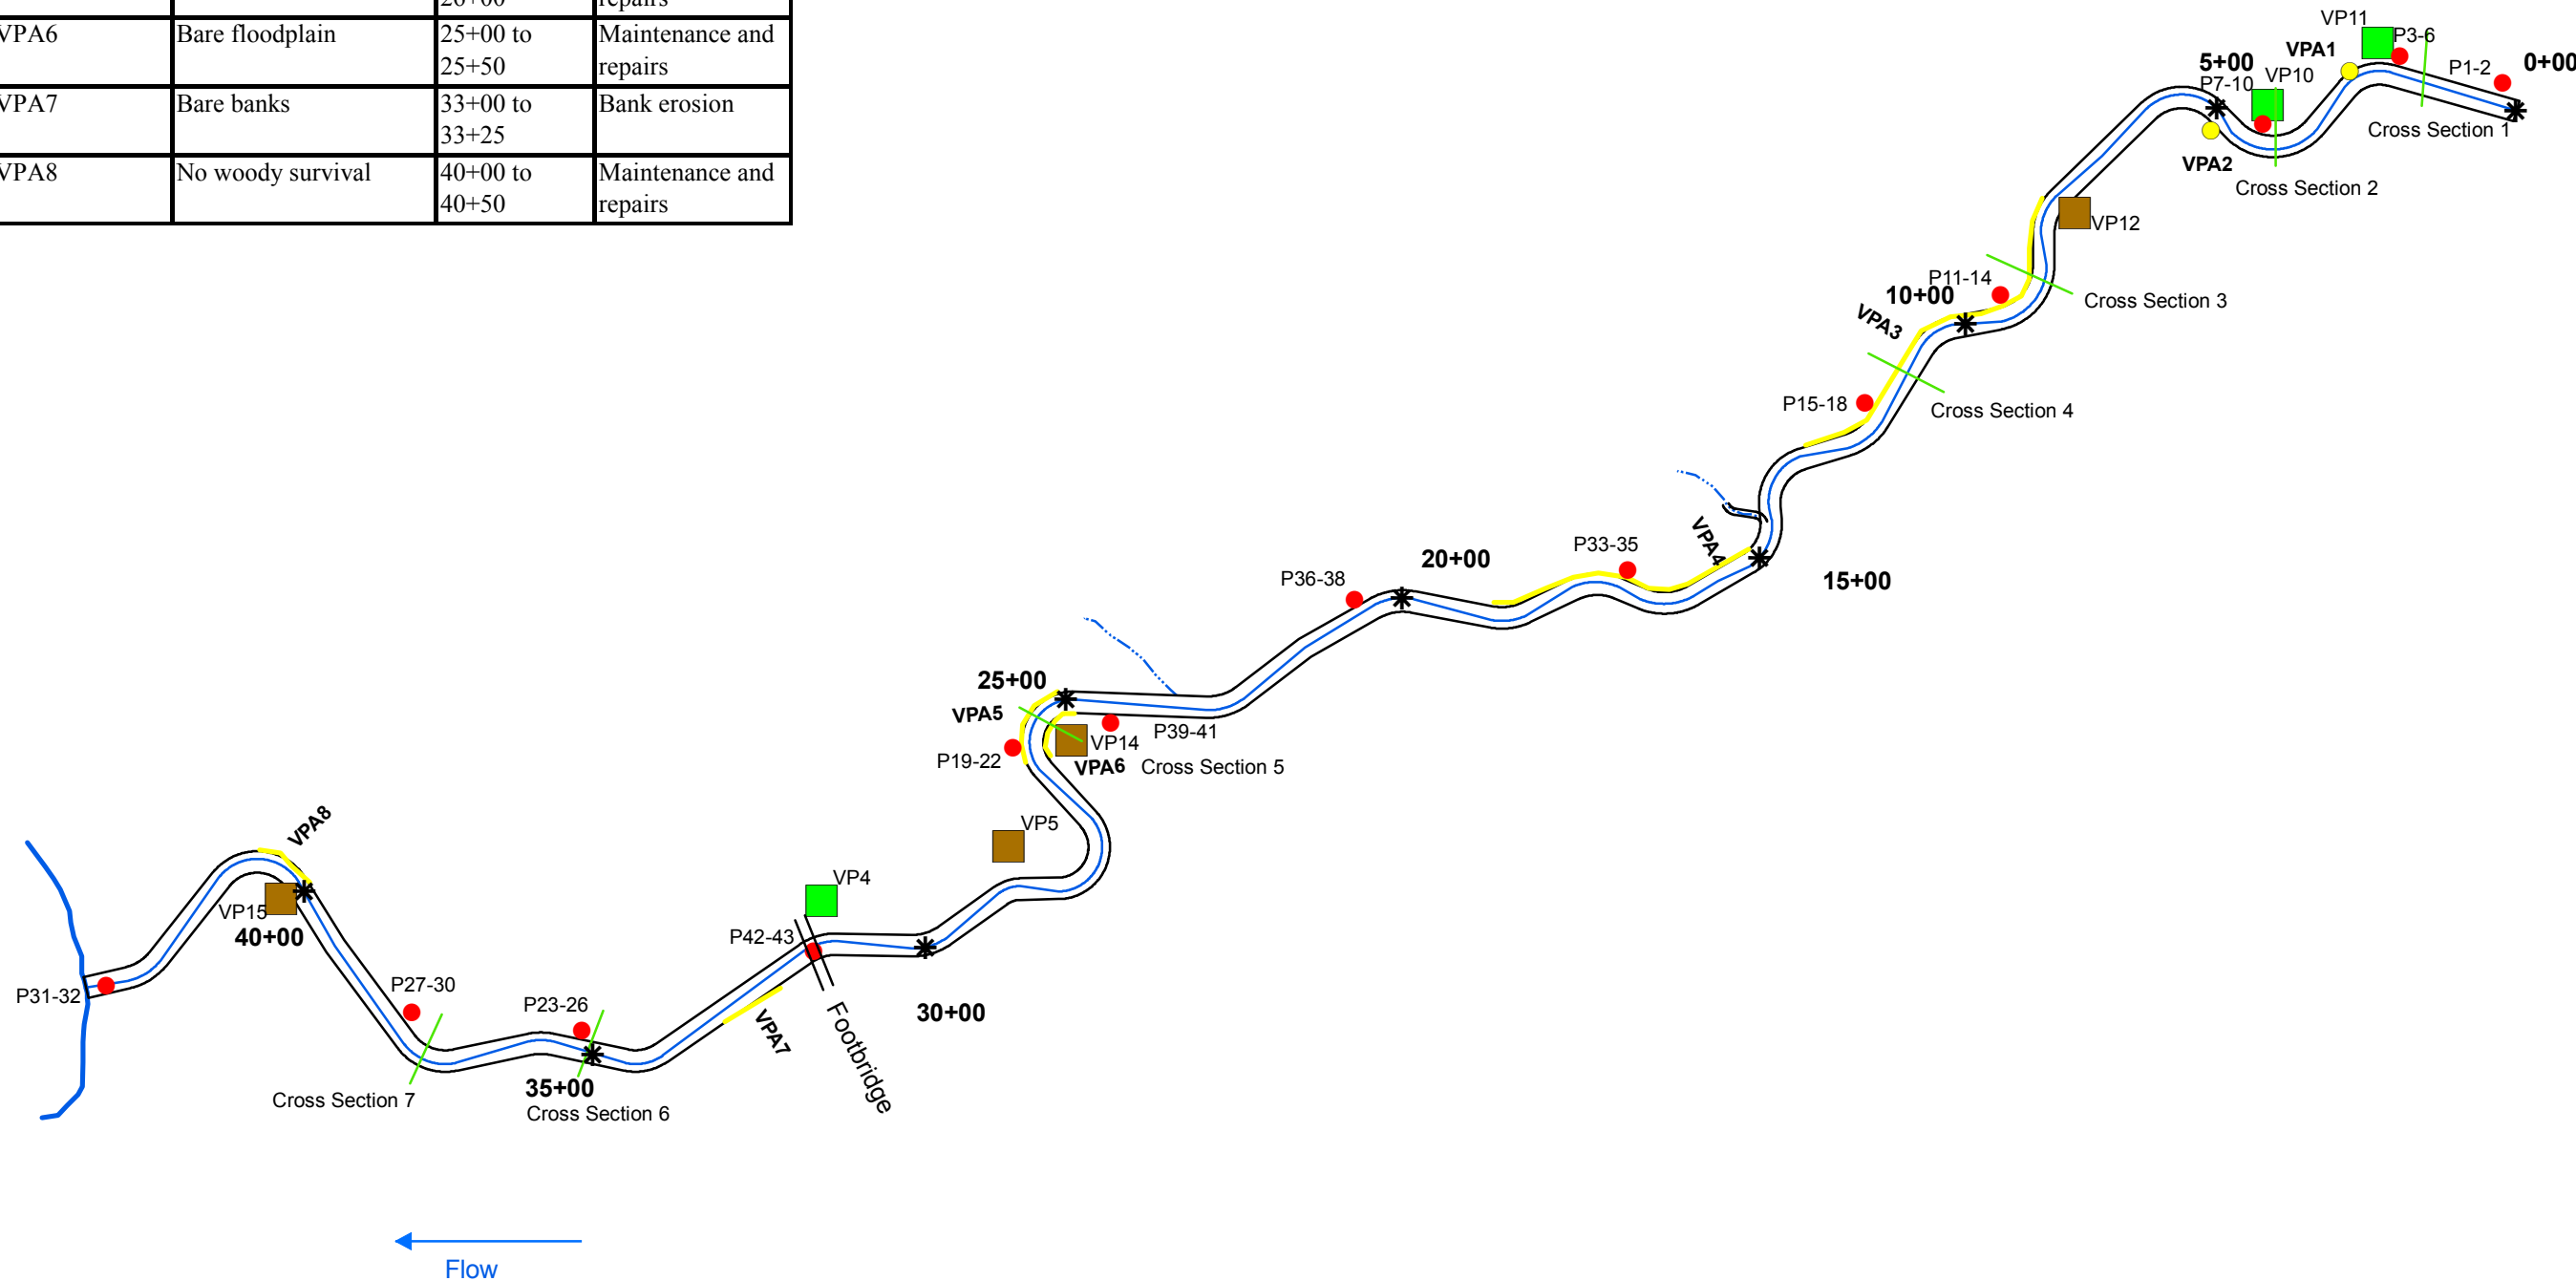
Vegetation  
 Current Condition  
 Plan View

Beaver Creek			
EEP Project Number 00028			
Feature #	Feature/Issue	Station # / Range	Suspected Cause
VPA1	Invasive/exotic plant	3+00	Kudzu
VPA2	Invasive/exotic plant	5+00	Kudzu
VPA3	No woody survival	8+00 to 13+00	Maintenance and repairs
VPA4	No woody survival	15+00 to 19+00	Maintenance and repairs
VPA5	No woody survival	25+00 to 26+00	Maintenance and repairs
VPA6	Bare floodplain	25+00 to 25+50	Maintenance and repairs
VPA7	Bare banks	33+00 to 33+25	Bank erosion
VPA8	No woody survival	40+00 to 40+50	Maintenance and repairs

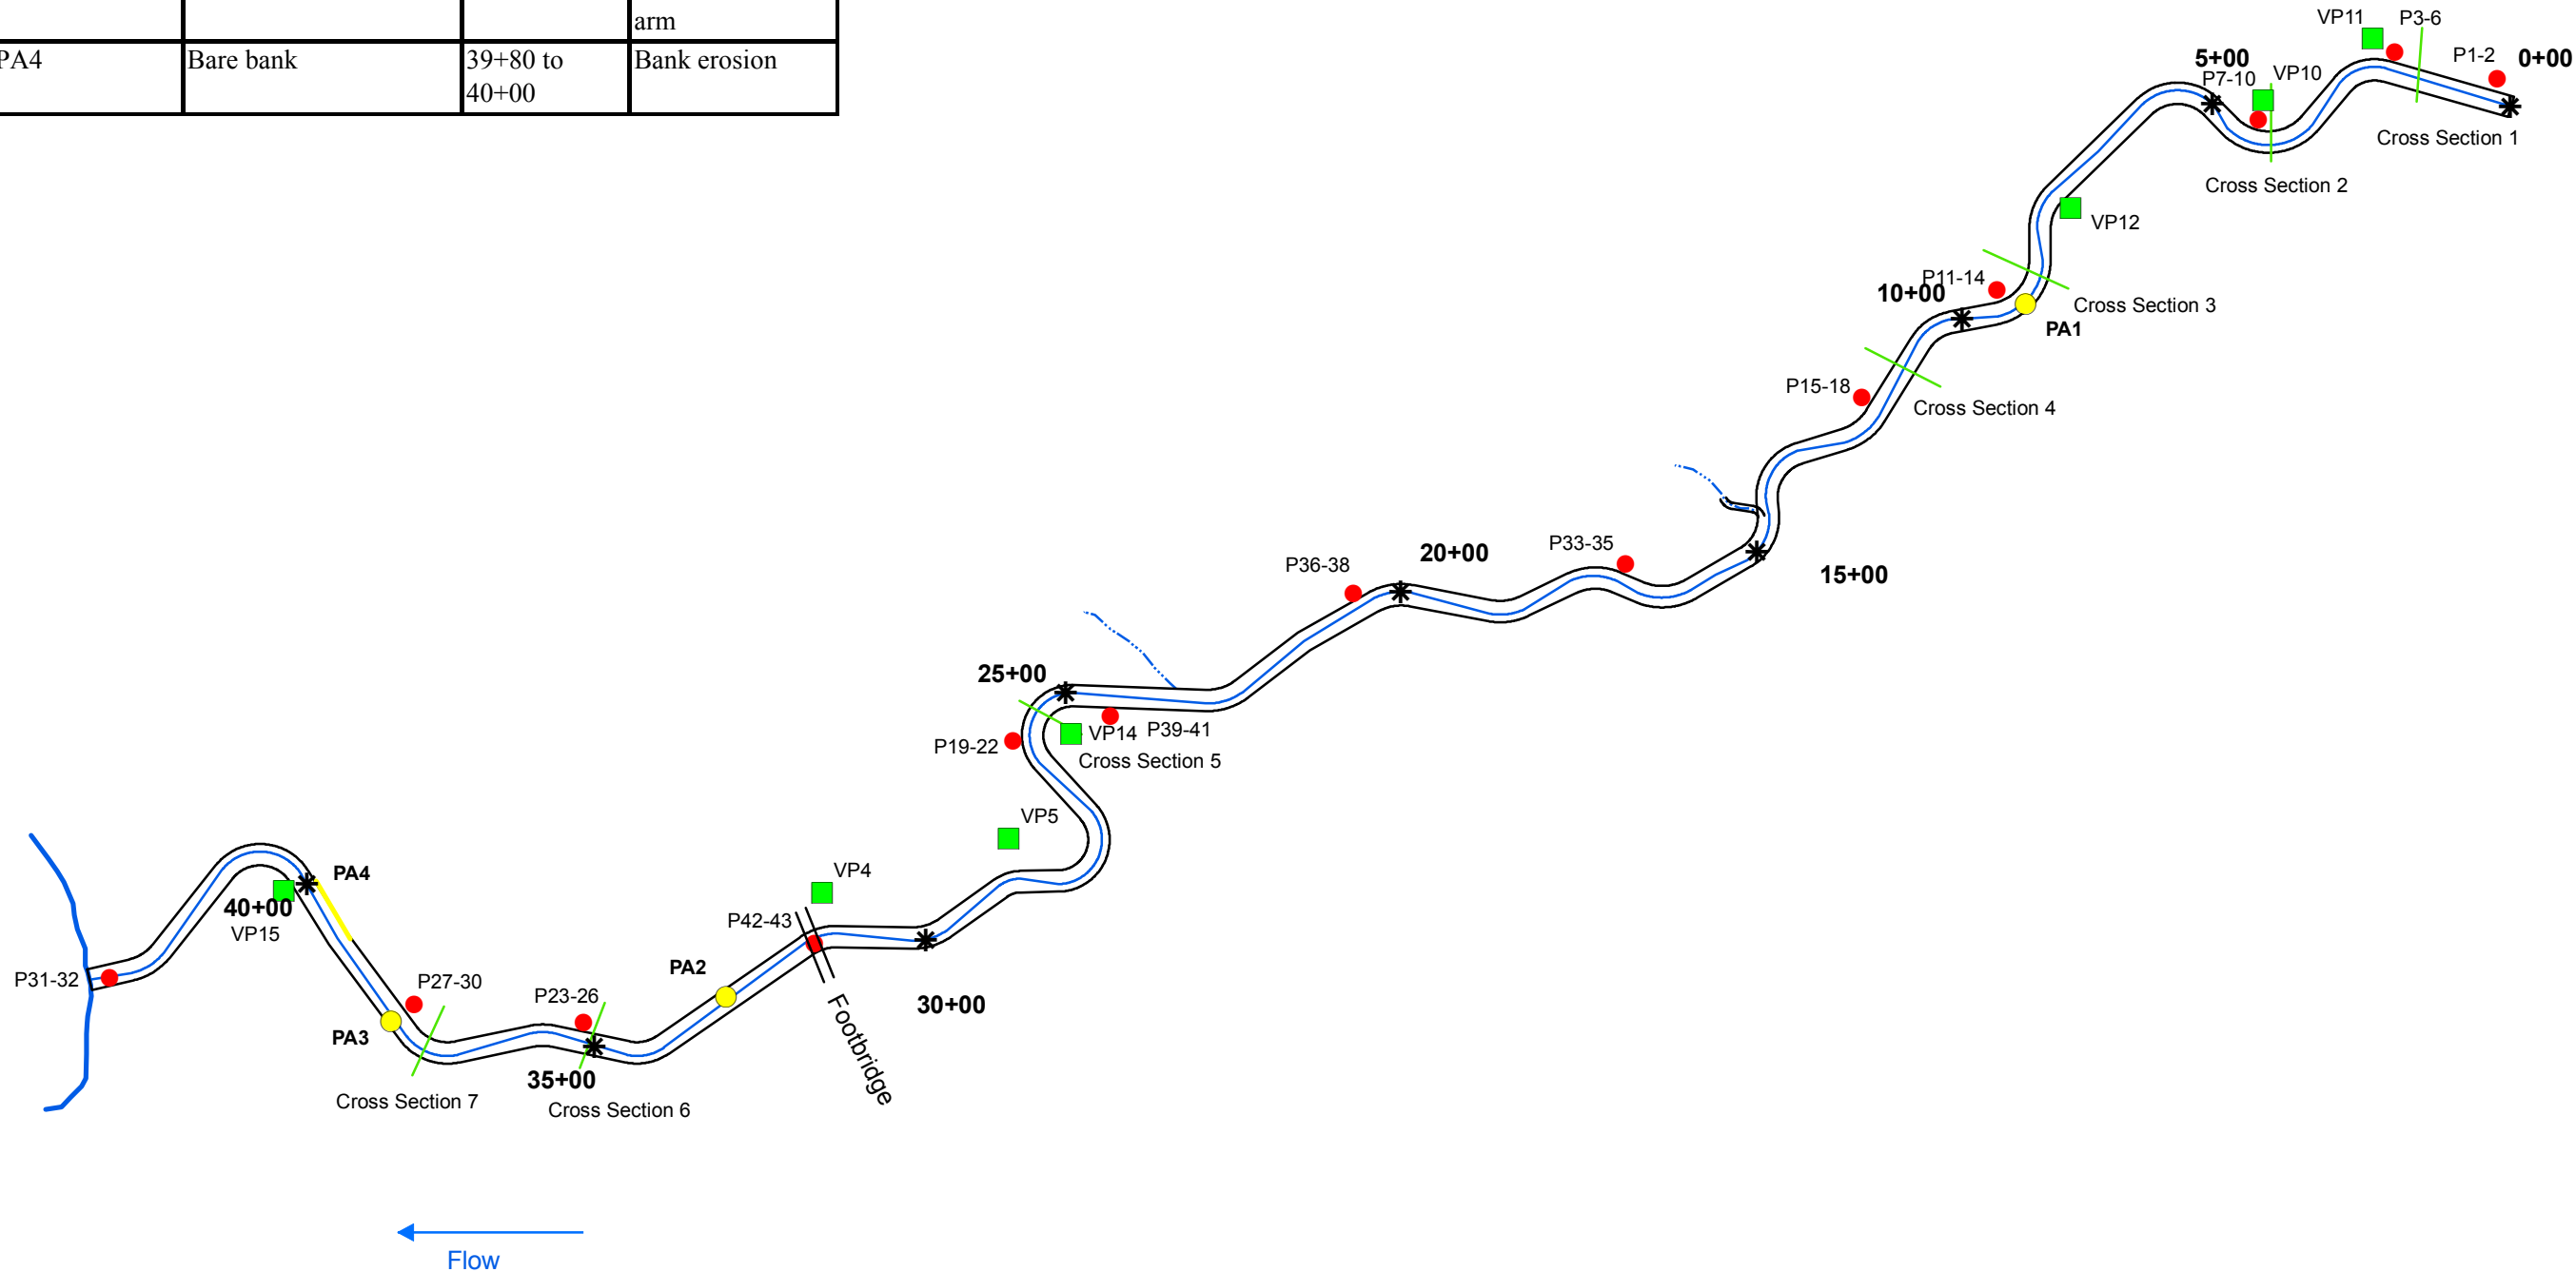
Stream  
 Current Condition  
 Plan View

Beaver Creek			
EEP Project Number 00028			
Feature #	Feature/Issue	Station # / Range	Suspected Cause
PA1	Structure failure	9+40	Improper design and/or construction
PA2	Structure failure	33+00	Improper design and/or construction
PA3	Structure failure	38+00	Scour behind vane arm
PA4	Bare bank	39+80 to 40+00	Bank erosion

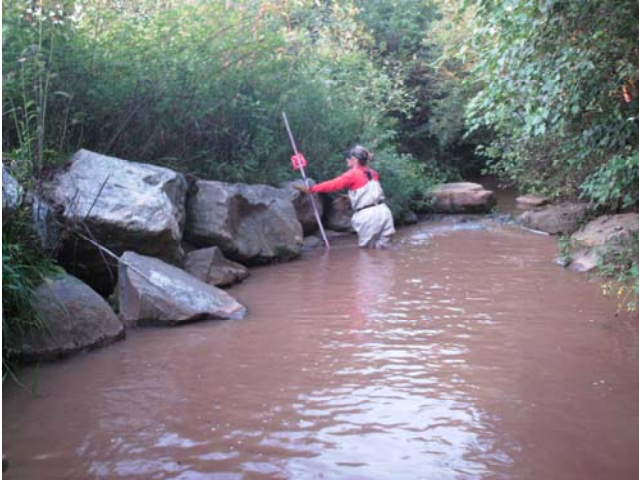
PA1 facing upstream

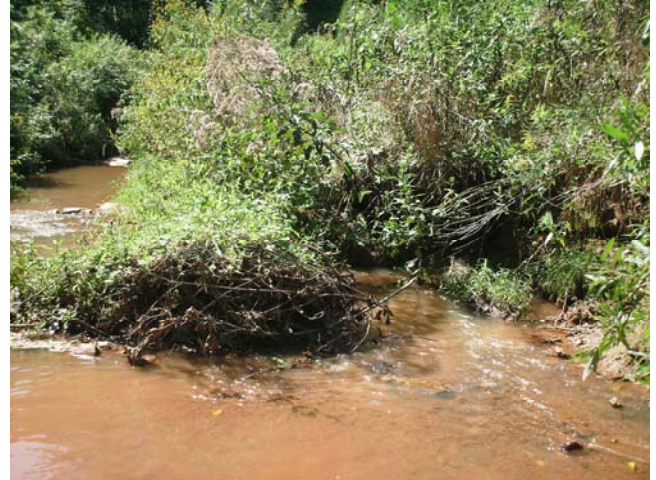
PA2 facing right bank

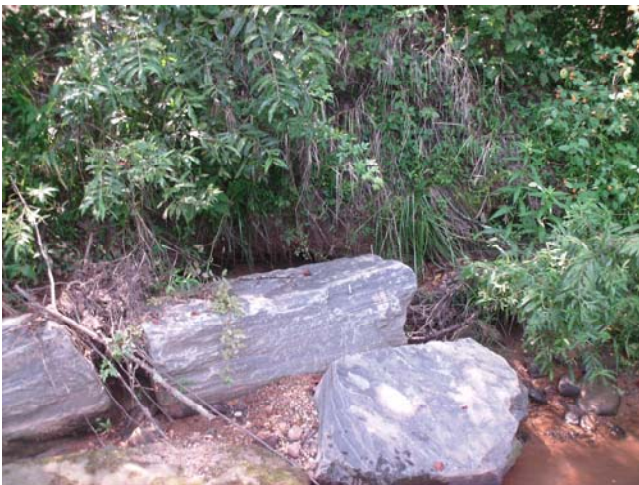
PA3 facing left bank

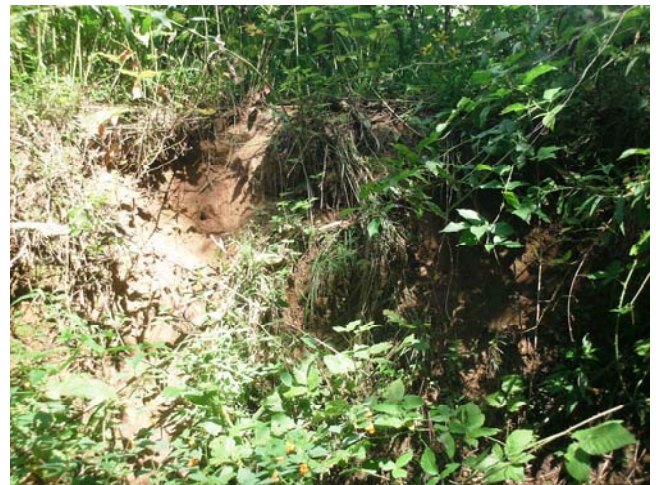
PA4 facing right bank
