**Beaver Creek
Stream Restoration Monitoring Report**

DMS Project # 028

Monitoring Year: 2015

**BEAVER CREEK STREAM RESTORATION
PROJECT #28 - MONITORING YEAR 04**
SURRY COUNTY, NORTH CAROLINA

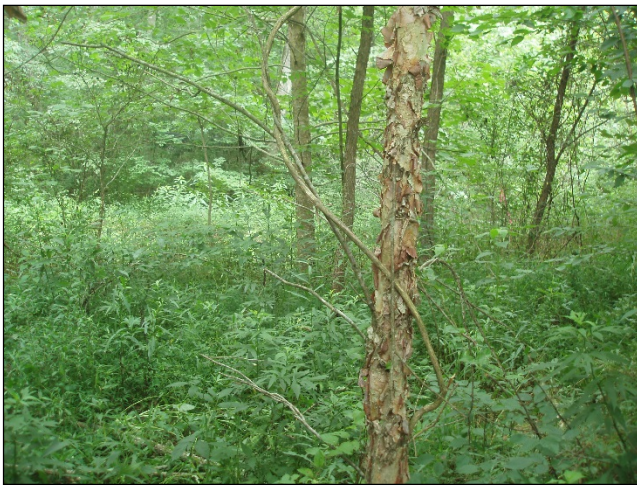
Plot 4 Photo. MY04 – 7/23/15

Table 7. Vegetation Plot Criteria Attainment	
Project Number and Name: 028 - Beaver Creek	
Vegetation Plot ID	Vegetation Survival Threshold Met?
4	No
10	Yes
11	Yes
12	Yes
15	No

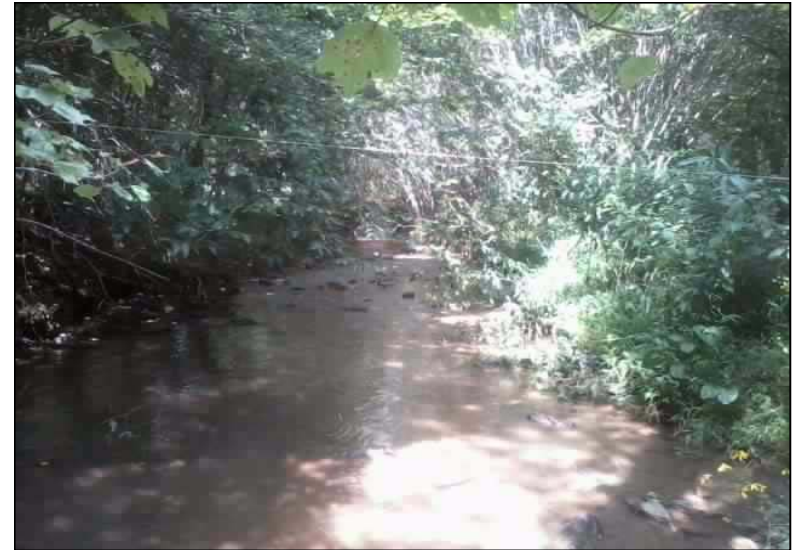
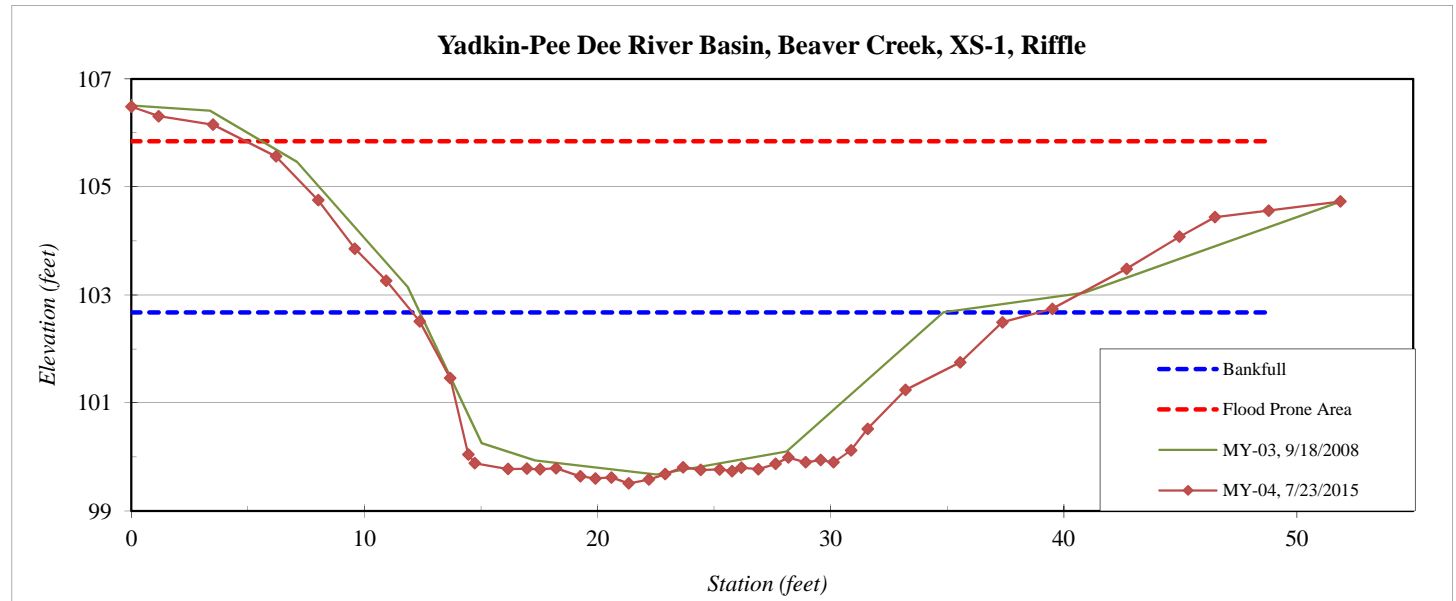
River Basin:	Yadkin-Pee Dee
Watershed:	Beaver Creek
XS ID	XS-1, Riffle
Drainage Area (sq mi):	5.90
Date:	7/23/2015
Field Crew:	T. Seelinger and B. Williams

SUMMARY DATA	
Bankfull Elevation:	102.7
Bankfull Cross-Sectional Area:	58.6
Bankfull Width:	26.9
Flood Prone Area Elevation:	105.8
Flood Prone Width:	>50
Max Depth at Bankfull:	3.2
Mean Depth at Bankfull:	2.2
W / D Ratio:	12.4
Entrenchment Ratio:	1.9
Bank Height Ratio:	1.0

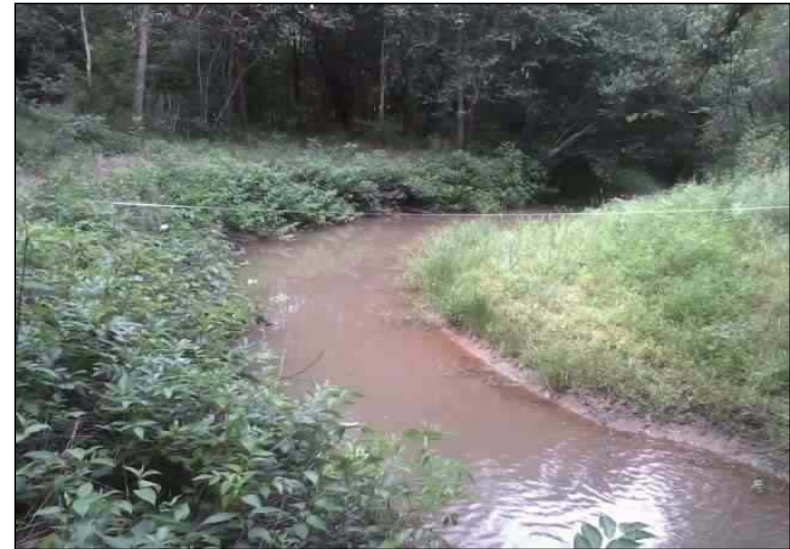
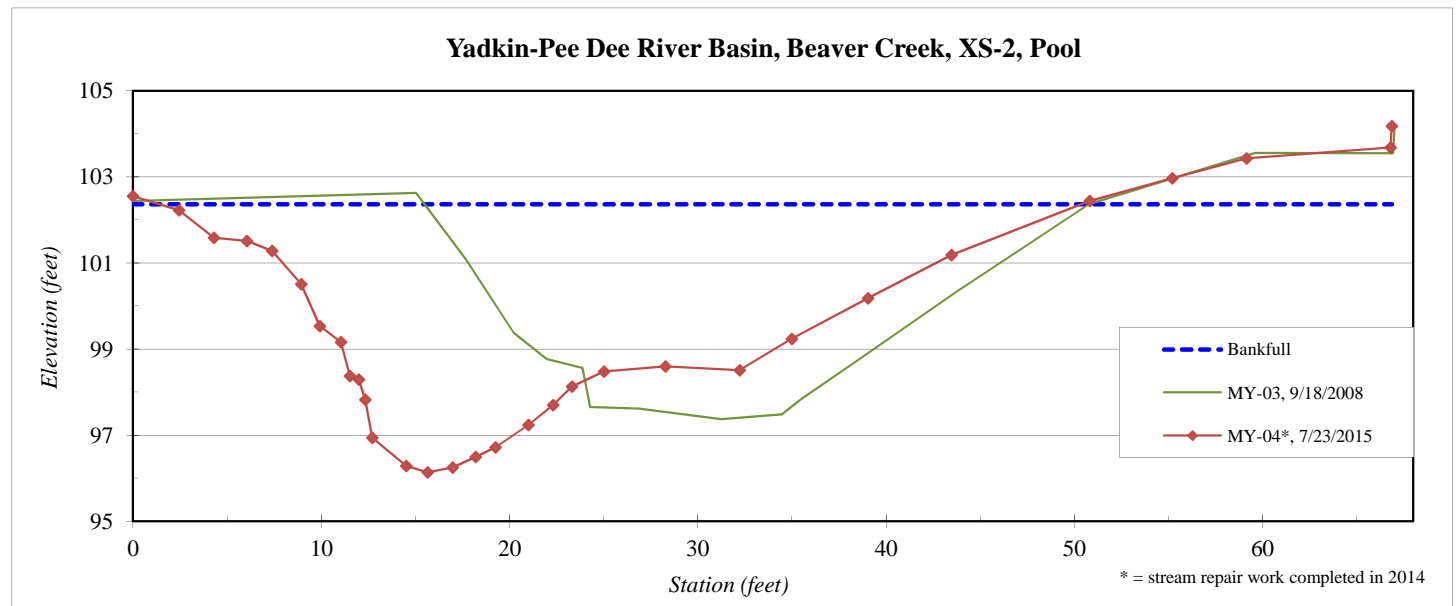
River Basin:	Yadkin-Pee Dee
Watershed:	Beaver Creek
XS ID	XS-2, Pool
Drainage Area (sq mi):	5.90
Date:	7/23/2015
Field Crew:	T. Seelinger and B. Williams

SUMMARY DATA	
Bankfull Elevation:	102.4
Bankfull Cross-Sectional Area:	144.5
Bankfull Width:	49.0
Flood Prone Area Elevation:	-
Flood Prone Width:	-
Max Depth at Bankfull:	6.2
Mean Depth at Bankfull:	2.9
W / D Ratio:	-
Entrenchment Ratio:	-
Bank Height Ratio:	-

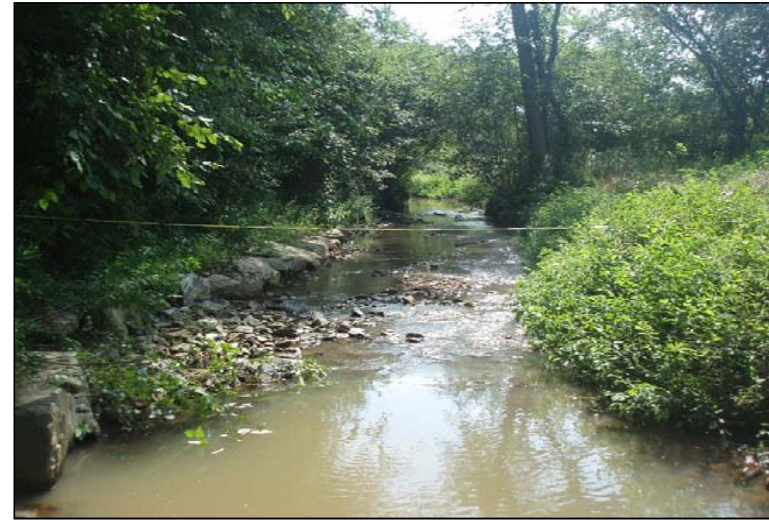
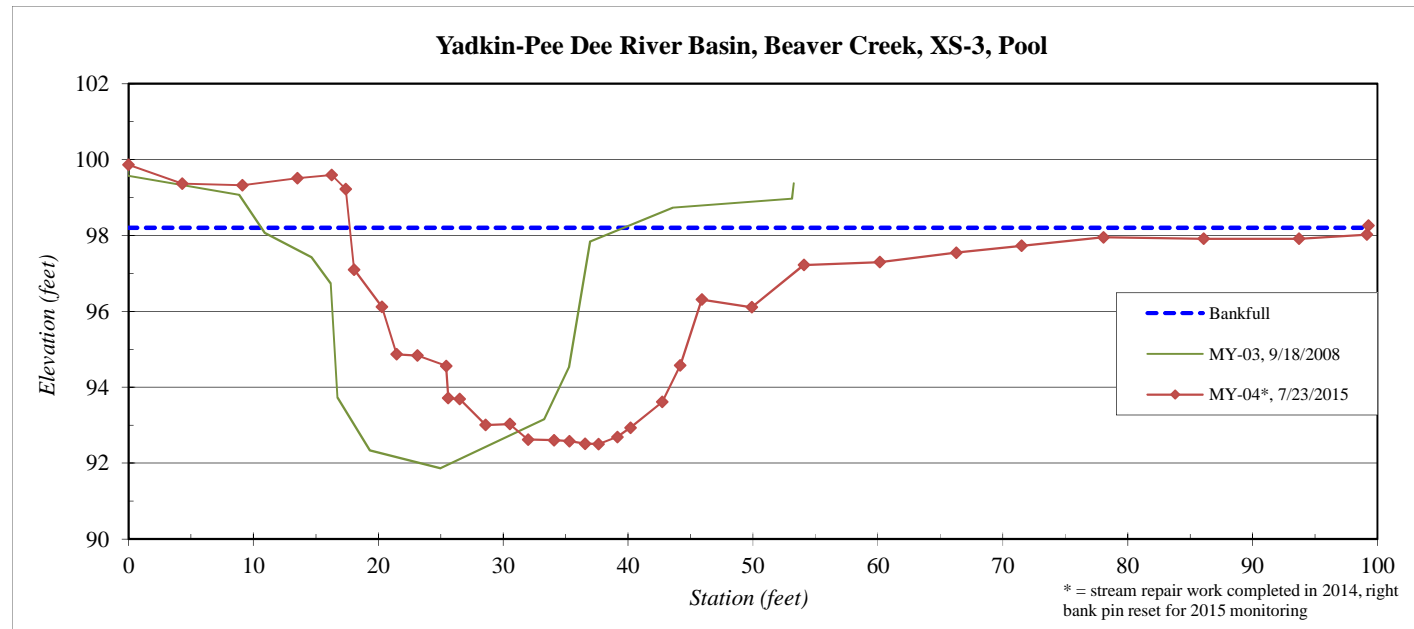
River Basin:	Yadkin-Pee Dee
Watershed:	Beaver Creek
XS ID	XS-3, Pool
Drainage Area (sq mi):	5.90
Date:	7/23/2015
Field Crew:	T. Seelinger and B. Williams

SUMMARY DATA	
Bankfull Elevation:	98.2
Bankfull Cross-Sectional Area:	93.2
Bankfull Width:	34.9
Flood Prone Area Elevation:	-
Flood Prone Width:	-
Max Depth at Bankfull:	4.5
Mean Depth at Bankfull:	2.7
W / D Ratio:	-
Entrenchment Ratio:	-
Bank Height Ratio:	-

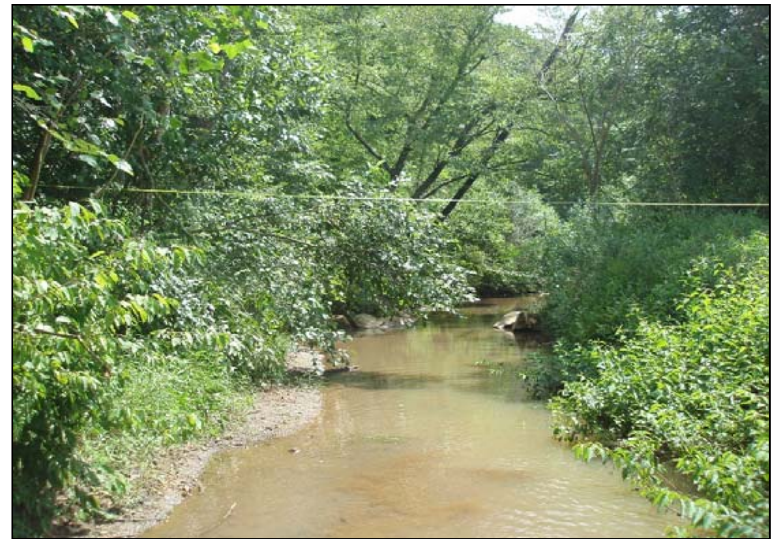
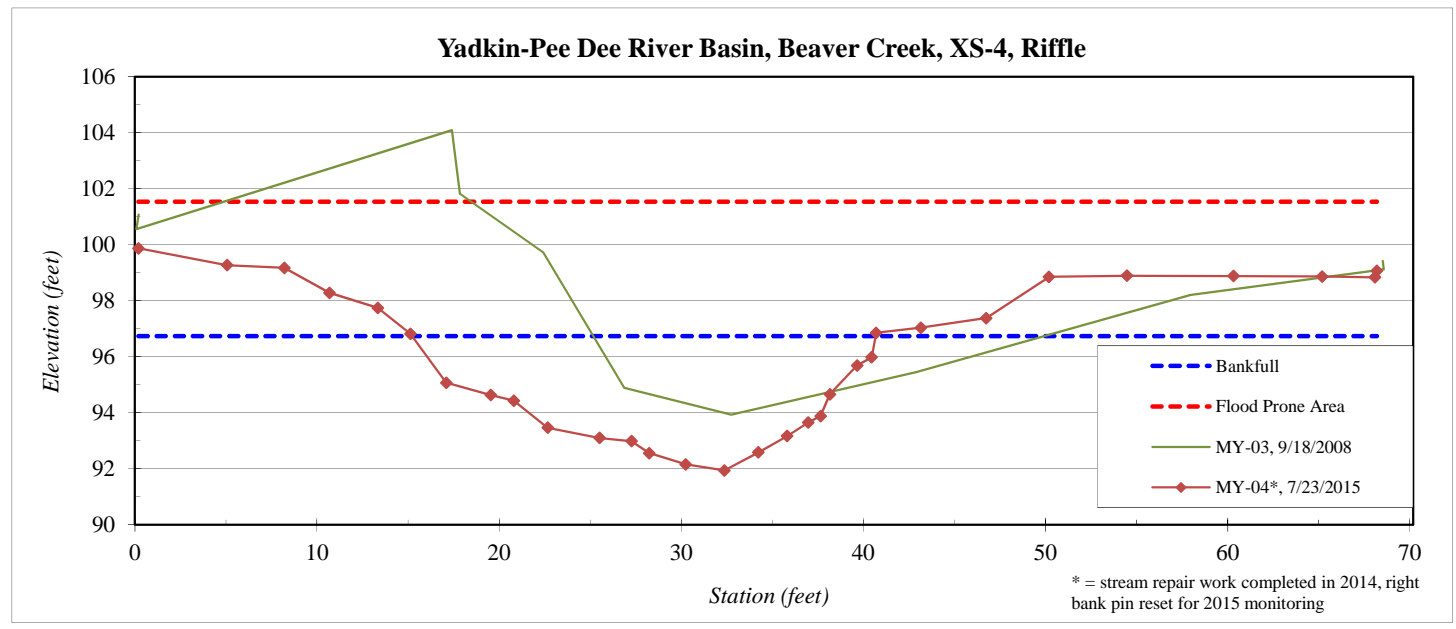
River Basin:	Yadkin-Pee Dee
Watershed:	Beaver Creek
XS ID	XS-4, Riffle
Drainage Area (sq mi):	5.90
Date:	7/23/2015
Field Crew:	T. Seelinger and B. Williams

SUMMARY DATA	
Bankfull Elevation:	96.7
Bankfull Cross-Sectional Area:	77.8
Bankfull Width:	25.5
Flood Prone Area Elevation:	101.5
Flood Prone Width:	>60
Max Depth at Bankfull:	4.8
Mean Depth at Bankfull:	3.1
W / D Ratio:	8.3
Entrenchment Ratio:	1.8
Bank Height Ratio:	1.0

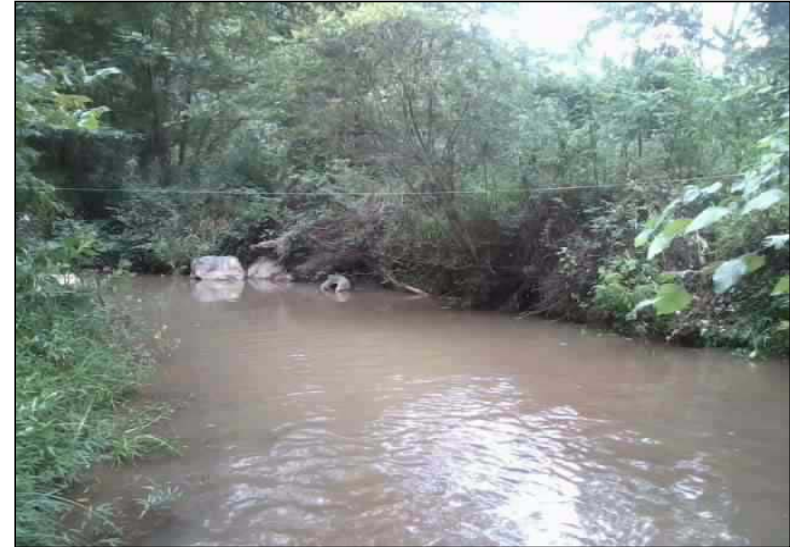
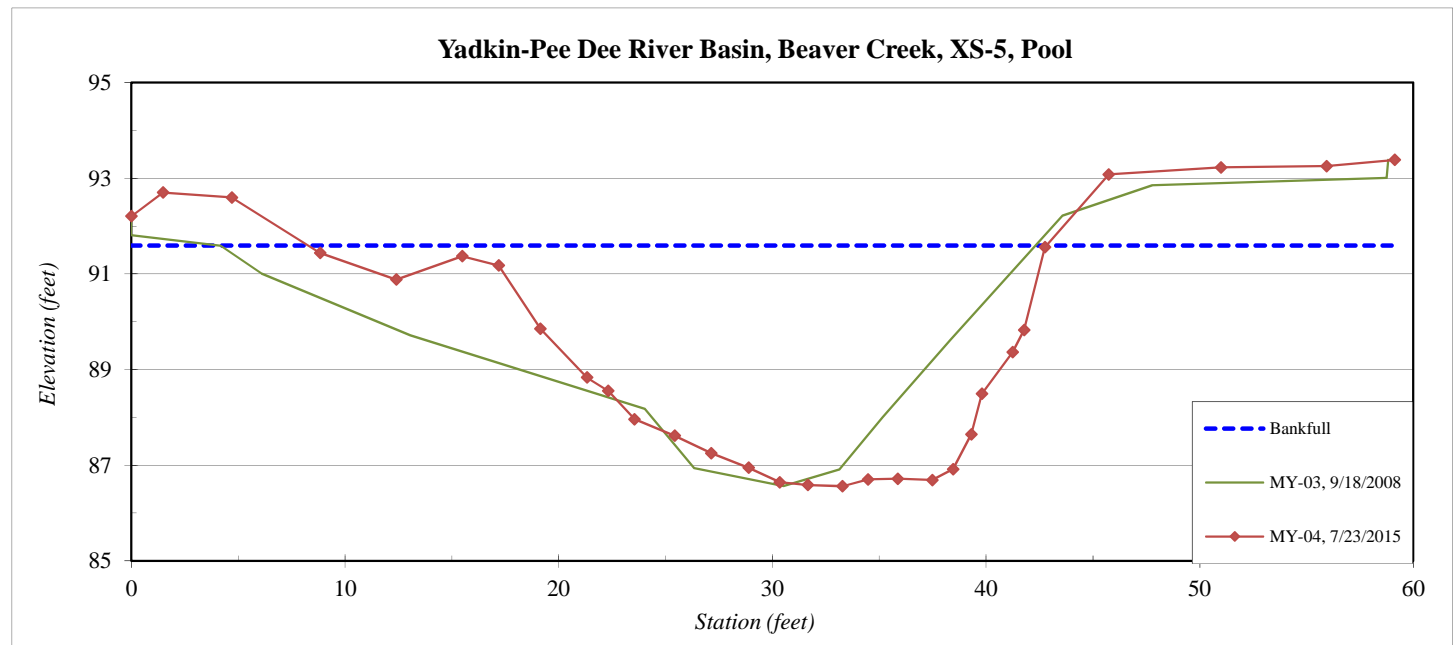
River Basin:	Yadkin-Pee Dee
Watershed:	Beaver Creek
XS ID	XS-5, Pool
Drainage Area (sq mi):	5.90
Date:	7/23/2015
Field Crew:	T. Seelinger and B. Williams

SUMMARY DATA	
Bankfull Elevation:	91.6
Bankfull Cross-Sectional Area:	135.7
Bankfull Width:	41.3
Flood Prone Area Elevation:	-
Flood Prone Width:	-
Max Depth at Bankfull:	5.0
Mean Depth at Bankfull:	3.3
W / D Ratio:	-
Entrenchment Ratio:	-
Bank Height Ratio:	-

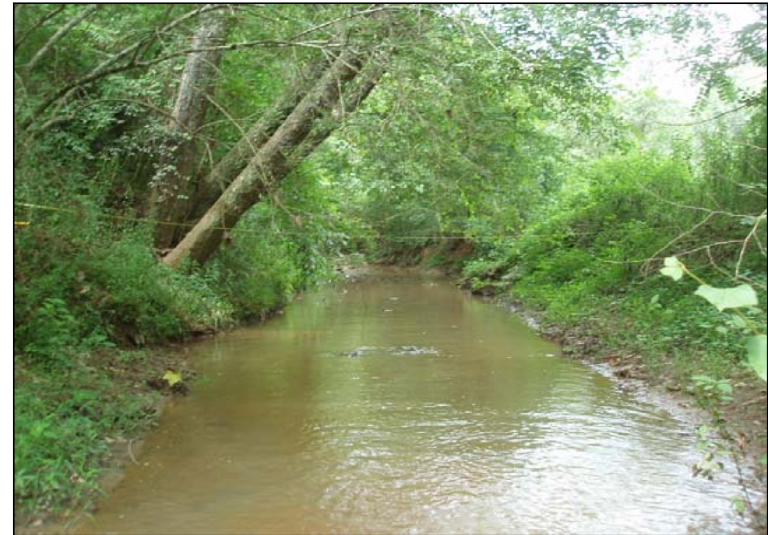
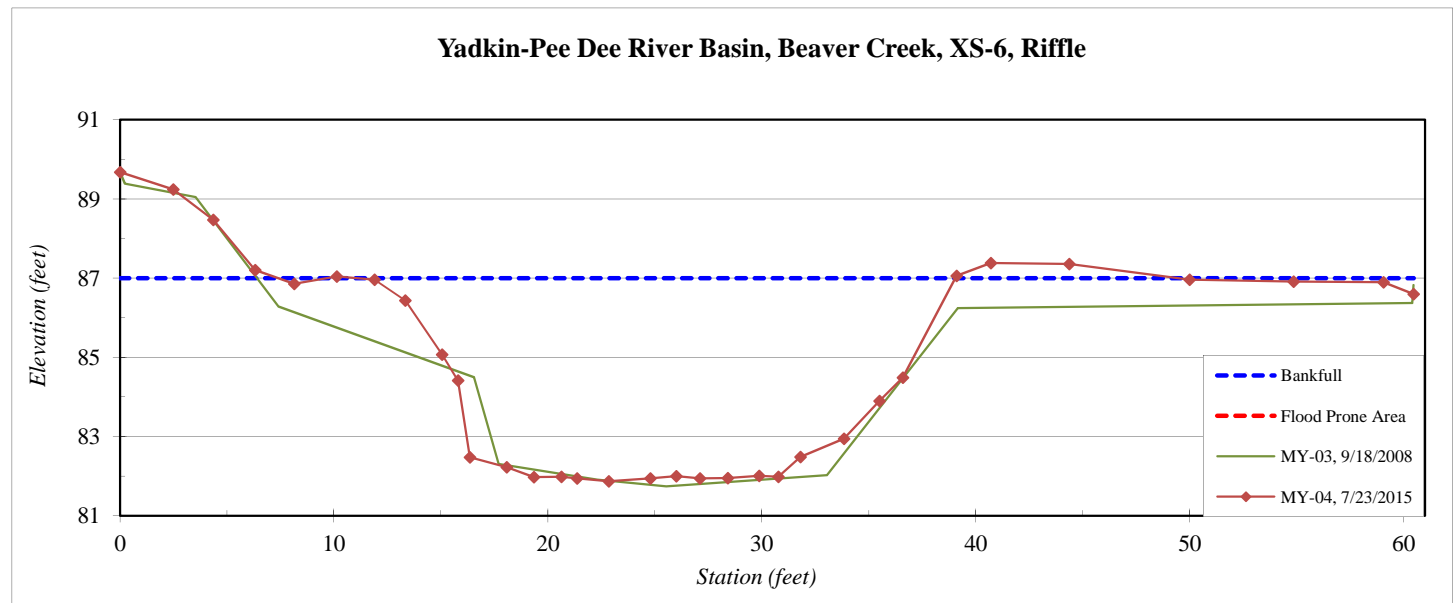
River Basin:	Yadkin-Pee Dee
Watershed:	Beaver Creek
XS ID	XS-6, Riffle
Drainage Area (sq mi):	5.90
Date:	7/23/2015
Field Crew:	T. Seelinger and B. Williams

SUMMARY DATA	
Bankfull Elevation:	87.0
Bankfull Cross-Sectional Area:	104.9
Bankfull Width:	38.2
Flood Prone Area Elevation:	92.1
Flood Prone Width:	>60
Max Depth at Bankfull:	5.1
Mean Depth at Bankfull:	2.7
W / D Ratio:	13.9
Entrenchment Ratio:	1.6
Bank Height Ratio:	1.0

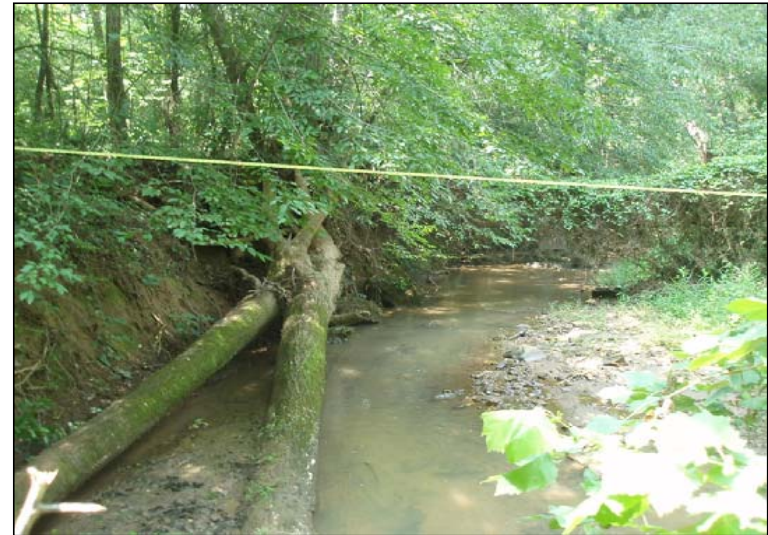
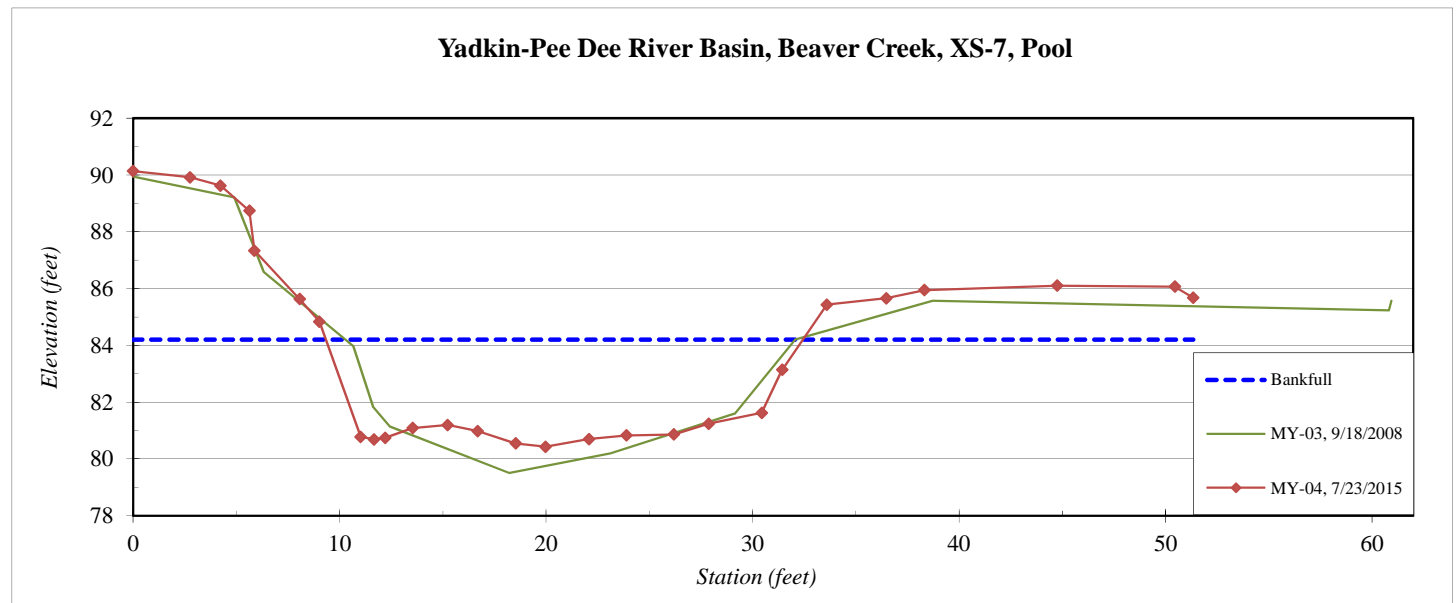
River Basin:	Yadkin-Pee Dee
Watershed:	Beaver Creek
XS ID	XS-7, Pool
Drainage Area (sq mi):	5.90
Date:	7/23/2015
Field Crew:	T. Seelinger and B. Williams

SUMMARY DATA	
Bankfull Elevation:	84.2
Bankfull Cross-Sectional Area:	69.1
Bankfull Width:	23.1
Flood Prone Area Elevation:	-
Flood Prone Width:	-
Max Depth at Bankfull:	3.8
Mean Depth at Bankfull:	3.0
W / D Ratio:	-
Entrenchment Ratio:	-
Bank Height Ratio:	-
