**Beaver Creek
Stream Restoration Monitoring Report**

DMS Project # 028

Monitoring Year: 2016

**BEAVER CREEK STREAM RESTORATION
PROJECT #28 - MONITORING YEAR 05**
SURRY COUNTY, NORTH CAROLINA

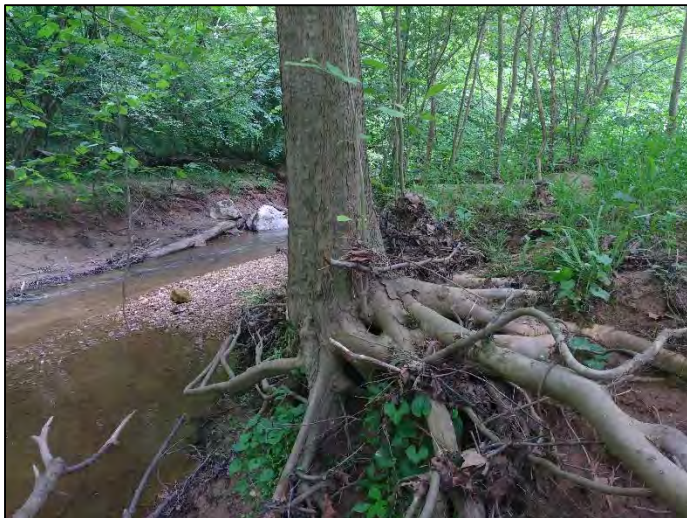
Photo 1. Wrack lines at bankfull

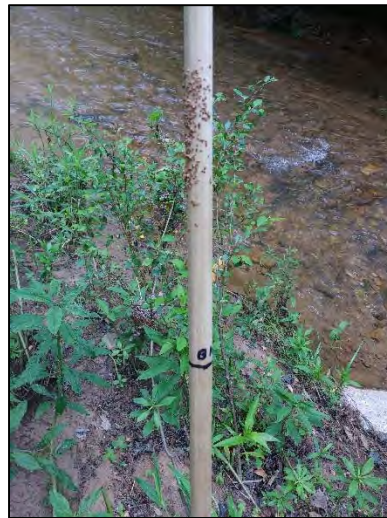
Photo 2. Crest gauge showing a bankfull event
