**BEAVERDAM CREEK
STREAM RESTORATION PROJECT**
ANNUAL MONITORING REPORT FOR 2007-2008 (YEAR 2)

Project Number: D05016-1

Prepared by: Michael Baker Engineering, Inc.

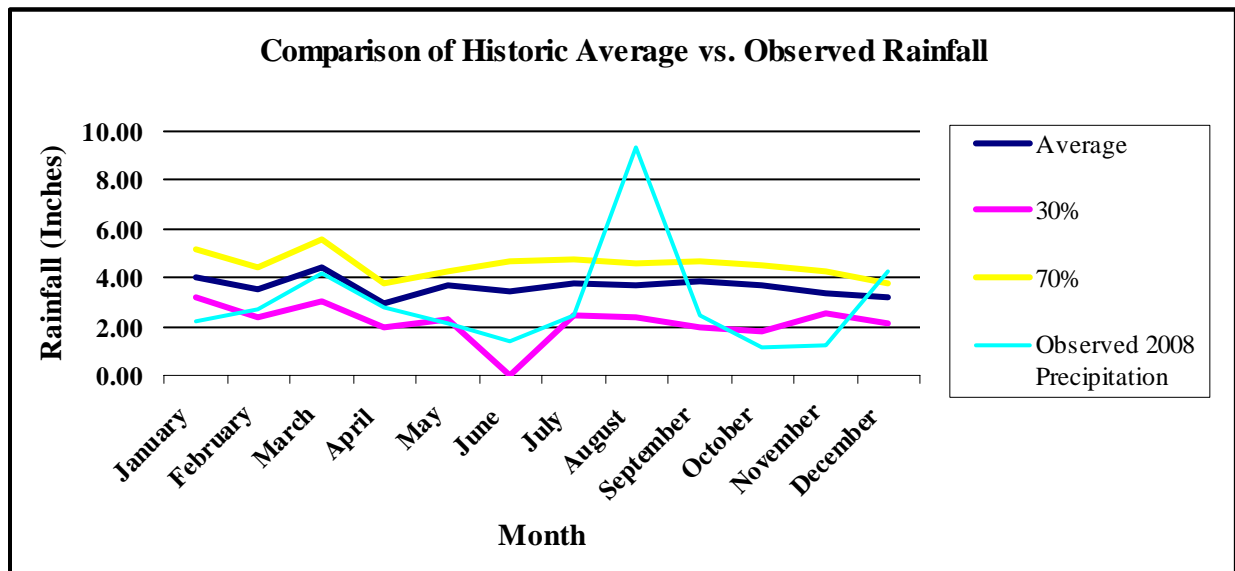
Figure 5. Historic Average vs. Observed Rainfall

Rainfall data were collected to document the hydrologic conditions throughout the project area in the 2008 growing season. Since no rain gauges were installed within the project boundaries, monthly rainfall totals were calculated from data downloaded from the Withers Cove USGS gauge 35090308100454 in Mecklenburg County, NC. Historical rainfall data were collected from the Charlotte WSO AP WETS Station in Mecklenburg County (NC 1690) using NRCS National Water and Climate Data Center website.
