**BEAVERDAM CREEK
STREAM RESTORATION PROJECT**
ANNUAL MONITORING REPORT FOR 2008-2009 (YEAR 3)

Project Number: D05016-1

December, 2009

Prepared by: Michael Baker Engineering, Inc.

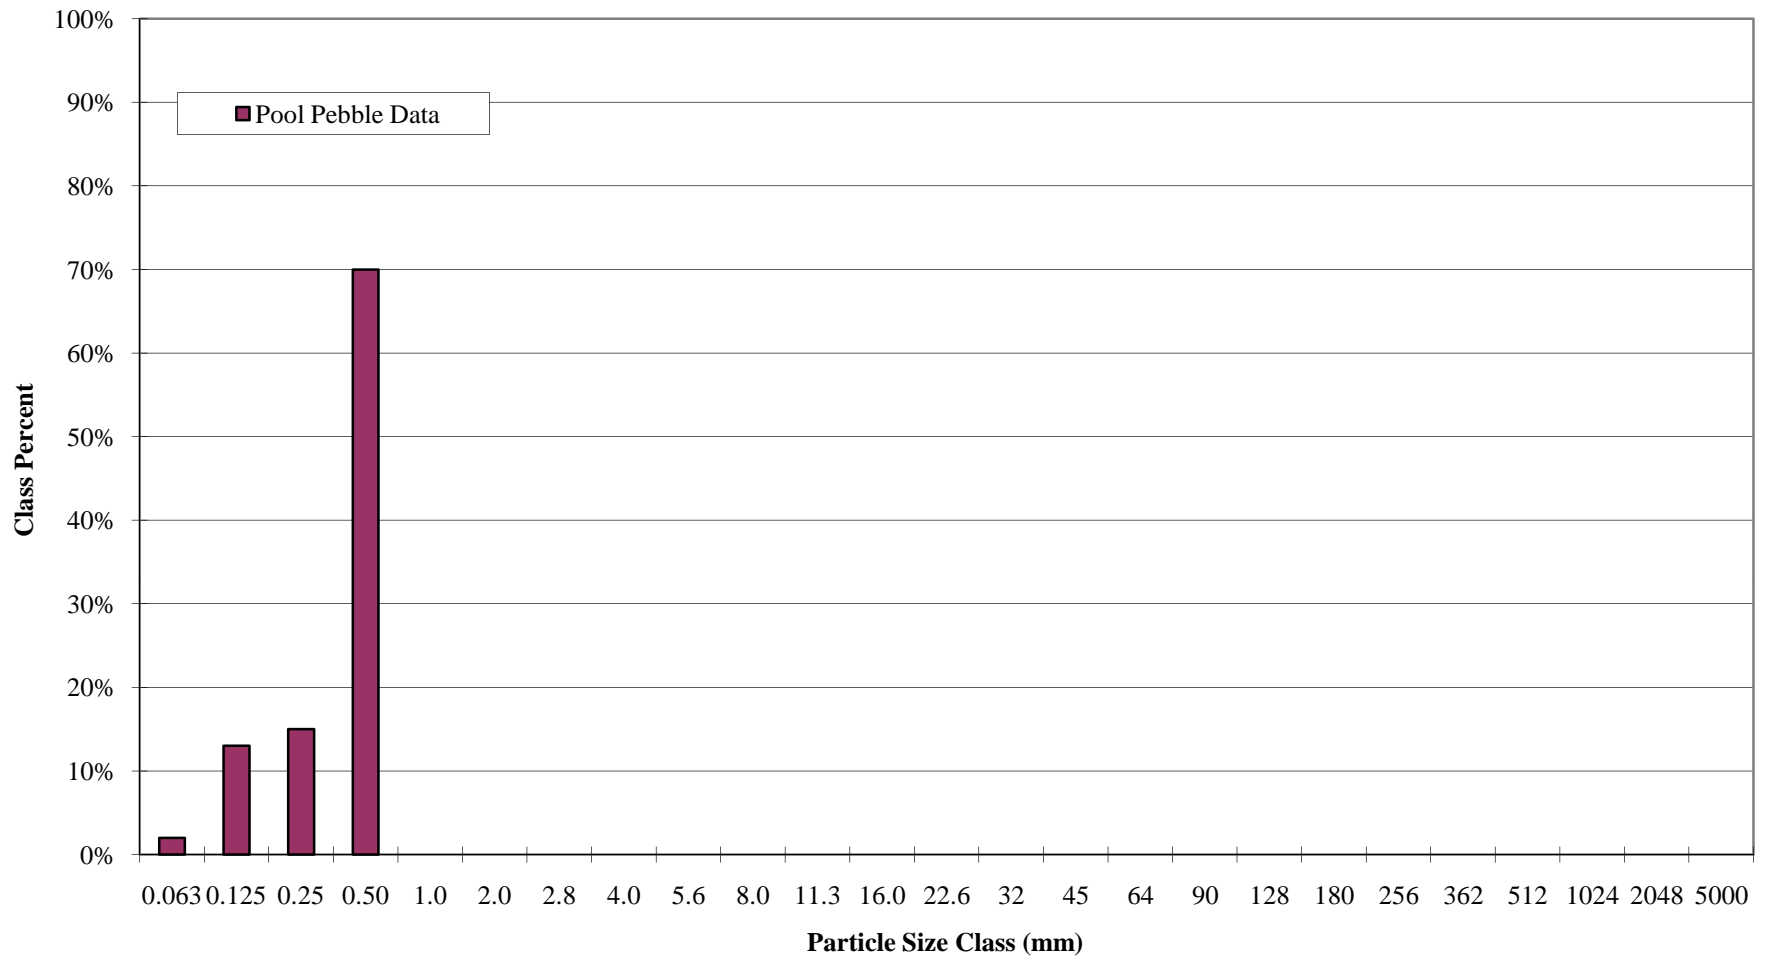
**UT1D
X11-Pool
Pebble Count Size Class Distribution**

Cross-sections 11 and 17, are located across pools that have have experienced aggradation during Year 3. The aggradation documented at X11 is due to an unknown offsite sediment source. The recent deposition is only present at the very top of UT1D. X17 experienced bed scour during Year 2 as a result of 7.54 inch precipitation event between August 25 and 27, 2008. During Year 3 X17 has aggraded back towards its as-built depth. Scour followed by aggradation is a natural cycle in pool features and has not resulted in any observed channel instability. Photographs of X17 indicate that the banks of the stream are stable with vegetation.

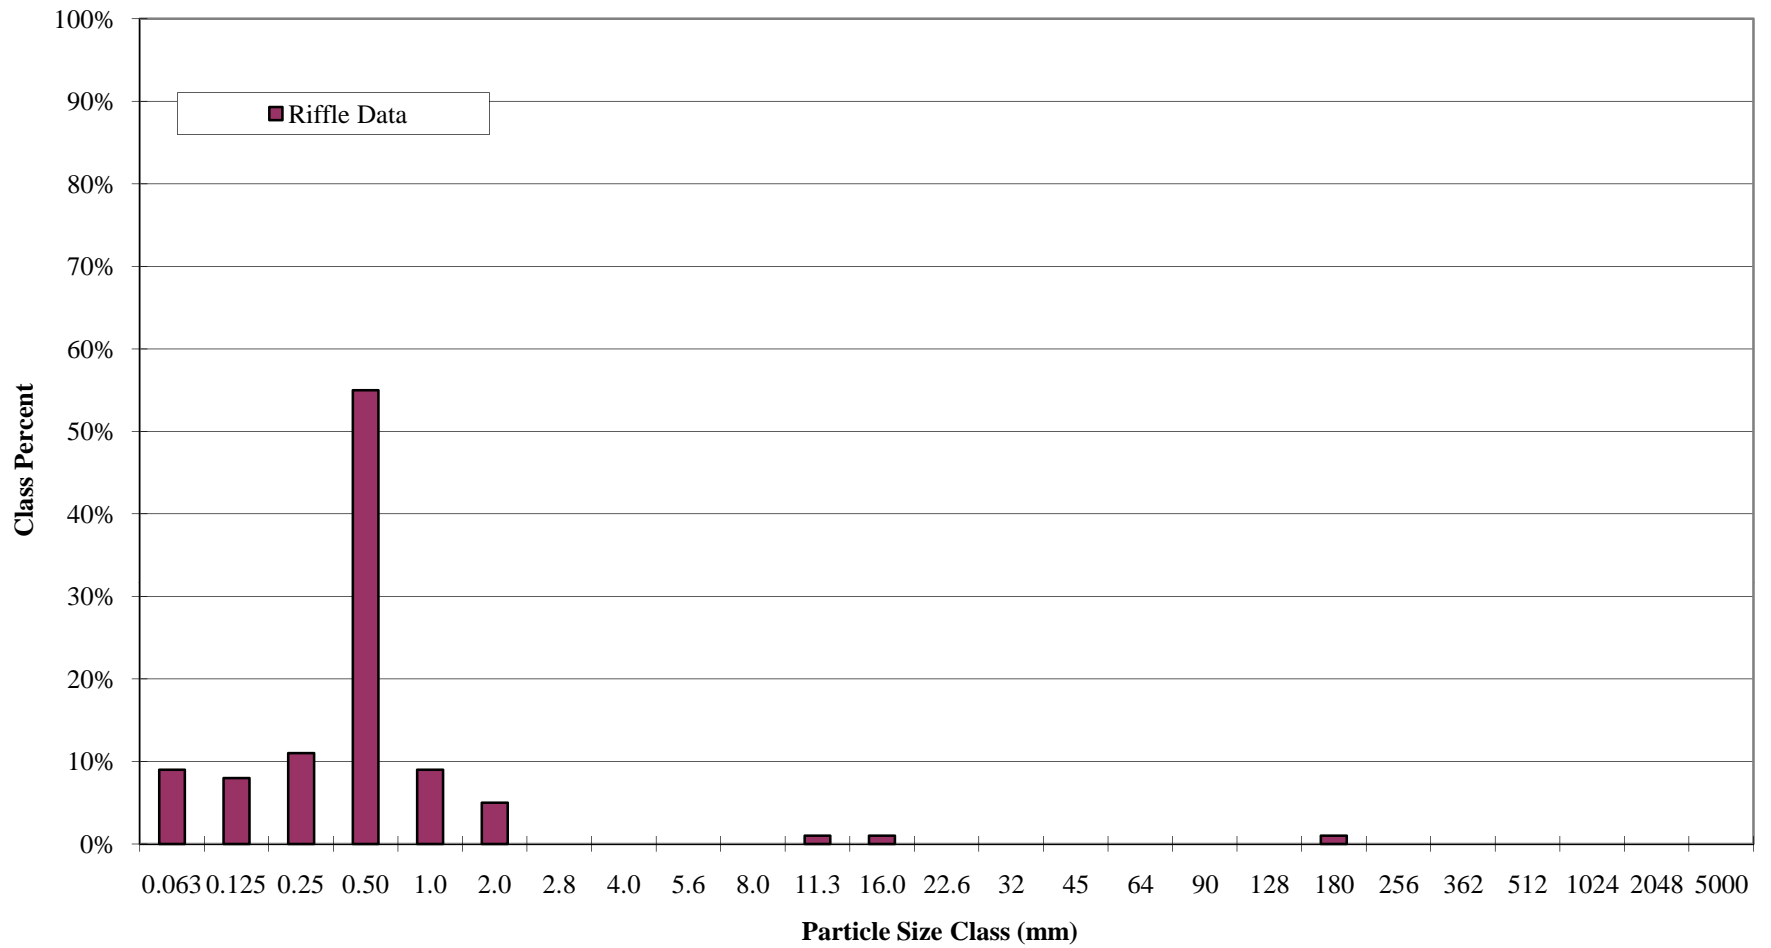
**UT1
X15-Riffle
Pebble Count Size Class Distribution**

Cross-section 15, a riffle, also experienced aggradation. X15 is located immediately upstream of a large in-stream boulder. The aggradation in Year 3 followed scour observed during Year 2. This change in channel geometry is most likely influenced by the boulder structure and will be monitored, however no other action is required at this time.
