BEAVERDAM CREEK STREAM RESTORATION PROJECT

ANNUAL MONITORING REPORT FOR 2009 - 2010 (YEAR 4)

Project Number: D05016-1

Prepared by: Michael Baker Engineering, Inc.

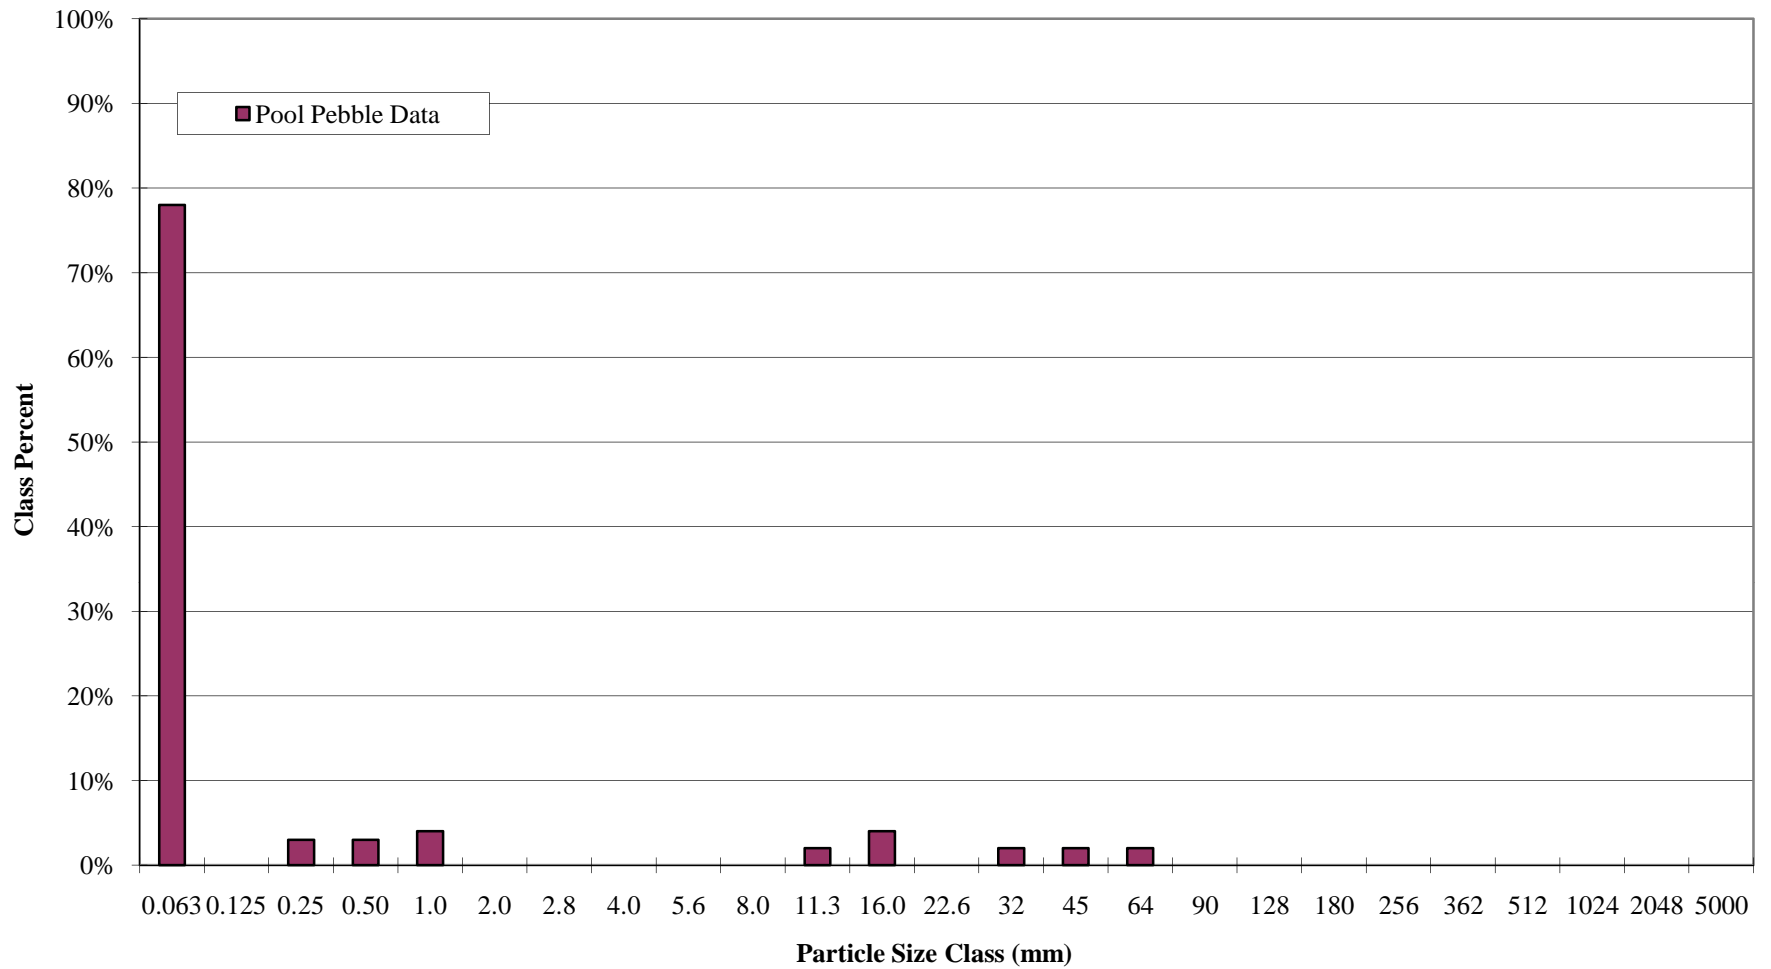
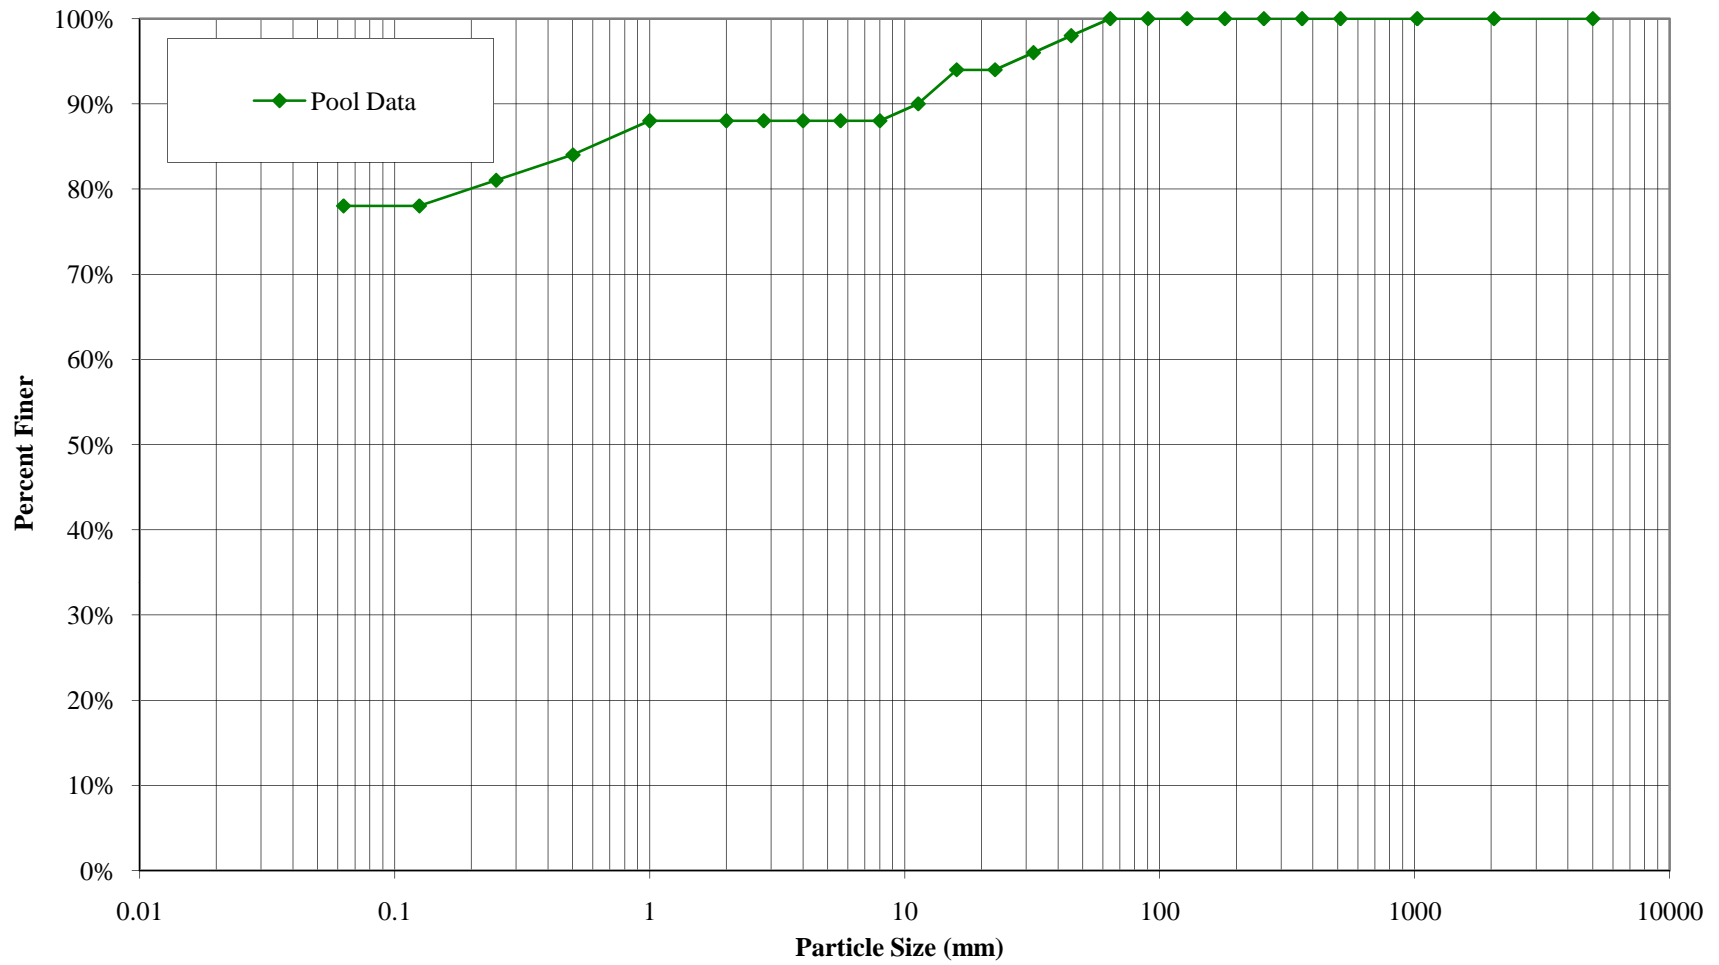
**UT1
X10-Pool
Pebble Count Size Class Distribution**

Cross-section 10 is located across a pool that has experienced minor degradation during Year 4. Scour and deepening of some pools is expected and has not resulted in any observed channel instability. Photographs of X10 indicate that the banks of the stream are stable with vegetation.

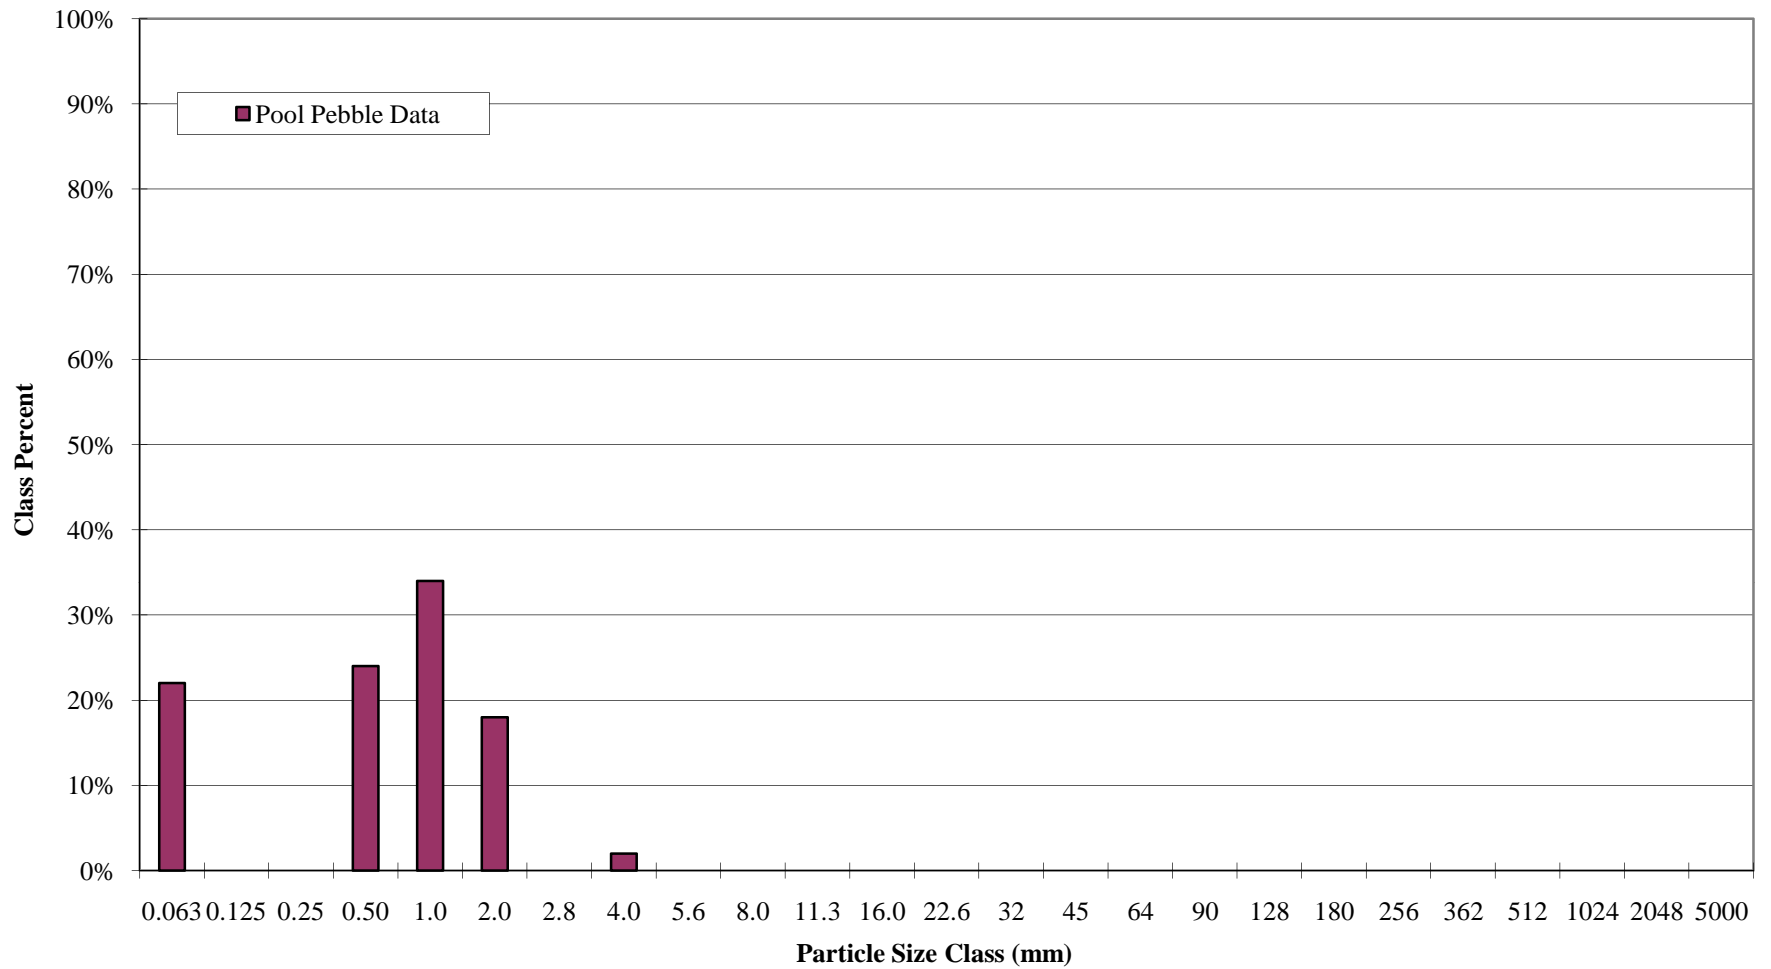
**UT1
X13-Pool
Pebble Count Size Class Distribution**

Cross-section 13 is located in a pool that has experienced minor bed aggradation along the inner half of the meander bend during Year 4. This slight adjustment has not resulted in any observed channel instability.
