**BEAVERDAM CREEK
STREAM RESTORATION PROJECT**
ANNUAL MONITORING REPORT FOR 2010 - 2011 (YEAR 5)

Project Number: D05016-1

December, 2011

Prepared by: Michael Baker Engineering, Inc.

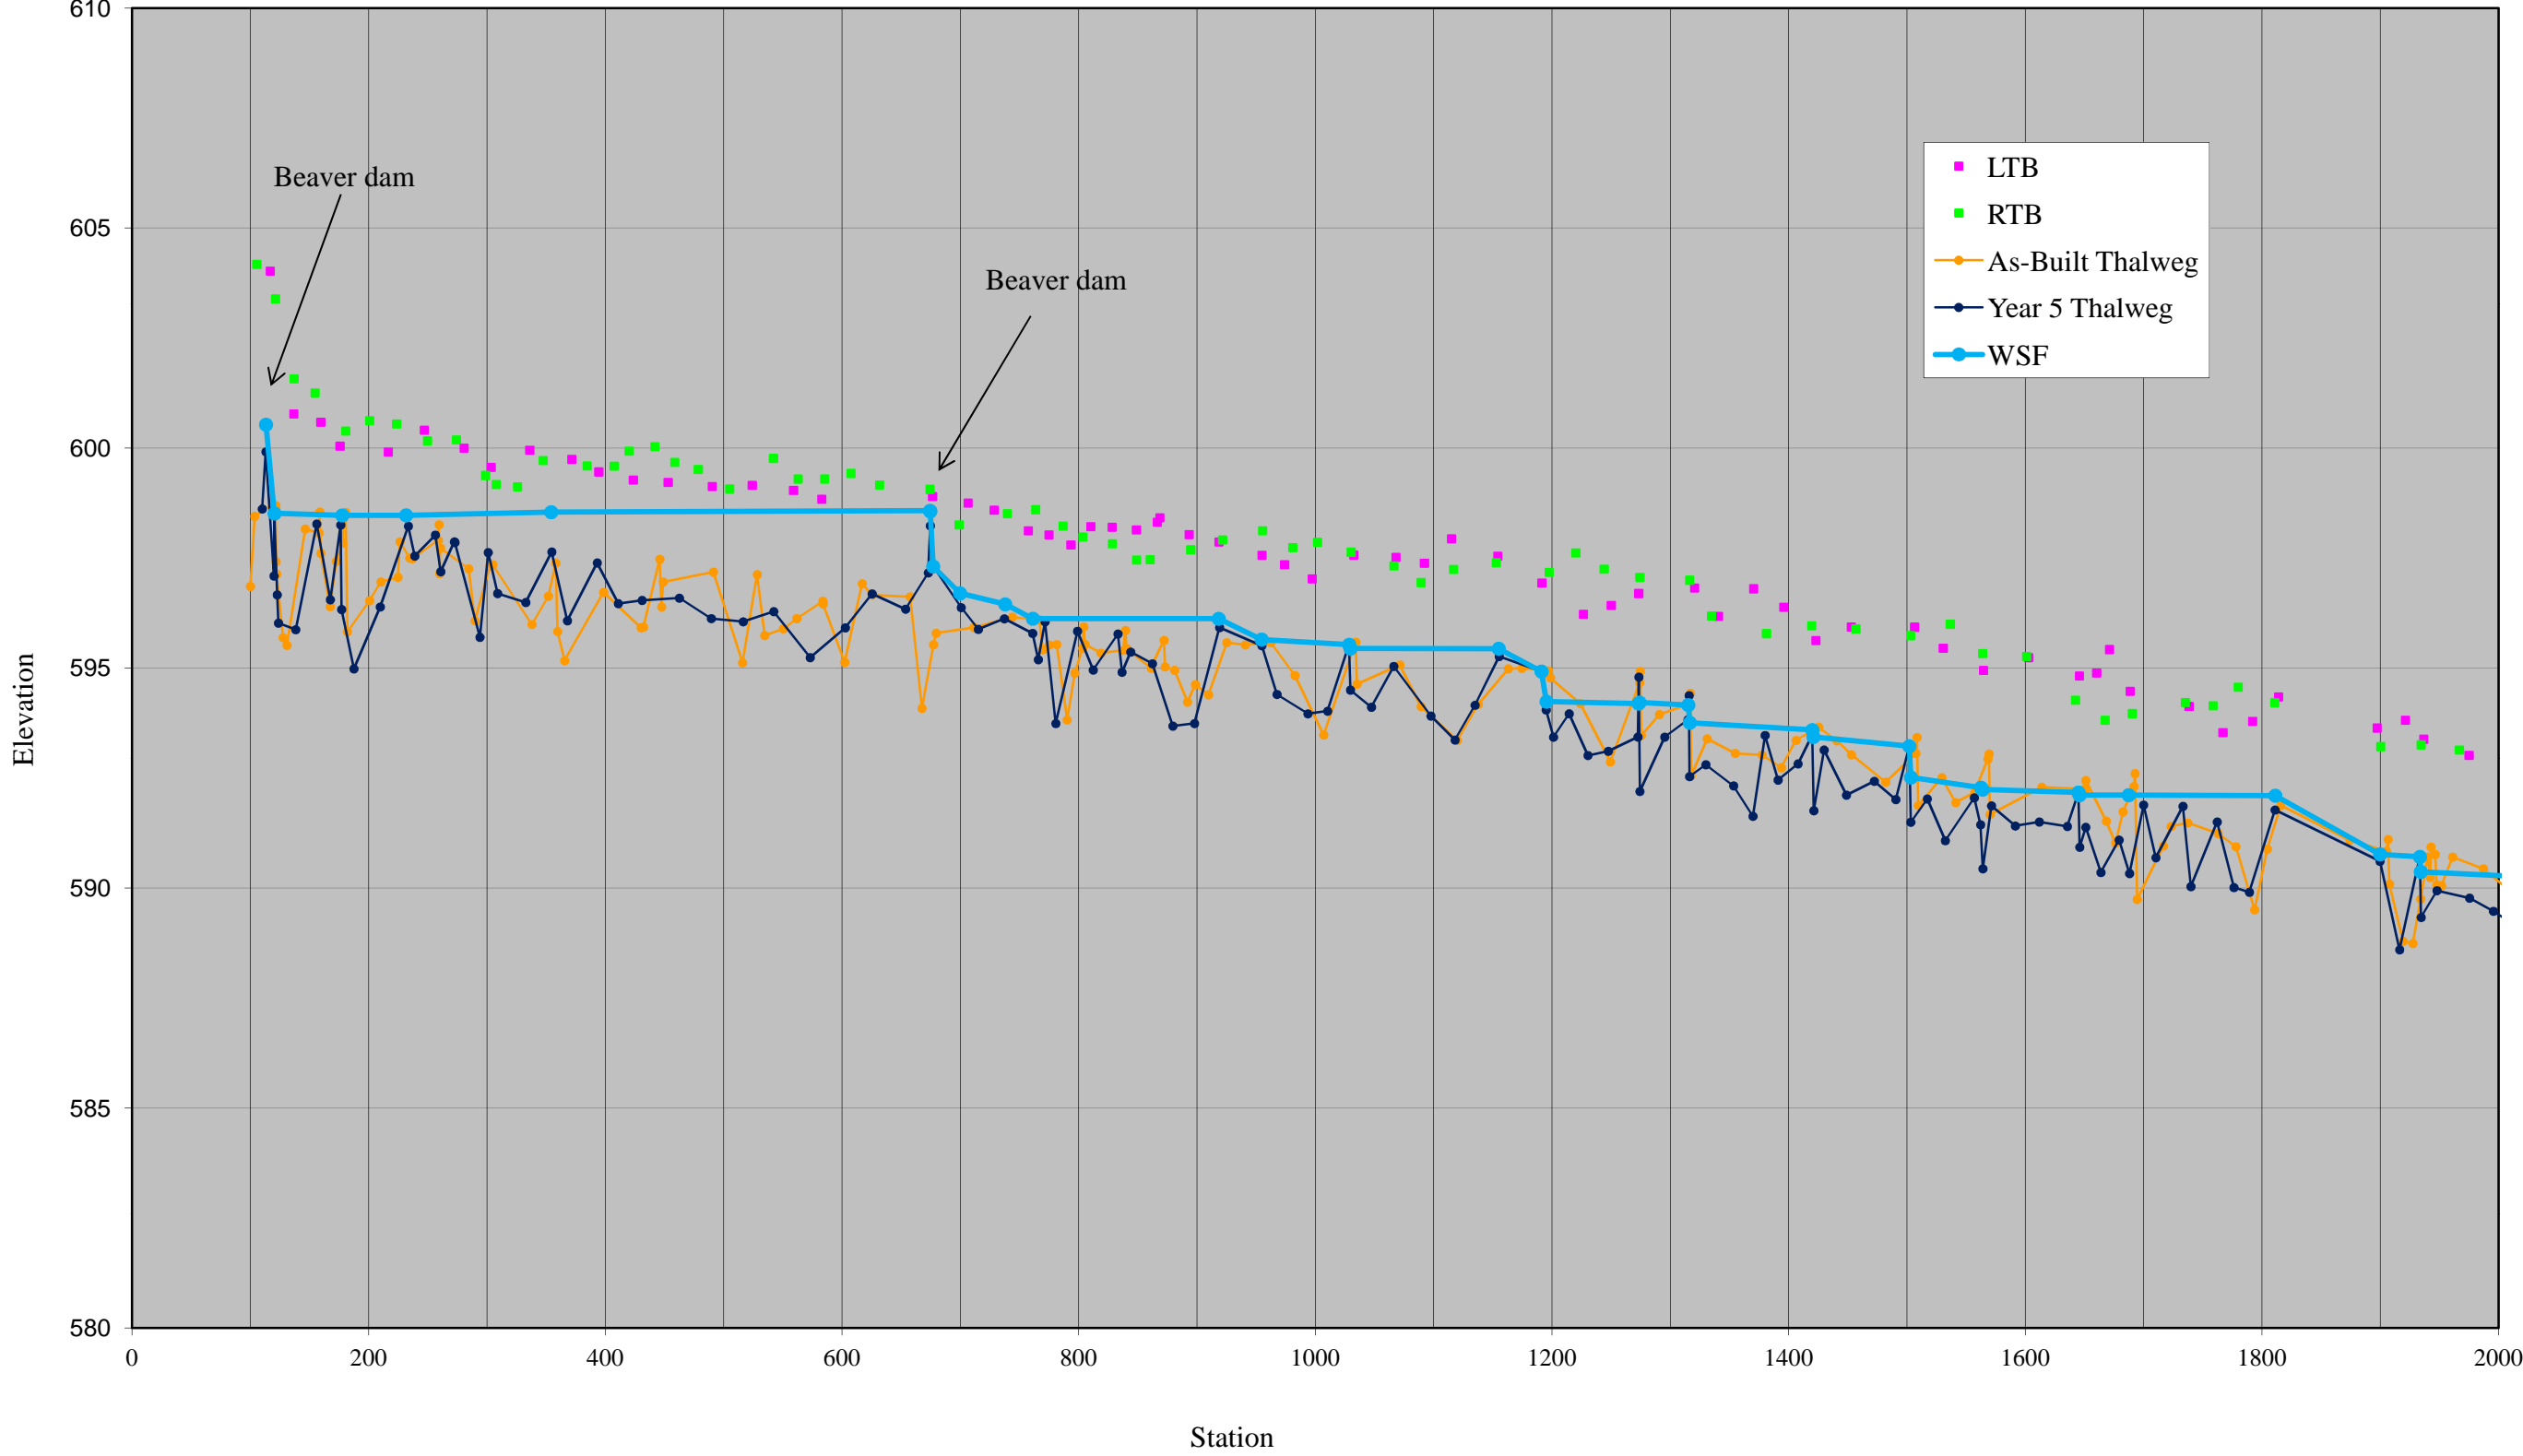
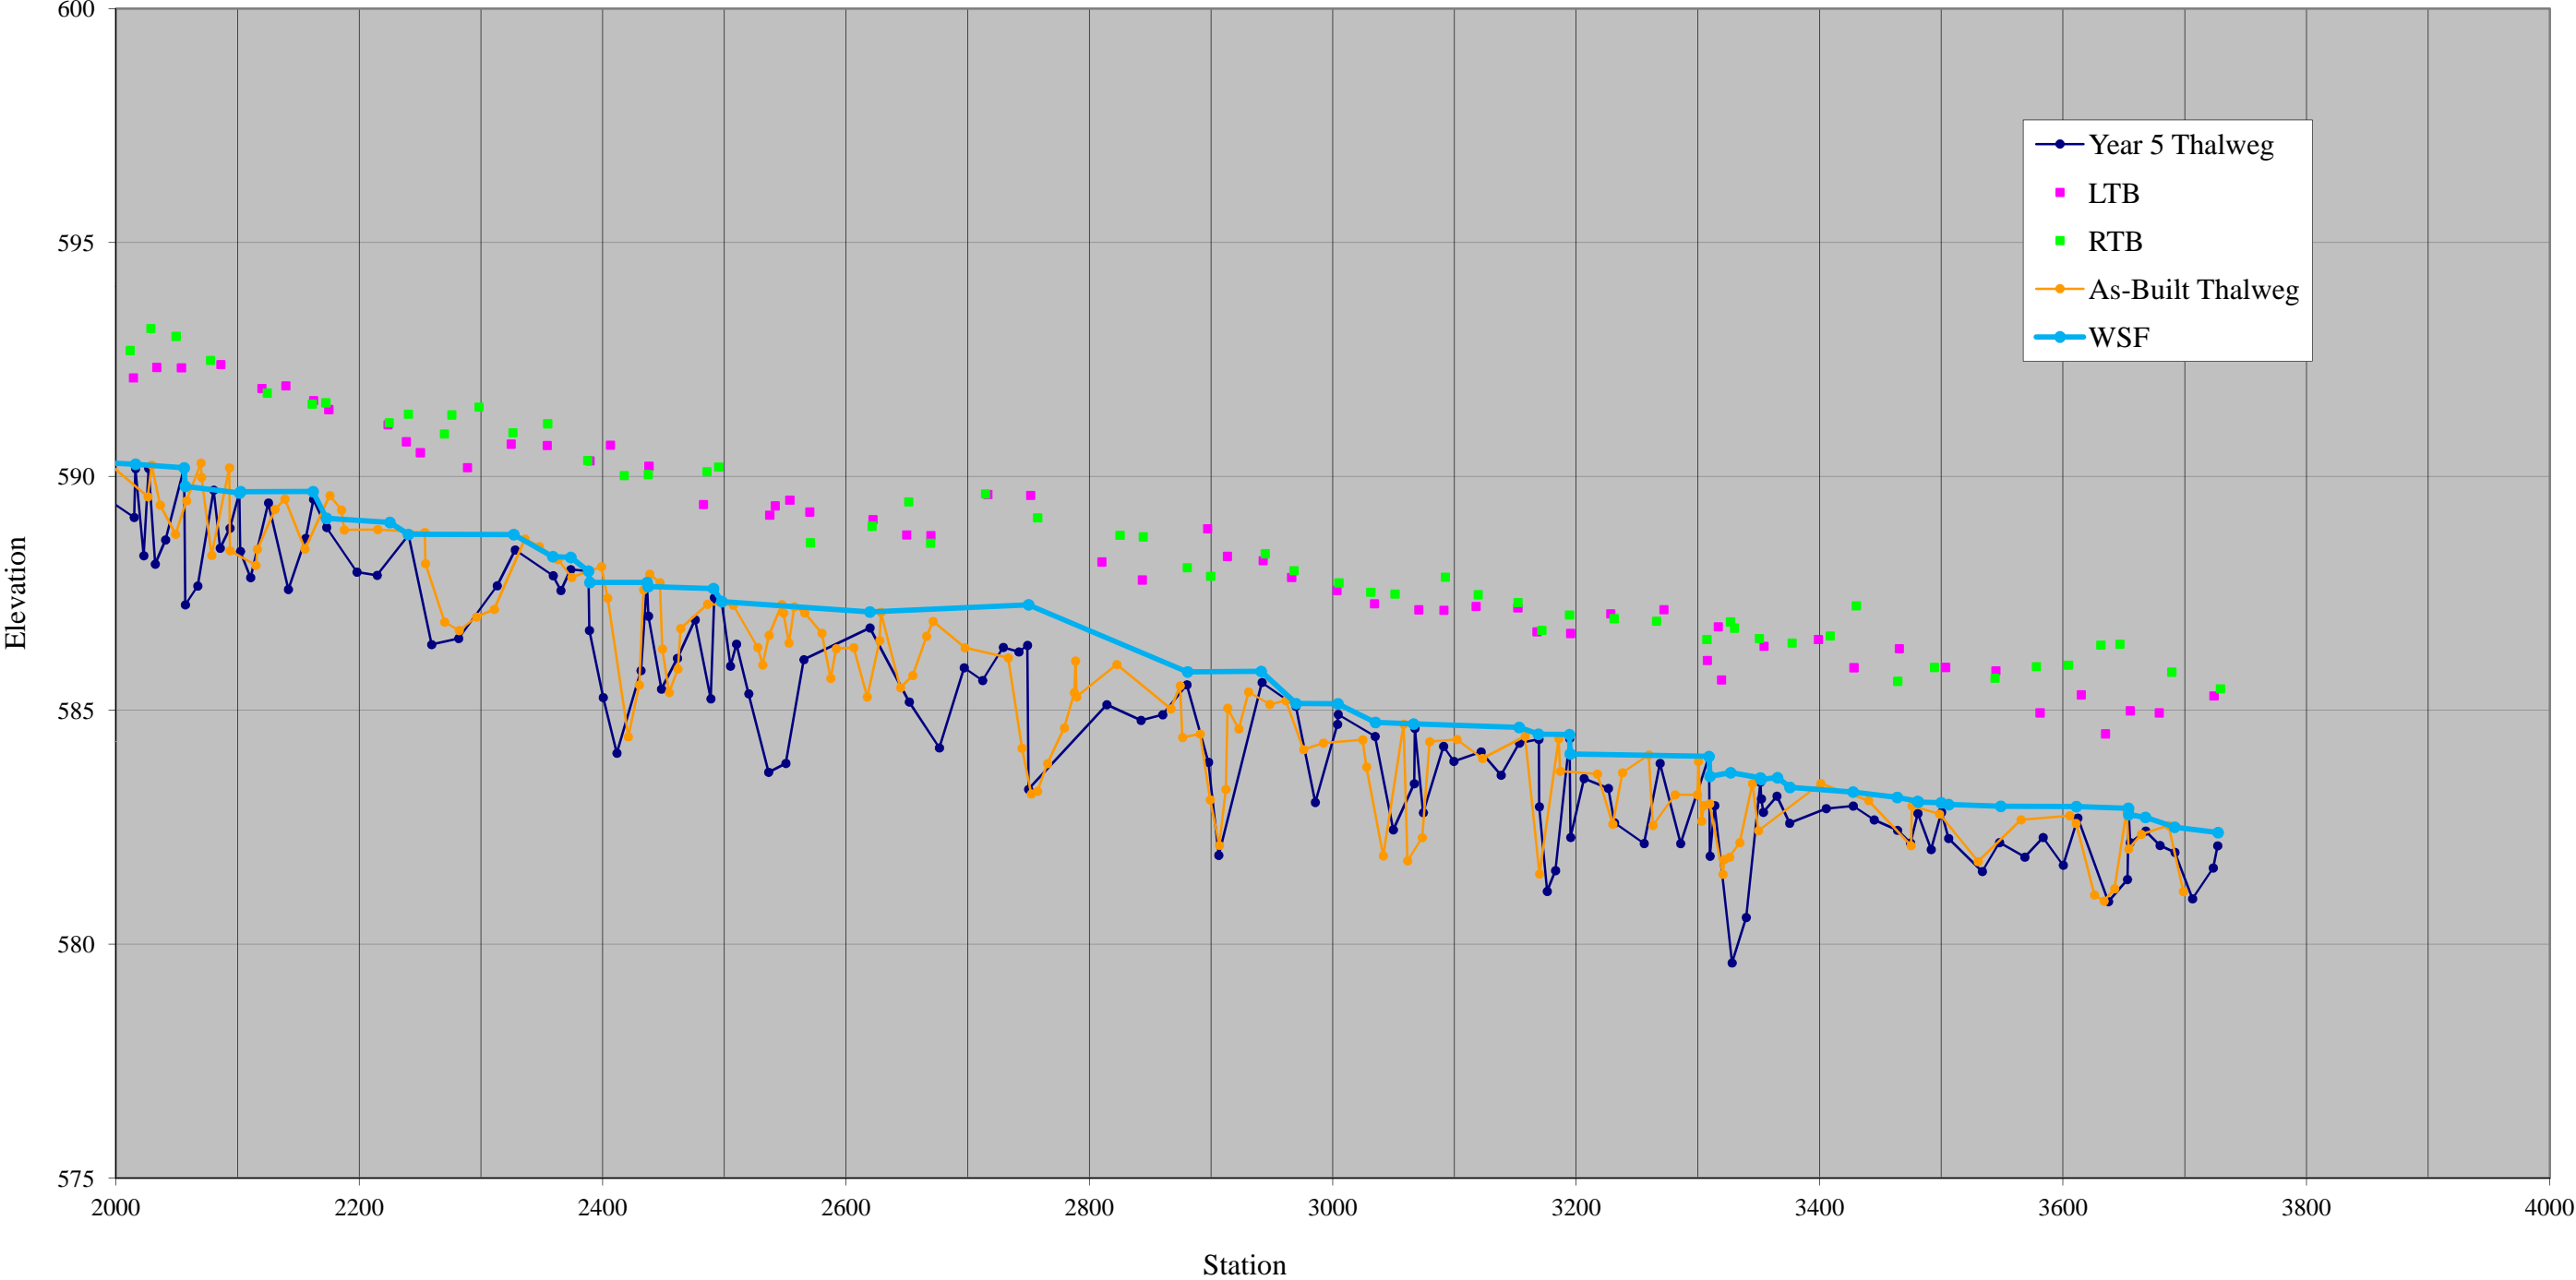
Beaverdam Creek UT1 Mainstem Profile (2011 Monitoring)

The representative longitudinal profile along the restored channel was resurveyed to document stream profile at the end of monitoring Year 5. Riffle slopes and pool-to-pool spacing were not calculated for Reach 1 of UT1 because the entire reach is experiencing backwater conditions resulting from a beaver dam located at Station 15+70 of UT1.

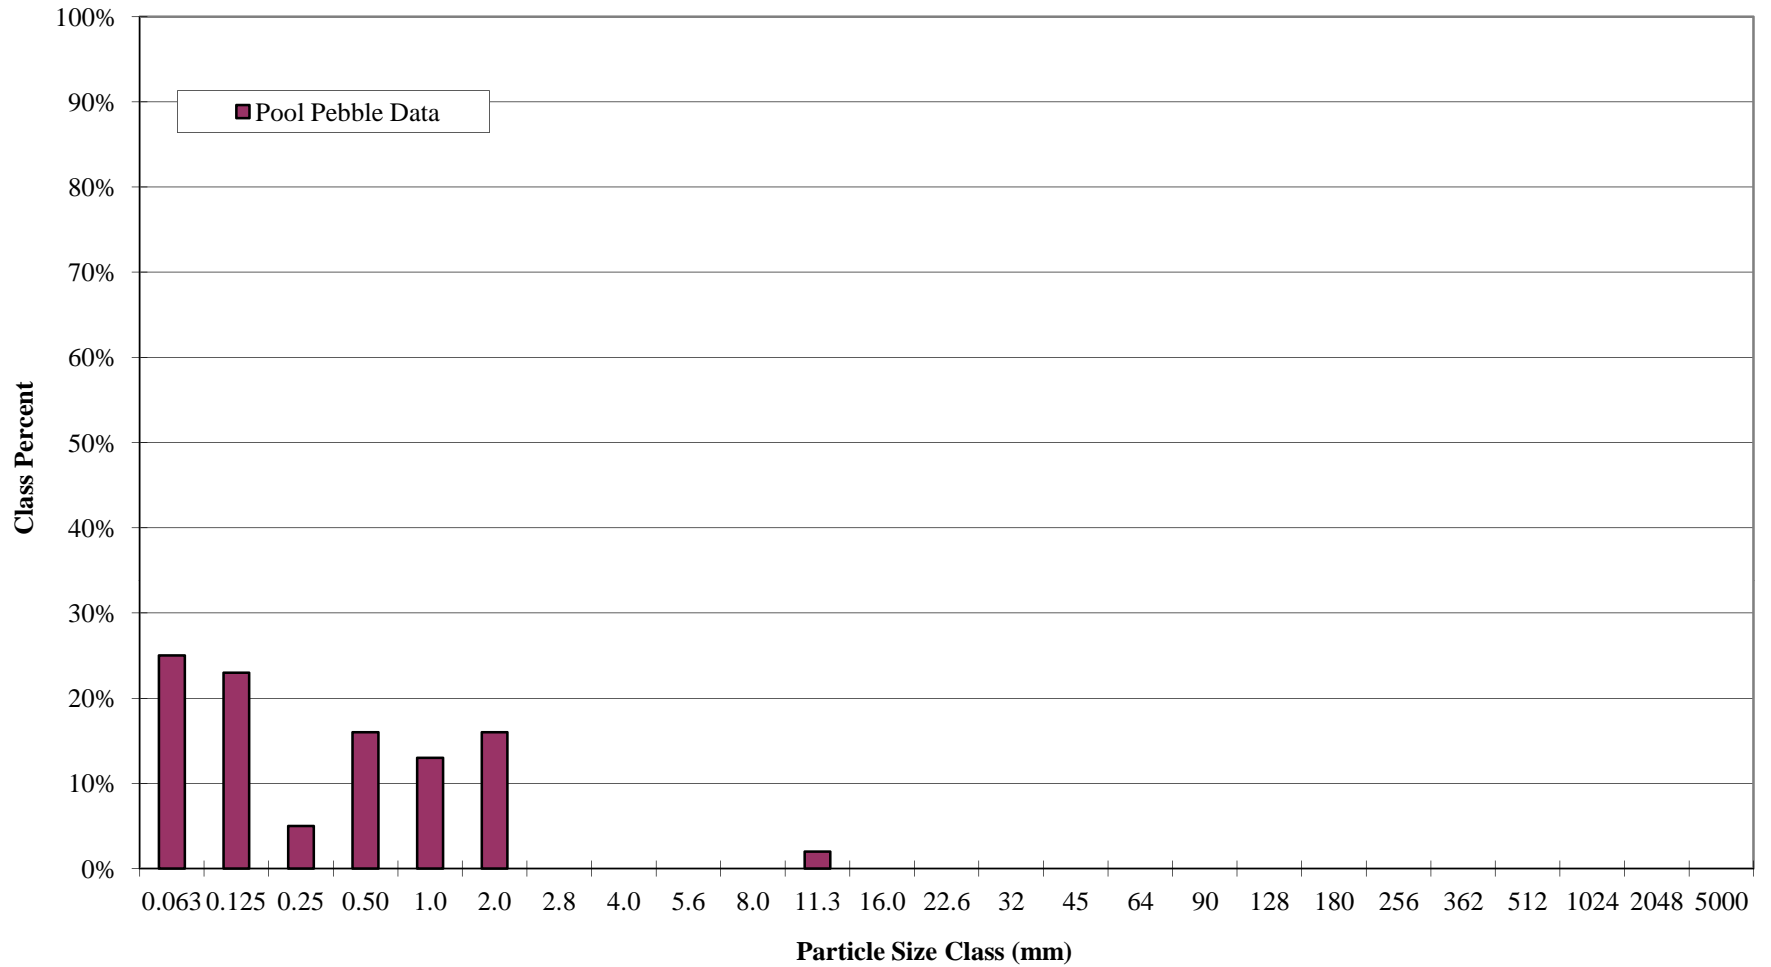
**UT1
X13-Pool
Pebble Count Size Class Distribution**

Cross-section 13 is located across a pool that has experienced minor degradation during Year 5. This cross-section has experienced a cyclic pattern of minor degradation and aggradation through the five years of monitoring. These fluctuations in pool geometry are expected and have not resulted in any observed channel instability.

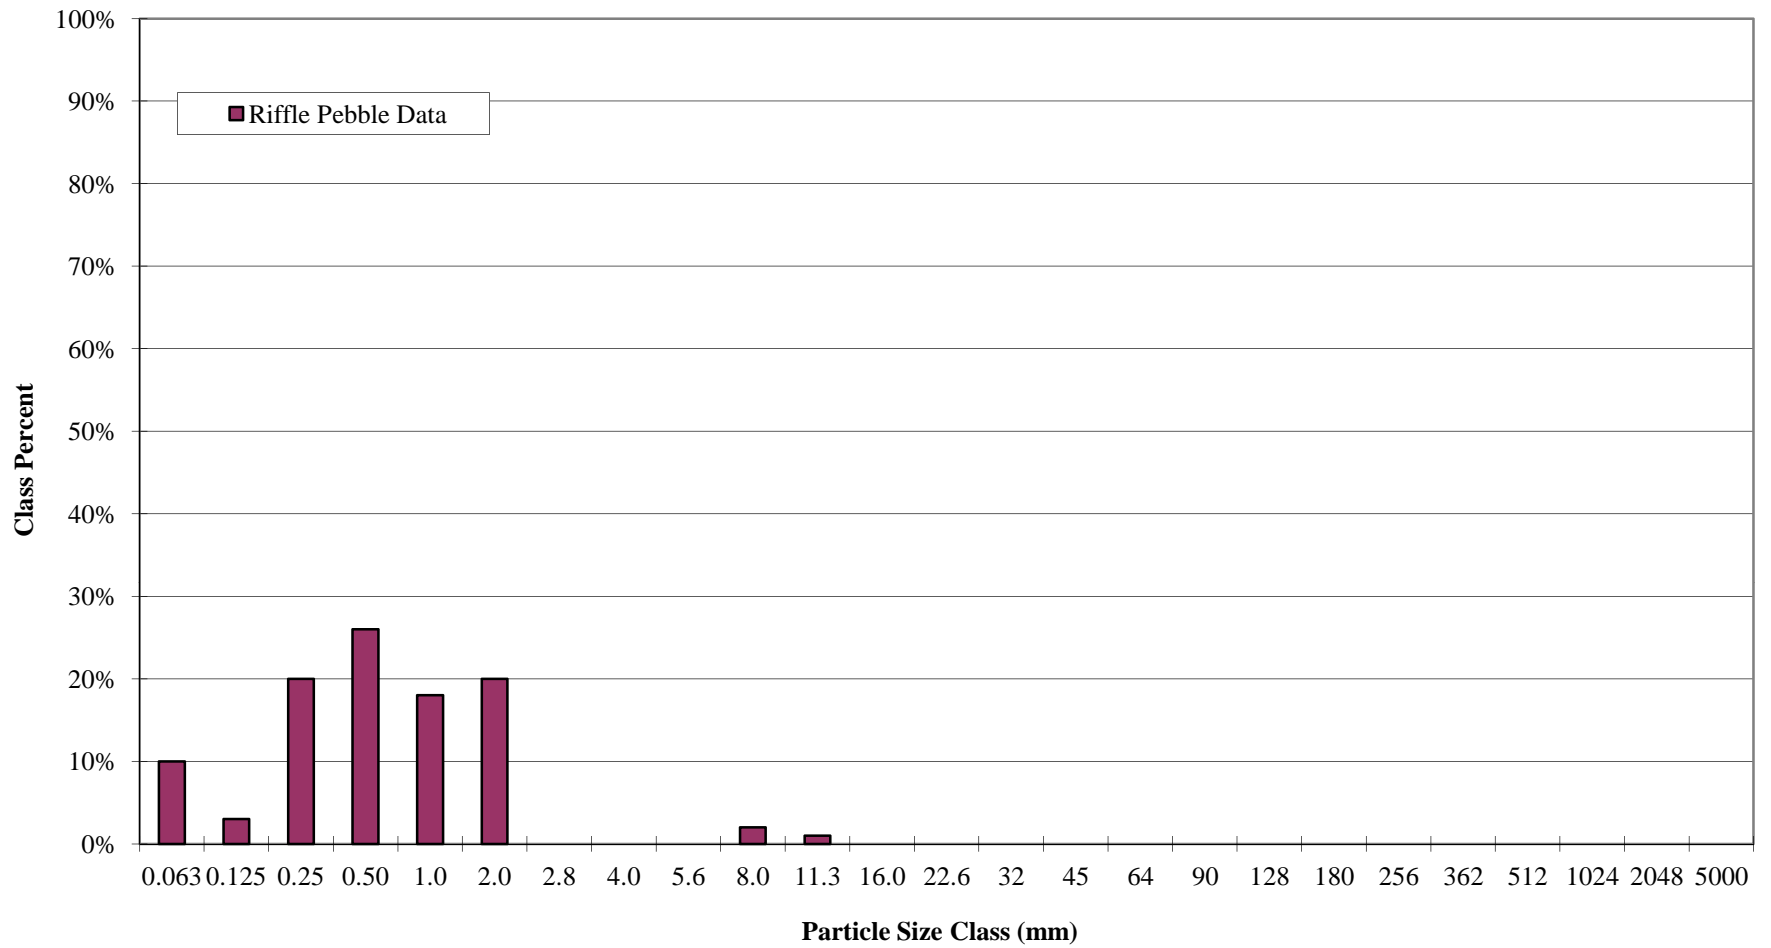
**UT1
X15-Riffle
Pebble Count Size Class Distribution**

Cross-section 15, a riffle, also experienced degradation and similar to X13 this cross-section has exhibited a cyclic pattern of minor degradation and aggradation during post-construction monitoring. These minor fluctuations in channel geometry are likely the result of a large in-stream boulder immediately upstream of X15.
