# **Year 1 Monitoring Report for Stream Restoration of Beaverdam Creek and Unnamed Tributaries**

Union County, NC  
SCO # D06054-C

**Submitted:** December 2009

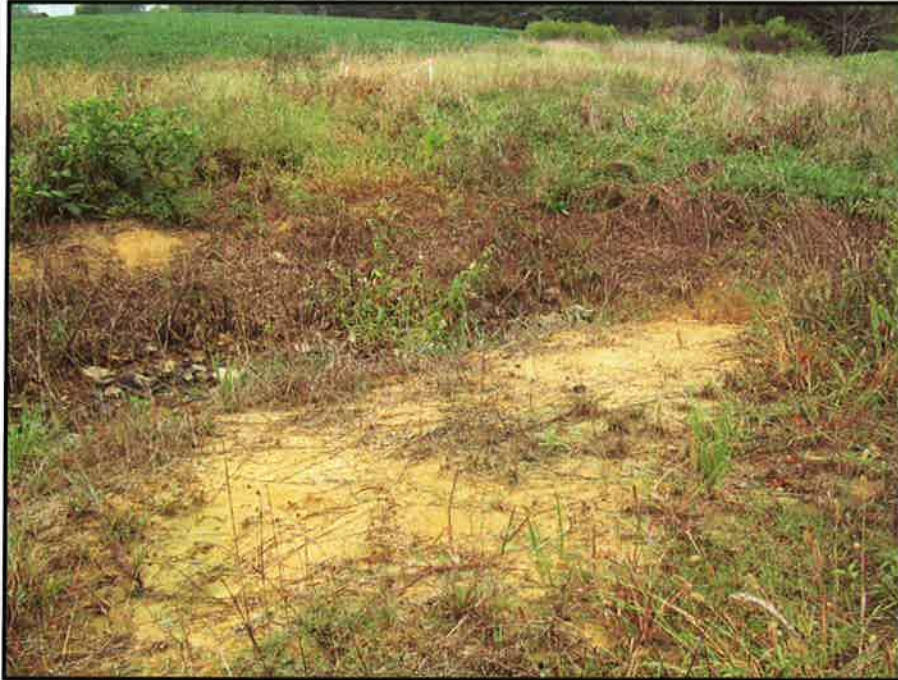
**VPA 1**

Two areas along the tributaries of Beaverdam Creek were noted to have low overall herbaceous cover along the riparian corridor. These areas are small patches near the stream channel, neither of which is exhibiting colonization by invasive species. Because this is the first year of vegetative development, it is expected that the vegetation from the permanent seeding will spread to fill in sparsely covered areas. Due to these reasons, these areas are considered as a low concern at this time.

**Sparse vegetation along the bank of UT1 at station 10+75.  
(EMH&T, Inc. 9/20/09)**

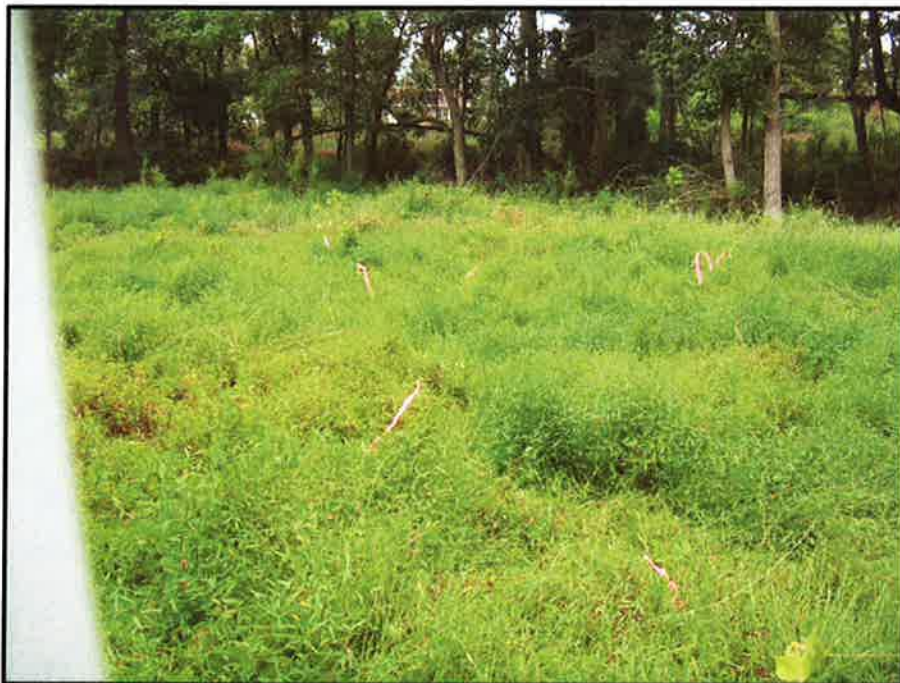
**VPA 2**

There were a few areas with a population of *Microstegium vimineum*. This species is common along streambanks and ditches, and at the edges of forests and damp fields, and as such, was likely present before the onset of restoration activities. As further evidence of a pre-existing population, the locations where this species occurred were those areas not impacted during restoration of the stream channels. Because the grass remained short at the time of vegetative monitoring, it did not appear to be impacting the survival of woody stems and is therefore considered a problem of low concern at this time. However, proactive management in the form of herbicide treatments has been conducted in the fall of 2009, with follow-up treatments planned for the spring of 2010, to limit the impact of this species on the vegetative success of the project.

**View of the spread of microstegium in Vegetation Plot 2. This invasive grass is found in various patches along the project corridor, but is most prominent in this area.  
(EMH&T, Inc. 9/20/09)**

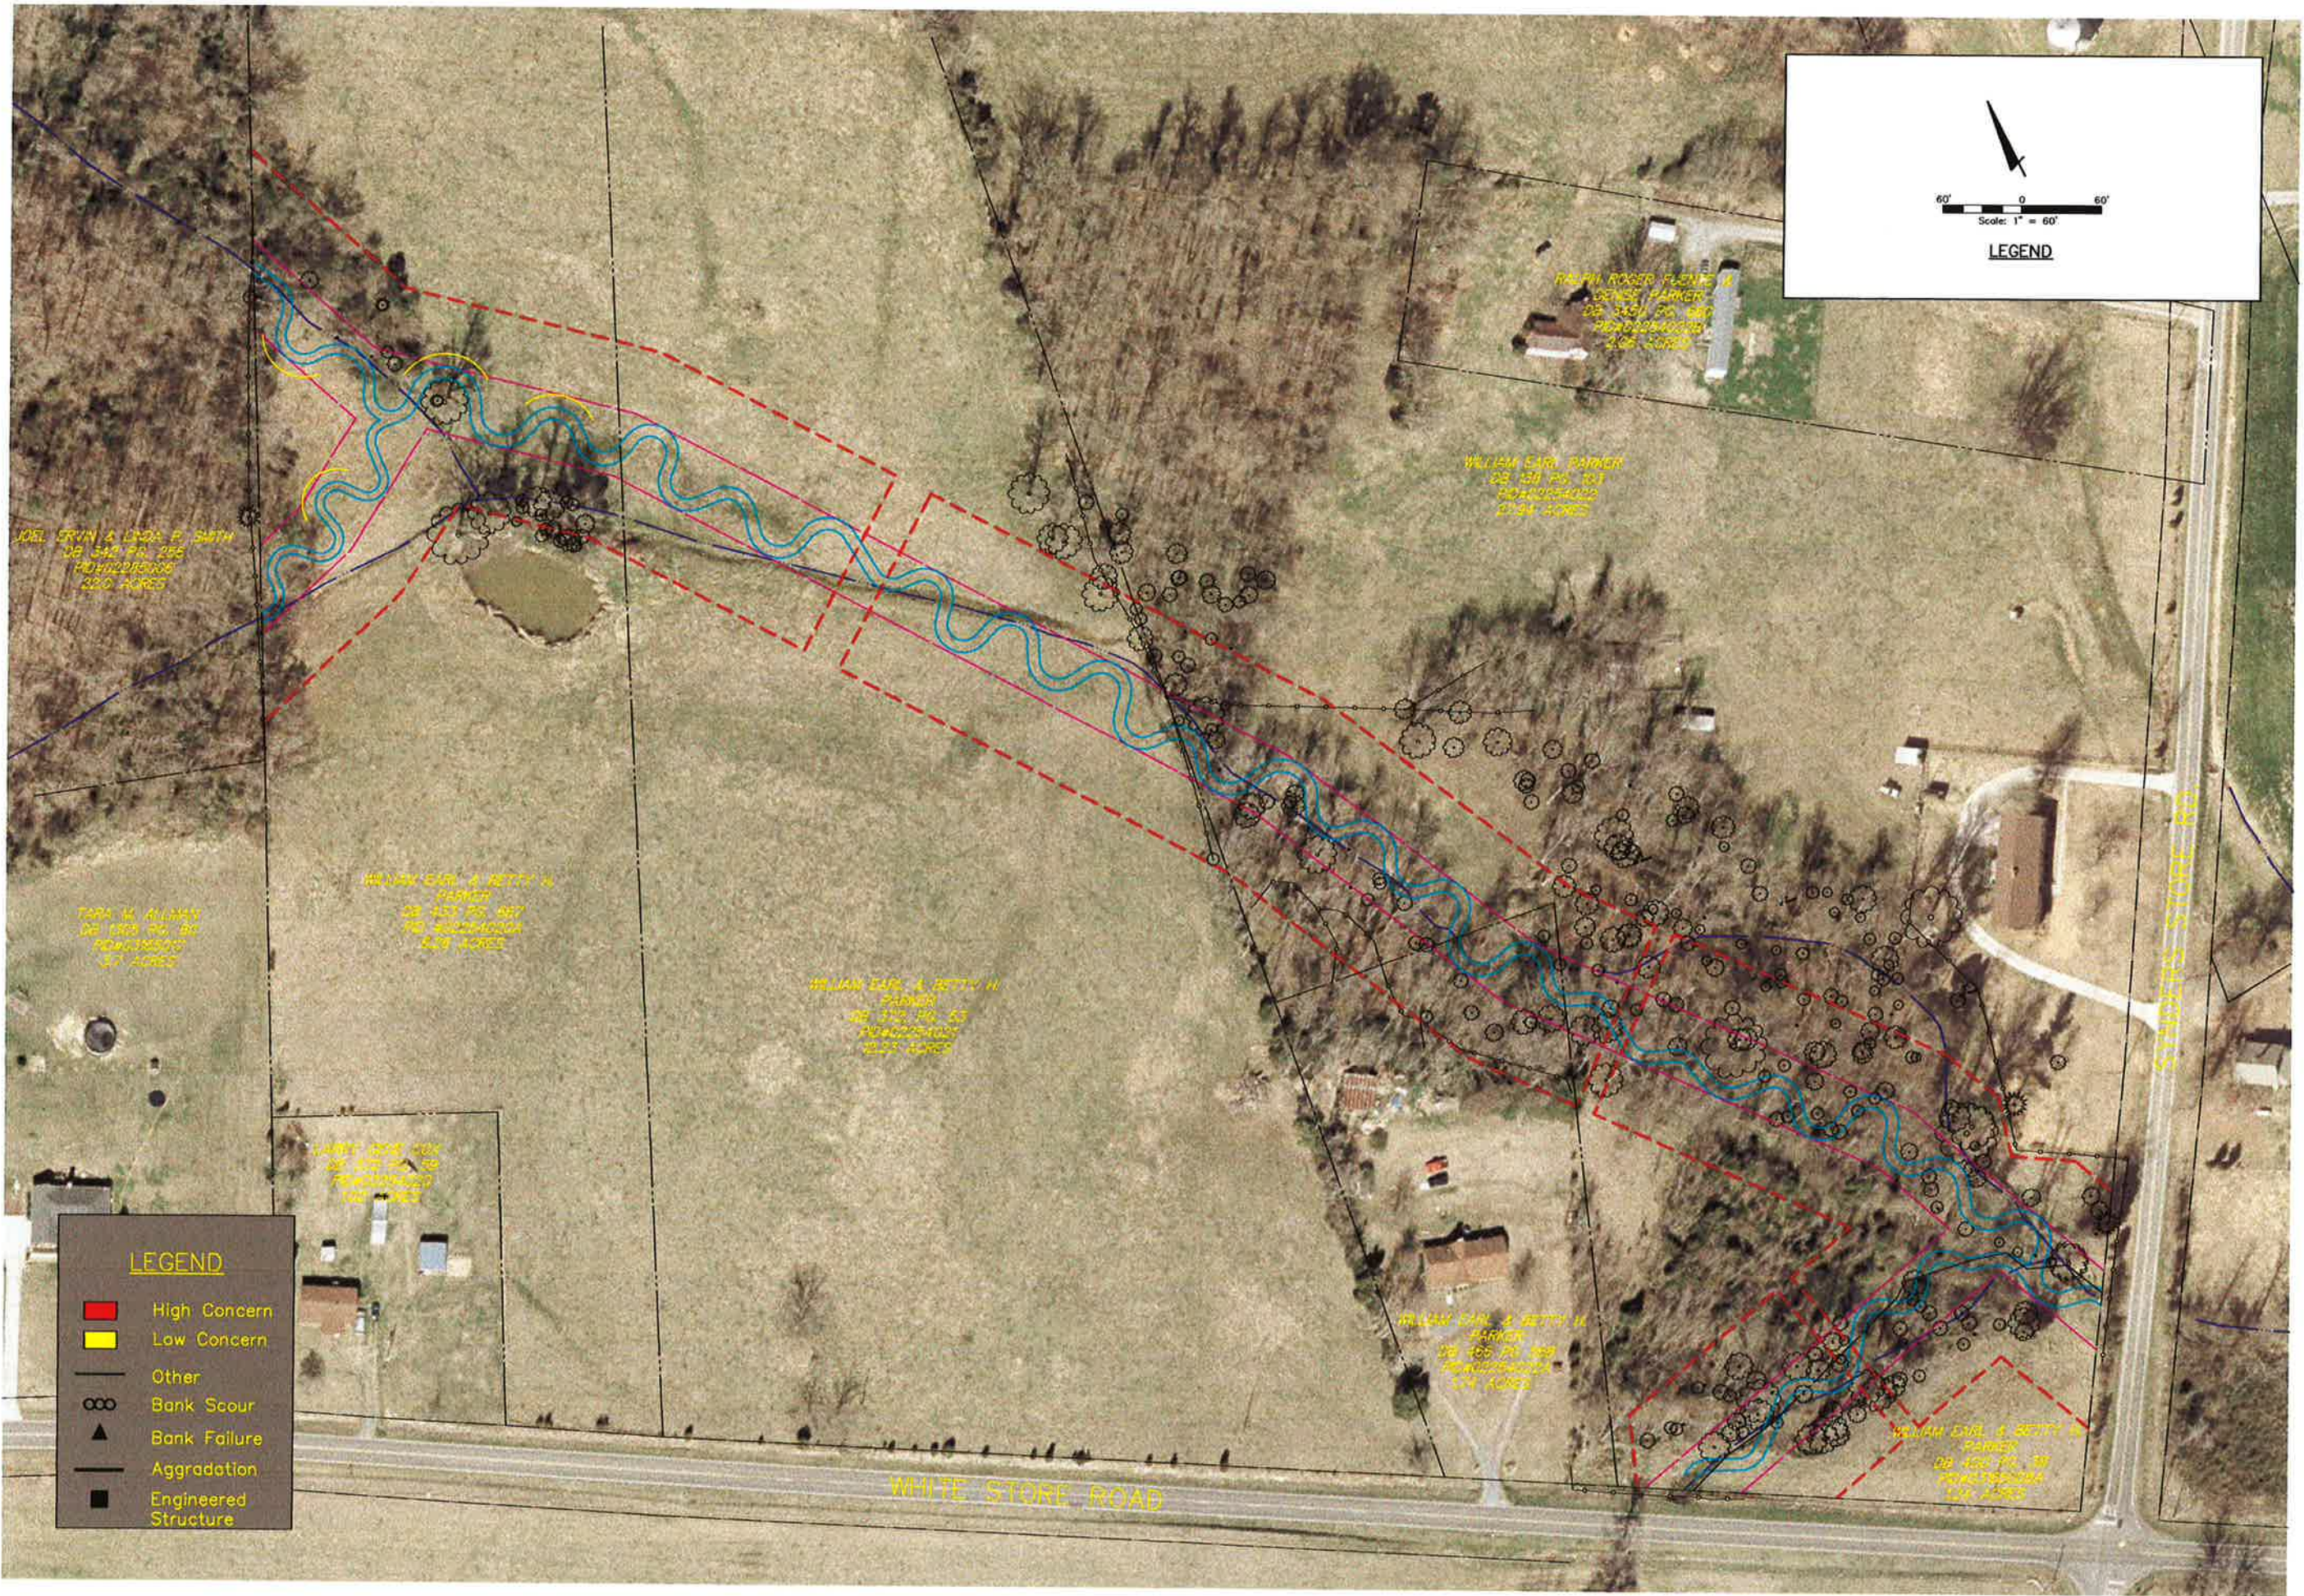
Table X. Stream Problem Areas Beaverdam Creek Stream Restoration / EEP Project No. D06054-C			
Feature Issue	Station Numbers	Suspected Cause	Photo Number
Other	0+80 to 0+90 UT1	Unvegetated banks - concern for future stability if vegetation does not develop	SPA 1, 2
	2+75 to 2+90 UT1	Unvegetated banks - concern for future stability if vegetation does not develop	
	4+05 to 4+20 UT1	Unvegetated banks - concern for future stability if vegetation does not develop	
	1+60 UT2	Unvegetated banks - concern for future stability if vegetation does not develop

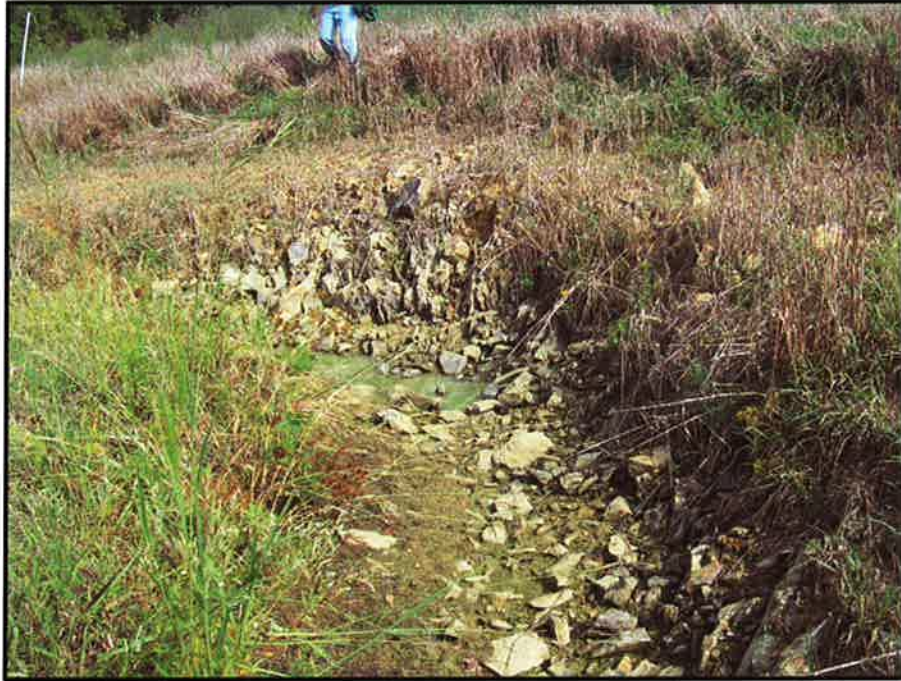
**SPA 1**

Areas of instability were not observed along the Beaverdam Creek Mainstem. The only type of problem area noted along UT1 and UT2 is isolated to a few outside meander bends along these tributaries. The banks of the outside bends do not have established vegetation to stabilize the slopes. These areas are considered low concern at this time, as the bends are not actively eroding beyond the minor sloughing of loose soil. No remedial maintenance is scheduled at this time. These areas are

**Steep banks along an outer meander bend on UT1 near station 4+10. Concern for stability if vegetation does not develop.**

noted in order that they be watched to catch any erosion problems that may occur before vegetation becomes fully established along these slopes. Actively monitoring these areas will allow developing problems to be caught early and managed without the need for mechanical intervention. If erosion problems arise, the outside meander bends could be stabilized using vegetative methods such as seeding and live stakes, or with a natural fiber (coconut) geotextile.

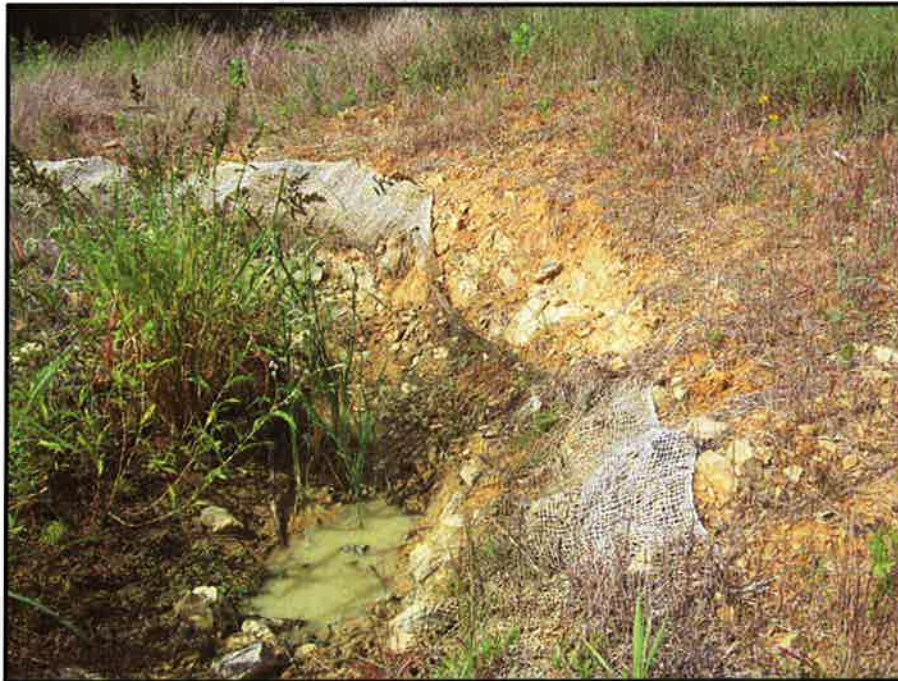
**SPA 2**

**Steep banks along an outer meander bend on UT2 near station 1+60. Concern for stability if vegetation does not develop.**
