Subject: Year 2 Monitoring Report for Stream Mitigation of Beaverdam Creek
SCO# D06054-C

Year 2 Monitoring Report for Stream Restoration of Beaverdam Creek and Unnamed Tributaries

Union County, NC
SCO # D06054-C

Submitted: December 2010

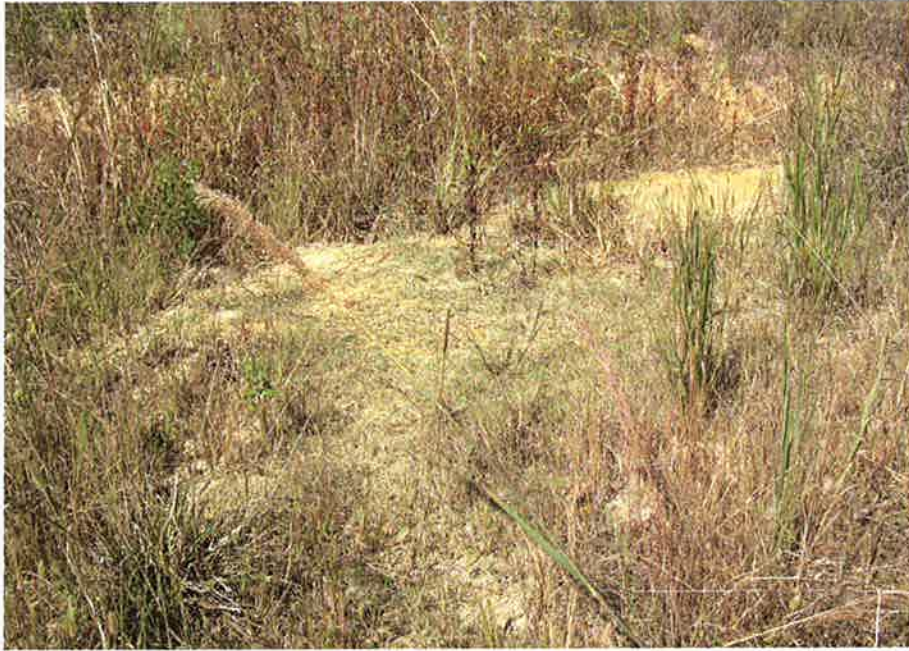
VPA 1

A few areas along the tributaries of Beaverdam Creek were noted to have low overall herbaceous cover along the riparian corridor in Year 2. These areas are small patches near the stream channel and are most likely caused by poor, rocky soil. Due to these reasons, the areas mentioned above are considered as a low concern at this time.

**Sparse vegetation along the bank of UT1 at station 9+50.
(EMH&T, Inc. 9/19/10)**

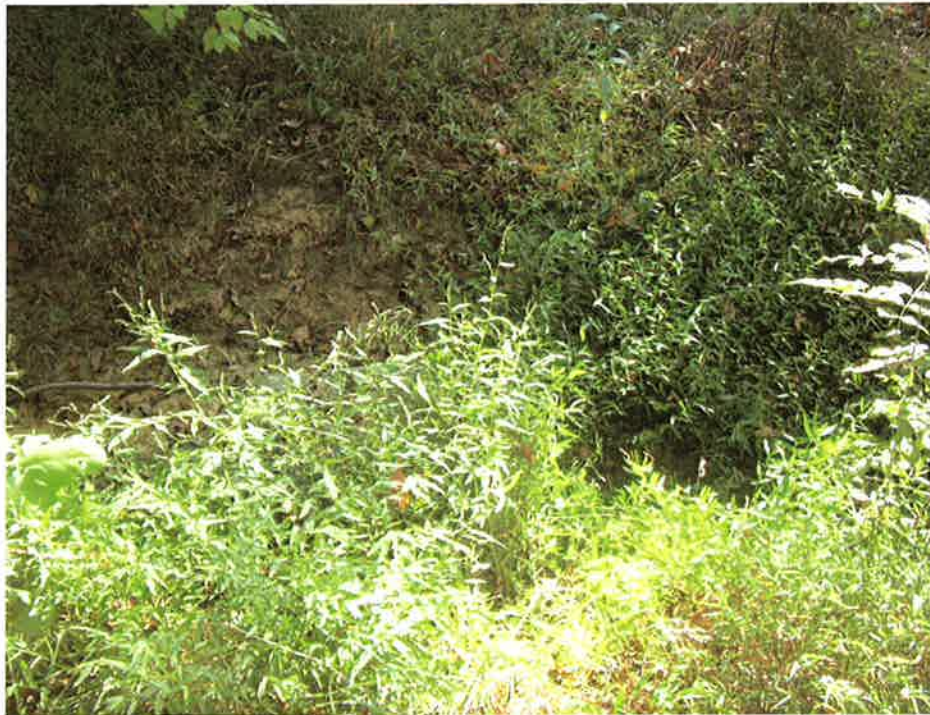
VPA 2

There were a few areas with a population of Japanese stiltgrass (*Microstegium vimineum*). *Microstegium vimineum* appears to be infiltrating bare ground on UT1 around station 15+50. This species is common along streamsides and ditches, and at the edges of forests and damp fields, and as such, was likely present before the onset of restoration activities. As further evidence of a pre-existing population, the locations where this species occurred were those areas not impacted during restoration of the stream channels.

View of the spread of microstegium at Cross Section 6 (UT1, station 19+60). This invasive grass is found in various patches along the project corridor, but is most prominent in this area.

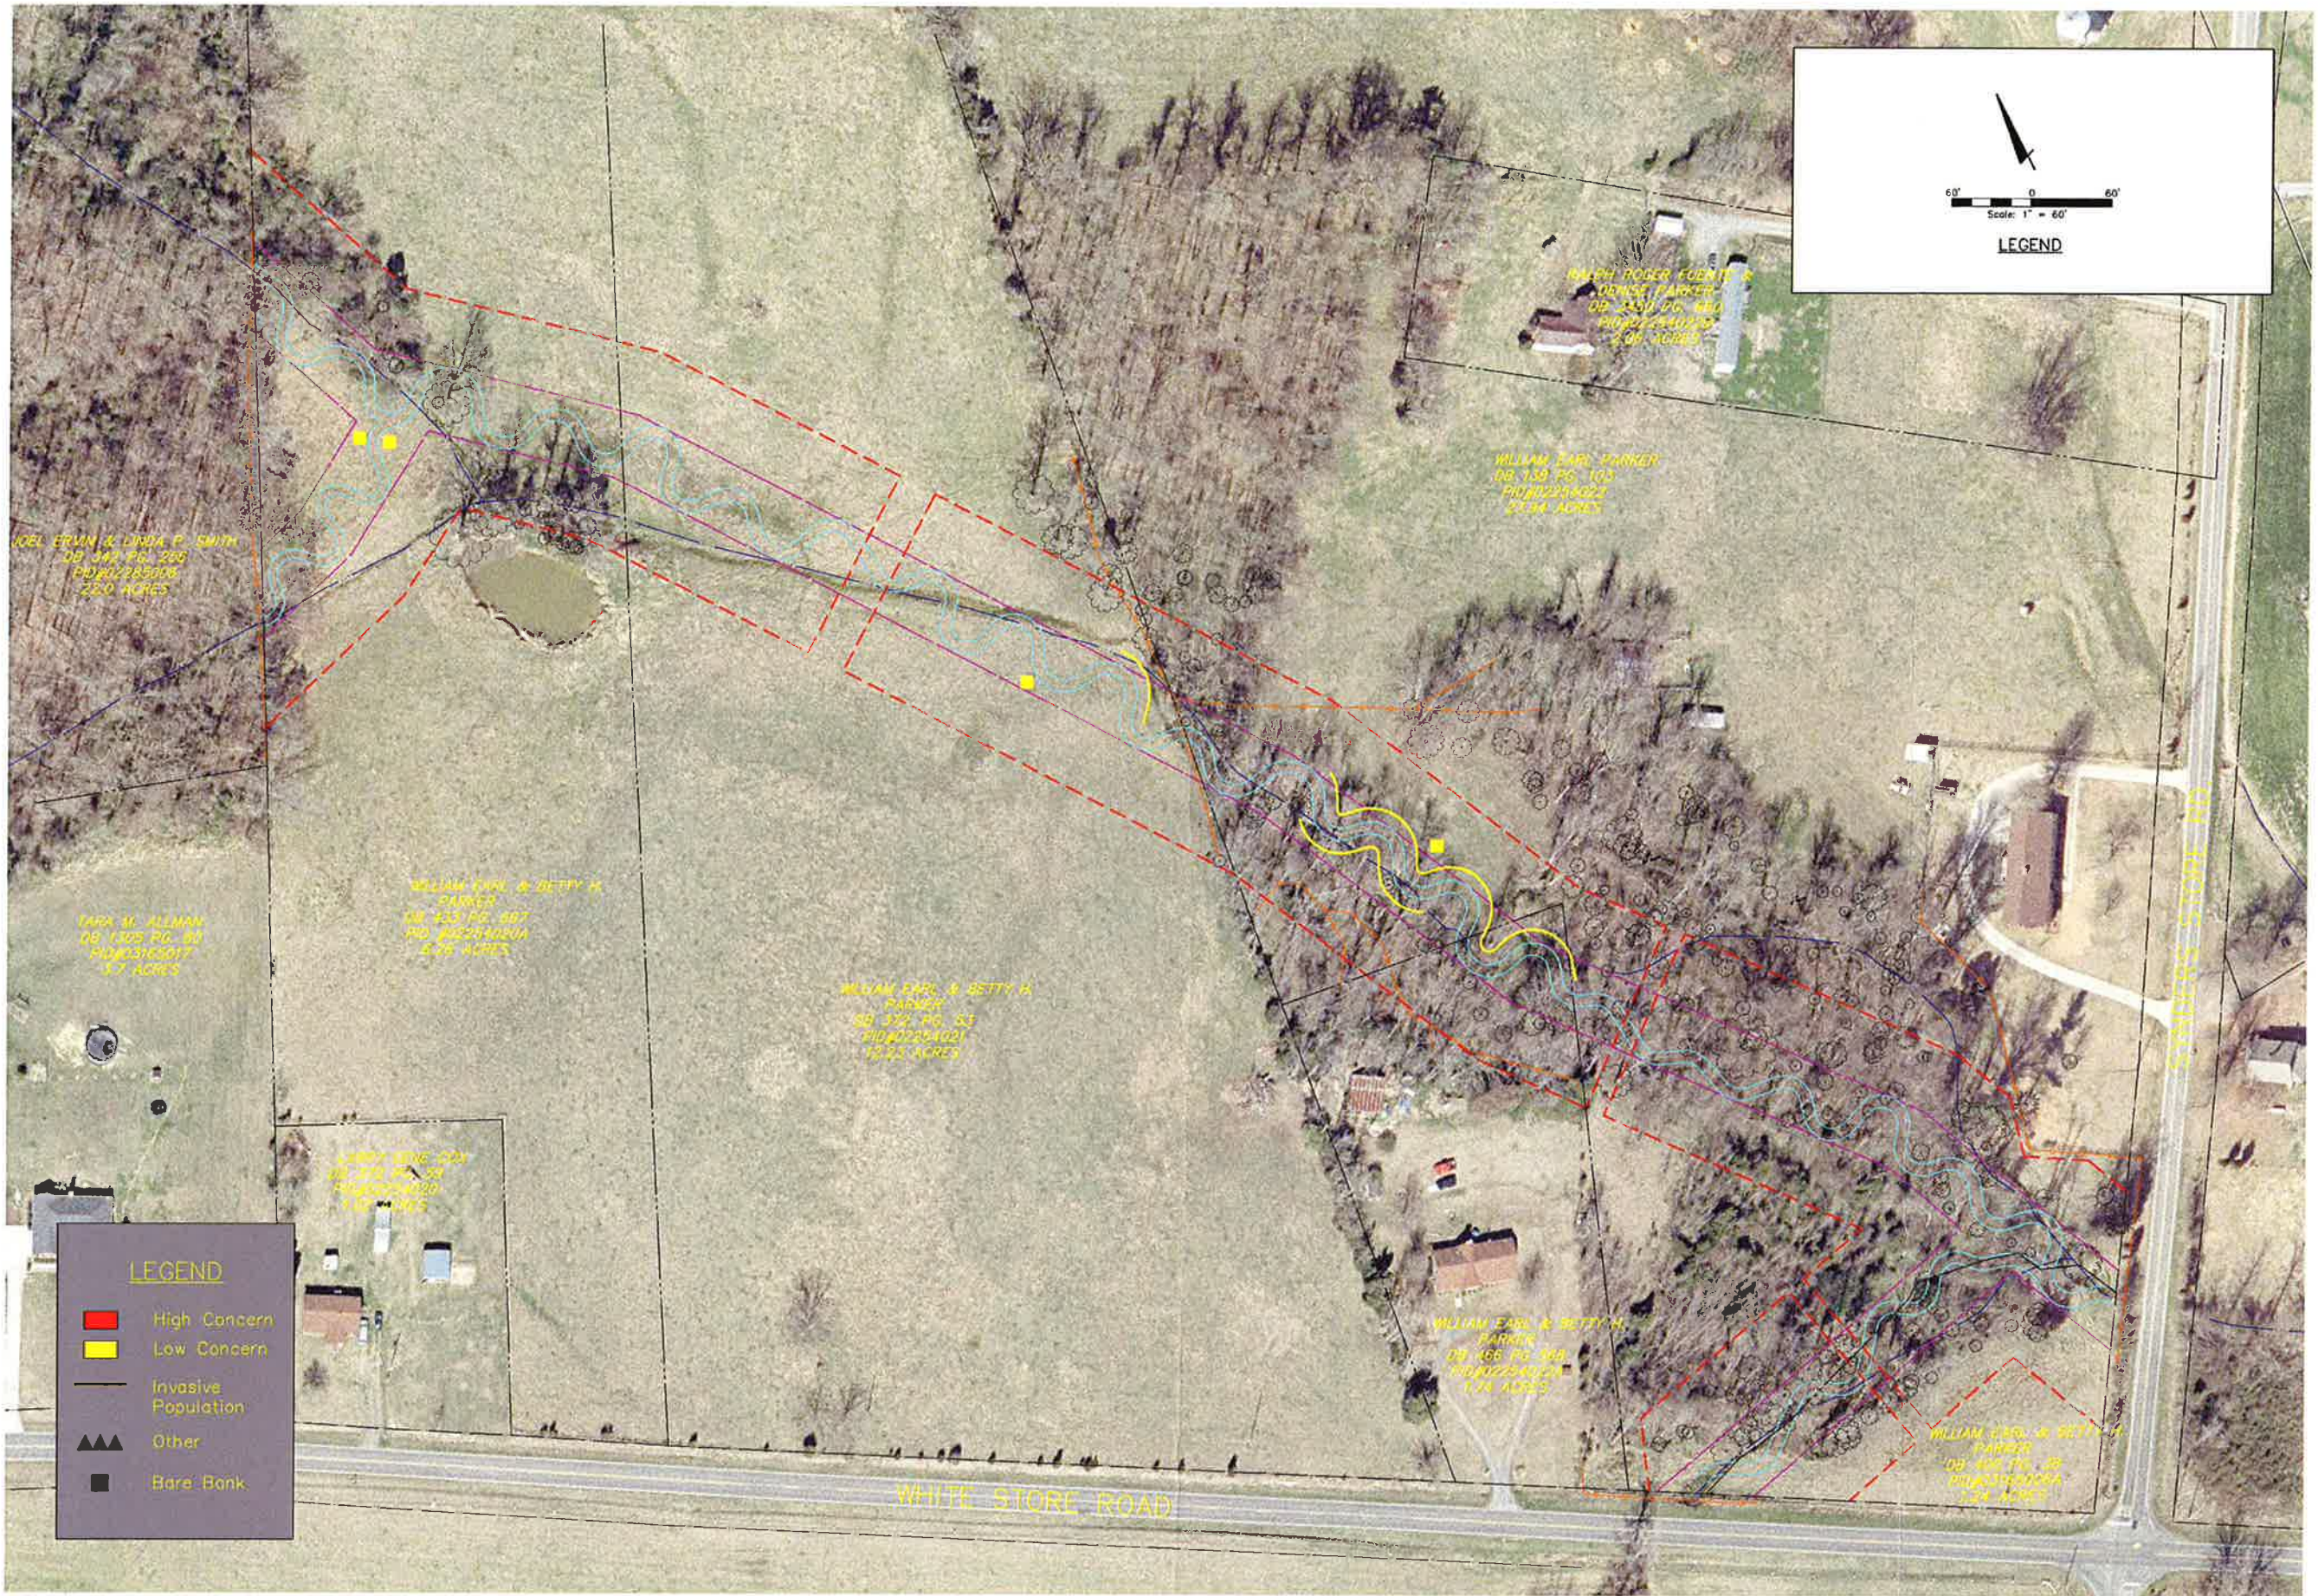
UNION COUNTY, NORTH CAROLINA
STREAM RESTORATION PLAN
FOR
BEAVERDAM CREEK
AND UNNAMED TRIBUTARIES
APPENDIX A
VEGETATION PROBLEM AREA PLAN VIEW

Table VII. Vegetative Problem Areas Beaverdam Creek Stream Restoration / EEP Project No. D06054-C			
Feature/Issue	Station # / Range	Probable Cause	Photo #
Bare Banks	2+50 UT2	Unknown: could be poor, rocky soil	VPA 1
	9+50 UT1		
	15+50 UT1		
Invasive Population	See Plan View	Microstegium: encroachment from outside source	VPA 2

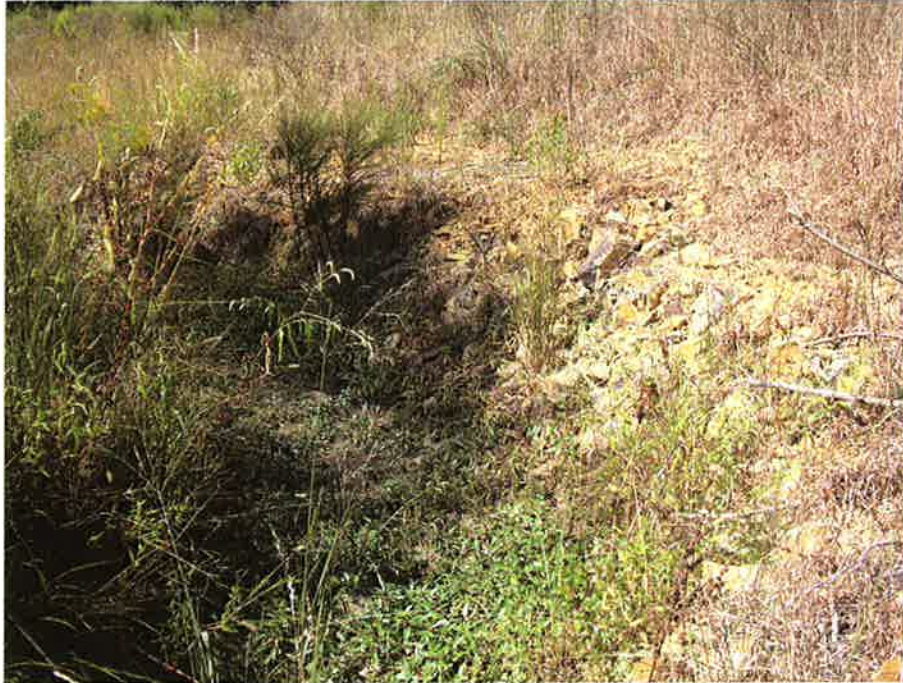
SPA 1

Areas of instability were not observed along the Beaverdam Creek Mainstem. The only type of problem area noted along UT1 and UT2 is isolated to a few outside meander bends along these tributaries. The banks of the outside bends do not have enough established vegetation to stabilize the slopes. These areas are considered low concern at this time because they are not actively eroding beyond the minor sloughing of loose soil. The bend on UT1 between stations 0+80 and 0+90 has begun to slough. Because vegetation continues to increase in density on this bank, immediate action is not warranted. Year 3 monitoring will bring another assessment of the vegetation growth on this bank and any persisting sloughing.

Steep banks along an outer meander bend on UT1 near station 4+20. Concern for stability if vegetation does not develop.

If necessary, recommendations regarding bank stabilization options will be made after Year 3 monitoring. No remedial maintenance is scheduled at this time. These areas are noted in order that they be watched to catch any erosion problems that may occur before vegetation becomes fully established along these slopes. Actively monitoring these areas will allow developing problems to be caught early and managed without the need for mechanical intervention. If erosion problems arise in these or any new areas, the outside meander bends could be stabilized using vegetative methods such as seeding and live stakes, or with a natural fiber (coconut) geotextile.

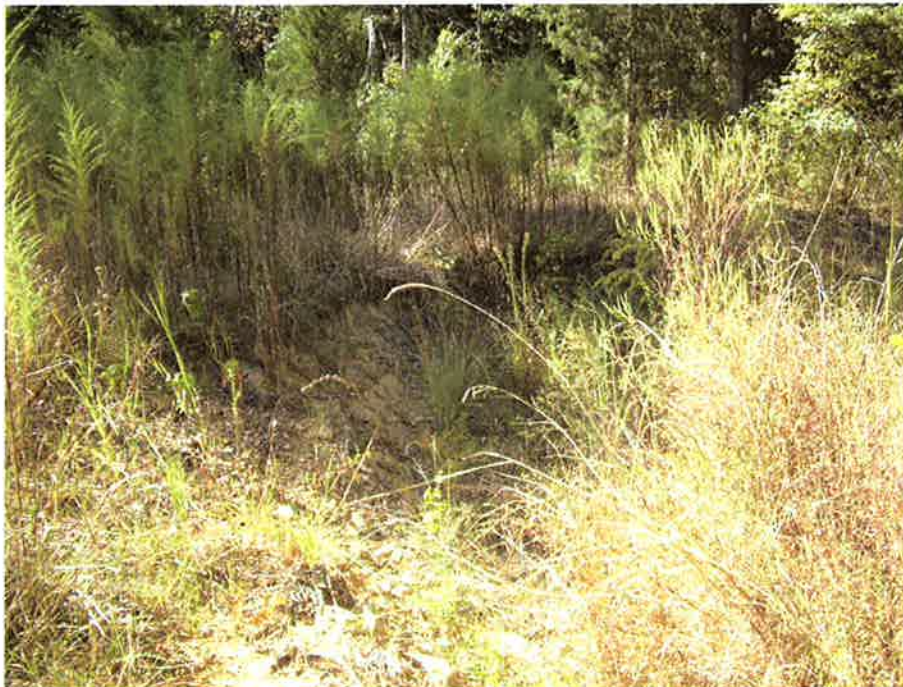
SPA 2

Steep bank with bank shear along an outer meander bend on UT1 near station 0+75. Concern for stability if vegetation does not develop.

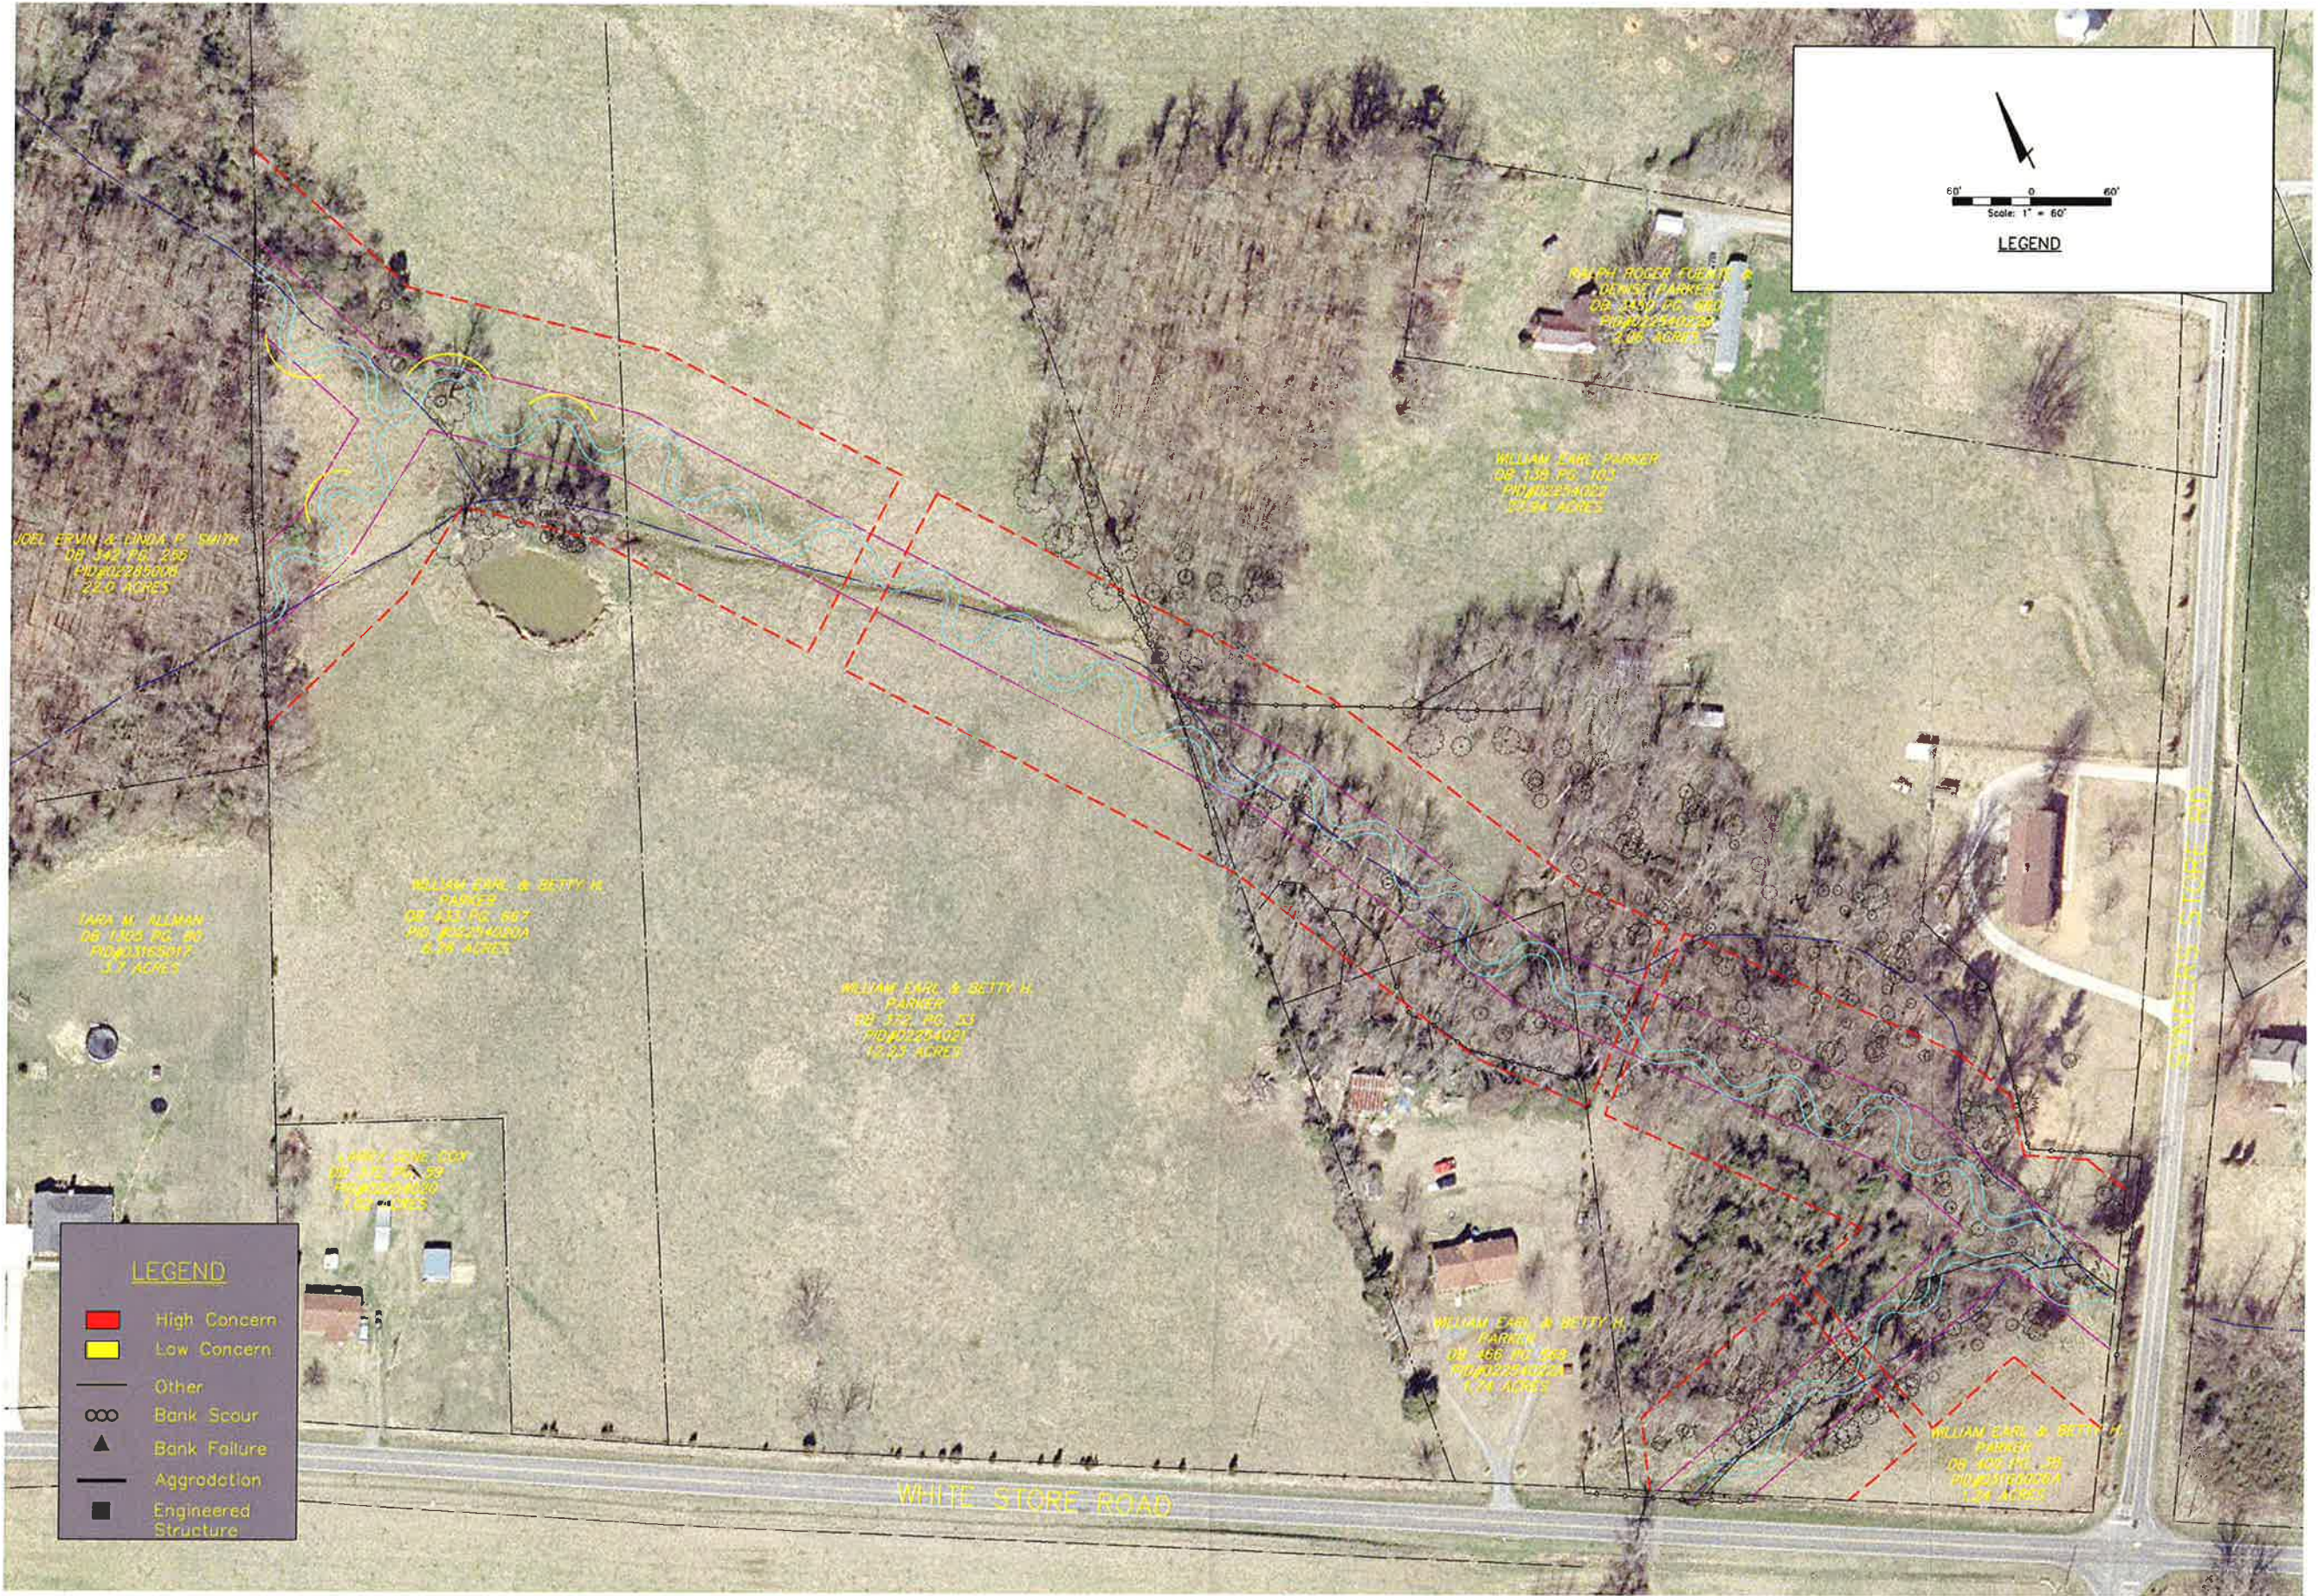
Table X. Stream Problem Areas Beaverdam Creek Stream Restoration / EEP Project No. D06054-C			
Feature Issue	Station Numbers	Suspected Cause	Photo Number
Other	0+80 to 0+90 UT1	Unvegetated banks - concern for future stability if vegetation does not develop	SPA 1, 2
	2+75 to 2+90 UT1	Unvegetated banks - concern for future stability if vegetation does not develop	
	4+05 to 4+20 UT1	Unvegetated banks - concern for future stability if vegetation does not develop	
	1+60 UT2	Unvegetated banks - concern for future stability if vegetation does not develop
