Subject: Year 3 Monitoring Report for Stream Mitigation of Beaverdam Creek  
SCO# D06054-C

# **Year 3 Monitoring Report for Stream Restoration of Beaverdam Creek and Unnamed Tributaries**

Union County, NC  
SCO # D06054-C

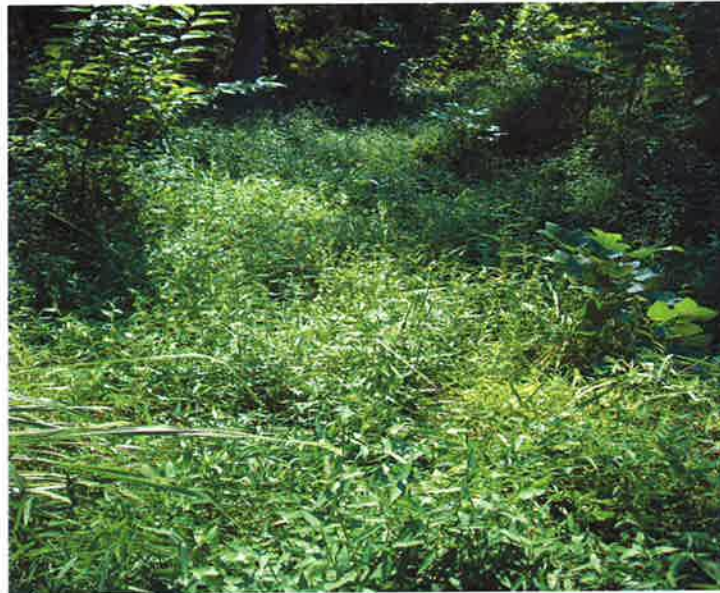
**VPA 2**

A few areas with a population of Japanese stiltgrass (*Microstegium vimineum*) were noted during 2010 (Year 2) monitoring. *Microstegium vimineum* continues to infiltrate bare ground along UT1 and the population has grown in Year 3 to cover the channel and/or areas of the riparian corridor between stations 14+00 and 17+50, as well as between stations 19+50 and 20+00. This species is common along streamsides and ditches, and at the edges of forests and damp fields, and as such, was likely present before the onset of restoration activities. As further evidence of a pre-existing population, the locations where this species is present are those areas that were not impacted during restoration of the stream channels.

**View of the spread of *microstegium* at along UT1, between stations 16+00 and 17+50. This invasive grass is found in various patches along the project corridor, but is most prominent in this area.  
(EMH&T, 9/13/11)**

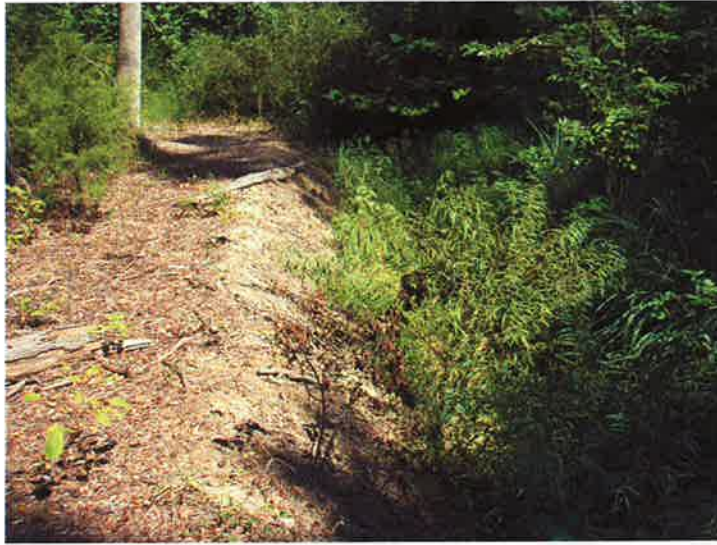
**VPA 3**

As in Year 2, a few areas along the tributaries of Beaverdam Creek were noted to have low overall herbaceous cover in the riparian corridor, leading to noticeable bare banks. These areas are small patches near the stream channel and are most likely caused by poor, rocky soil. The areas mentioned above are considered as a low concern at this time.

**Sparse vegetation along the right bank of UT1 at station 17+80.  
(EMH&T, 9/13/11)**

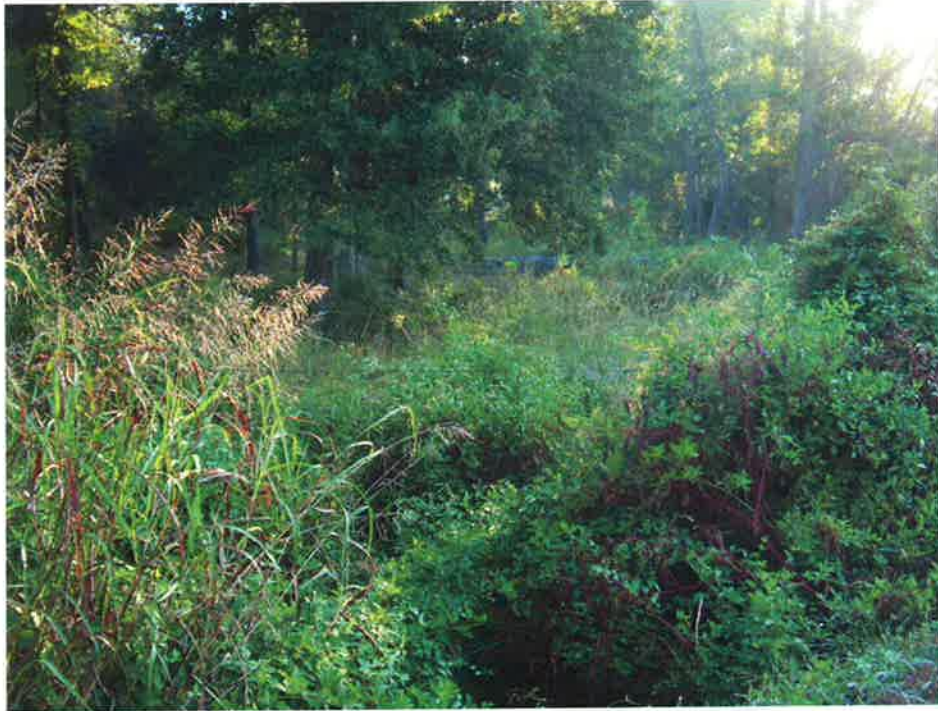
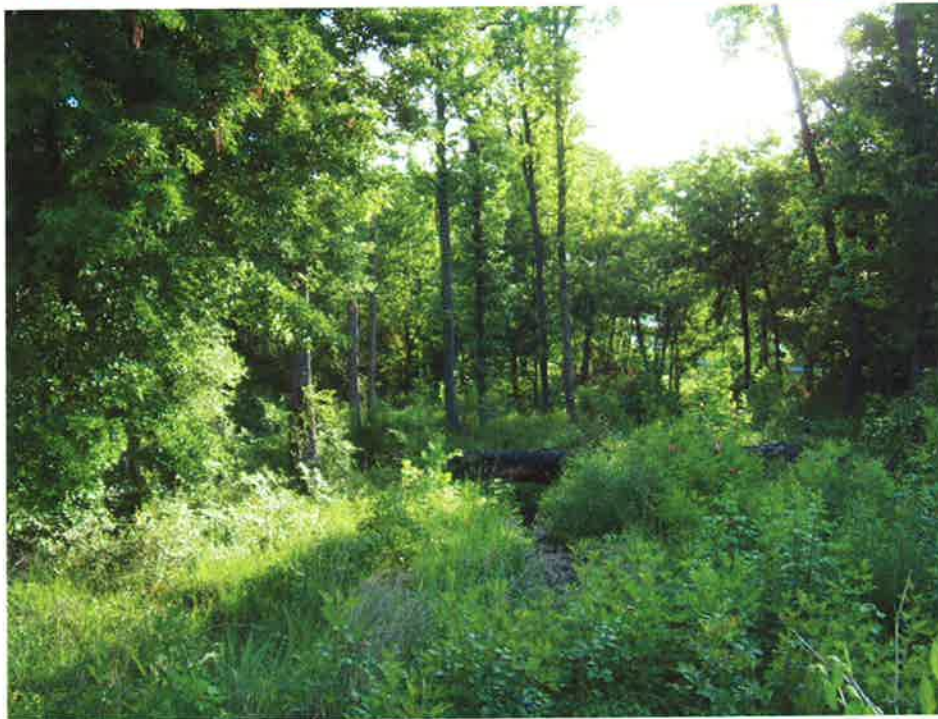
**Fixed Station 1**  
**Overview of Beaverdam Creek, looking downstream**  
(Top Photo – Year 2: 9/19/10, Bottom Photo – Year 3: 9/13/11).  
(EMH&T)

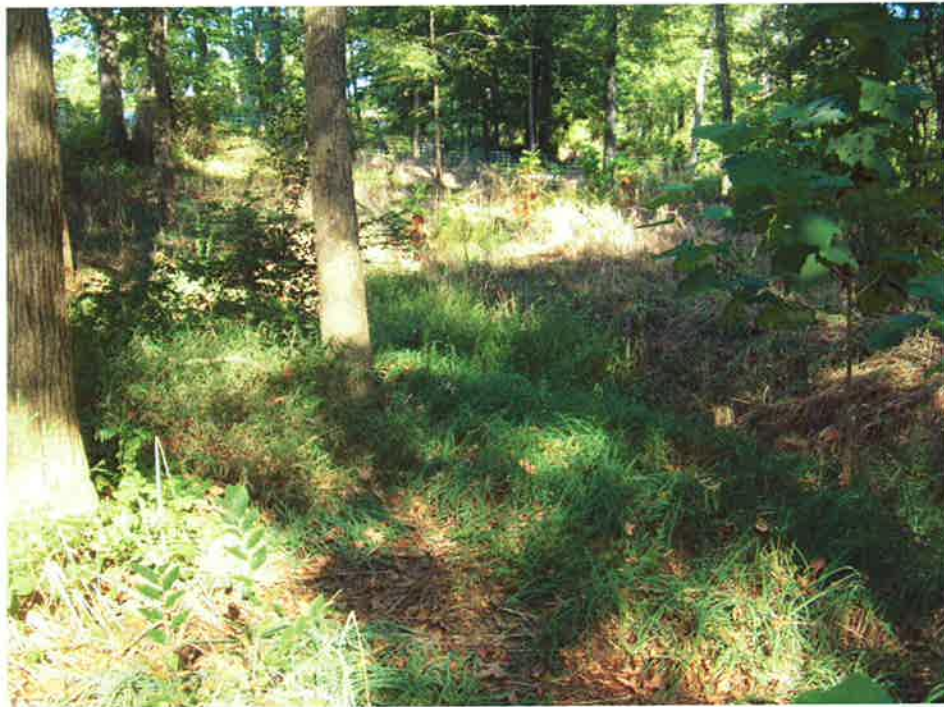
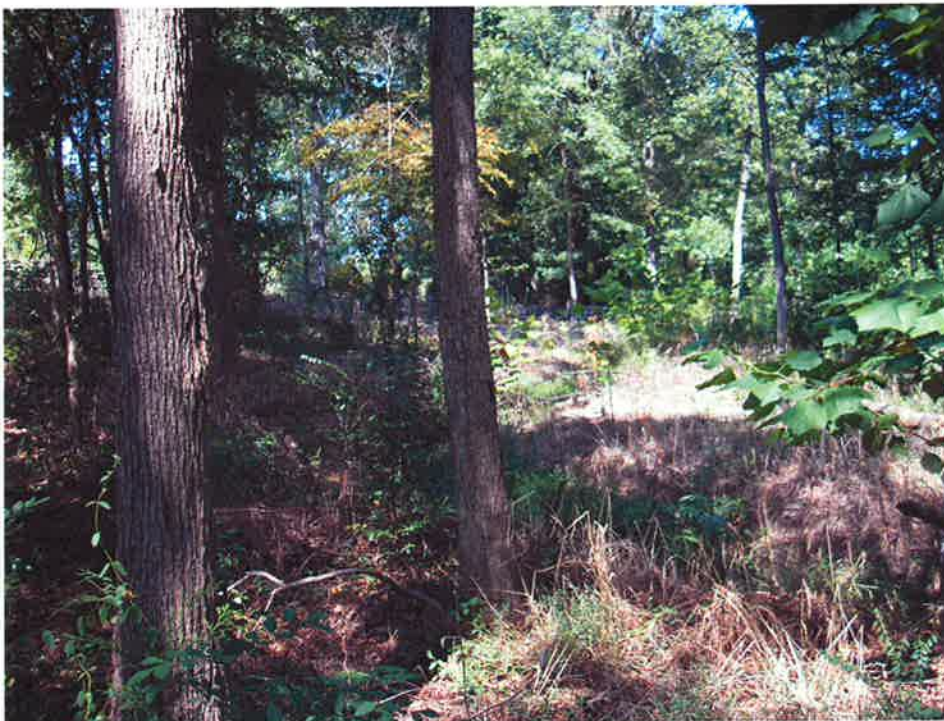
**Fixed Station 2**  
**Overview of UT1, looking upstream near station 19+00**  
(Top Photo – Year 2: 9/19/10, Bottom Photo – Year 3: 9/13/11).  
(EMH&T)

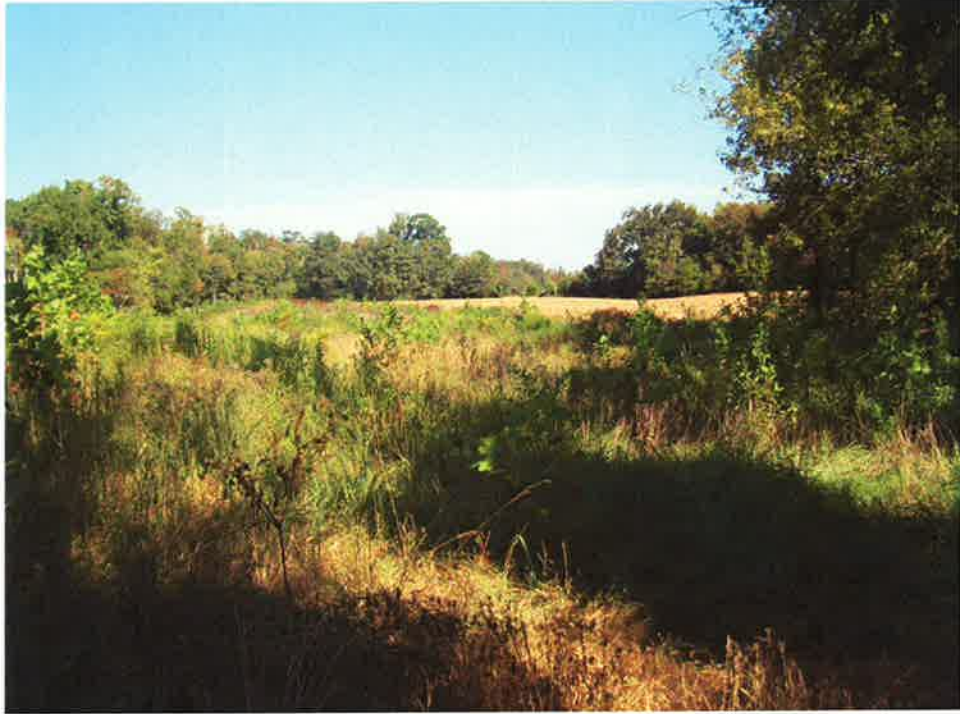
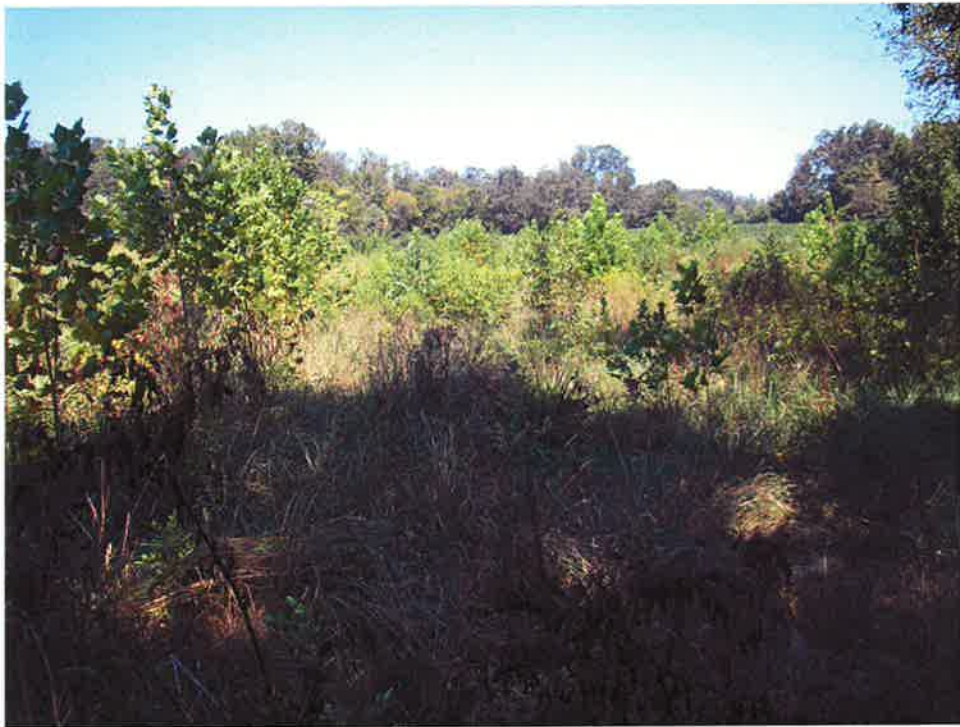
**Fixed Station 3**  
**Overview of valley along UT1, looking upstream near station 13+00**  
(Top Photo – Year 2: 9/19/10, Bottom Photo – Year 3: 9/13/11).  
(EMH&T)

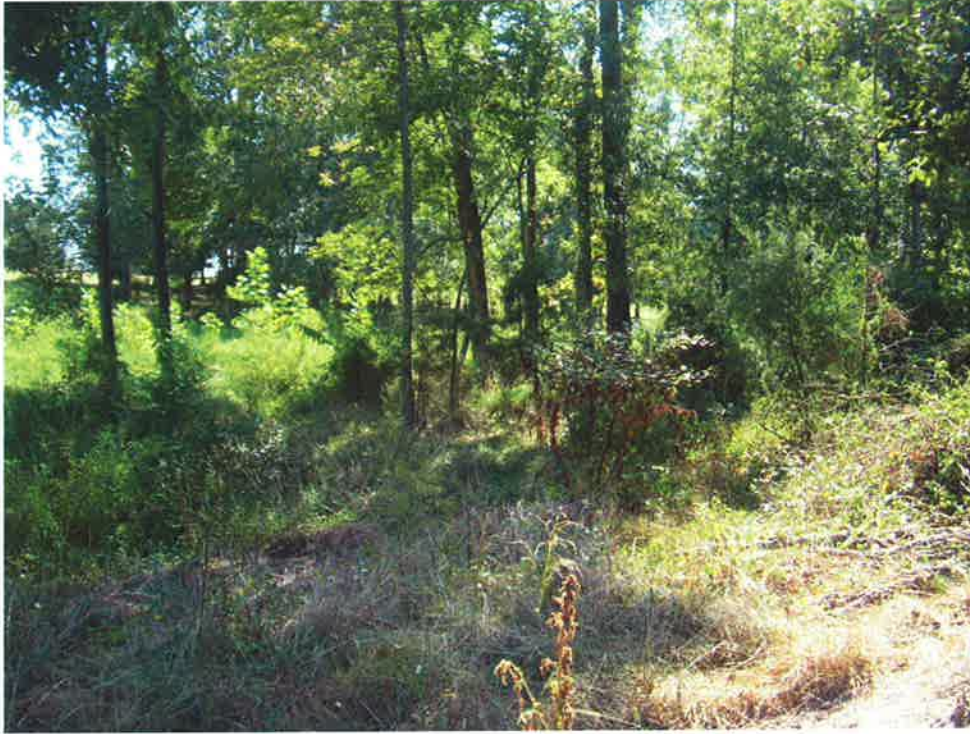
**Fixed Station 4**  
**Overview of valley along UT1, looking downstream near station 13+00**  
(EMH&T, Inc. 9/19/10)

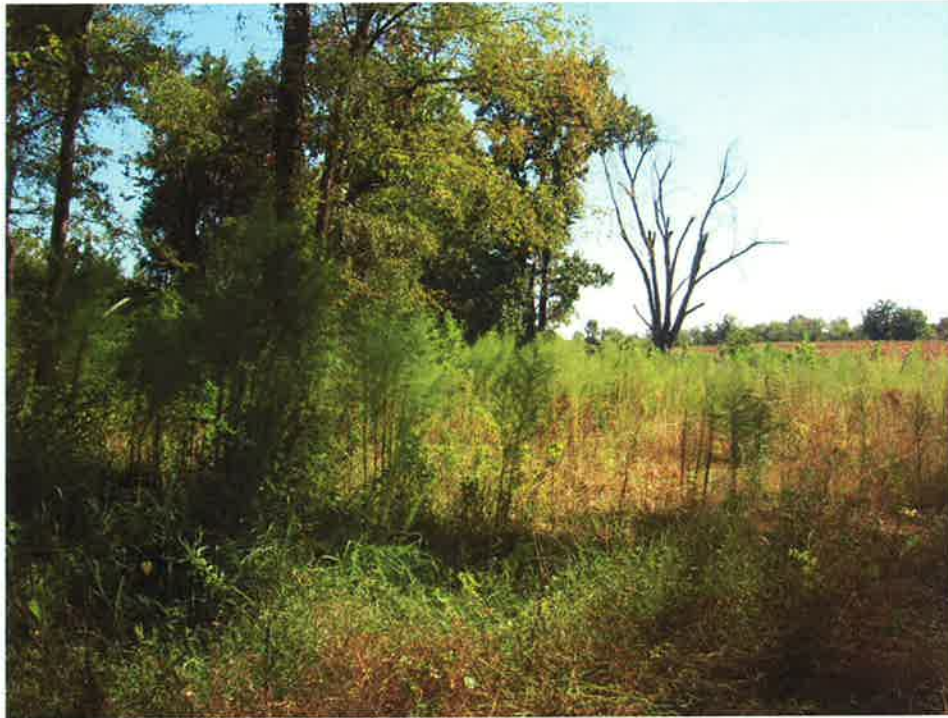
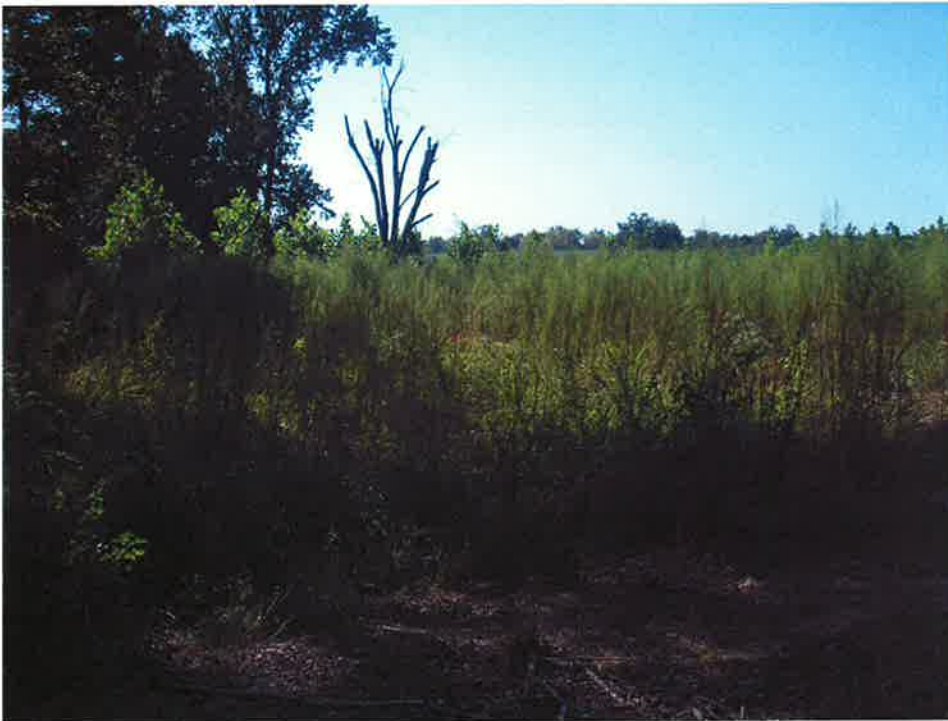
**Fixed Station 5**  
**Overview of UT1, looking downstream from upstream project limits**  
(Top Photo – Year 2: 9/19/10, Bottom Photo – Year 3: 9/13/11).  
(EMH&T)

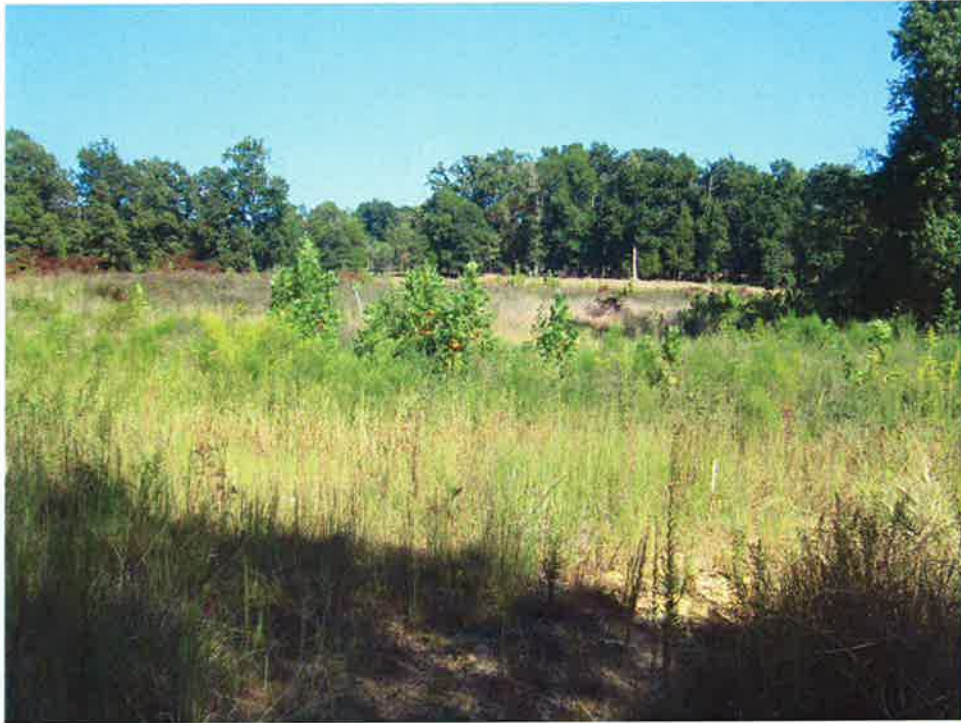
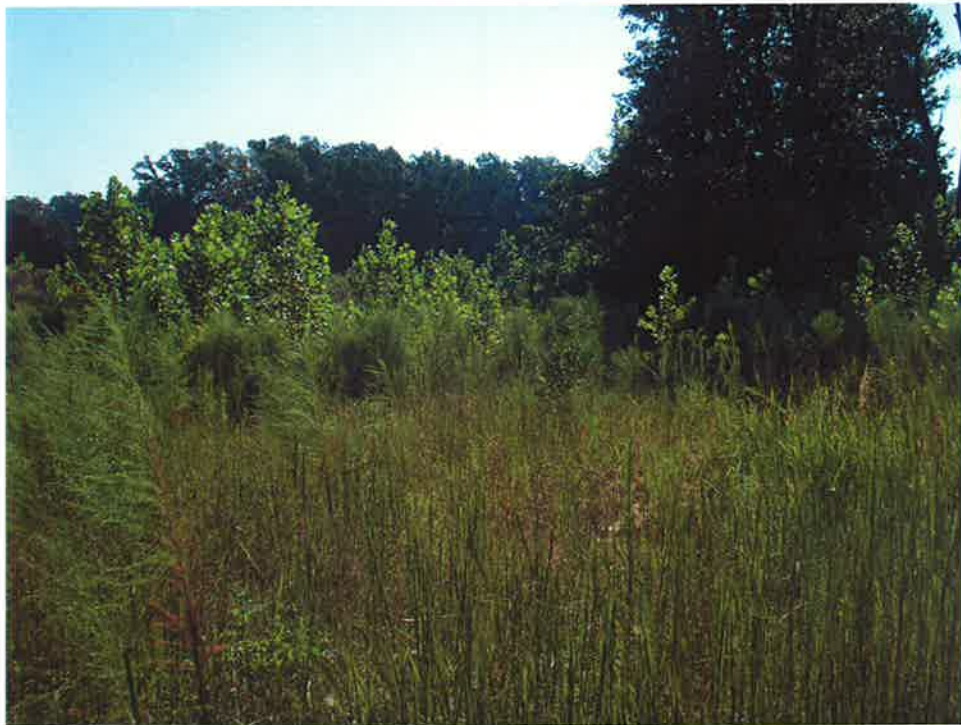
**Fixed Station 6**  
**Overview of UT2, looking downstream**  
(Top Photo – Year 2: 9/19/10, Bottom Photo – Year 3: 9/13/11).  
(EMH&T)

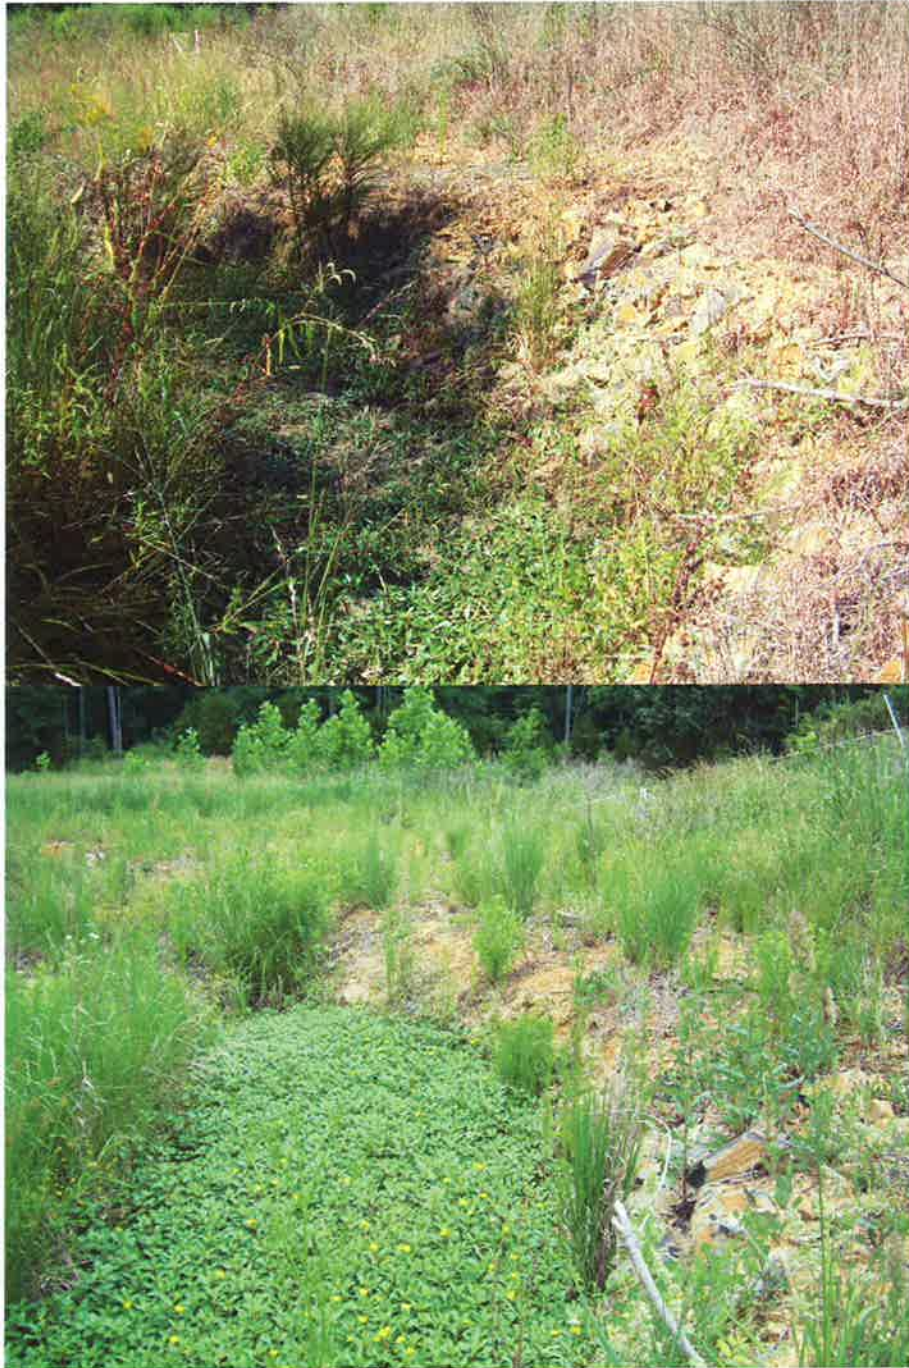
**SPA 1**

As in Year 2, areas of instability were not observed along the Beaverdam Creek Mainstem in Year 3. The only type of problem area noted along UT1 and UT2 is isolated to a few outside meander bends along these tributaries. The banks of the outside bends do not have enough established vegetation to stabilize the slopes. It appears that some minor erosion is occurring at the stations listed in Table X. These areas are considered of low concern at this time because they are not actively eroding beyond the minor sloughing of loose soil. The bend on UT1 between stations 0+75 and 0+90 has begun to slough. Because vegetation continues to increase in density on this bank, immediate action is not warranted. Overall, the density of vegetation has increased for all stations listed in the table above. The exception is station 1+60 on UT2. Year 4 monitoring will bring another assessment of the vegetation growth on this bank and any persisting sloughing. Vegetation colonization and growth will be closely monitored in 2012 in order to ascertain any trends with regards to increased or decreased bank stabilization along UT1 and UT2.

**Steep banks and bank scour along an outer meander bend on UT1 near station 4+20.**

If necessary, recommendations regarding bank stabilization remediation will be made after Year 4 monitoring. No remedial maintenance is scheduled at this time. These areas are noted in order that they be watched to catch any erosion problems that may occur before vegetation becomes fully established along these slopes. Actively monitoring these areas will allow developing problems to be caught early and managed without the need for mechanical intervention. If erosion problems arise in these or any new areas, the outside meander bends could be stabilized using vegetative methods such as seeding and live stakes, or with a natural fiber (coconut) geotextile.

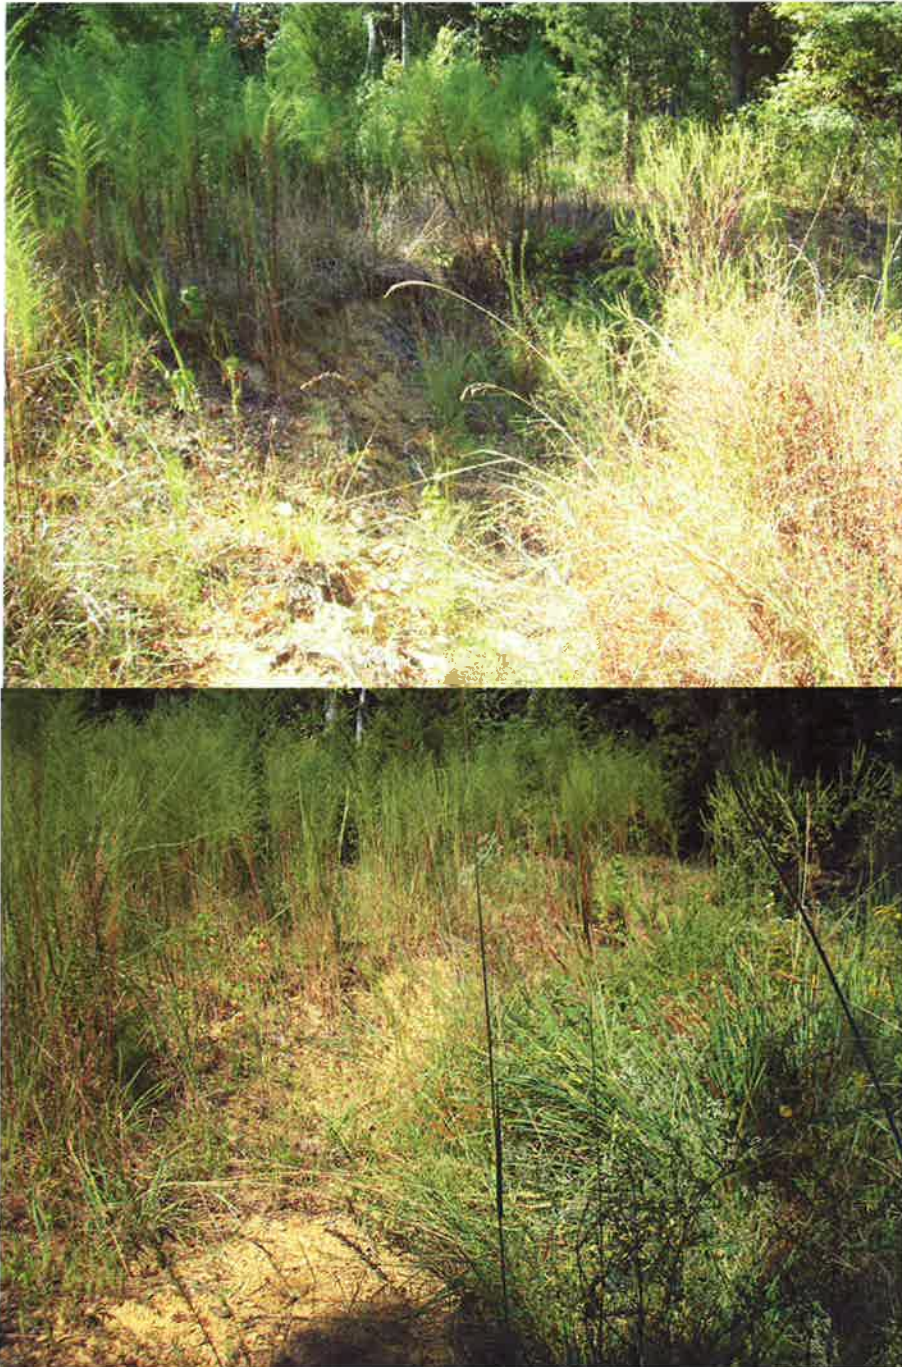
**SPA 2**

There are a few meanders along UT1 that also have minor erosion along the outer bends. One meander bend began the sloughing process in 2010. In 2011, this bend at station 0+75 to 0+90 has remained in a state of limited erosion, as mentioned in Part 2 and Table X, above, and there is evidence this sloughing issue is improving, due to increased bank vegetation (Stream Problem Area Photos, Appendix B). In addition to the meander category, there were three pools along the terminal 500 feet of UT1 that did not match the as-built condition, in regards to feature elevations (as presented in the graphs of the longitudinal profile). These pools, in the 500 linear feet before the confluence with Beaverdam mainstem, were noted to be shallower and shorter in Year 3 as compared Years 1 & 2 profile and the as-built profile. It appears that sedimentation may be occurring in the center of these pools, although all remain present and retain their essential function.

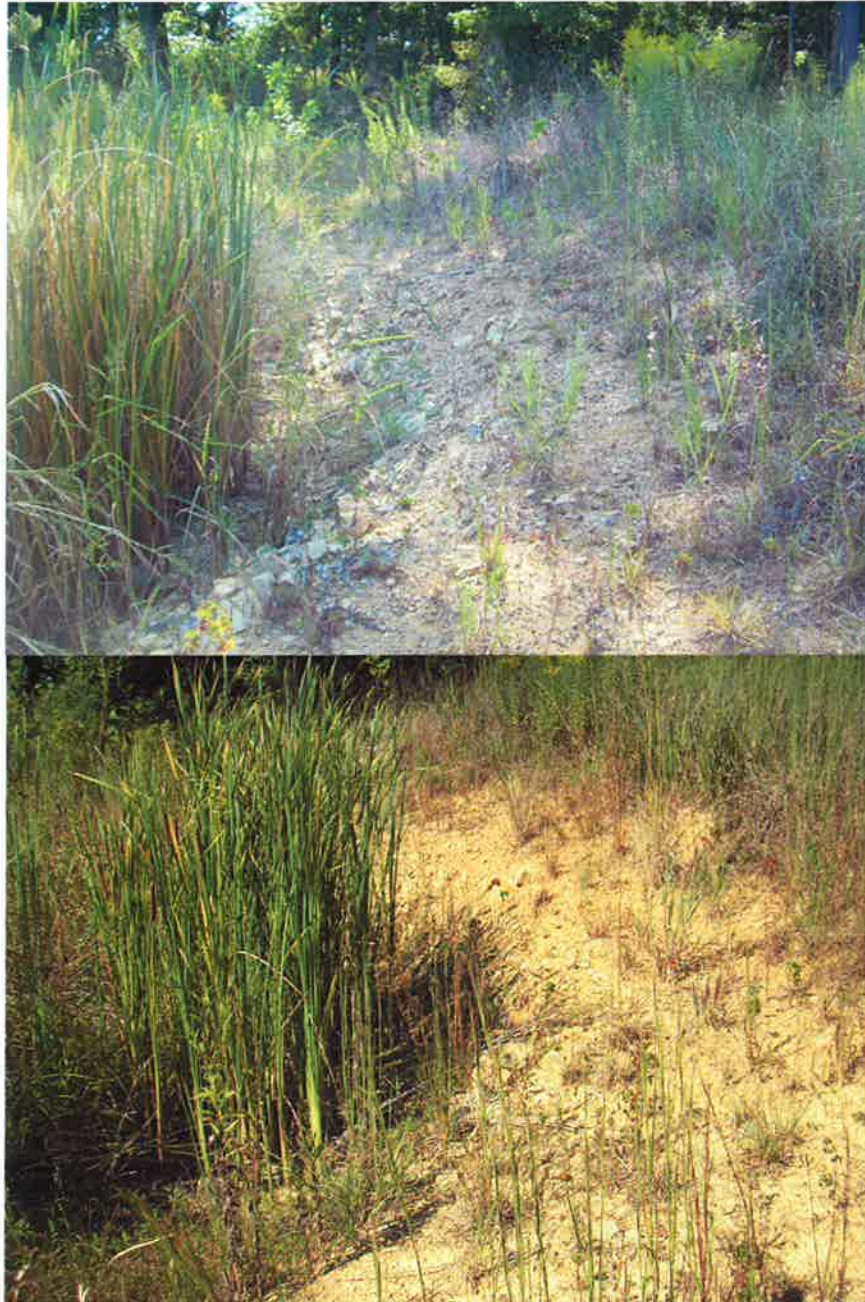
**SPA 3**

<b>Table X. Stream Problem Areas</b>			
<b>Beaverdam Creek Stream Restoration / EEP Project No. D06054-C</b>			
<b>Feature Issue</b>	<b>Station Numbers</b>	<b>Suspected Cause</b>	<b>Photo Number</b>
Bank Scour/ Unvegetated Banks	0+75 to 0 +90 UT1	Unvegetated and eroding banks - concern for future stability if vegetation does not develop	SPA 2
	2+75 to 2+90 UT1	Unvegetated and eroding banks - concern for future stability if vegetation does not develop	
	4+05 to 4+20 UT1	Unvegetated and eroding banks - concern for future stability if vegetation does not develop	SPA 1
	1+60 UT2	Unvegetated and eroding banks - concern for future stability if vegetation does not develop	SPA 3

**Bank scour and bare bank along an outer meander bend on UT2 near station 2+50.  
Concern for stability and increased stream aggradation if vegetation does not develop.**
