Subject: Year 4 Monitoring Report for Stream Mitigation of Beaverdam Creek
SCO# D06054-C

Year 4 Monitoring Report for Stream Restoration of Beaverdam Creek and Unnamed Tributaries

Union County, NC
SCO # D06054-C

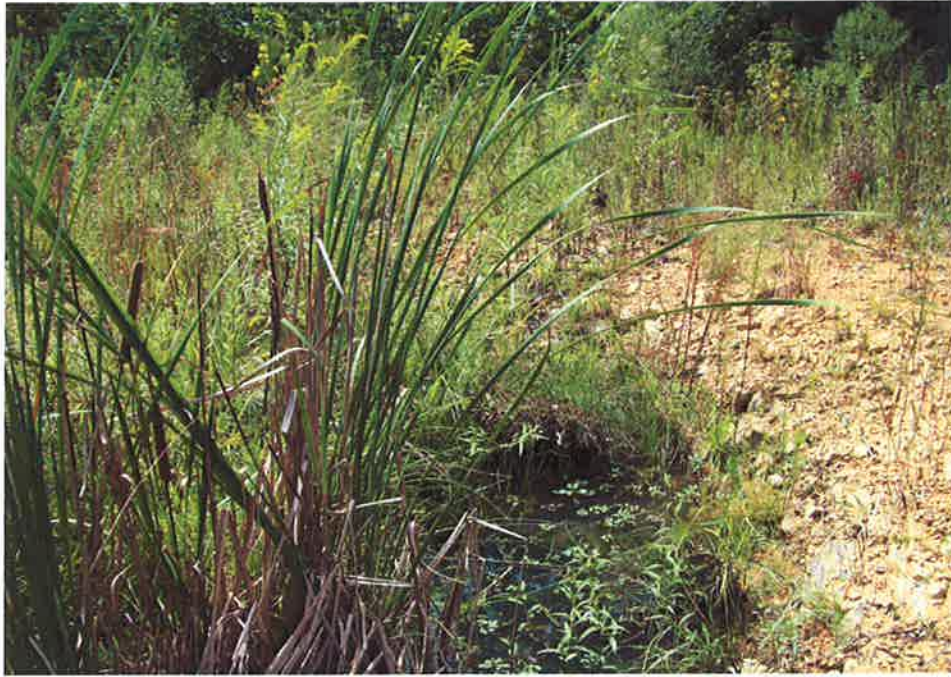
VPA 1

As in Years 2 and 3, a few areas along the tributaries of Beaverdam Creek were noted to have low overall herbaceous cover in the riparian corridor, leading to noticeable bare banks. These areas are small patches near the stream channel and are most likely caused by poor, rocky soil. The areas mentioned above are considered as a low concern at this time.

**Sparse vegetation along the left bank of UT2 at station 2+50.
(EMH&T, 9/11/12)**

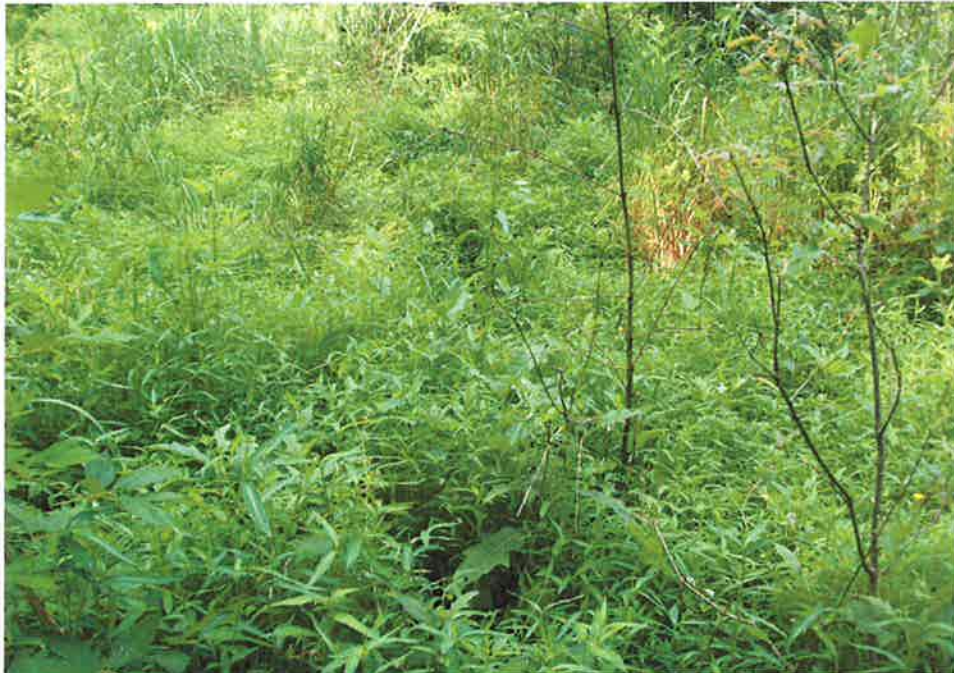
VPA 2

A few areas with a population of Japanese stiltgrass (*Microstegium vimineum*) were noted during 2010 (Year 2) monitoring. *Microstegium vimineum* continues to infiltrate bare ground along UT1 and the population has grown in Year 4 to cover the channel and/or areas of the riparian corridor between stations 14+00 and 17+50, as well as between stations 19+50 and 20+00. This species is common along streamsides and ditches, and at the edges of forests and damp fields, and as such, was likely present before the onset of restoration activities. As further evidence of a pre-existing population, the locations where this species is present are those areas that were not impacted during restoration of the stream channels.

**View of the spread of *microstegium* at along UT1, between stations 16+00 and 17+50. This invasive grass is found in various patches along the project corridor, but is most prominent in this area.
(EMH&T, 9/12/11)**

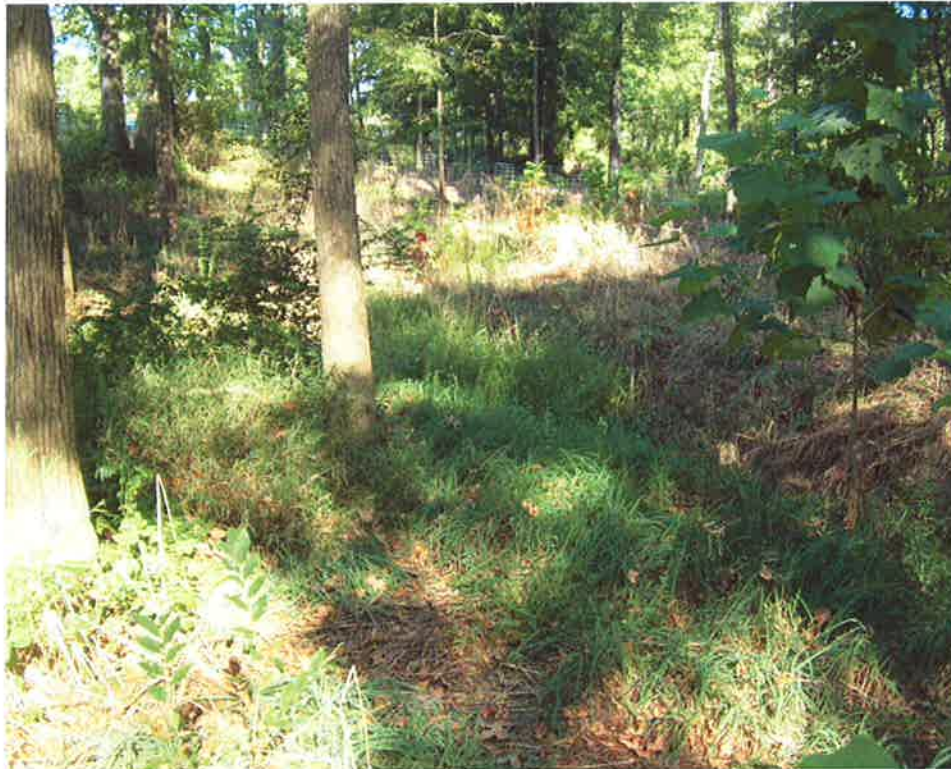
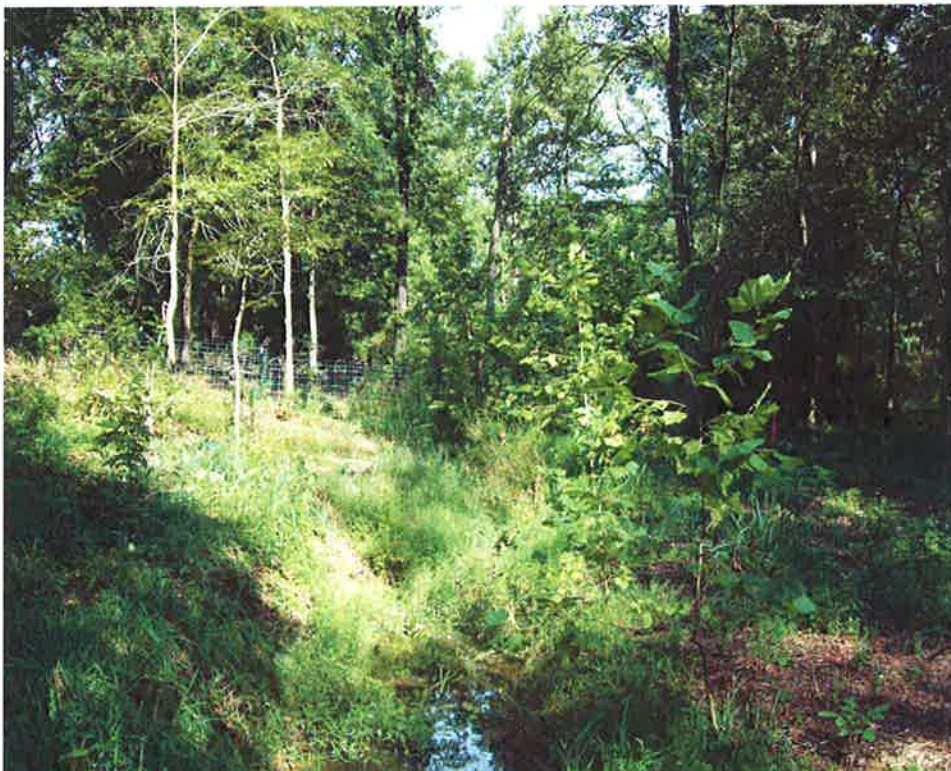
Fixed Station 2

Overview of UT1, looking upstream near station 19+00
(Top Photo – Year 2: 9/19/10, Bottom Photo – Year 4: 9/11/12).
(EMH&T)

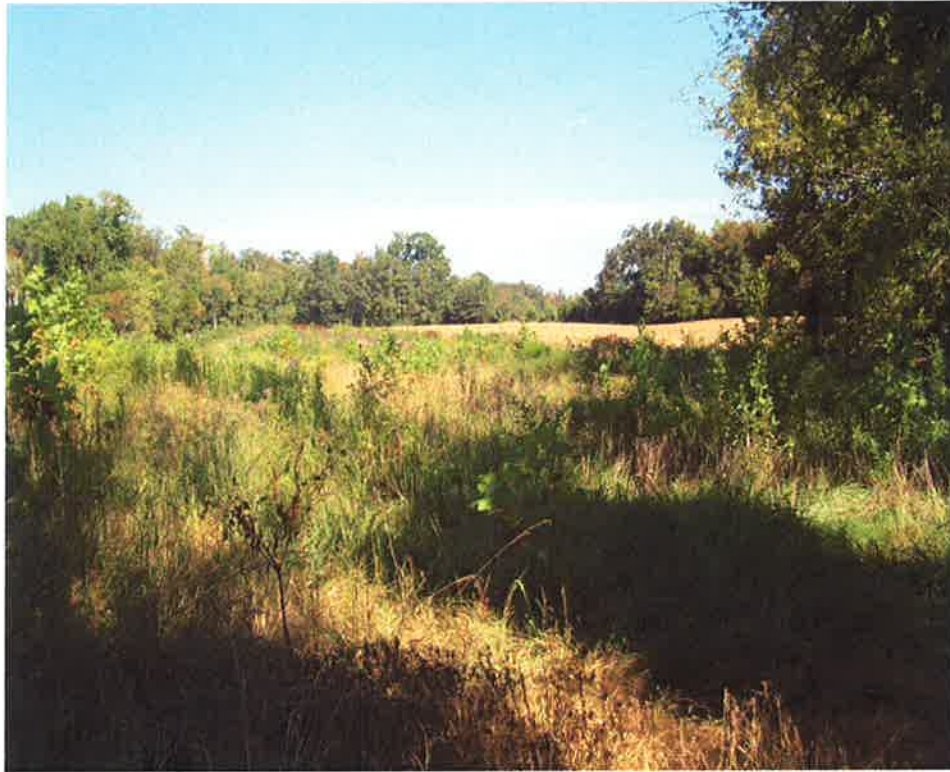
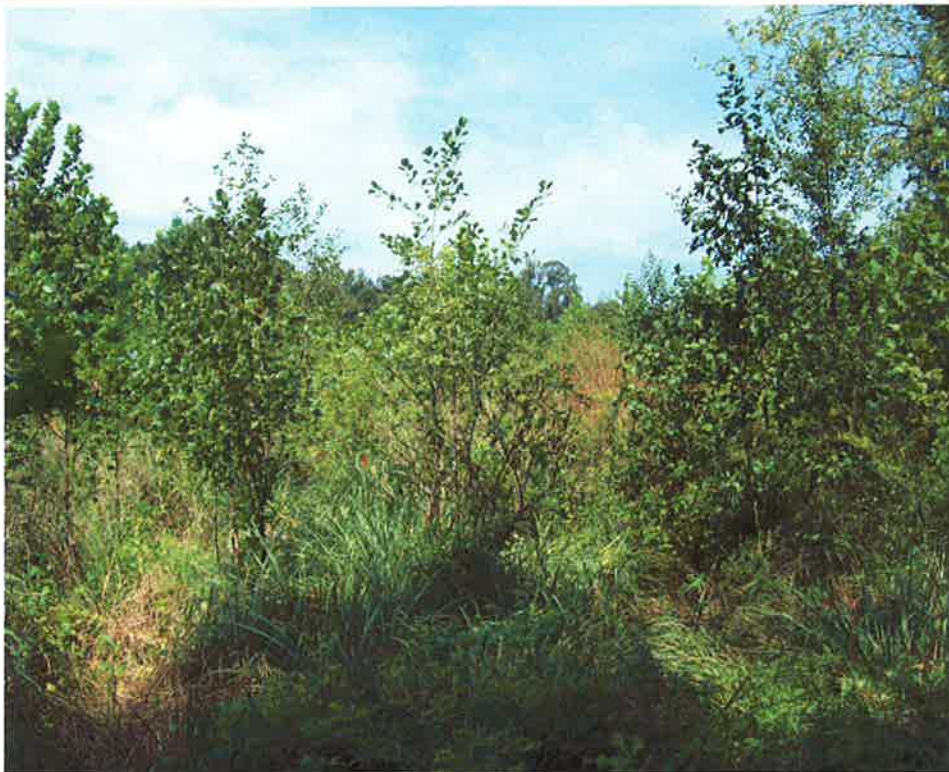
Fixed Station 3

Overview of valley along UT1, looking upstream near station 13+00

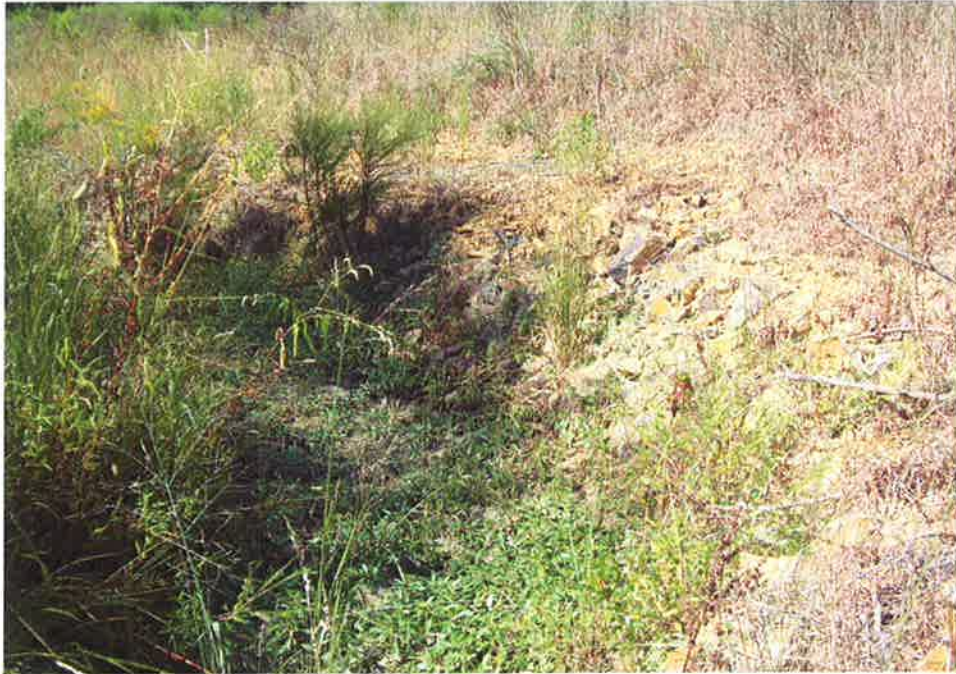
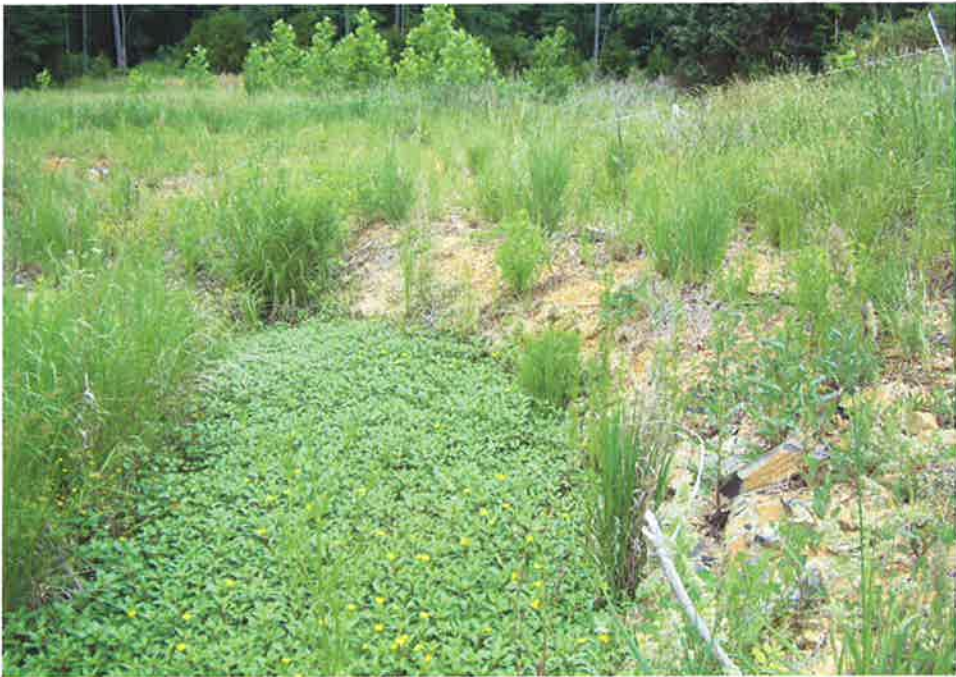
SPA 1

As in Years 2 & 3, areas of instability were not observed along the Beaverdam Creek Mainstem in 2012. The only type of stream problem areas noted along UT1 and UT2 are isolated to a few outside meander bends along these tributaries. The banks of these particular outside bends do not have enough established vegetation to stabilize the slopes and therefore it appears that some minor erosion is occurring at the stations listed in Table X. These areas are considered of low concern at this time because they are not actively eroding beyond the minor sloughing of loose soil. The bend on UT1 between stations 0+75 and 0+90 has begun to slough slightly. Because vegetation continues to increase in density on this bank, immediate action is not warranted. Overall, the density of vegetation has increased for all stations listed in the table above. The exception is station 1+60 on UT2. Year 5 monitoring will bring another assessment of the vegetation growth on this bank and any persisting sloughing. Vegetation colonization and growth will be closely monitored in 2013 in order to ascertain any trends with regards to increased or decreased bank stabilization along UT1 and UT2.

Steep banks and bank scour along an outer meander bend on UT1 near station 4+20.

At present, no recommendations regarding bank stabilization remediation are warranted and no remedial maintenance is scheduled at this time. These areas are noted in order that they be watched to catch any erosion problems that may occur before vegetation becomes fully established along these slopes. Actively monitoring these areas will allow developing problems to be caught early and managed without the need for mechanical intervention. If erosion problems arise in these or any new areas, the outside meander bends could be stabilized using vegetative methods such as seeding and live stakes, or with a natural fiber (coconut) geotextile.
