Subject: Year 5 Monitoring Report for Stream Mitigation of Beaverdam Creek; Union County, NC; SCO# D06054-C

Year 5 Monitoring Report for Stream Restoration of Beaverdam Creek and Unnamed Tributaries

Union County, NC
SCO # D06054-C

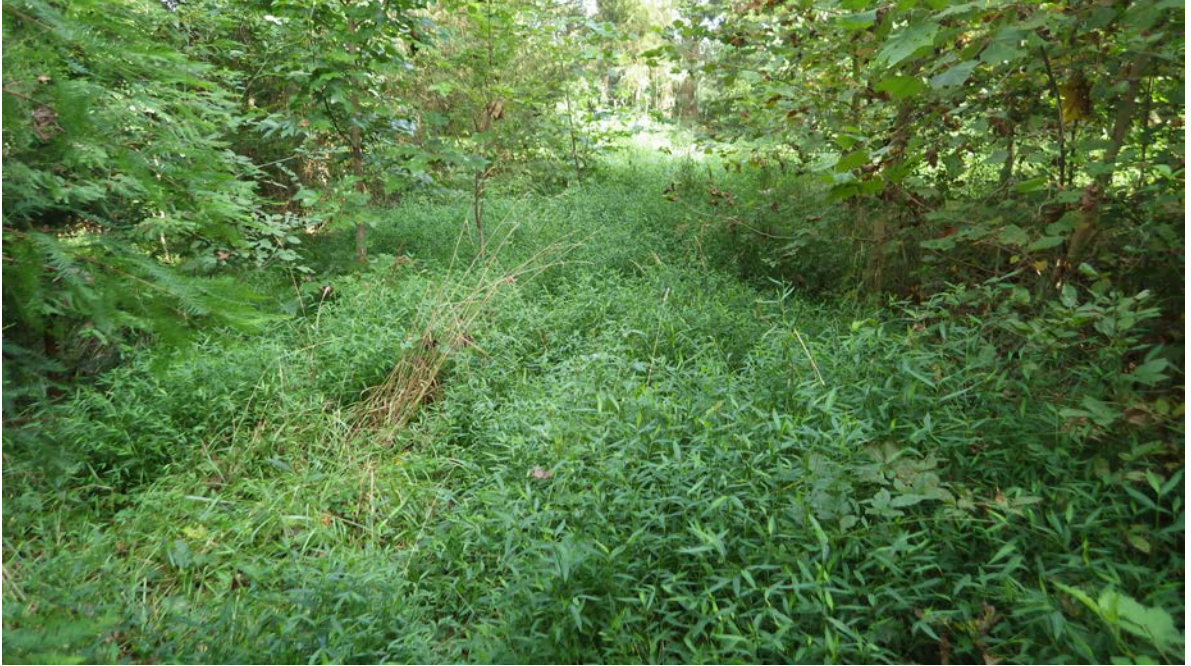
Feature/Issue	Station # / Range	Probable Cause	Photo #
Invasive Population	12+50-15+00 UT1	Microstegium: encroachment from outside source	VPA 1
	00+75-2+500 main stem; 5+10-7+00, 1+00-2+00 UT1; 00+75-2+75 UT2	Ligustrum (Privet)	N/A
	5+10-7+00, 1+00-2+00 UT1; 00+75-2+75 UT2	Rosa multiflora	N/A

A few areas with a population of Japanese stiltgrass (*Microstegium vimineum*) were noted during 2010 (Year 2) monitoring. *Microstegium vimineum* continues to be present along UT1 in Year 5. The population has slightly decreased and shifted its location along UT1. In Year 4, it covered the channel and/or areas of the riparian corridor between stations 14+00 and 17+50, as well as between stations 19+50 and 20+00. It is now between stations 12+50 and 15+00, as well as between stations 22+50 and 23+00 in Year 5. This species is common alongside streams and ditches and at the edges of forests and damp fields and, as such, was likely present before the onset of restoration activities. As further evidence of a pre-existing population, the locations where this species is present are those areas that were minimally or not impacted during restoration of the stream channels.

View of the spread of *microstegium* at along UT1, between stations 12+50 and 15+00. This invasive grass is found in various patches along the project corridor, but is most prominent in this area.

During Year 5, a few additional vegetation problem areas were observed. These included small patches of Privet (*Ligustrum*), Multiflora rose (*Rosa multiflora*), and Japanese honeysuckle (*Lonicera japonica*). None of these species appear to be impacting the survival of woody stems and are therefore considered problem areas of low concern. Herbicide treatment has been applied to these areas in the fall of 2013 to prevent the further spread of these species. These areas will be observed again in the early spring of 2014 for a possible second herbicide application.

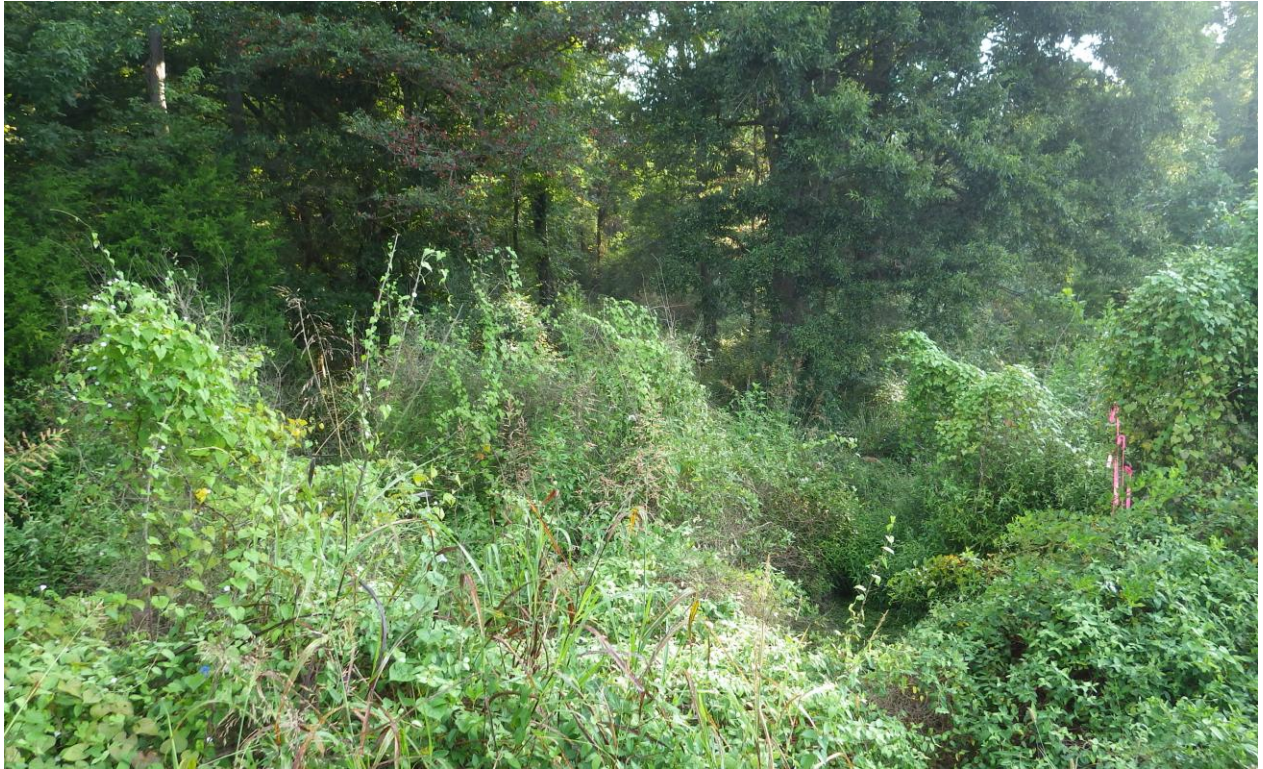
Fixed Station 1
Overview of Beaverdam Creek, looking downstream
(EMH&T, 9/5/13).

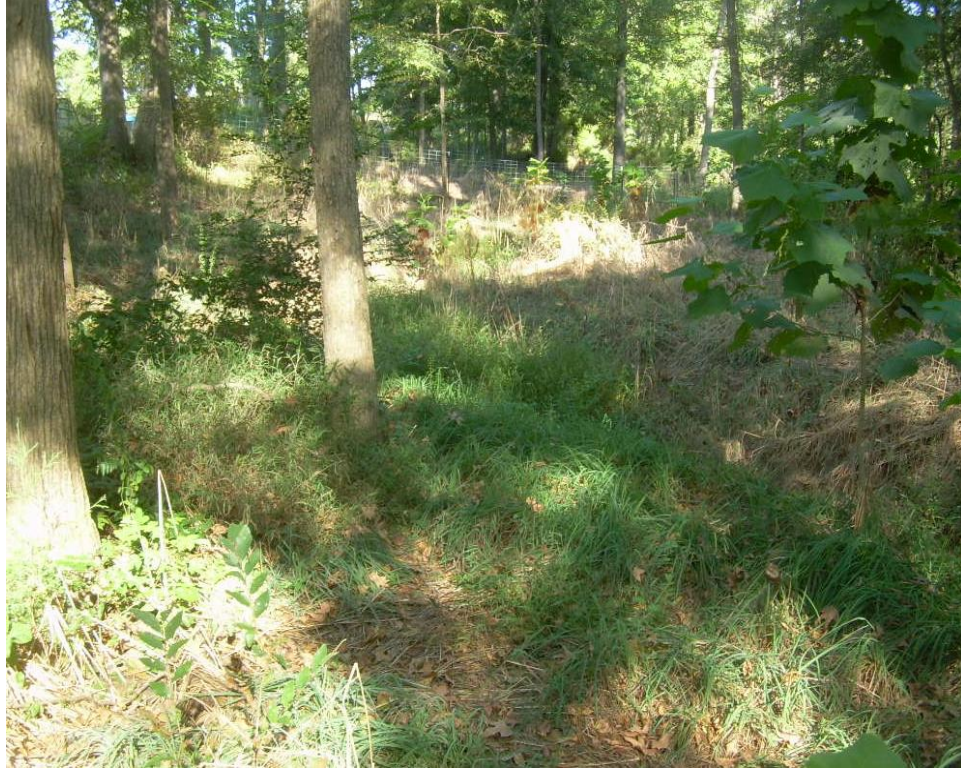
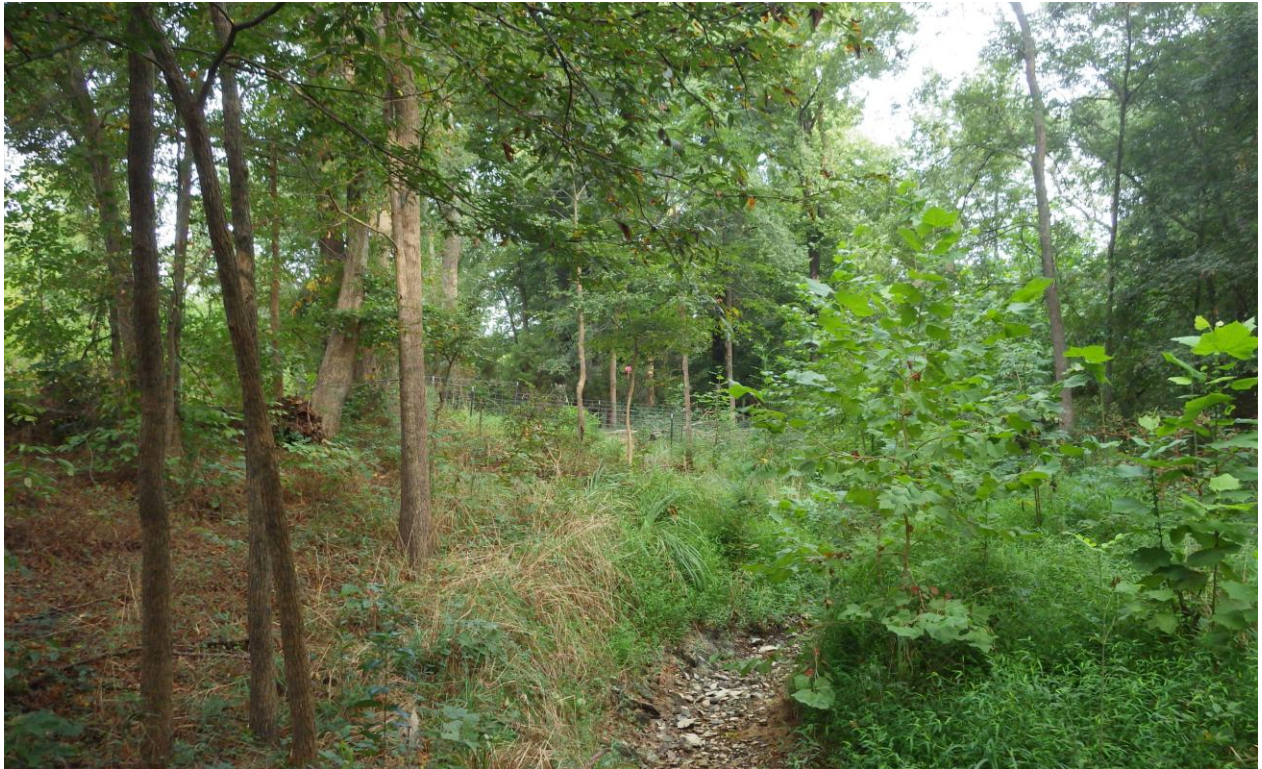
Fixed Station 2

Overview of UT1, looking upstream near station 19+00
(Top Photo – Year 2: 9/19/10, Bottom Photo – Year 5: 9/5/13).
(EMH&T)

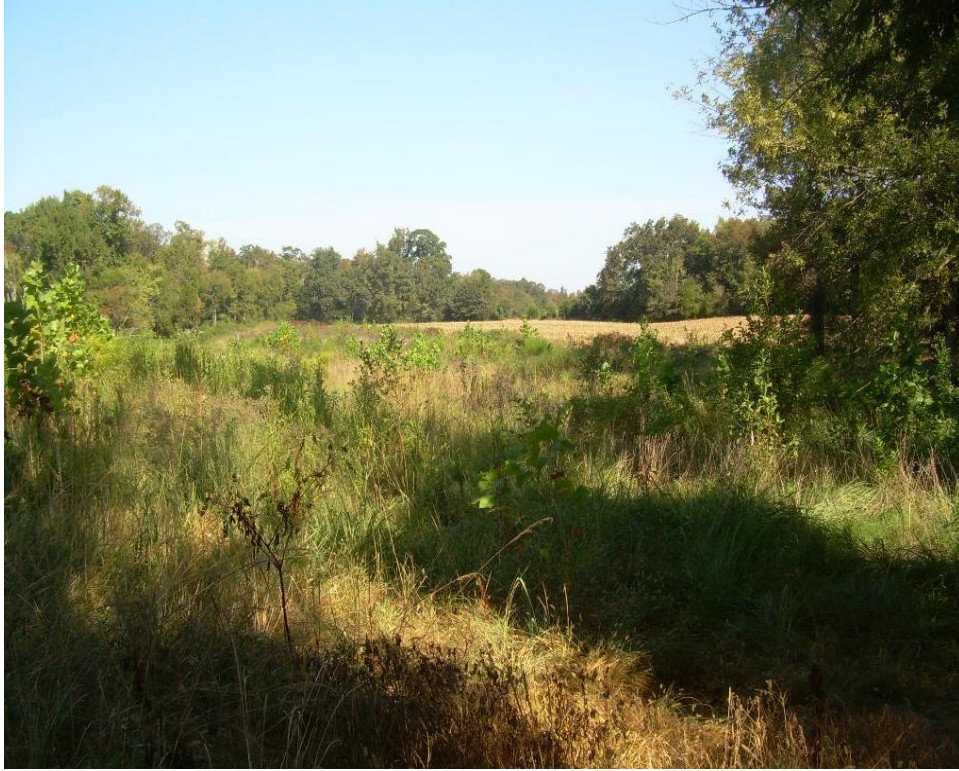
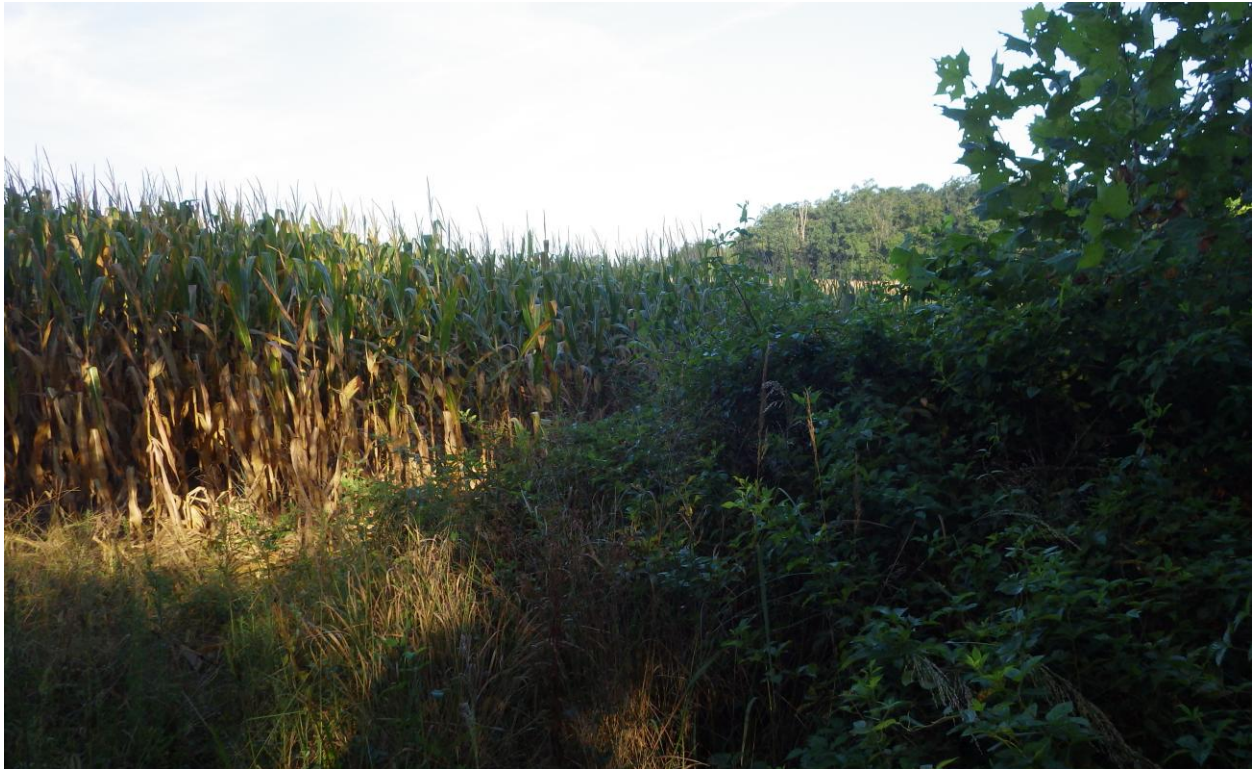
Fixed Station 3
Overview of valley along UT1, looking upstream near station 13+00
(Top Photo – Year 2: 9/19/10, Bottom Photo – Year 5: 9/5/13).
(EMH&T)

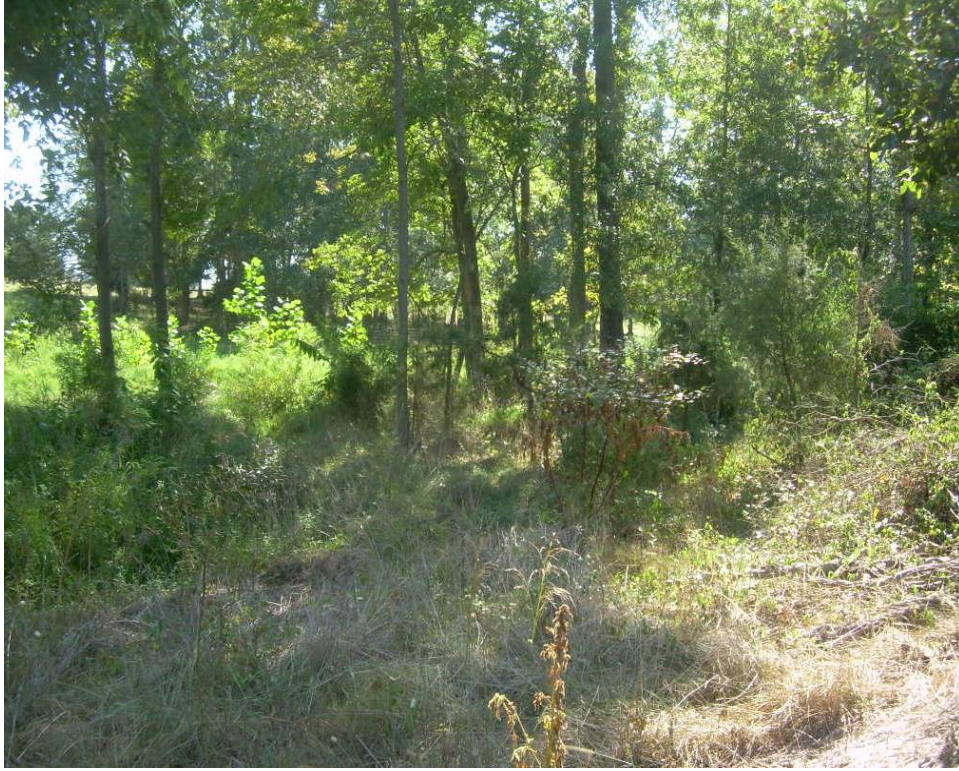
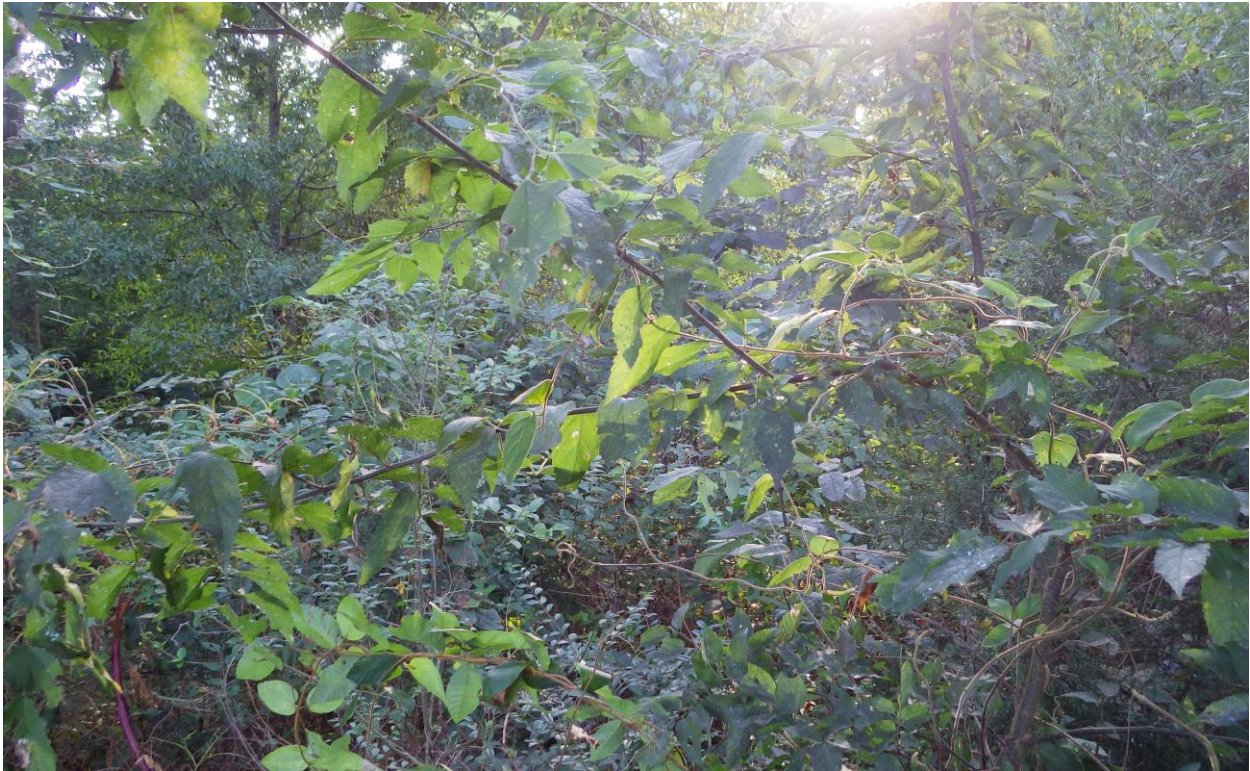
Fixed Station 4
Overview of valley along UT1, looking downstream near station 13+00
(Top Photo – Year 2: 9/19/10, Bottom Photo – Year 5: 9/11/13).
(EMH&T)

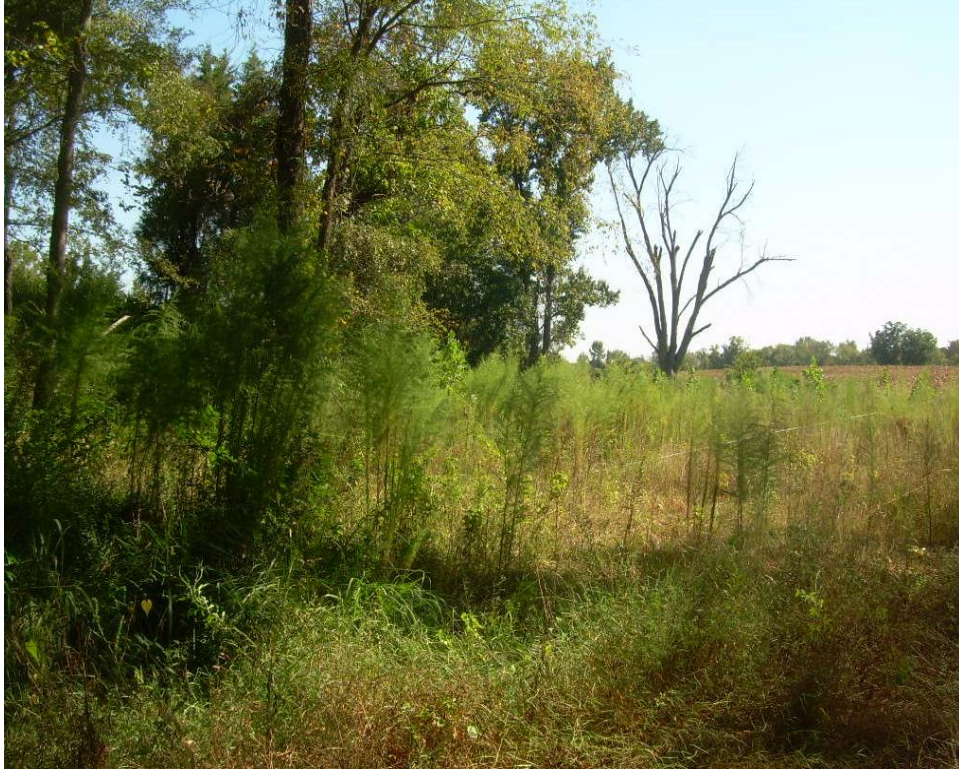
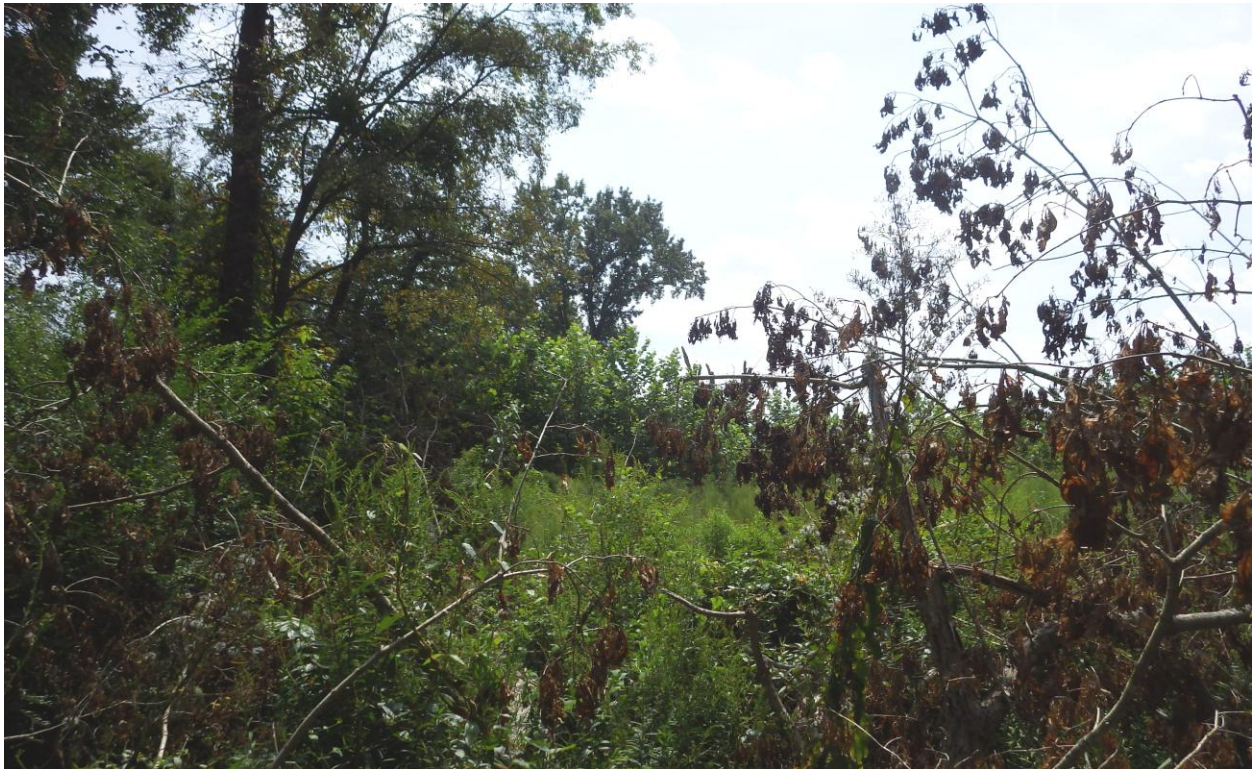
Fixed Station 5
Overview of UT1, looking downstream from upstream project limits
(Top Photo – Year 2: 9/19/10, Bottom Photo – Year 5: 9/5/13).
(EMH&T)

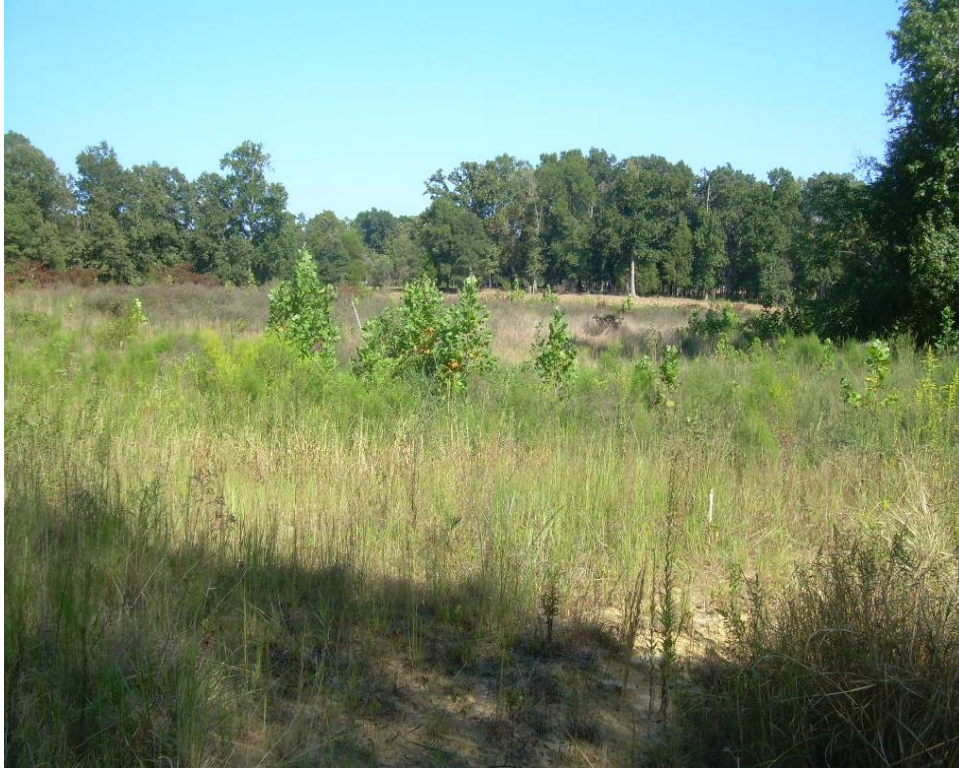
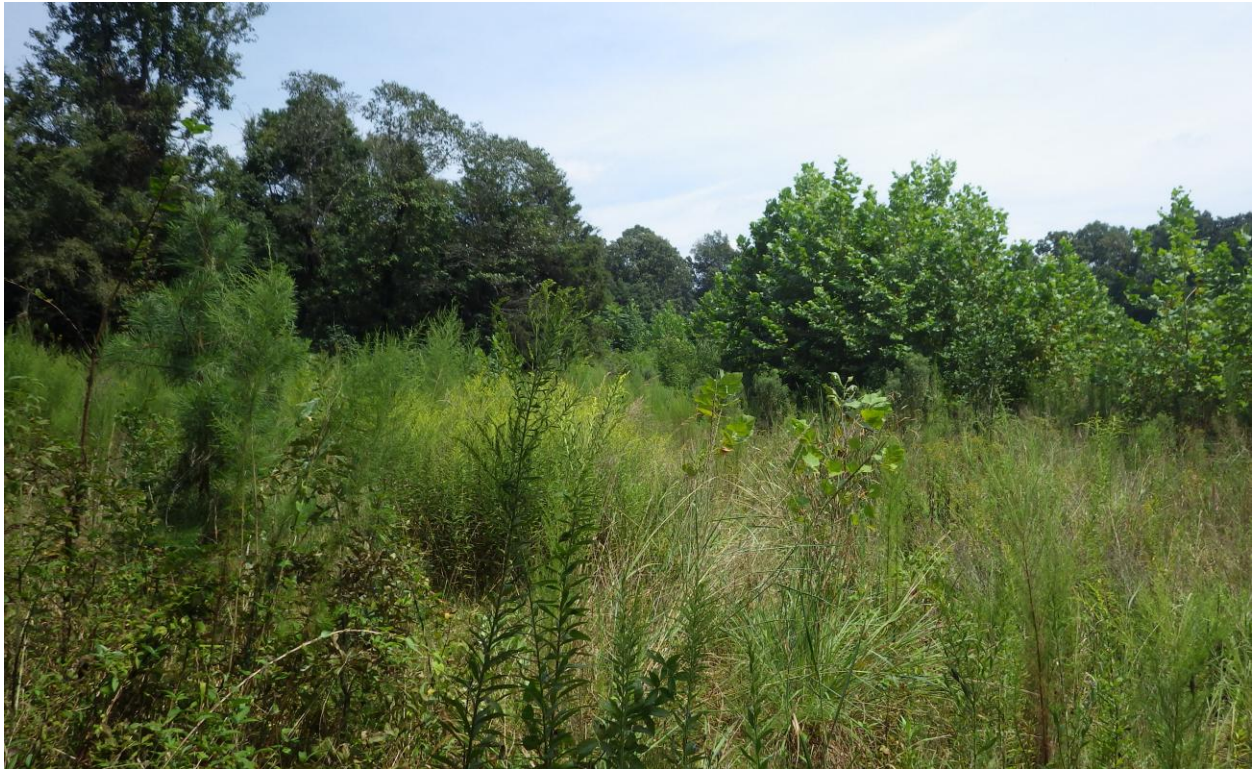
Fixed Station 6
Overview of UT2, looking downstream
(Top Photo – Year 2: 9/19/10, Bottom Photo – Year 5: 9/5/13).
(EMH&T)

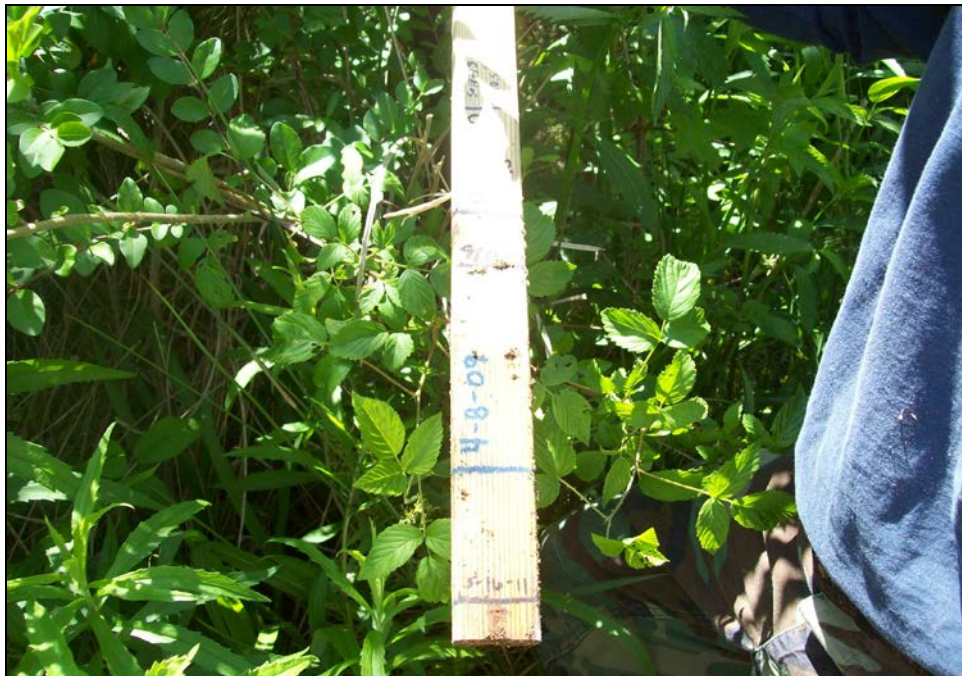
When the crest gages were read in May 2013 for Year 5, the crest gage furthest upstream on UT1 registered a bankfull event at a height of 10-1/2 inches above the bottom of the crest gage. The crest gage along the main stem of Beaverdam Creek near the confluence with UT1 did not document a bankfull event for Year 5, although it is likely to have occurred. Year 3 (May 2011) was the last recorded bankfull event along the main stem, at a height of 1-inch above the bottom of the crest gage. The Year 5 observed bankfull event is likely associated with the rainfall event that led to the elevated gage heights and higher peak flood discharge events recorded at USGS Gage 02124692 on April 29 or May 6, 2013. On April 29, 2013, the recorded maximum gage height at the Goose Creek station was 6.29 feet and the maximum recorded discharge was 856 ft³/s. On May 6, 2013, the recorded maximum gage height was 6.39 feet and the maximum recorded discharge was 892 ft³/s.

BF 4
Crest gage at 5+ 50 on UT1 (Year 5).
(EMH&T, 5/14/13)
