**Benbow Park
Stream Restoration Monitoring Report
EEP Project # 29
Monitoring Year – 03
2007**

NCDENR-EEP, 1652 Mail Service Center, Raleigh, NC 27699-1652

February 2008

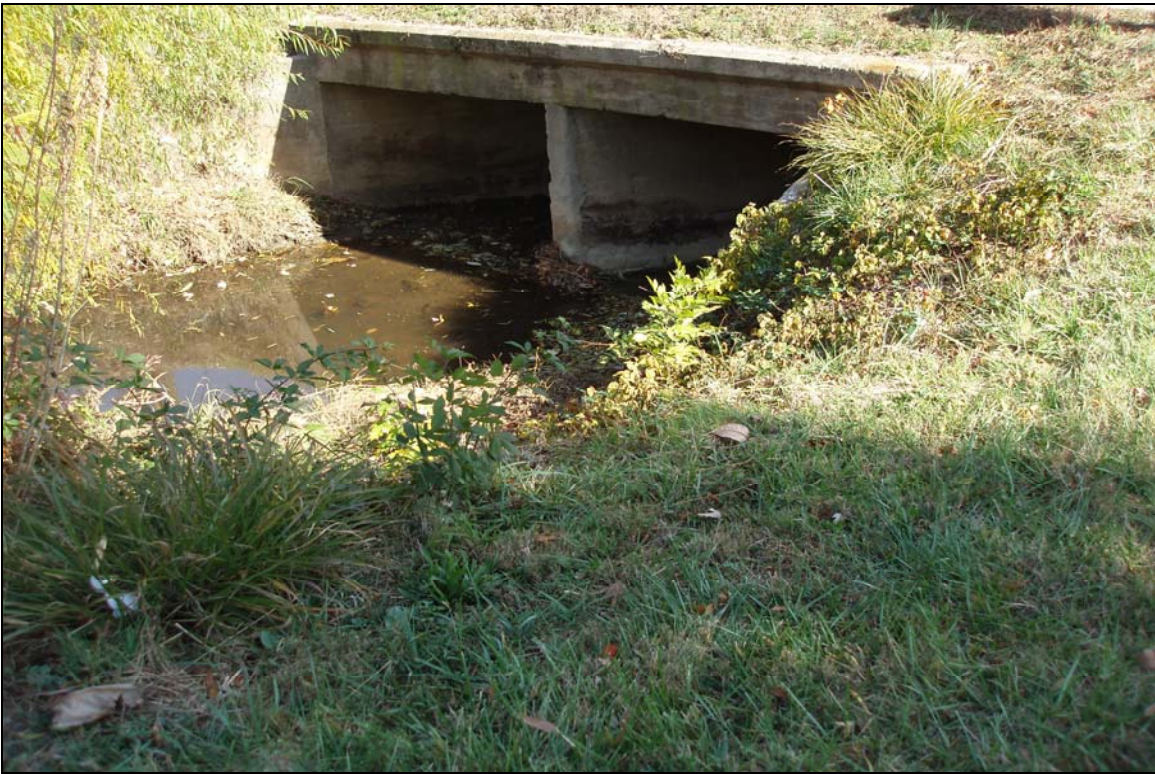
VP1 - Mowed vegetative buffer north of Benbow Ave. Photo taken near Station 17+75. 11/16/07 - MY 03

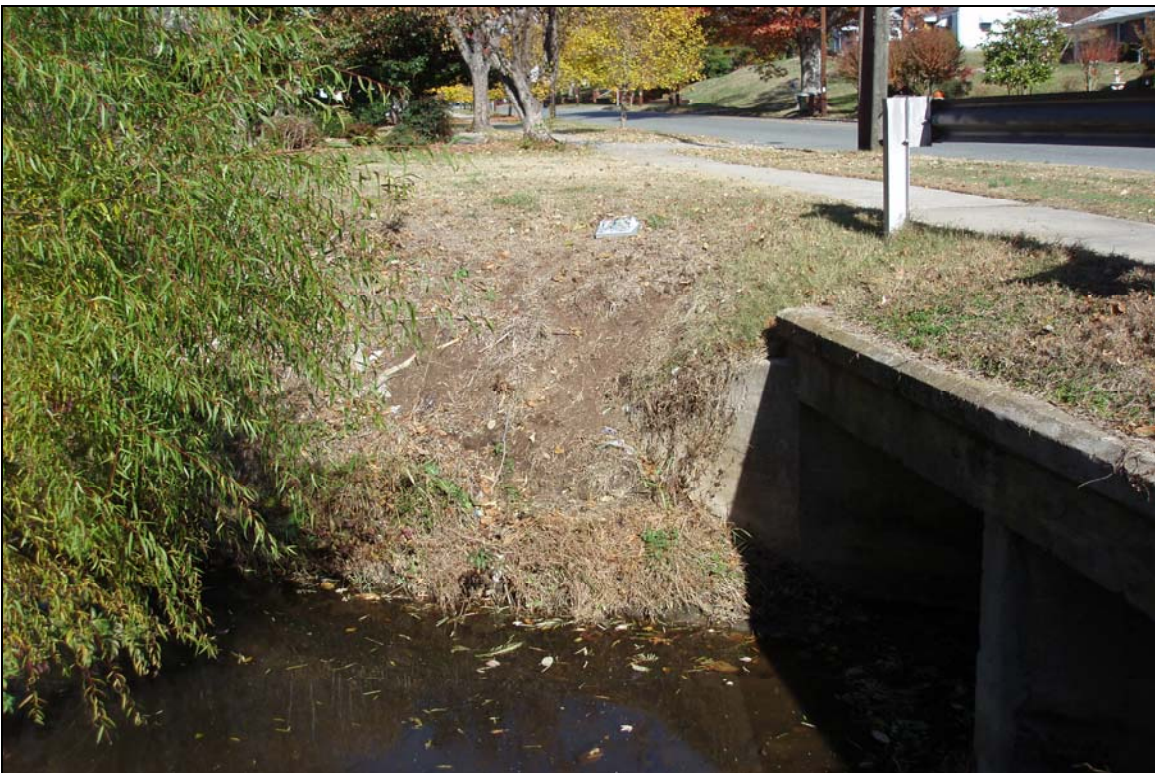
VP2 - Bare bank with coir matting exposed. Photo taken near Station 17+75. 11/16/07 - MY 03

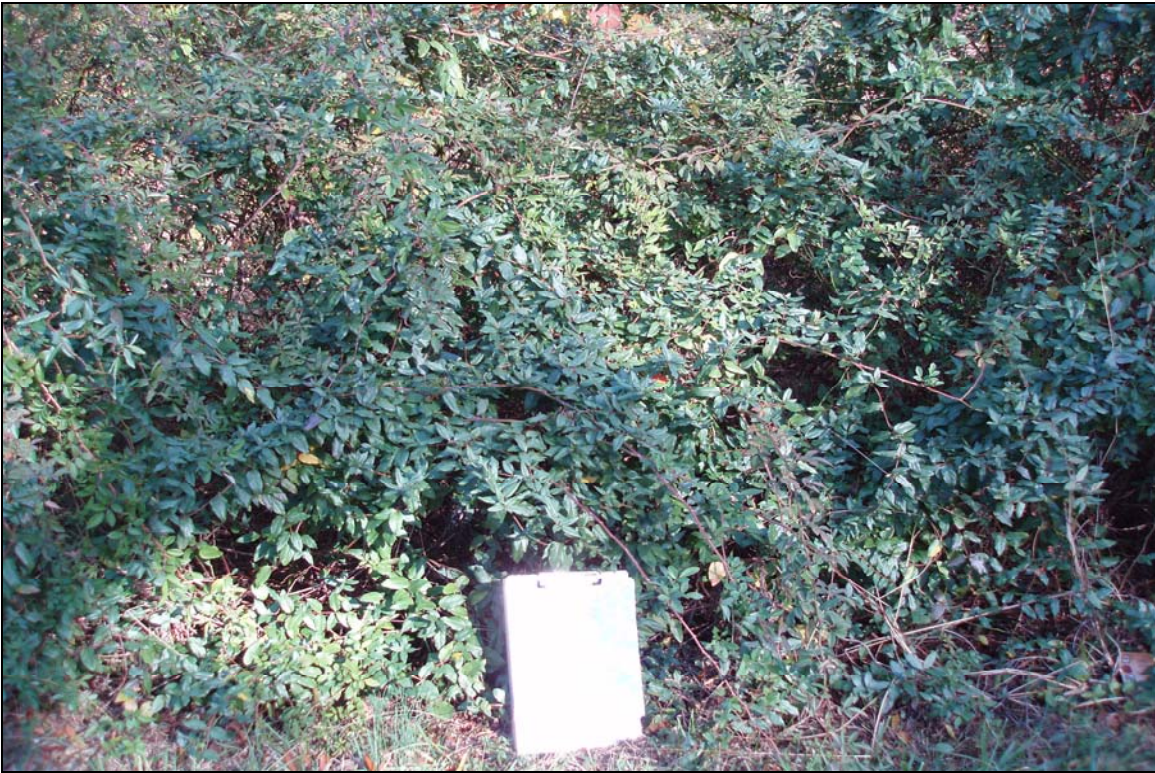
VP3 – Japanese honeysuckle enveloping multiflora rose taken near Station 16+50. 11/16/07 - MY 03

The third year of monitoring assessed the new vegetation monitoring plots established in year two of monitoring. The third year of monitoring showed one hundred percent survivability among all plots and species. Two *Cornus amomum* were corrected to *Salix sericea*. However, there was a greater percentage of plants affected by insect damage. There is a high potential for invasive species to become more plentiful at this site due to the urban setting. As mentioned previously Mimosa (*Albizia julibrissin*) and Bradford pear (*Pyrus calleryana*) are present in the riparian buffer. These trees should be removed to control the immediate seed source of these invasive species. The other invasive species noted on site include white malberry (*Morus alba*), Japanese honeysuckle (*Lonicera japonica*), Japanese hops (*Humulus japonicus*), multiflora rose (*Rosa multiflora*), and lespedeza (*Lespedeza cuneata*). Some of the larger invasive shrubs should also be removed.

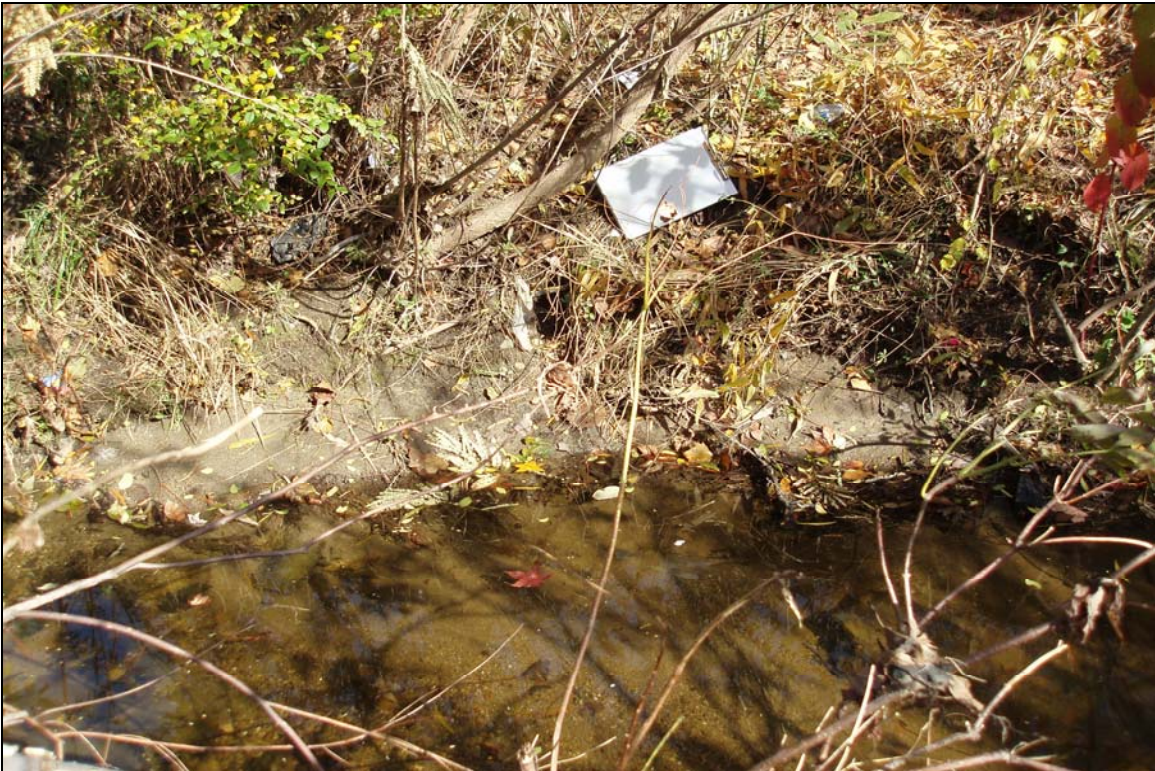
SP1 - Bank erosion. Photo taken near Station 11+15. 11/16/07 - MY 03

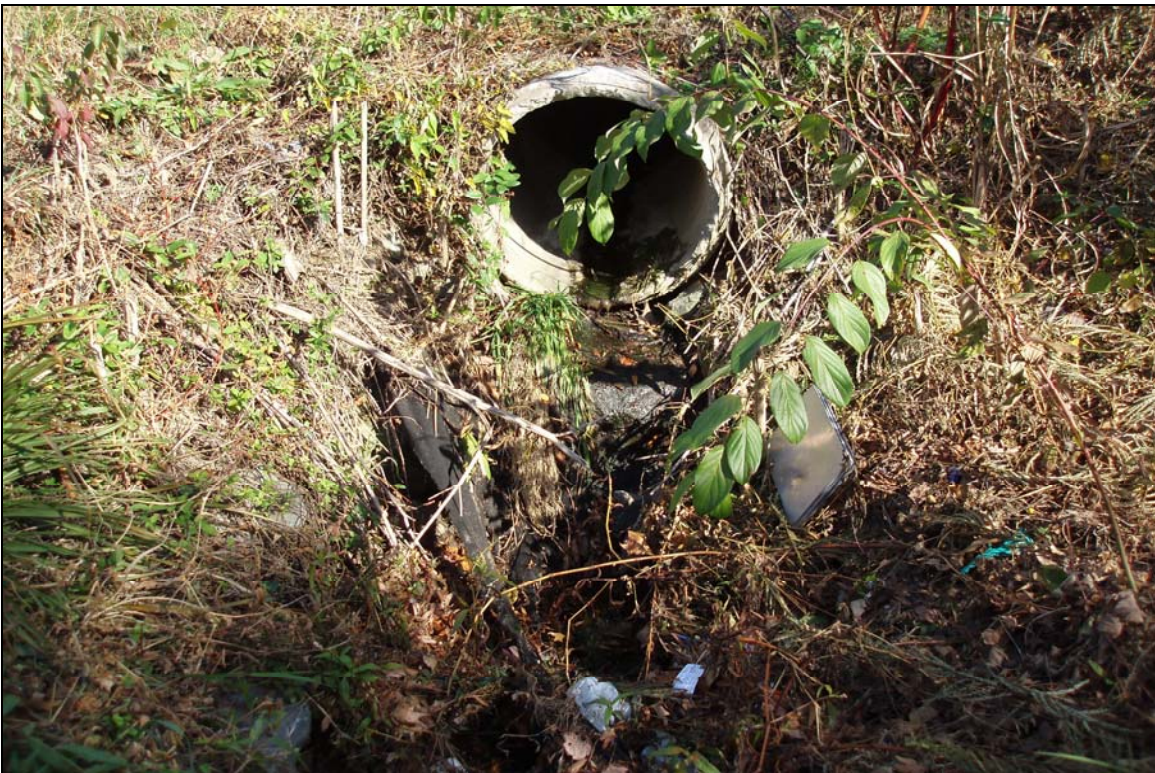
SP2 - Step pool structure failed, de-stabilizing stormwater drain outlet. Photo taken near Station 19+00. 11/16/07 - MY 03

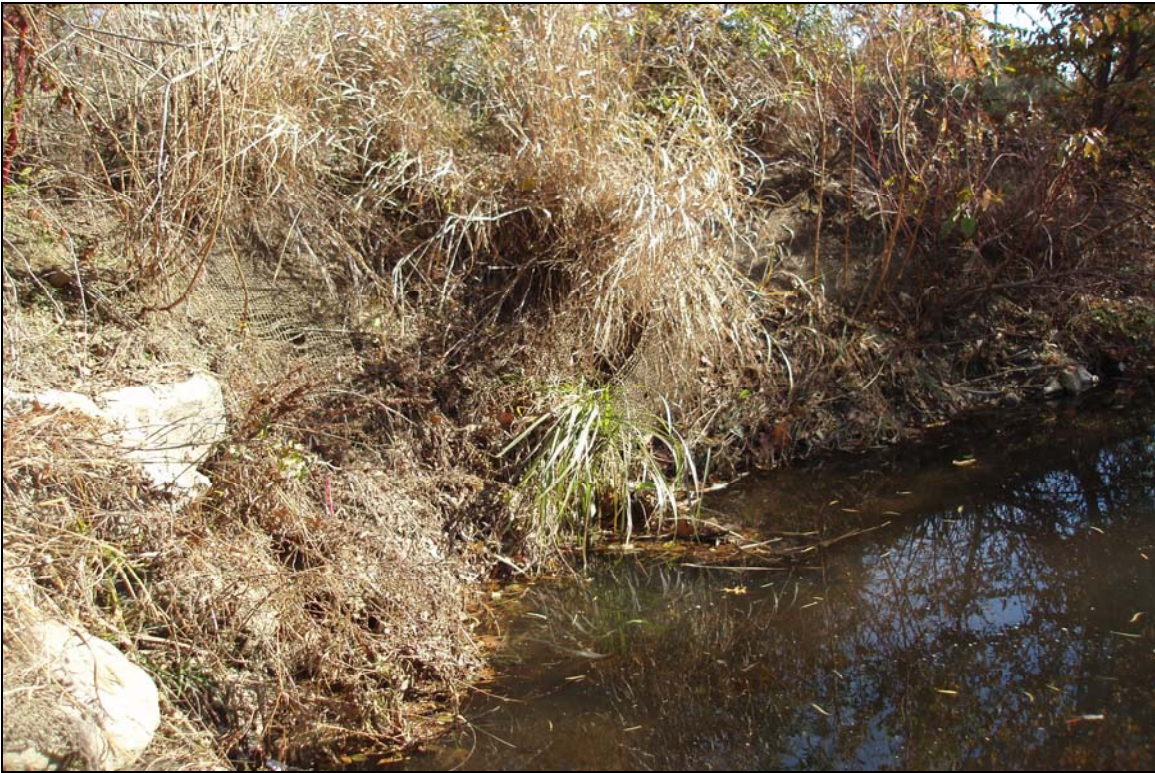
SP3 - Bank erosion has occurred behind coir matting. Photo taken near Station 19+50. 11/16/07 - MY 03

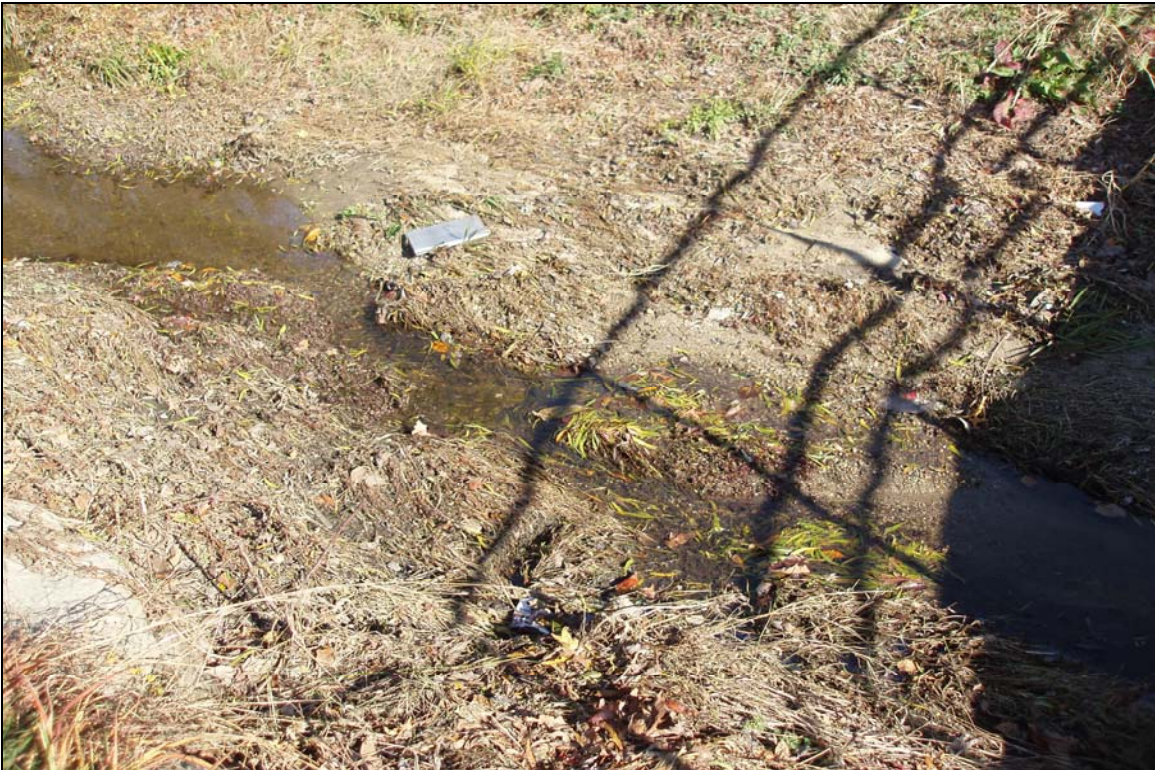
SP4 - Aggradation narrowing channel. Photo taken near Station 20+15. 11/16/07 - MY 03

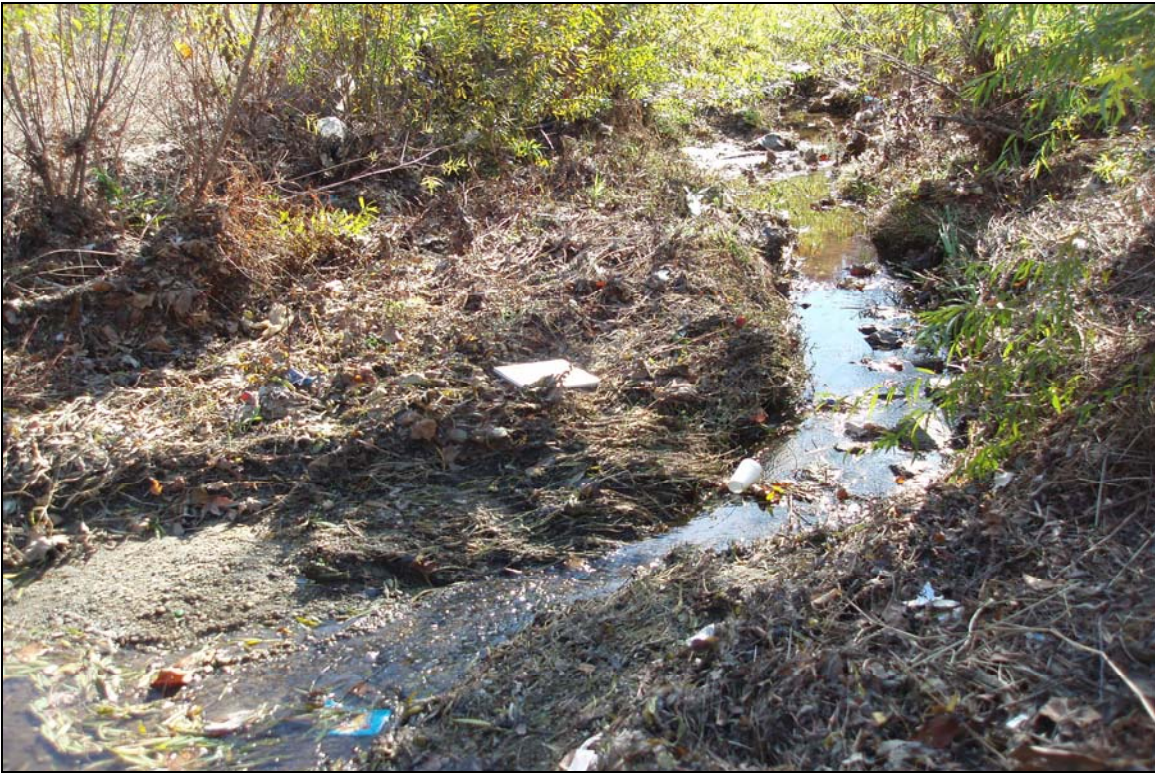
SP5 - Stream aggradation over constructed riffle causing narrowing of the channel. Photo taken near Station 21+60. 11/16/07 - MY 03
