**Benbow Park  
Stream Restoration Monitoring Report  
EEP Project # 29  
Monitoring Year – 04  
2008**

**March 2009**

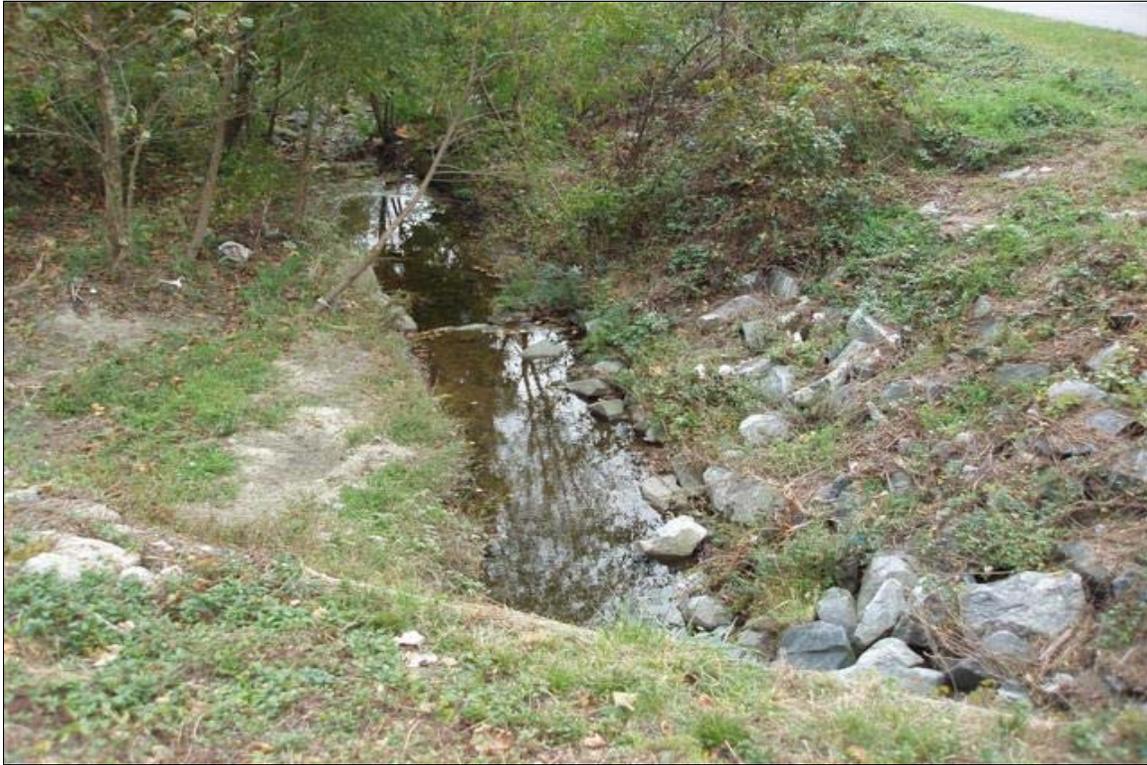
VP1 - Mowed vegetative buffer south of Florida Ave. Photo taken near Station 10+00. 10/29/08 - MY 04

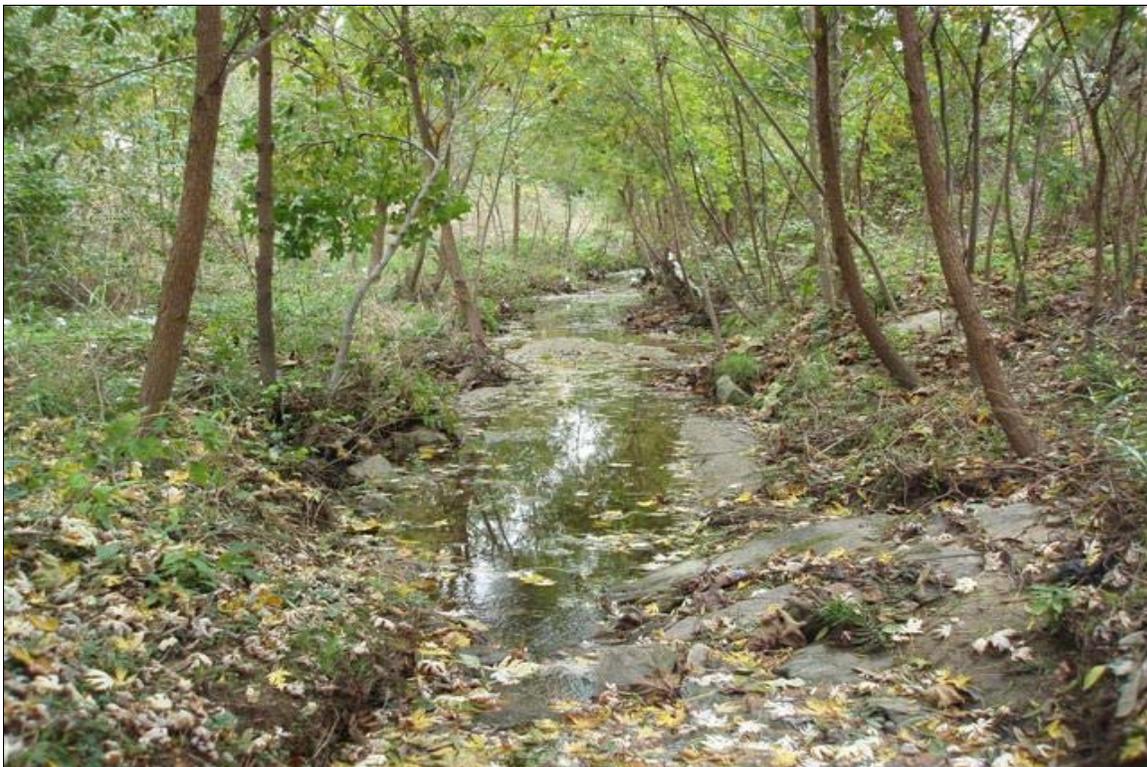
VP2 – Underbrush cleared and trees limbed up to approximately 5 feet high in the conservation easement. Photo taken near Station 12+00. 10/29/08 - MY 04

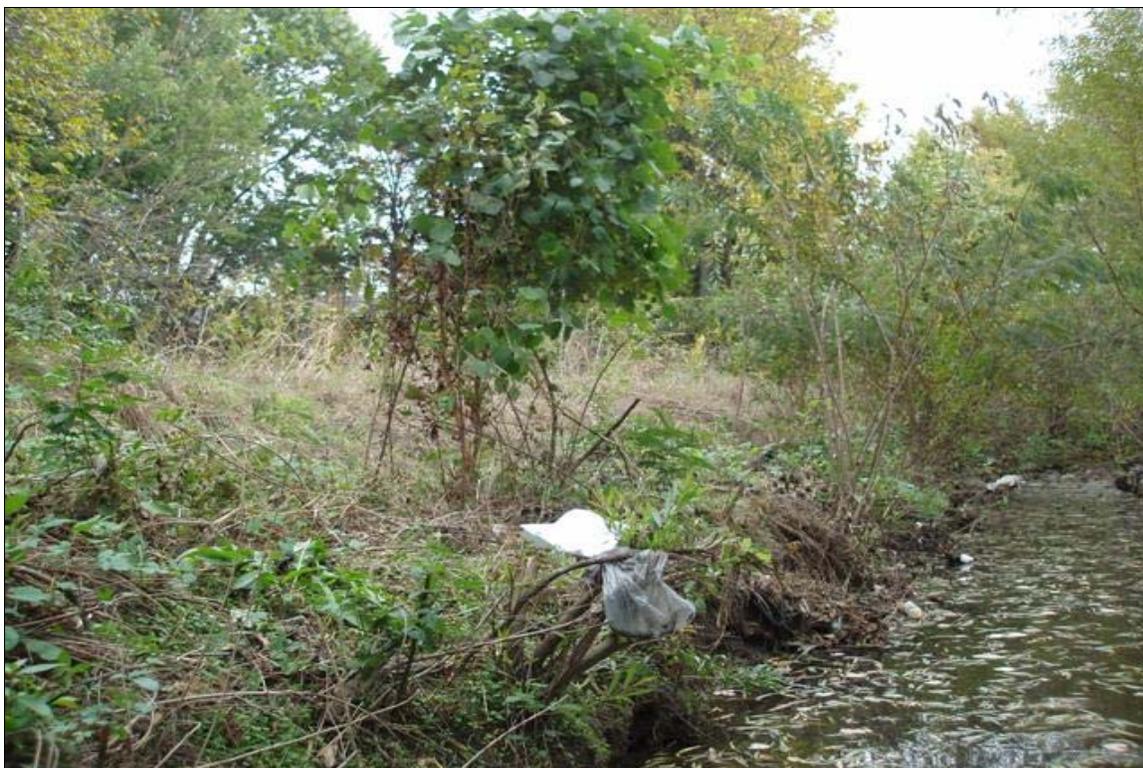
VP3 – Kudzu growing on a mimosa tree, taken near Station 14+30. Also note the cleared riparian area and that the streamside vegetation in the foreground has been significantly pruned. 10/29/08 - MY 04

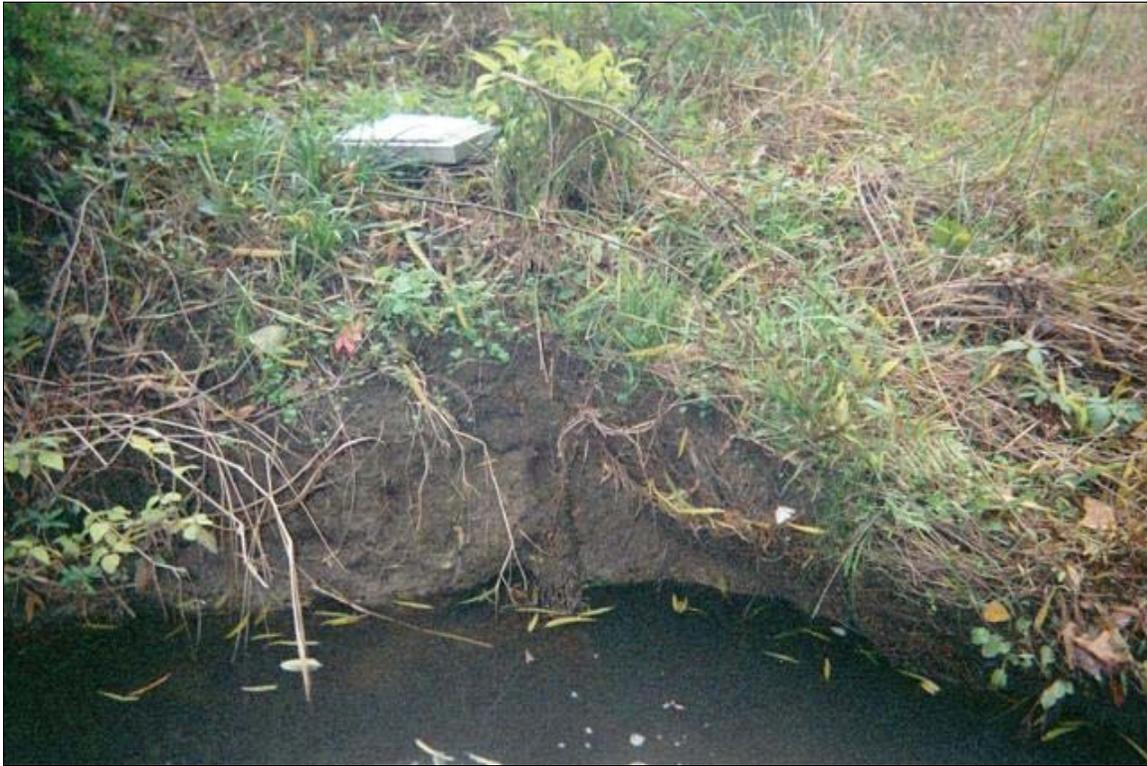
SP1 - Bank erosion. Photo taken near Station 25+50. 11/5/08 - MY 4

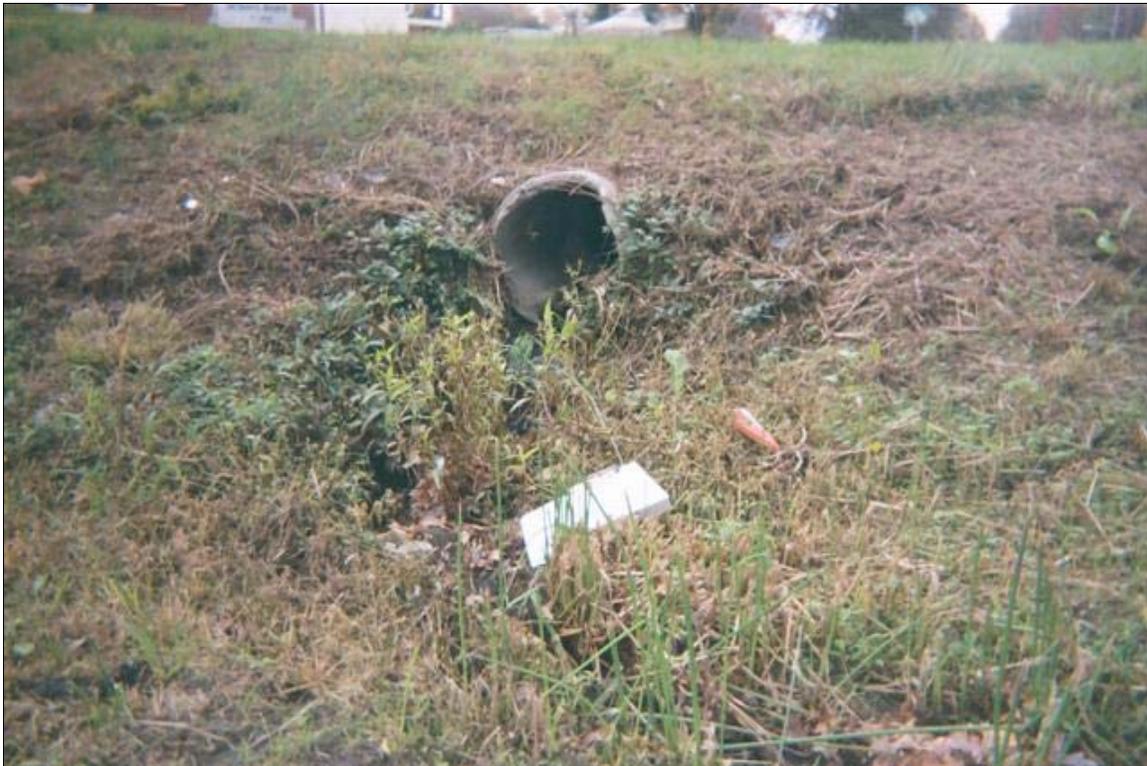
SP2 - Step pool structure failed, de-stabilizing stormwater outlet. Photo taken near Station 19+00. 11/5/08 - MY 04

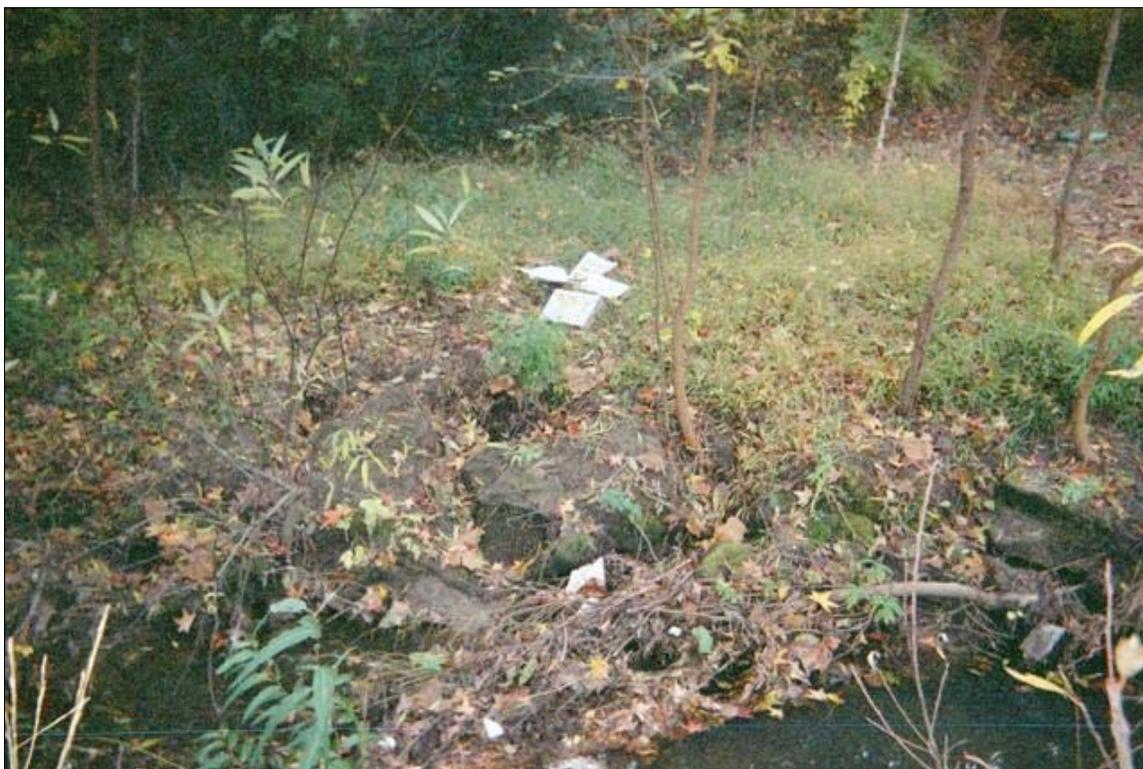
SP3 - Bank erosion has occurred behind rootwads. Photo taken near Station 26+75. 11/5/08 - MY 04

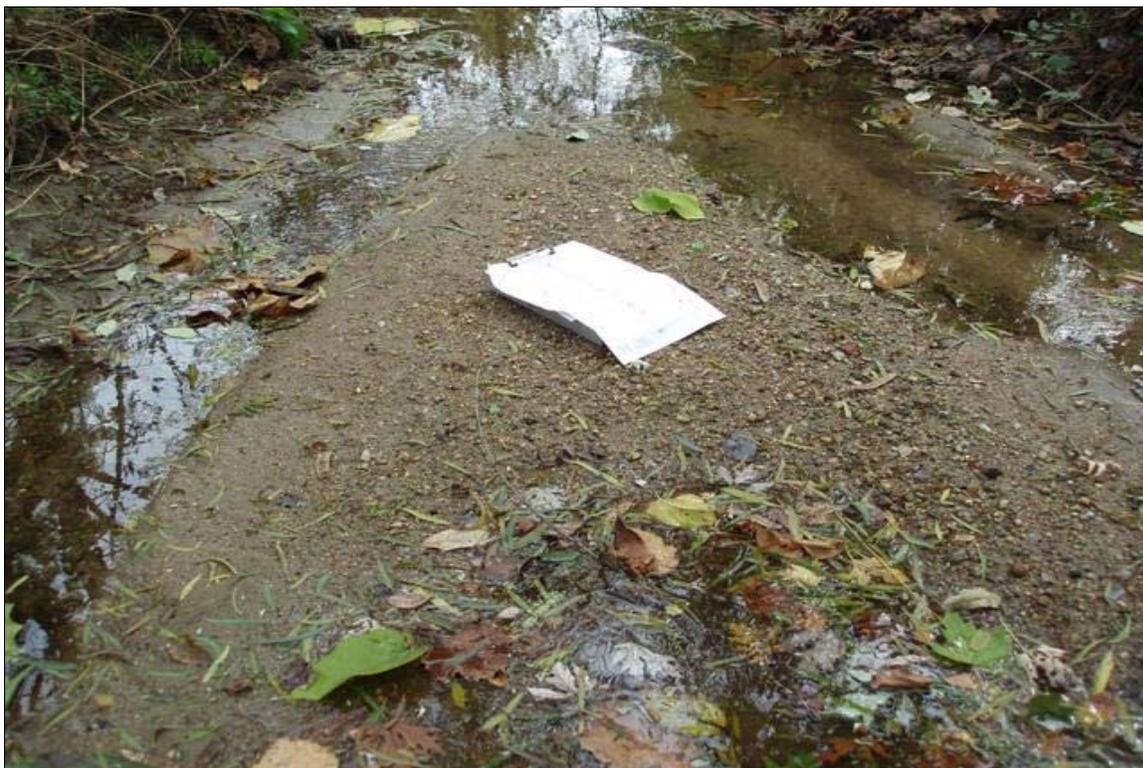
SP4 - Aggradation has occurred, creating a mid-channel bar. Photo taken near Station 12+75. 10/29/08 - MY 04

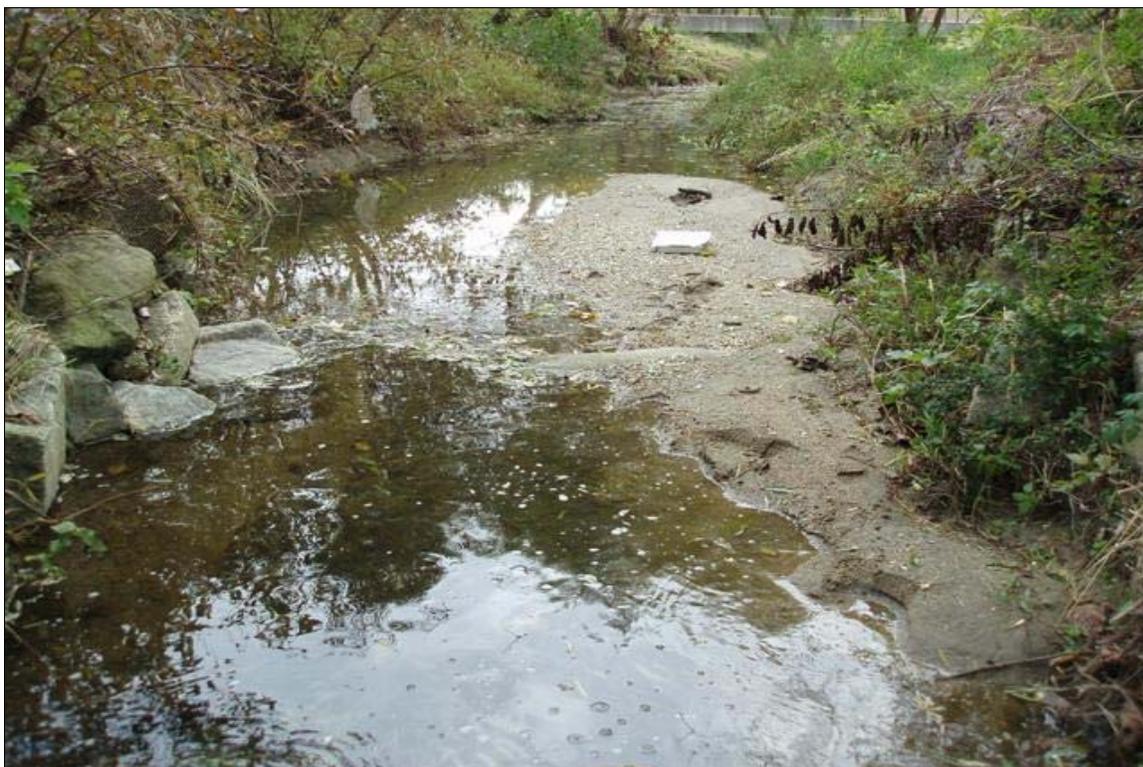
SP5 - Stream aggradation on right side of A-Vane. Photo taken near Station 20+00. 10/29/08 - MY 04

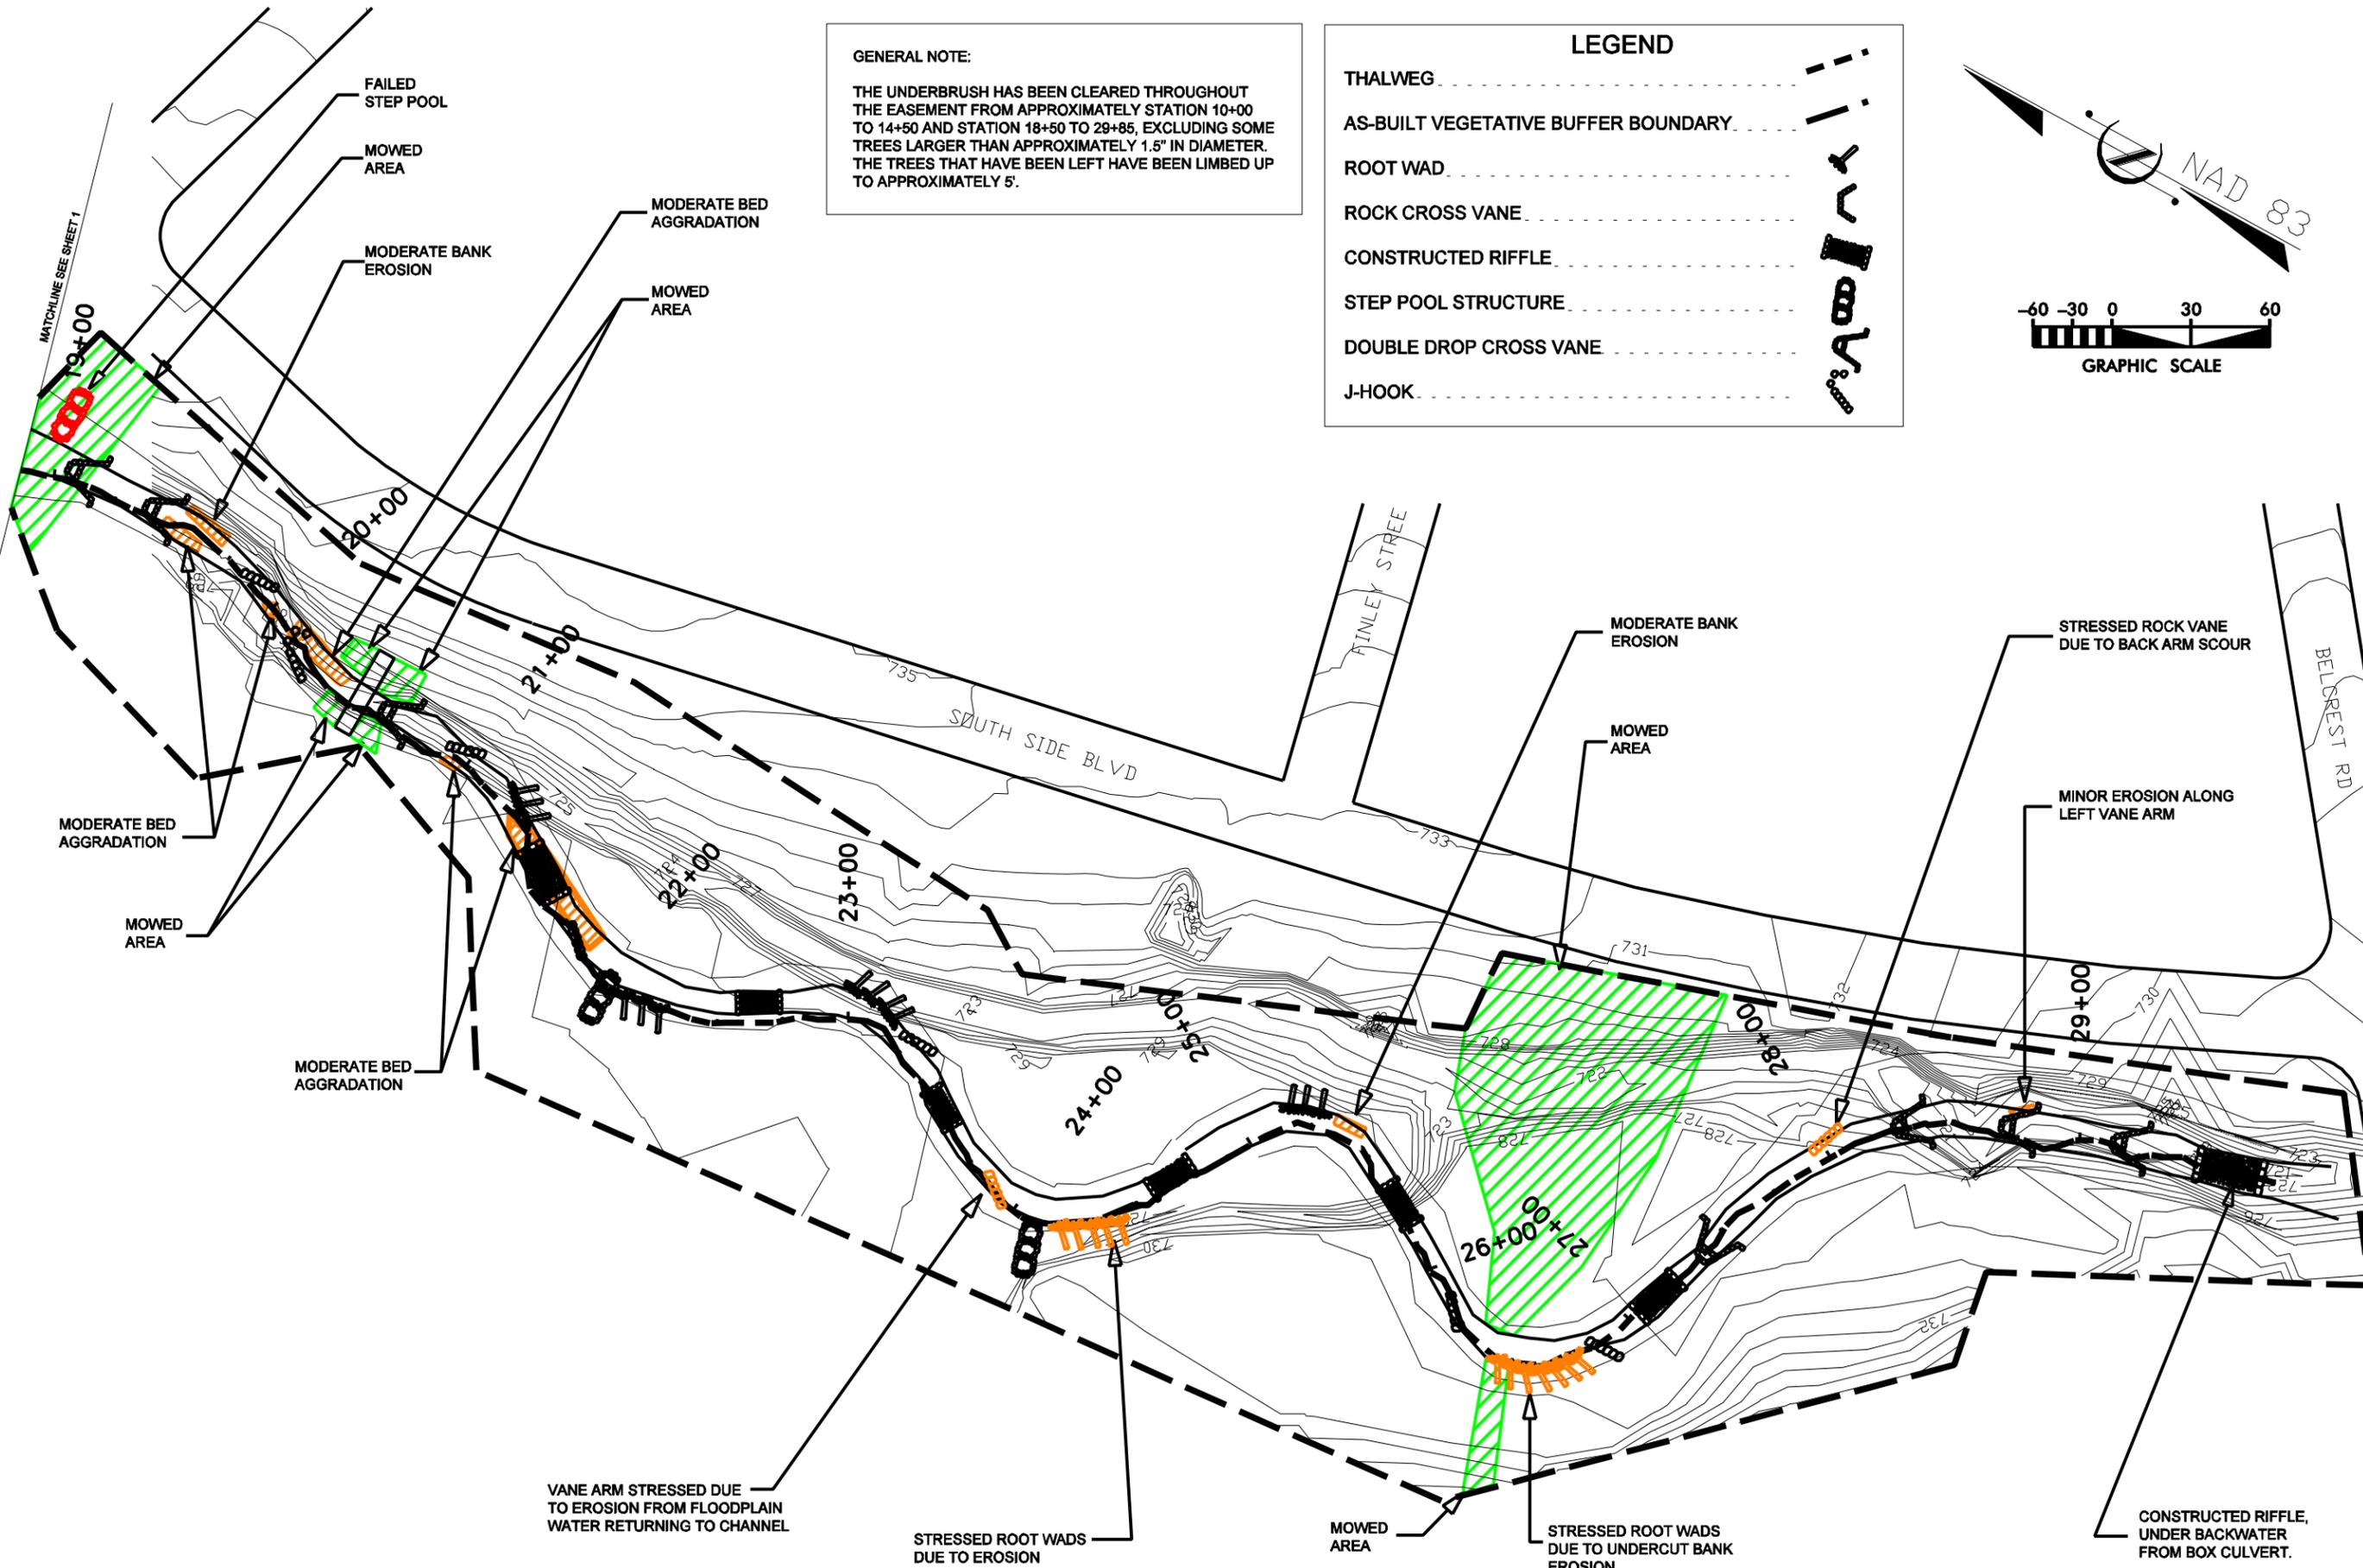
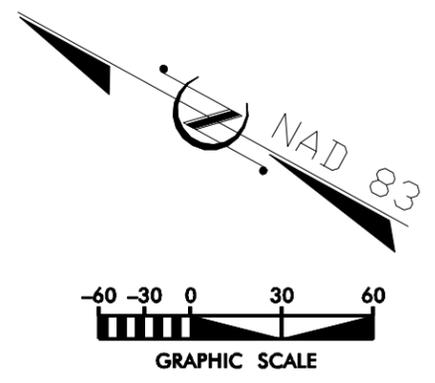
**CURRENT CONDITIONS PLAN VIEW**

**GENERAL NOTE:**  
 THE UNDERBRUSH HAS BEEN CLEARED THROUGHOUT THE EASEMENT FROM APPROXIMATELY STATION 10+00 TO 14+50 AND STATION 18+50 TO 28+85, EXCLUDING SOME TREES LARGER THAN APPROXIMATELY 1.5" IN DIAMETER. THE TREES THAT HAVE BEEN LEFT HAVE BEEN LIMBED UP TO APPROXIMATELY 5'.

FAILED STEP POOL  
 MOWED AREA  
 MODERATE BANK EROSION  
 MODERATE BED AGGRADATION  
 MOWED AREA

MODERATE BED AGGRADATION  
 MOWED AREA
