ANNUAL REPORT FOR 2003

Benson Grove Mitigation Site
Johnston County
Project No. 8.1402211
TIP No. R-2547WM

Prepared By:
Office of Natural Environment & Roadside Environmental Unit
North Carolina Department of Transportation
December 2003

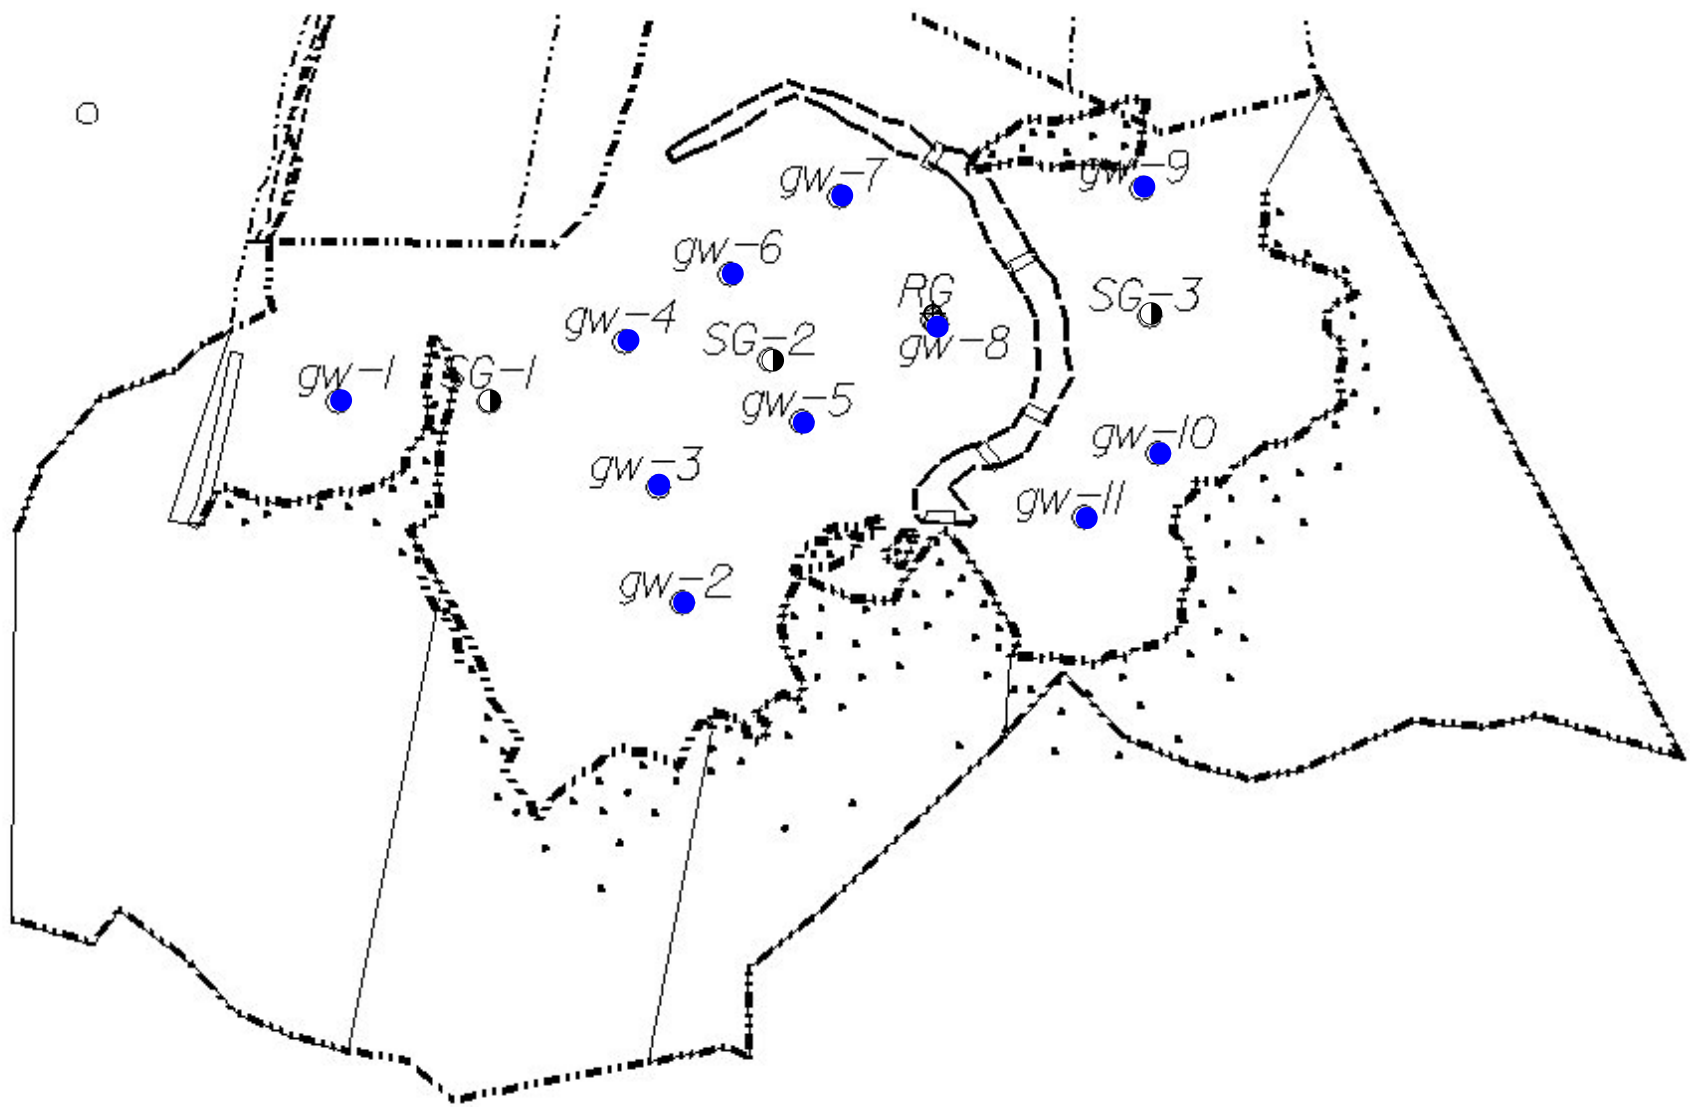
Figure 3. 2003 Hydrologic Monitoring Gauge Results

Figure 3 provides a graphical representation of the hydrologic results. Gauges highlighted in blue indicate wetland hydrology for more than 12.5% of the growing season. Gauges highlighted in red show hydrology between 8% and 12.5% of the season, while those in green indicate hydrology between 5% and 8% of the growing season. Gauges highlighted in gray indicate no wetland hydrology (less than 5% of the growing season).

Monitoring Well	<5%	5-8%	8-12.5%	>12.5%	Actual %	Success Dates
BGGW-1+				✘	100	March 26-Nov 10
BGGW-2				✘	47.0	March 26-May 17 May 19-Sept 3
BGGW-3				✘	69.6	March 26-Sept 1
BGGW-4				✘	25.7	March 26-May 13 July 2-Aug 29
BGGW-5				✘	75.7	March 26-Sept 15
BGGW-6+				✘	87.8	March 26-Oct 13
BGGW-7+				✘	100	March 26-Nov 10
BGGW-8				✘	75.7	March 26-Sept 15
BGGW-9+				✘	100	March 26-Nov 10
BGGW-10+				✘	87.8	March 26-Oct 13
BGGW-11+				✘	70.0	March 26-Sept 2 Sept 4-Nov 10

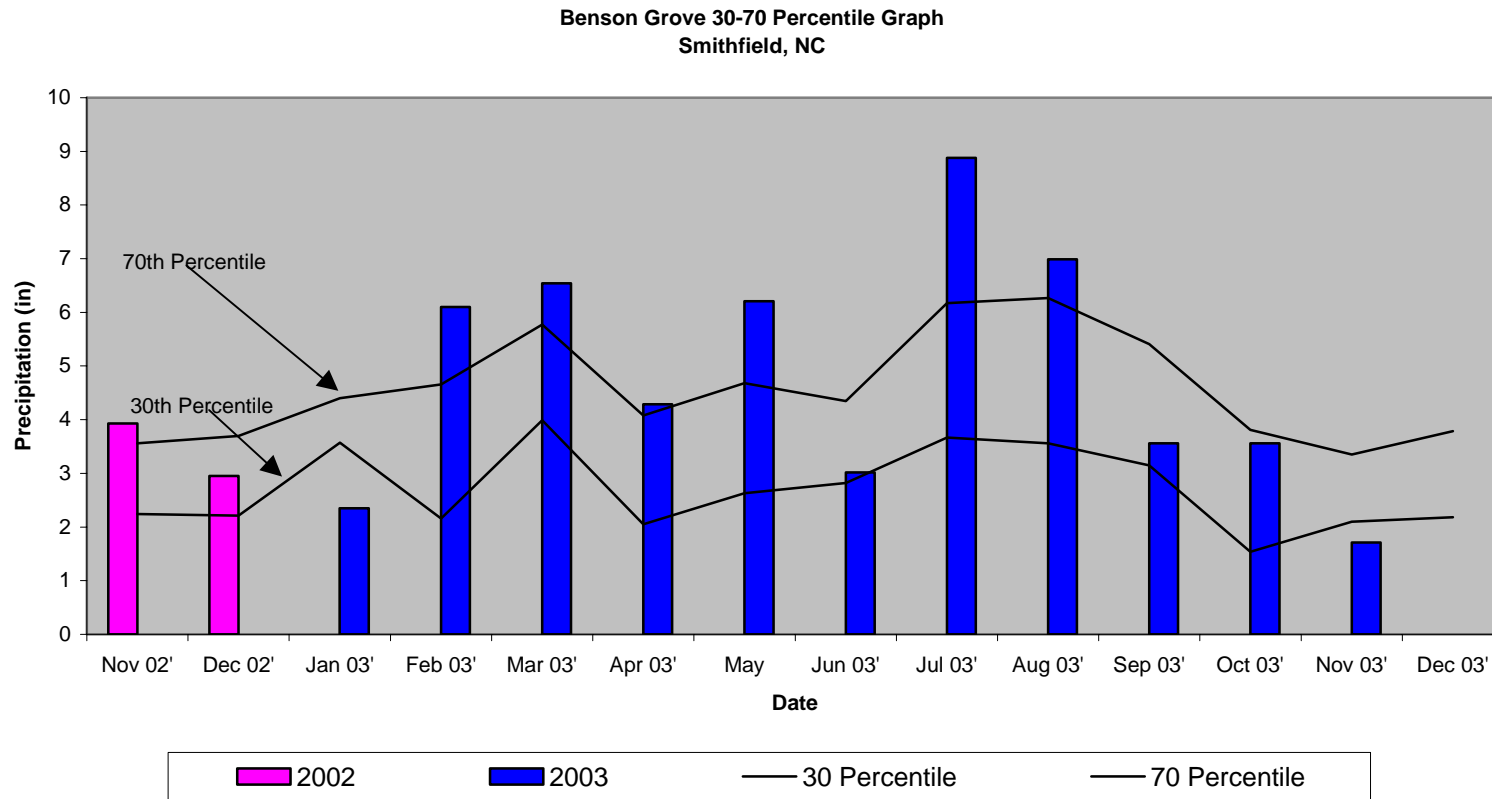
Figure 4: 30-70 Percentile Graph

Figure 4 represents an evaluation of the local climate in comparison with historical data in order to determine whether 2003 was “average” in terms of rainfall. The two lines represent the 30th and 70th percentiles of monthly precipitation for Smithfield. The bars are the monthly rainfall totals for the 2002 and 2003 hydrologic year. The historical data and monthly rainfall was collected by the National Climatic Data Center. The onsite rain gauge for Benson Grove malfunctioned, therefore the rain gauge from the Smithfield weather station was used for July 11 through November 28.

Months with below average rainfall include: January, June, and November. The months of December (02’), September, and October experienced average rainfall. November (02’), February, March, April, May, July, and August experienced above average rainfall. Overall, the site experienced average to above average rainfall in 2003.

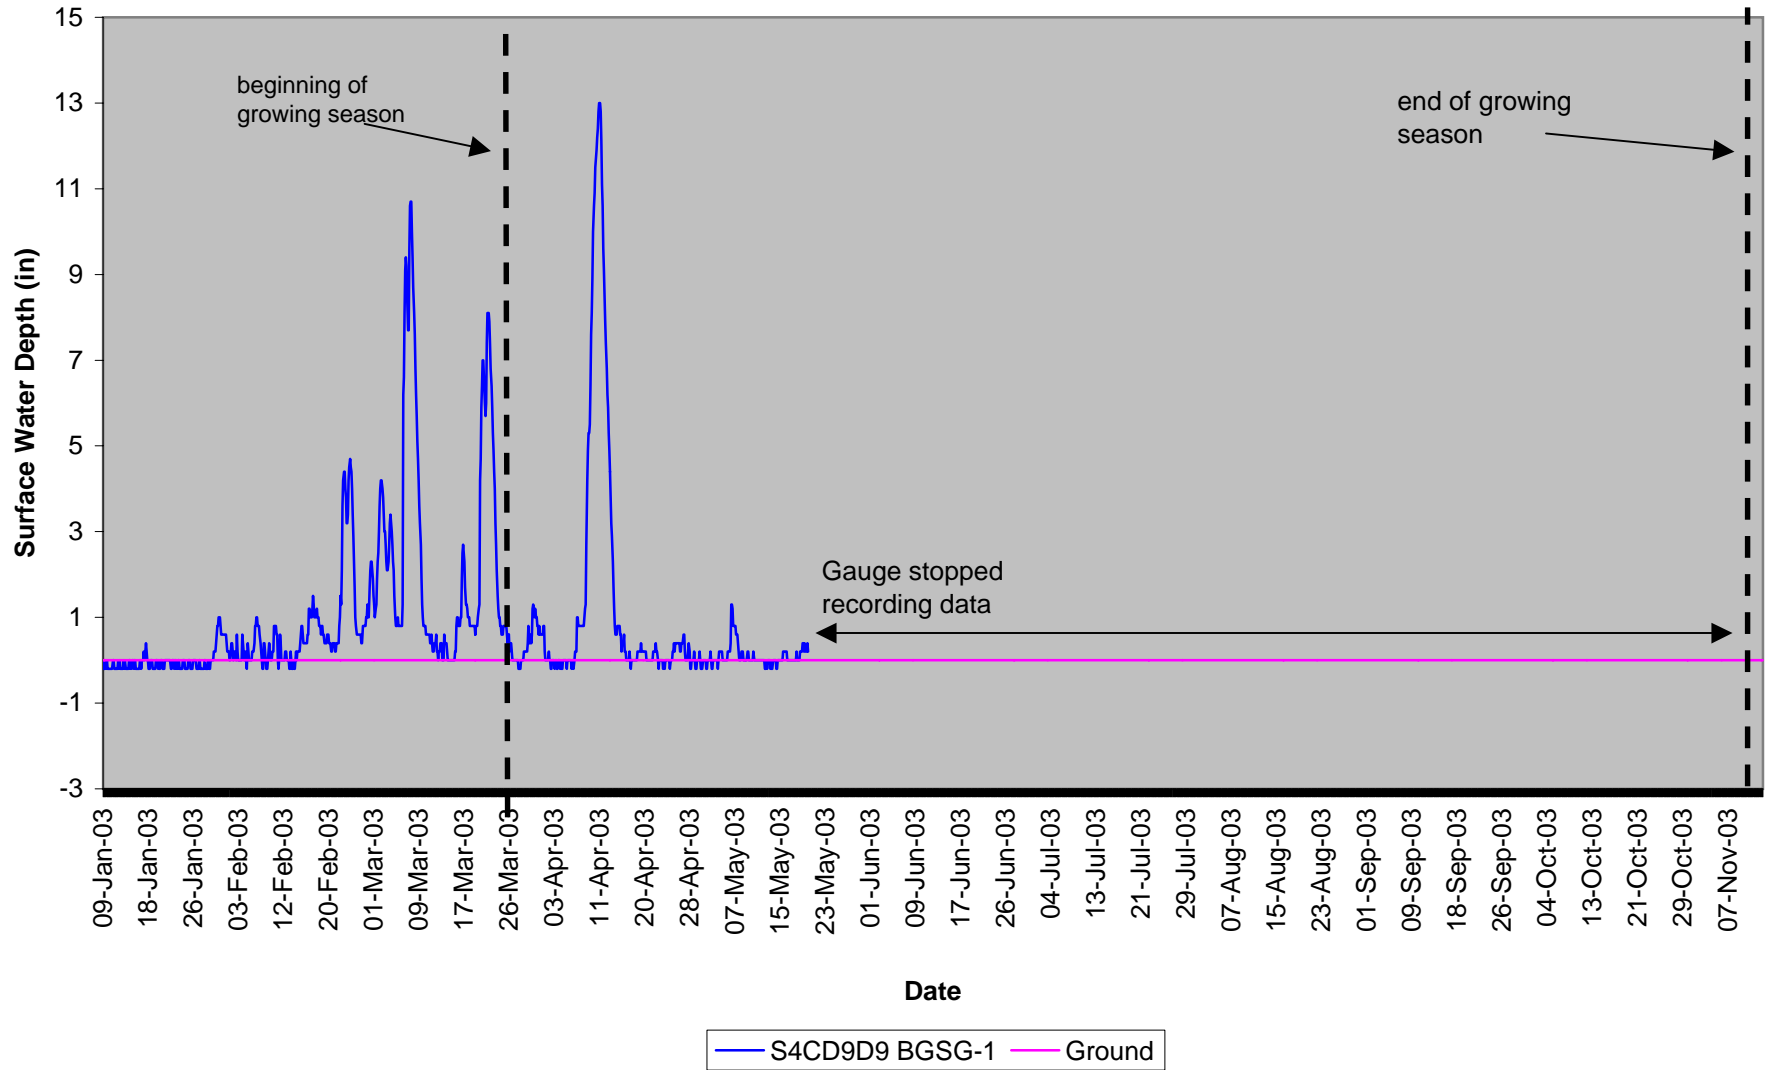
Benson Grove BGS-1

- Gauge BGS1 experienced a malfunction and stopped recording data at the end of May. The gauge was not downloaded for the rest of the growing season.
