# ANNUAL REPORT FOR 2004

**Benson Grove Mitigation Site**  
**Johnston County**  
**Project No. 8.1402211**  
**TIP No. R-2547WM**

Prepared By:  
Office of Natural Environment & Roadside Environmental Unit  
North Carolina Department of Transportation  
December 2004

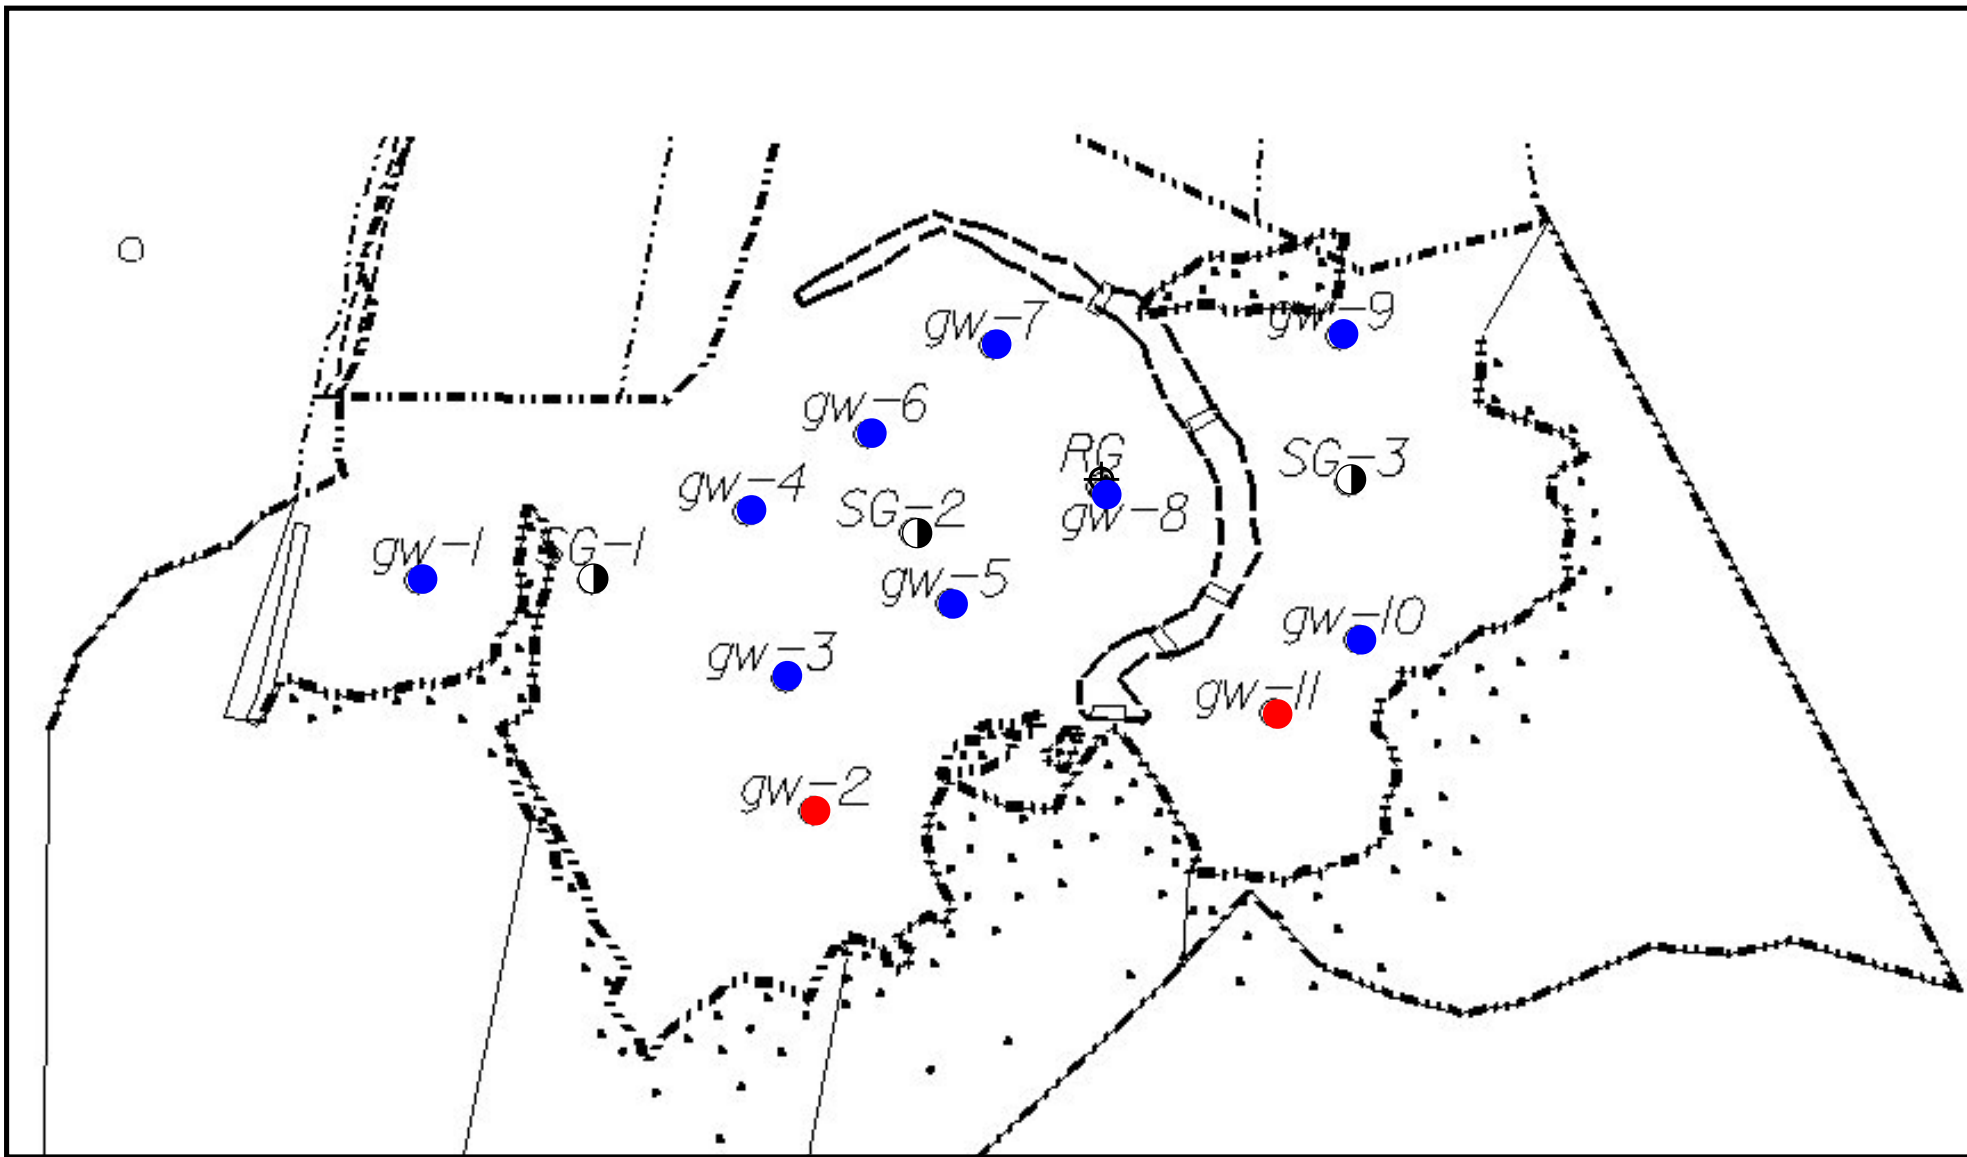
**Figure 3. 2004 Hydrologic Monitoring Gauge Results**

Figure 3 provides a graphical representation of the hydrologic results. Gauges highlighted in blue indicate wetland hydrology for more than 12.5% of the growing season. Gauges highlighted in red show hydrology between 8% and 12.5% of the season, while those in green indicate hydrology between 5% and 8% of the growing season.

Monitoring Well	<5%	5-8%	8-12.5%	>12.5%	Actual %	Success Dates
BGGW-1+				✘	25.3	March 26-May 17 May 20-July 16
BGGW-2			✘		12.2	March 26-April 8 May 23-June 19
BGGW-3+				✘	53.3	March 26-July 25 July 30-Oct 26
BGGW-4+				✘	44.1	March 26-April 23 July 30-Nov 7
BGGW-5+				✘	16.2	Aug 13-Aug 26 Aug 30-Oct 5
BGGW-6+				✘	45.4	March 26-May 17 May 23-July 15 July 30-Nov 10
BGGW-7+				✘	50.7	March 26-May 17 May 23-July 15 July 30-Nov 10
BGGW-8+				✘	44.5	March 26-May 16 May 23-June 24 July 30-Nov 8
BGGW-9+				✘	45.4	March 26-May 18 May 20-July 14 July 30-Nov 10
BGGW-10+				✘	45.4	March 26-May 13 May 23-June 19 July 30-Nov 10
BGGW-11			✘		10.0	July 30-Aug 21 Oct 26-Nov 10

- BGGW-11 malfunctioned during the beginning and the end of the growing season.

The 2004-year represents the third year for hydrologic monitoring. Nine of the eleven gauges indicated saturation within 12” of the ground for greater than 12.5% of the growing season. The three surface gauges revealed varying levels of inundation throughout the growing season. Surface gauges BGSG-2 and BGSG-3 malfunctioned during the growing season, however the gauges did exhibit periods of inundation prior to and after the malfunction.
