**BEST STREAM AND WETLAND RESTORATION PROJECT
MONITORING REPORT
MONITORING YEAR 1**

DUPLIN COUNTY, NORTH CAROLINA
CONTRACT NO. 004631 - PROJECT NO. 95353

March 2016

**Best
Duplin County, North Carolina
DMS Project ID 95353**

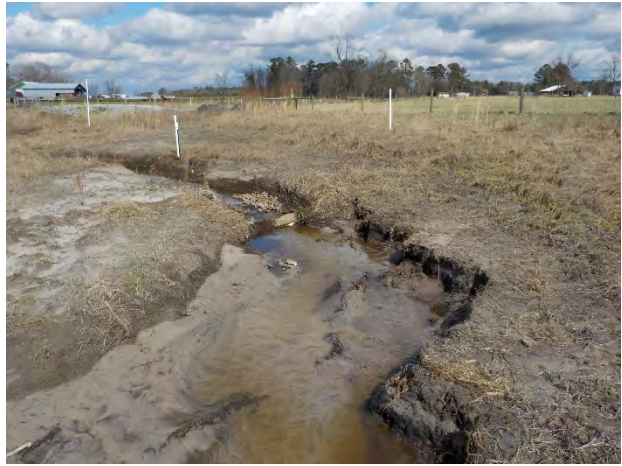
SPA2- Bank Erosion and Loose log structures- UT1 @ Sta. 15+90 to 16+80

Table 7. Stream Problem Areas			
Best Stream and Wetland Restoration Project - Project # 95353			
Feature Issue	Station # / Range	Suspected Cause; Repair	Photo Number
Bank Erosion	UT1- Sta 14+90	Lack of vegetation; regrade, plant livestakes and install matting	SPA1
Bank Erosion/Loose grade control structures	UT1- Sta. 15+90 to 16+80	Heavy rain event and sustained high flows; repair banks and repair/reinstall log structures, livestake and install matting after all work is complete	SPA2
Loose grade control structure	UT1- Sta. 17+60	Heavy rain event and sustained high flows; repair banks and repair/reinstall log structure	SPA3
Bank Erosion/Loose grade control structure	UT2- Sta. 25+50	Heavy rain event and sustained high flows; repair left bank and reinstall log structure, livestake and install matting after all work is complete	SPA4
Loose grade control structure	UT2- Sta. 26+25	Heavy rain event and sustained high flows; repair banks and repair/reinstall log structure	SPA5

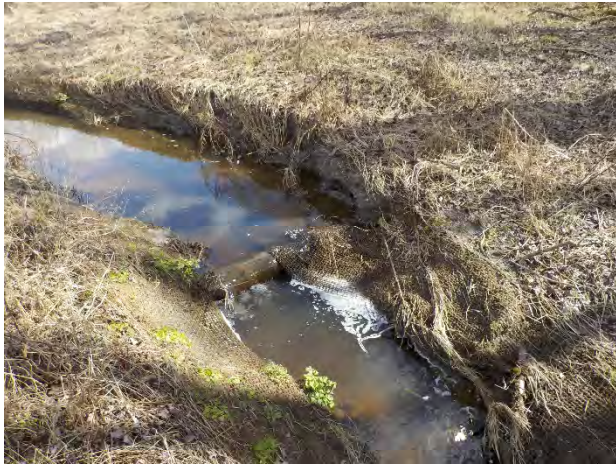
SPA3- Loose log structure- UT1 @ Sta. 17+60

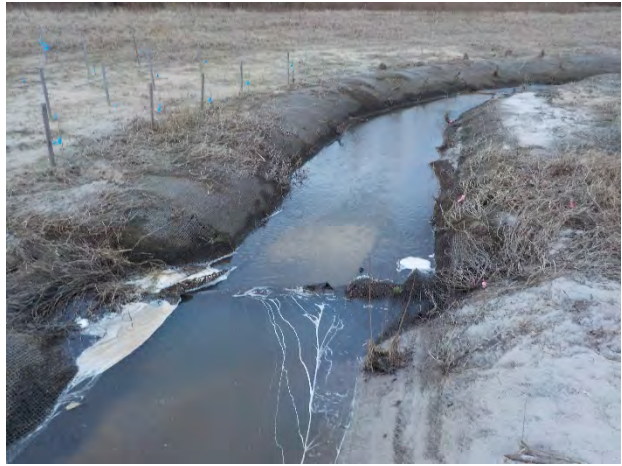
SPA4- Bank Erosion and Loose log structure- UT2 @ Sta. 25+50

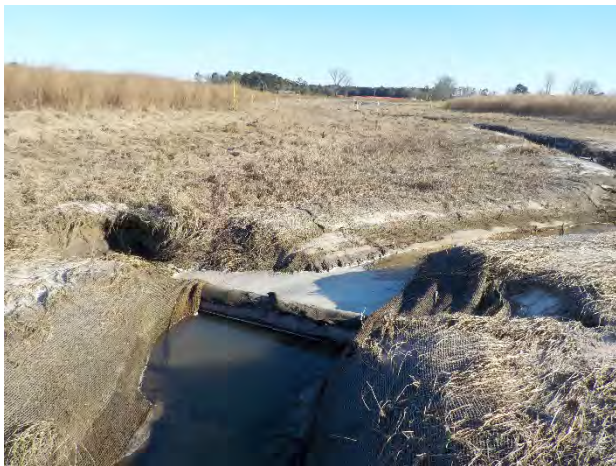
SPA5- Loose grade control structure- UT2 @ Sta. 26+25

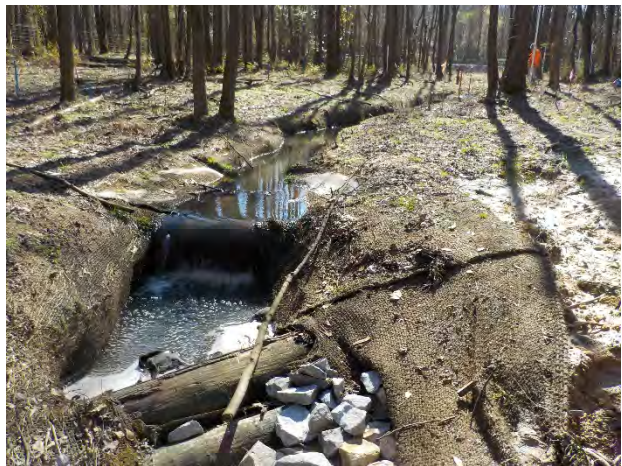
SPA6- Loose structure and bank erosion- UT4 @ Sta 10+25 to 11+00

Seven stream problems were identified during the Year 1 monitoring period and have been mapped on the Current Conditions Plan View (CCPV). Year 1 stream problems are likely the result of October 2015 Hurricane Joaquin which resulted in record amount of rainfall flowing through the newly constructed site. Stream problem 1 (SPA1) consists of minor bank erosion at station 14+90 on UT1 just below the crossing. This area can be repaired with livestakes and securing the matting back in place. Stream problems 2 and 3 (SPA2 and SPA3) are also located along UT1 and exhibit bank erosion and unstable log grade control structures. Remedial action activities will include repairing the bank erosion areas and re-installation of the log grade control structures. Stream problems 4 and 5 (SPA4 and SPA5) are similar to SPA2 and SPA3 but are located on UT2. These areas of bank erosion and log grade control failures are located from Sta. 25+50 - 26+25. Eroding stream banks and log structures will be repaired in this segment along UT2. Stream problem area 6 (SPA6) is located on UT4 and shows evidence of bed and bank erosion. Log structures within this 75 foot stream segment need repairing as well. Concentrated overland flow has created some gullies and rills. Structures and stream banks will be repaired on UT4 from Sta. 10+25 – 11+00. The last stream

Bank, Bed, and Floodplain Erosion	UT4- Sta. 10+25 to 11+00	Heavy rain event and sustained high flows; repair banks and repair/reinstall log structures, regrade floodplain to disperse concentrated overland flow	SPA6 (2 photos)
Bank Erosion/Failing Crossing	UT8- Sta. 4+07 to 4+67	Loose soil and heavy rain; repair/replace crossing, livestake and install matting on banks	SPA7 (2 photos)

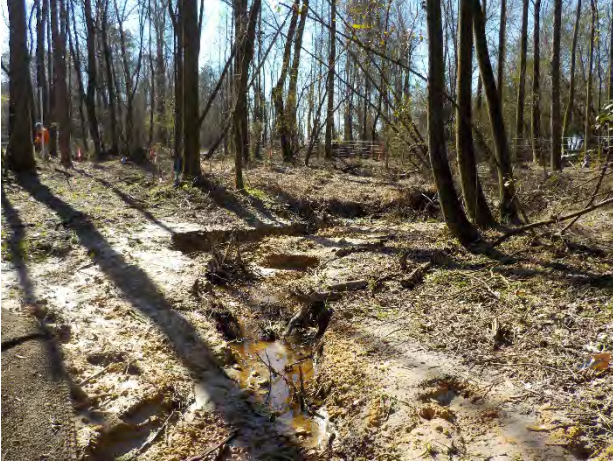
SPA6- Floodplain erosion/concentrated flow- UT4
@ Sta 10+25 to 11+00

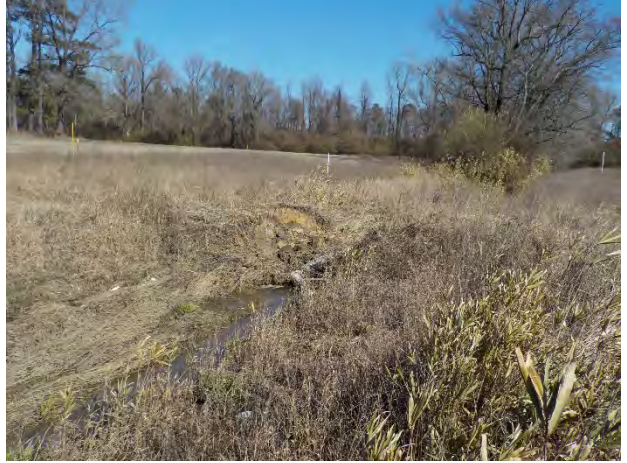
problem area (SPA7) is located on UT8 stream crossing. This area is within the easement break; however, the stream culvert and banks have blown out. The existing culvert remains in place but likely needs to be upsized and re-installed. This stream crossing was an existing culvert and was not upgraded during initial construction activities. Upon completion of all stream erosion and structure repairs, the areas will be matted and livestaked. All stream problem areas are localized and the overall stability of the project streams on site are stable. Remedial action repair work is planned for spring 2016.

SPA7- Failing Crossing- UT8 @ Sta 4+07 to 4+67

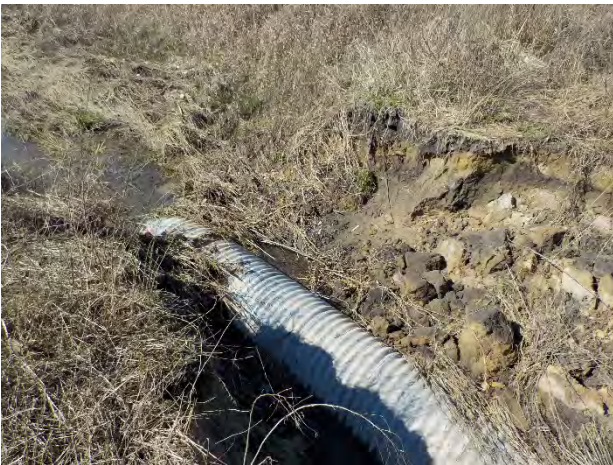
SPA7- Failing Crossing- UT8 @ Sta 4+07 to 4+67
