**BEST STREAM AND WETLAND RESTORATION PROJECT
MONITORING REPORT
MONITORING YEAR 2**

DUPLIN COUNTY, NORTH CAROLINA
CONTRACT NO. 004631 - PROJECT NO. 95353

**Best
Duplin County, North Carolina
DMS Project ID 95353**

**Cape Fear River Basin
HUC 03030007060010**

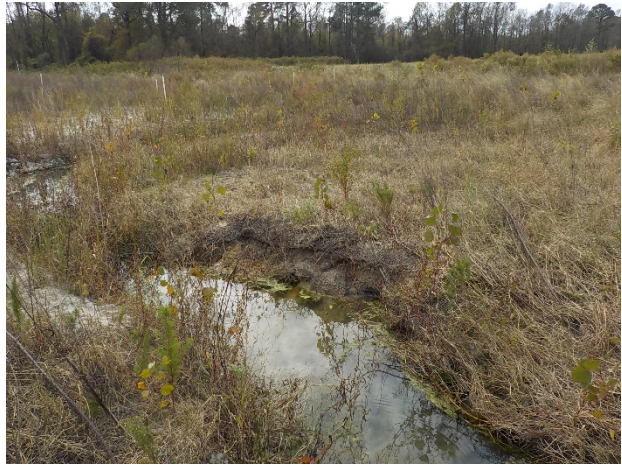
SPA2- Bank Erosion and Loose matting- UT2 @ Sta. 27+00

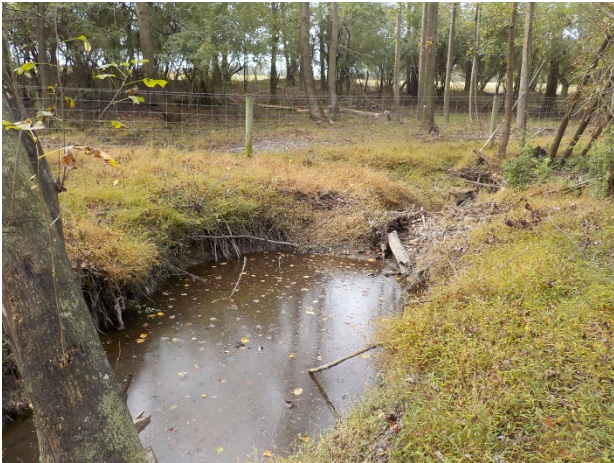
SPA3- Relic Channel Floodplain Erosion- UT4 @ Sta. 10+25 – 11+00

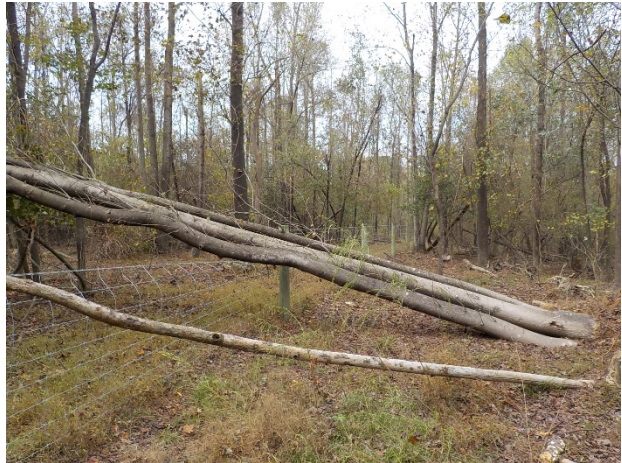
SPA4- Easement Fencing Damage- UT3 and UT4
(All damaged fence has been repaired)

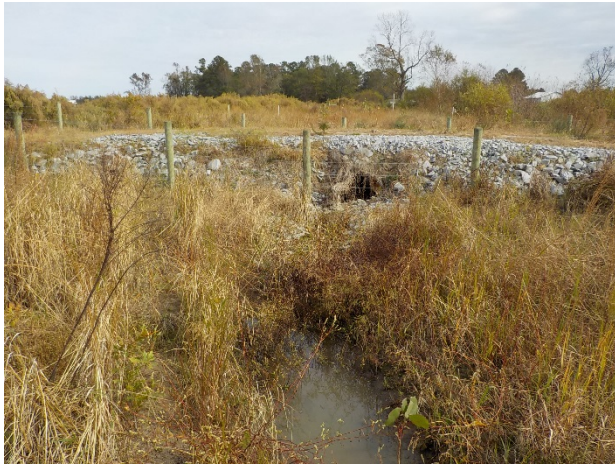
MY1 - SPA1- Bank Erosion- UT1

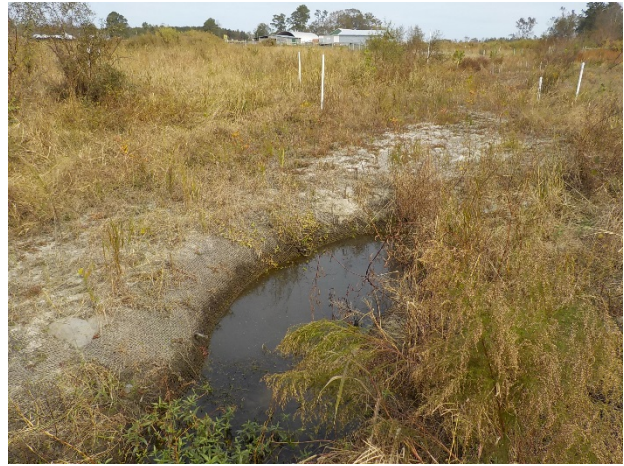
MY1 - SPA2- Bank Erosion and Loose log structures- UT1

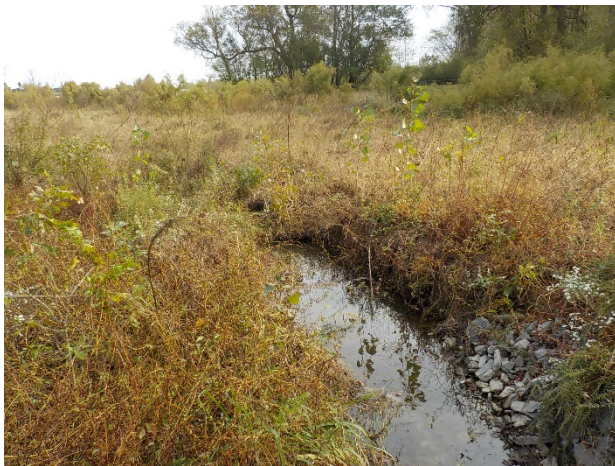
MY1 - SPA3- Loose log structure- UT1

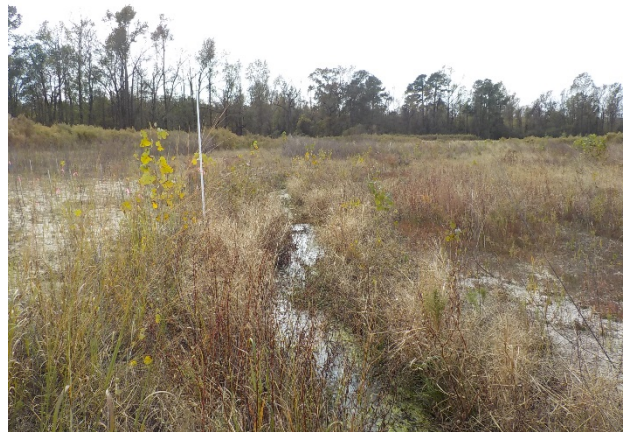
MY1 - SPA4- Bank Erosion and Loose log structures- UT2

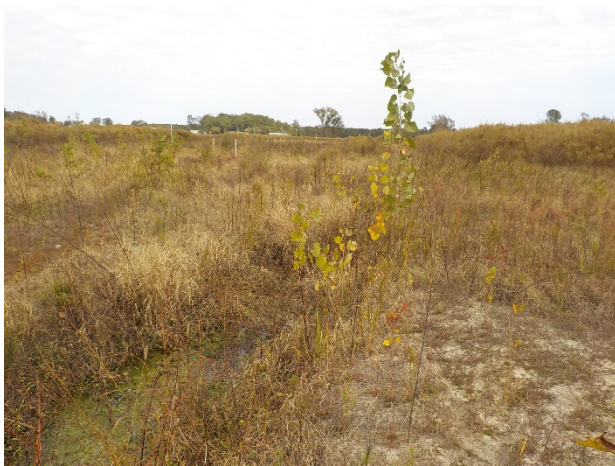
MY1 – SPA5- Bank Erosion and Loose log structures- UT2

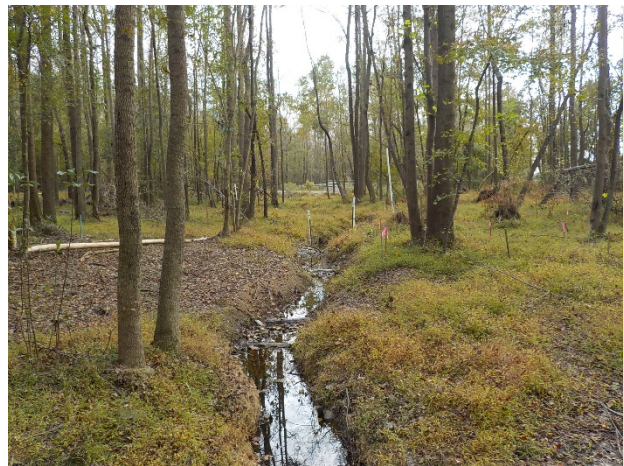
MY1 - SPA6- Loose structure and bank erosion- UT4

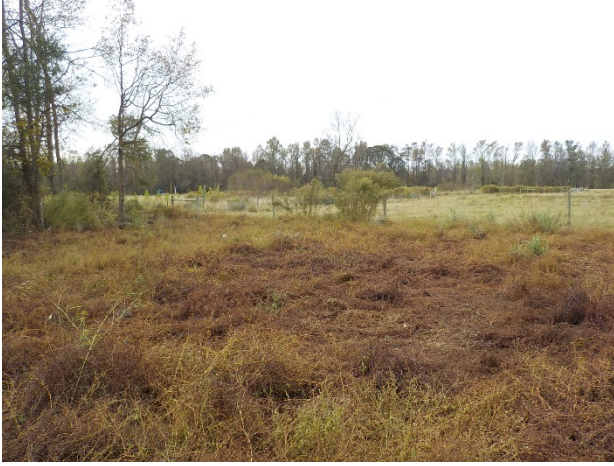
VPA1- Low Stem Density - UT1 @ Sta. 3+00 to 8+50 (0.47 Ac.)
