**BEST STREAM AND WETLAND RESTORATION PROJECT  
MONITORING REPORT  
MONITORING YEAR 3  
FINAL**

DUPLIN COUNTY, NORTH CAROLINA  
CONTRACT No. 004631 - PROJECT No. 95353  
USACE Action ID No. 2012-01384 -NCDWR Project No. 13-0865

RE: Best Stream and Wetland Restoration Site: MY3 Monitoring Report (NCDMS ID 95353)

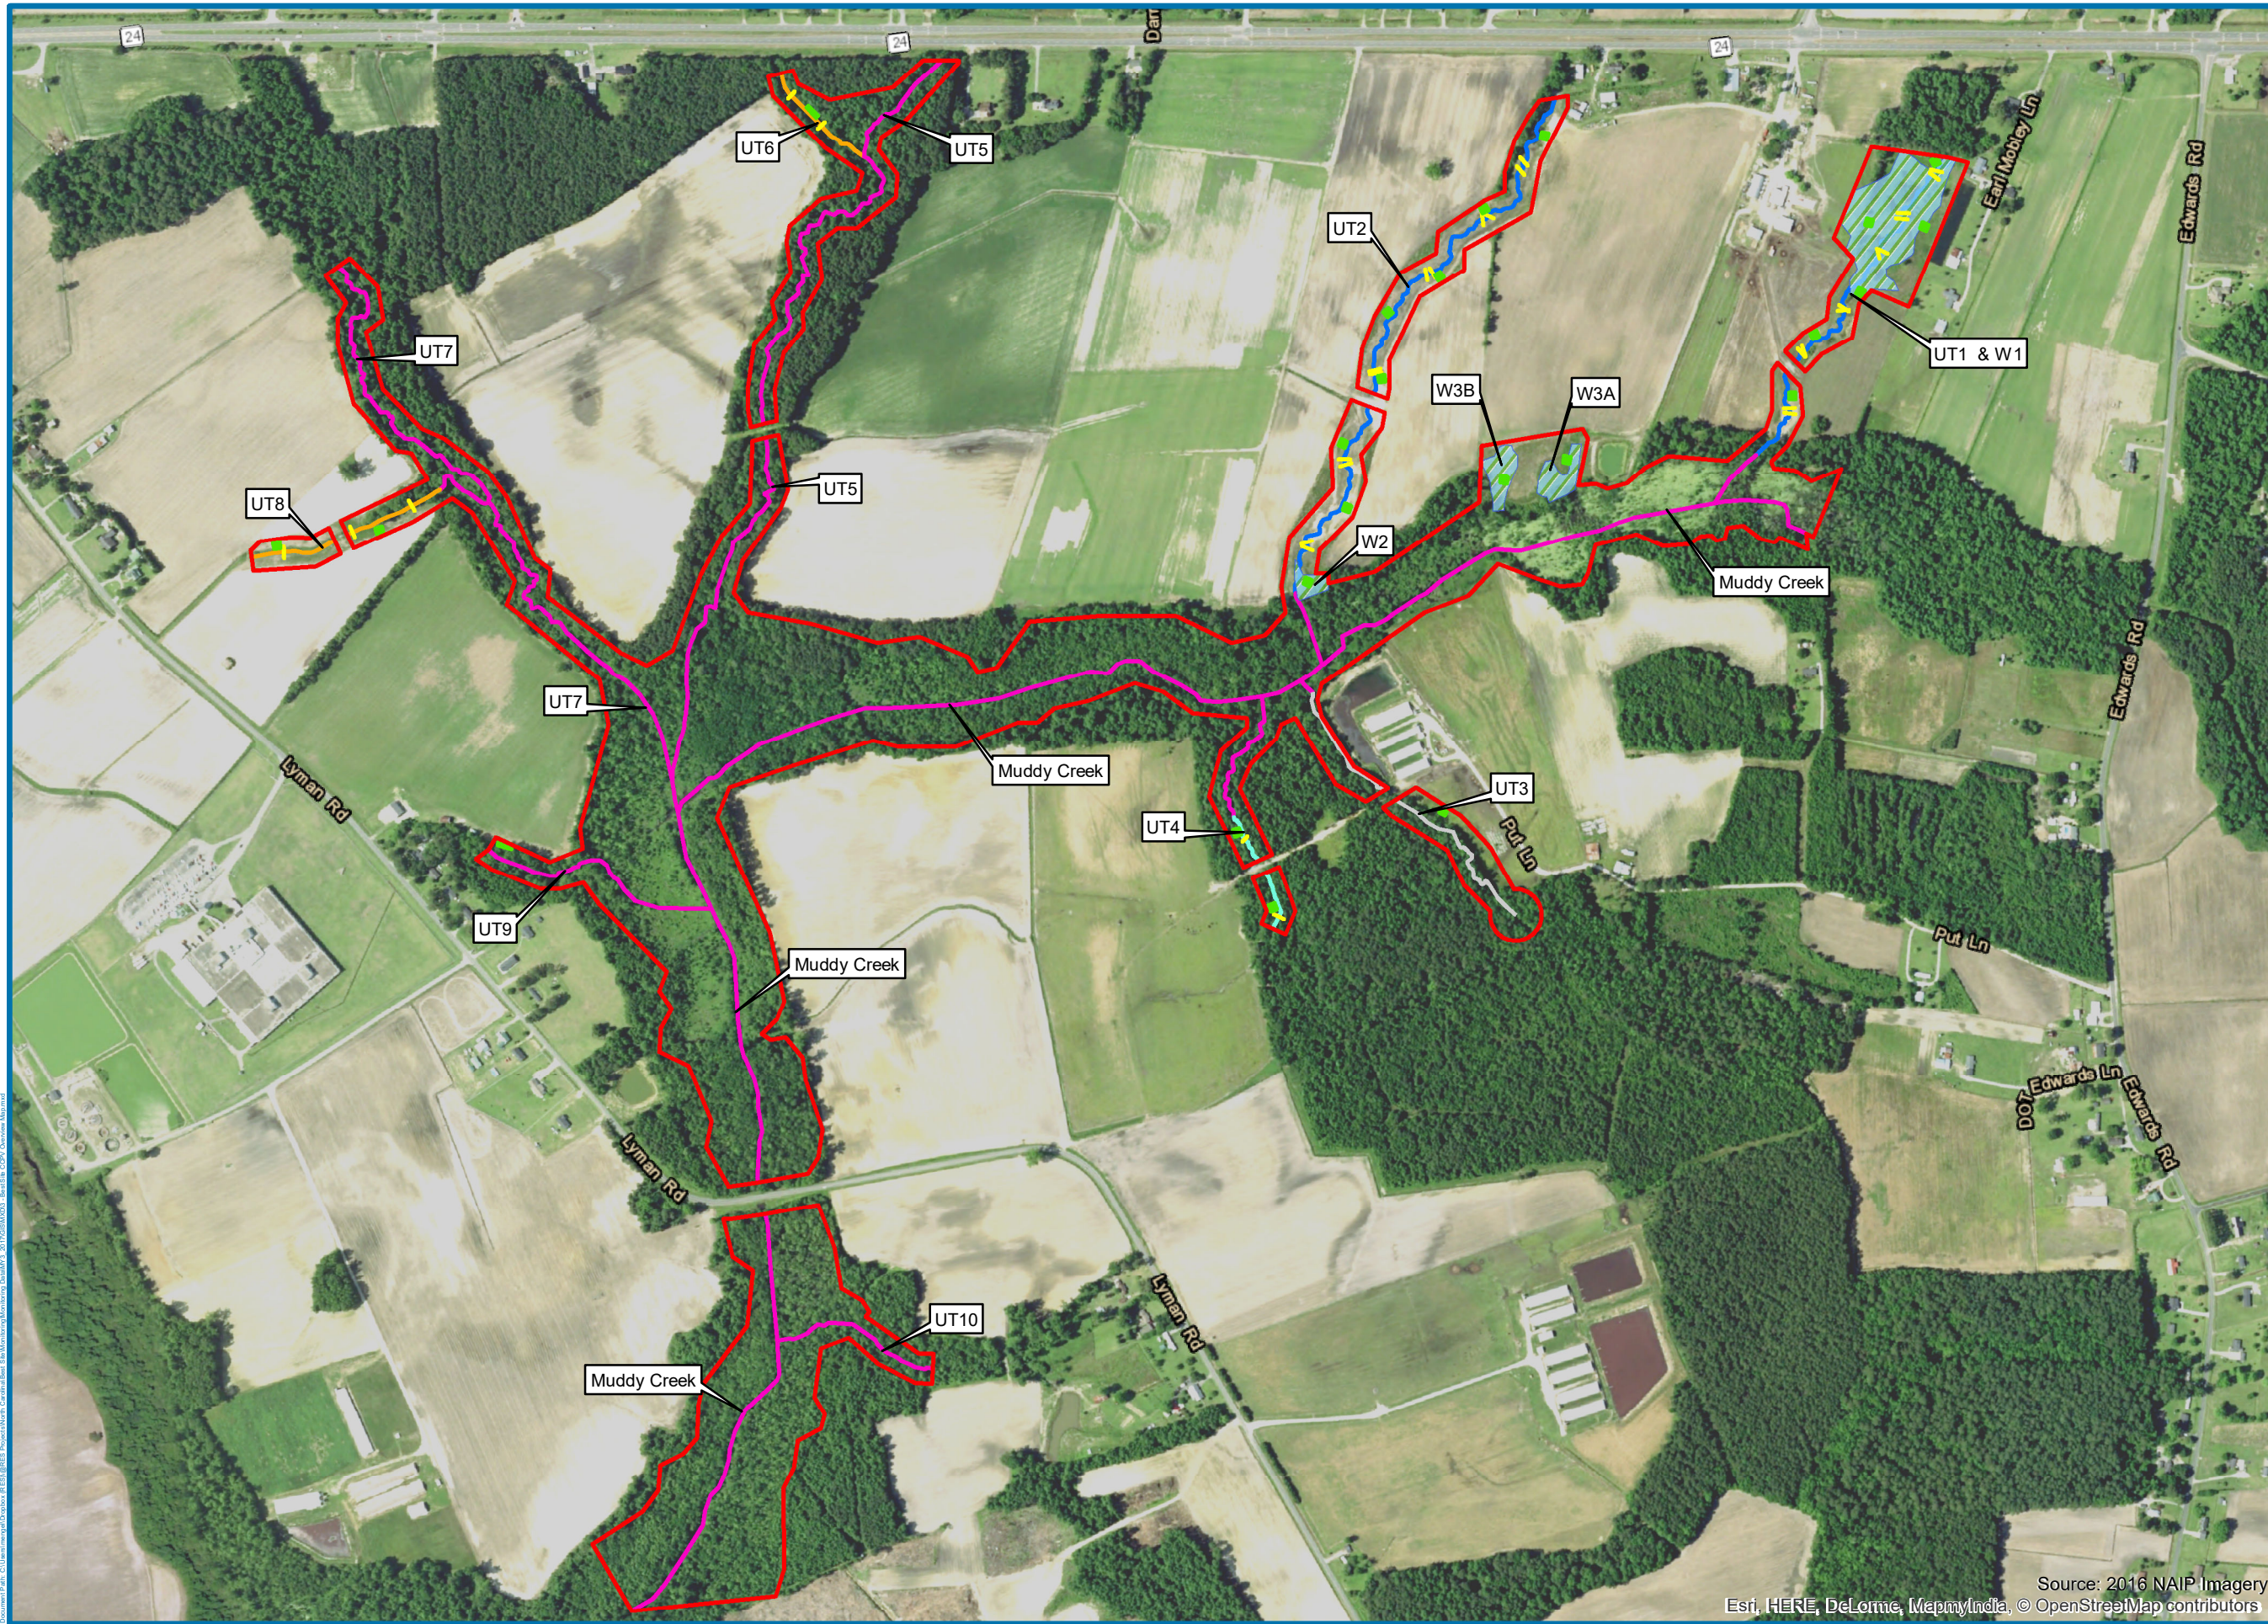
**Figure 3**  
**Best Stream and Wetland**  
**Restoration Project**  
**MY 3 2017**  
**Current Conditions**  
**Overview Map**

Four stream problems were identified during the Year 3 monitoring period and have been mapped on the Current Conditions Plan View (CCPV) (**Figure 3**). Stream problem area 1 (SPA1) is located on UT3 at station 7+50. Fence has been damaged due to fallen trees. Stream problem area 2 (SPA2) consists of minor bank erosion on UT4 at station 5+60 and station 7+00. These areas appear stable and RES plans to continue to monitor these areas to see if they worsen. If conditions continue to worsen, livestock and additional bank matting will be installed along the banks. Stream problem area 3 (SPA3) is located on UT4 from station 8+47 to 8+67. This area consists of ponding on the road, due to downstream issue at SPA4. The area involves adding fill material to eliminate the ponding on the road. SPA4 is located on UT4 from station 8+75 to 11+03, and is attributed to the subsidence of the plug that had been installed at construction. This problem is a continued portion of (MY1-SPA6, MY2-SPA3) and is associated with the relic stream channel. Fill material needs to be added to raise the plug elevation in the relic channel. All stream problem areas are localized and the overall condition of the project streams on site are stable. Remedial action repair work is planned for spring 2018.

Ten vegetation problems were identified during the Year 3 monitoring period. These vegetation problem areas are documented and mapped on the CCPV (**Figure 3**) as part of the annual monitoring report. Vegetation problem area 1 (VPA1) is a low stem density area along UT1 and Wetland 1. This area is approximately half an acre in size and is well vegetated with herbaceous cover but lacks woody planted stems. Vegetation problem area 2 (VPA2) is an area where the invasive species mimosa (*Albizia julibrissin*) and Chinese privet (*Ligustrum sinense*) are present along UT1 and Wetland 1. This area is approximately a tenth of an acre in size, and is well vegetated with native trees and native herbaceous cover. RES plans to treat the invasive species in this area in 2018. Vegetation problem area 3 (VPA3) is a low stem density area along UT1. This area is approximately half an acre in size and is well vegetated with herbaceous cover but lacks woody planted stems. Therefore, RES will perform an additional supplemental replant within this area in the spring 2018 with one gallon-containerized trees. Vegetation problem area 4 (VPA4) is a poor growth/vigor area along UT1. This area is approximately a quarter of an acre in size and is vegetated with herbaceous cover, however planted stems have poor vigor. Vegetation problem area 5 (VPA5) is an encroachment area along UT2. This area is less than a tenth of an acre in size and has been subject to overspray from the adjacent farming operation. Vegetation problem area 6 (VPA6) is a poor growth/vigor area along UT2. This area is approximately a quarter of an acre in size and is vegetated with herbaceous cover however, planted stems have poor vigor. Vegetation problem area 7 (VPA7) is an encroachment area along UT2. This area is approximately a tenth of an acre in size and has been subject to overspray from the adjacent farming operation. Vegetation problem area 8 (VPA8) is an area of low stem density. Vegetation plot 17 within this area exhibited complete mortality; therefore, RES will perform an additional supplemental replant within this area in the spring 2018. It should be noted that VPA8 was replanted in 2016 but likely did not have survival due to extensive herbaceous overgrowth and shading of planted stems. Spraying or mowing this area may be considered prior to replanting one gallon-containerized trees. Vegetation problem area 9 (VPA9) is a low stem density area along UT4. This area is approximately a sixth of an acre in size and is well vegetated with herbaceous cover but lacks woody planted stems. Therefore, RES will perform an additional supplemental replant within this area in the spring 2018. Vegetation problem area 10 (VPA10) is an encroachment area along UT8. This area is less than a tenth of an acre in size and has been subject to overspray from the adjacent farming operation.

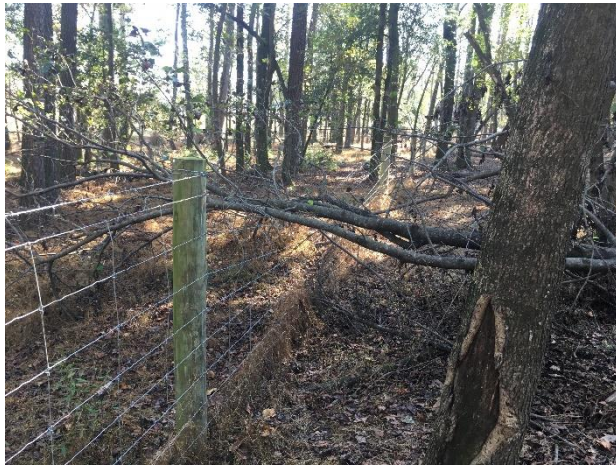
SPA1 – Fence Damage UT3 @ Sta. 7+50

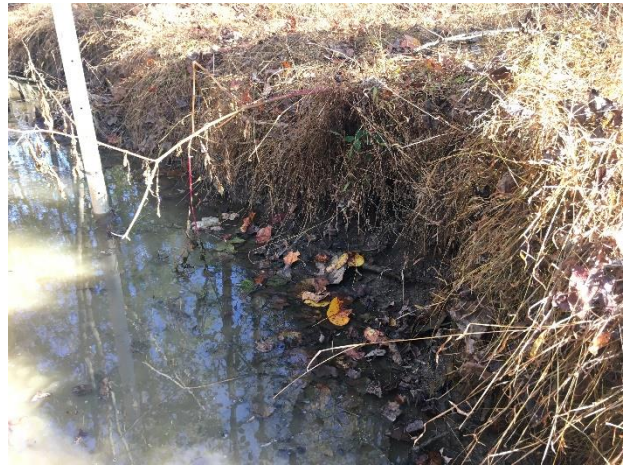
SPA2 – Minor Bank Erosion UT 4 @ Sta. 5+60 to 7+00

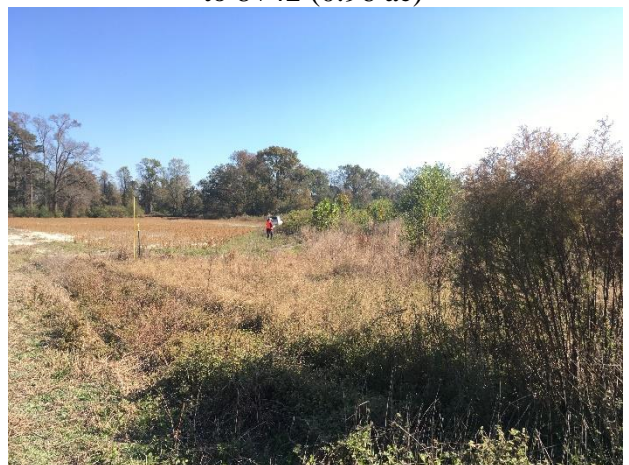
VPA 10 – Encroachment UT8 @ Sta. 0+00 to 1+50 (0.05 ac)
