**BEST STREAM AND WETLAND RESTORATION PROJECT
MONITORING REPORT
MONITORING YEAR 4
FINAL**

DUPLIN COUNTY, NORTH CAROLINA
CONTRACT No. 004631 - PROJECT No. 95353
USACE Action ID No. 2012-01384 -NCDWR Project No. 13-0865

**Best
Duplin County, North Carolina
DMS Project ID 95353**

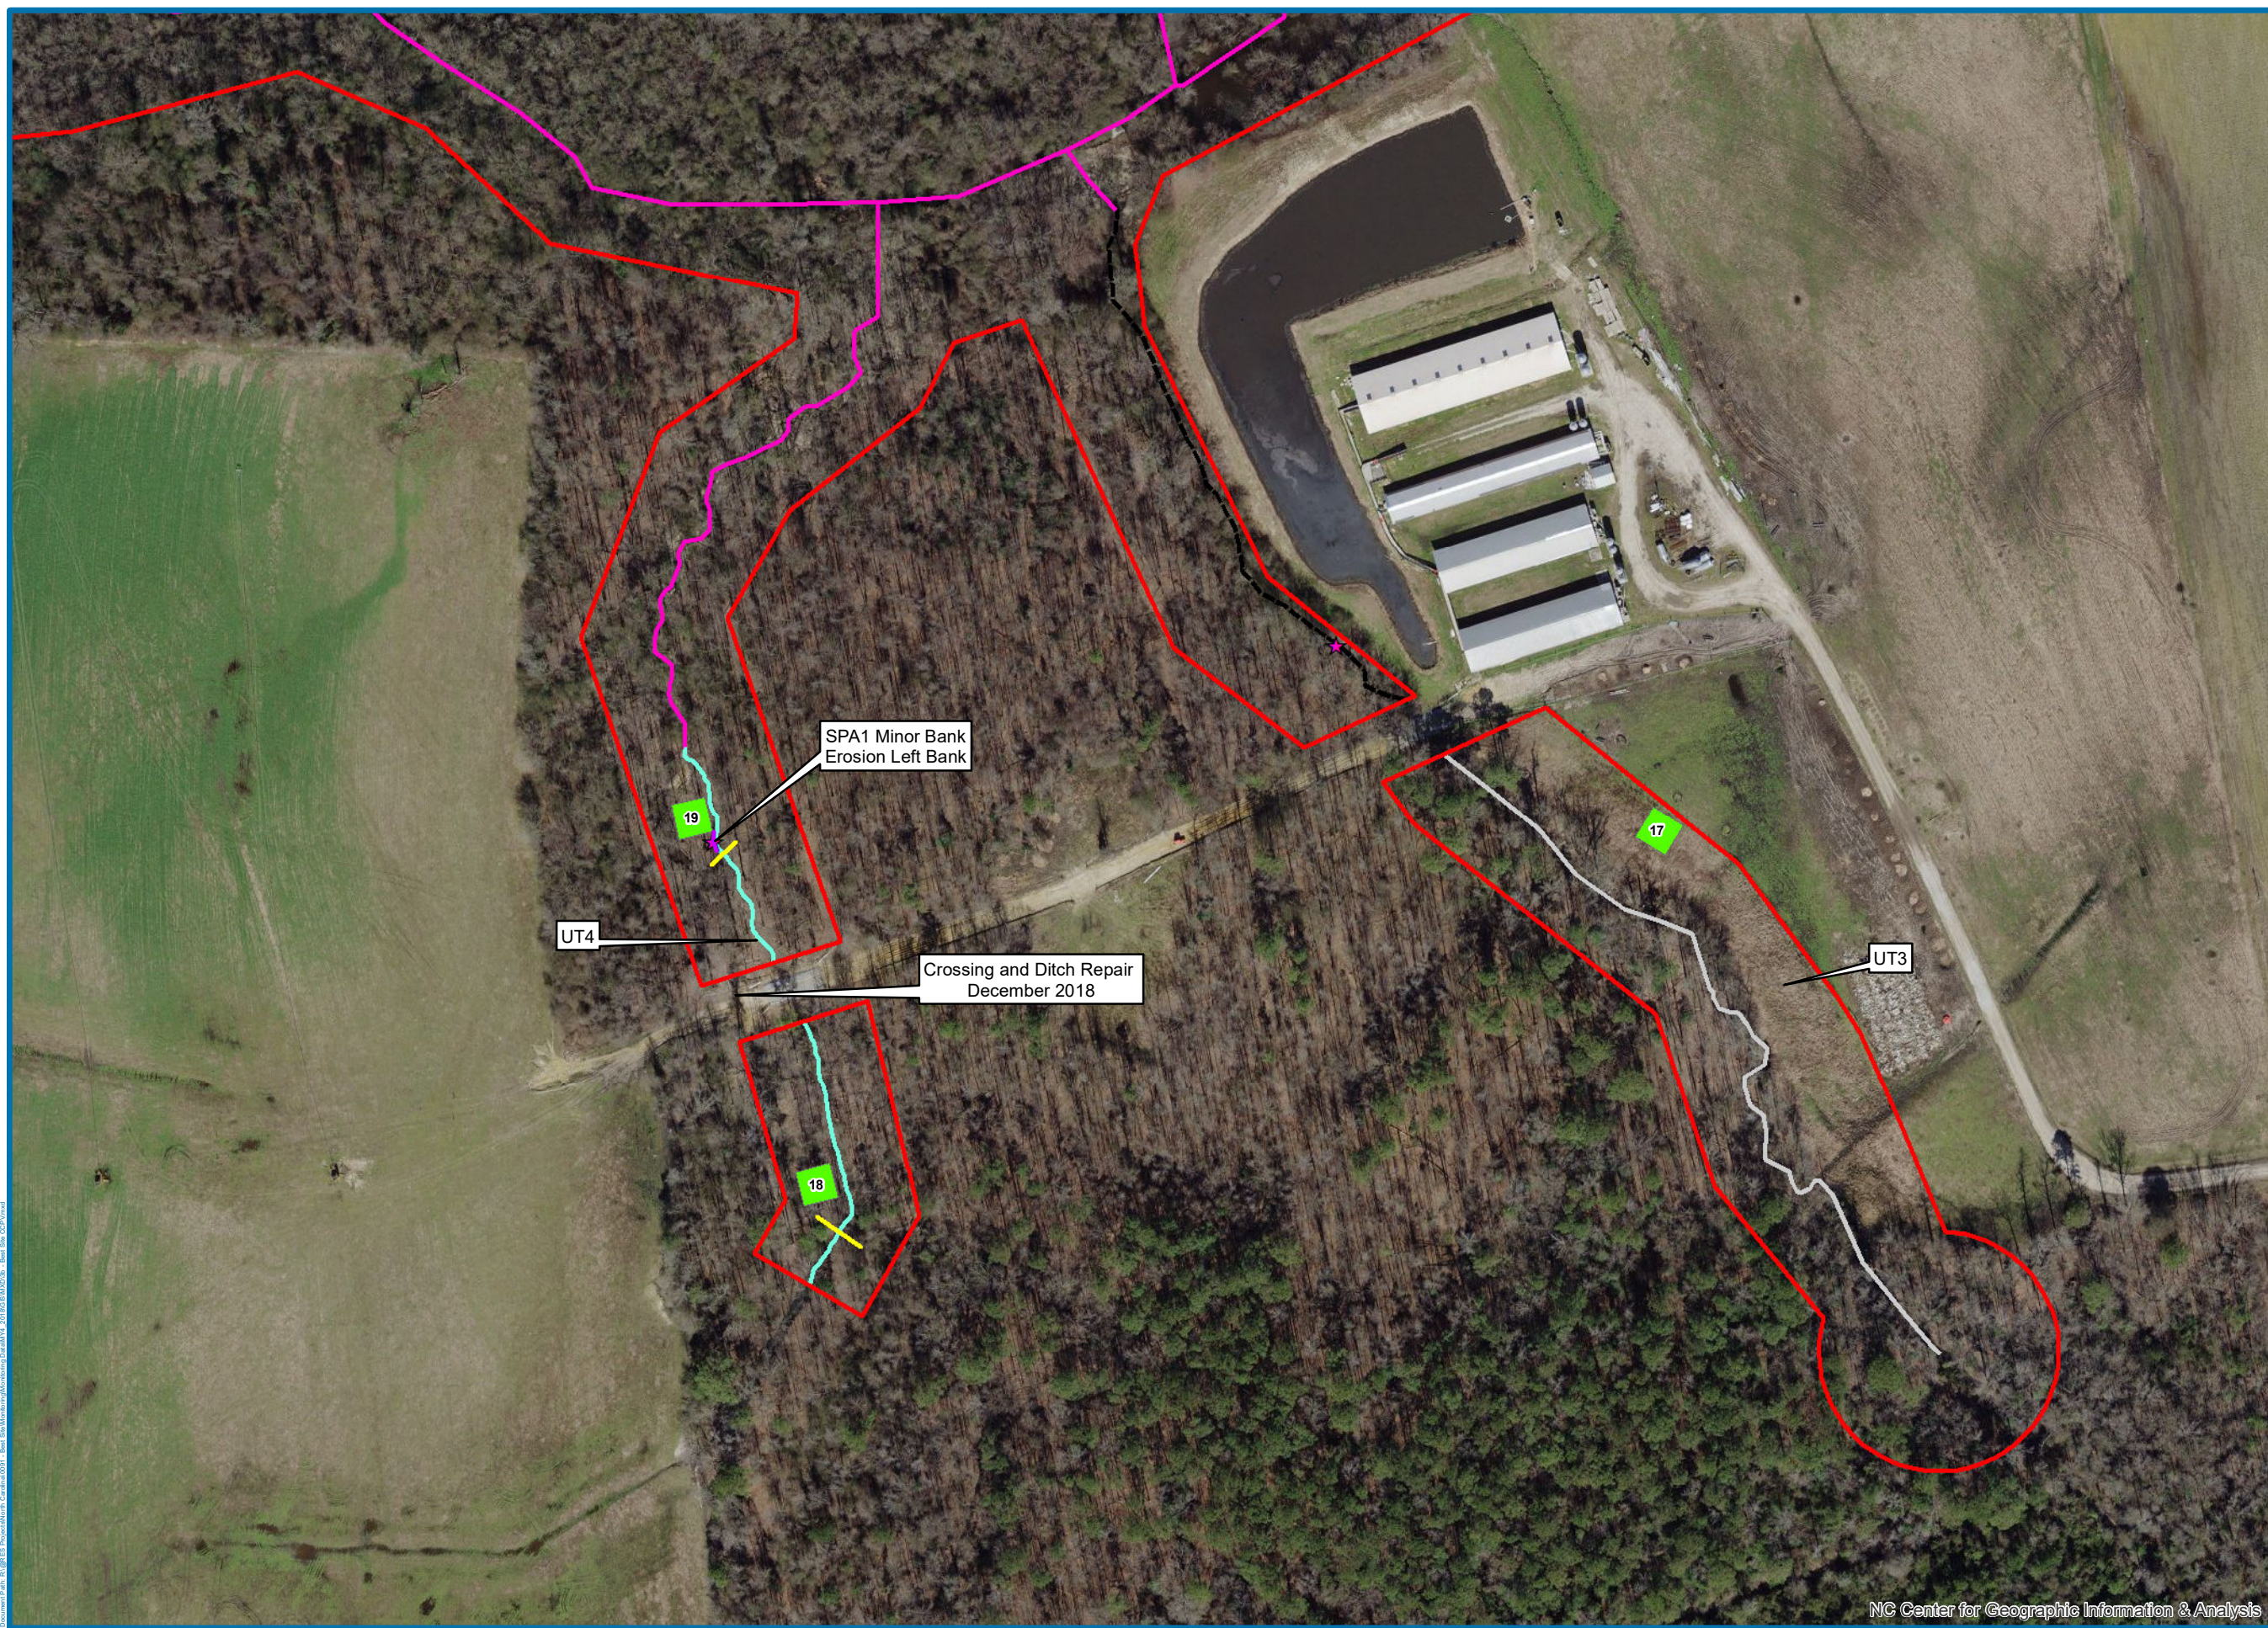
SPA1 Minor Bank Erosion Left Bank

Crossing and Ditch Repair December 2018

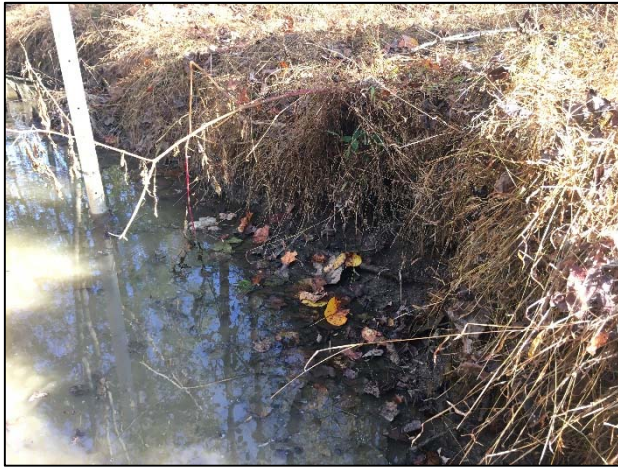
Table 7. Stream Problem Areas			
Best Stream and Wetland Restoration Project - Project # 95353			
Feature Issue	Station # / Range	Suspected Cause; Repair	Photo Number
Minor Bank Erosion	UT 4 - Sta. 10+20	Rain events and high flows; seems stable, continue to monitor	SPA 1
Ponding on Road	UT 4 - Sta. 8+47 to 8+67	Rain events and high flow; added fill to road to reduce ponding in Dec 2018	SPA 2
Relic Channel and Plug Subsidence	UT4- Sta. 8+75 to 11+03	Rain events and high flows; added fill material to raise plugs in relic channel in Dec 2018	SPA 3

SPA1 – Minor Bank Erosion UT 4 @ Sta. 10+10 to 10+30

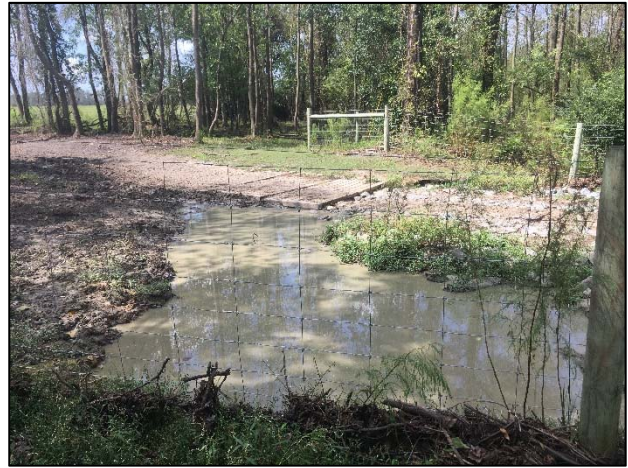
SPA2 – Ponding on Road UT 4 @ Sta. 8+47 to 8+67*

*Repair work completed in December 2018

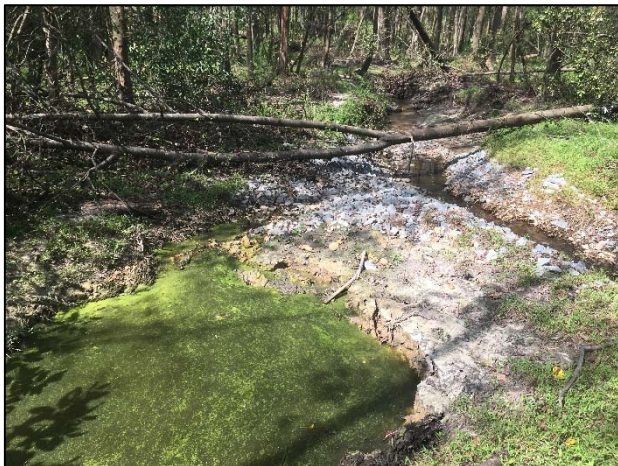
SPA3 – Relic Channel Floodplain Plug Subsidence UT4 @ Sta. 8+75 to 11+03*

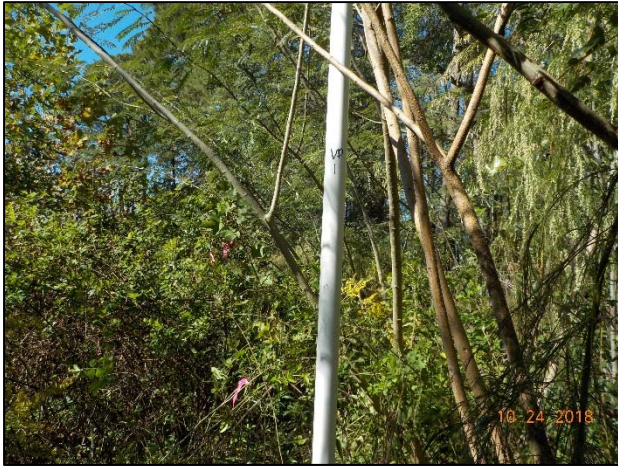
Table 8. Vegetation Problem Areas			
Best Stream and Wetland Restoration Project - Project # 95353			
Feature Category	Station Numbers	Suspected Cause; Repair	Photo Number
Invasives present	UT1 - Sta. 0+00 (0.13 ac)	Invasives present in easement due to offsite seed source; remove invasive by cutting down and applying herbicide	VPA 1
Low Stem Density	UT8	Low Soil Fertility, compaction, and competition with native weeds; Re-plant area with gallon containerized trees in Dec 2018	N/A

VPA 1 – Invasives Present UT1 @ Sta. 0+00
(0.13ac)
