**BEST STREAM AND WETLAND RESTORATION PROJECT
MONITORING REPORT
MONITORING YEAR 5
FINAL**

DUPLIN COUNTY, NORTH CAROLINA
CONTRACT No. 004631 - PROJECT No. 95353
USACE Action ID No. 2012-01384 -NCDWR Project No. 13-0865

February 2020

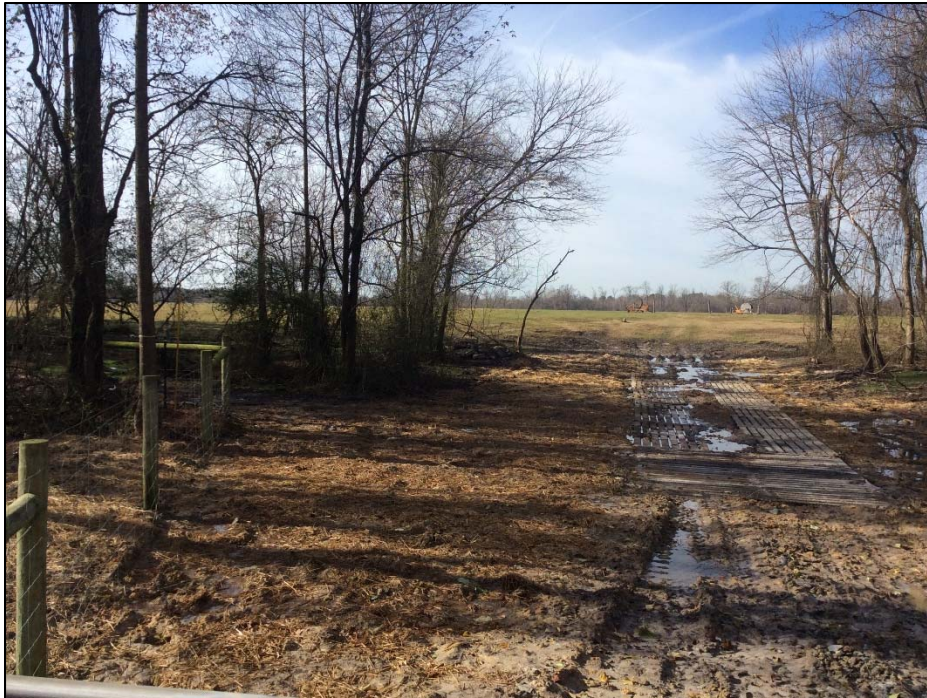
The three stream problems that were identified during the Year 4 monitoring period are no longer problems in Year 5. The minor bank erosion on UT4 at station 10+20 has stabilized and the relic channel along UT4 that caused the road to washout and floodplain erosion was repaired in December 2018.

SPA2 – Ponding on Road UT 4 @ Sta. 8+47 to 8+67 (Photo of repair - December 2018)

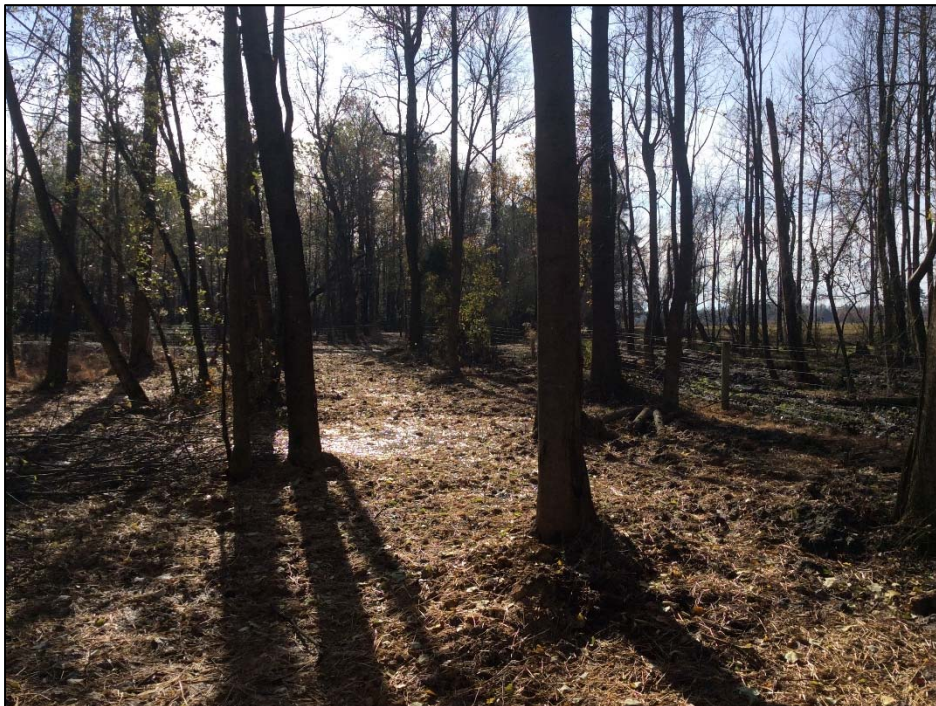
SPA3 – Relic Channel Floodplain Plug Subsidence UT4 @ Sta. 8+75 to 11+03 (Photo of repair - December 2018)

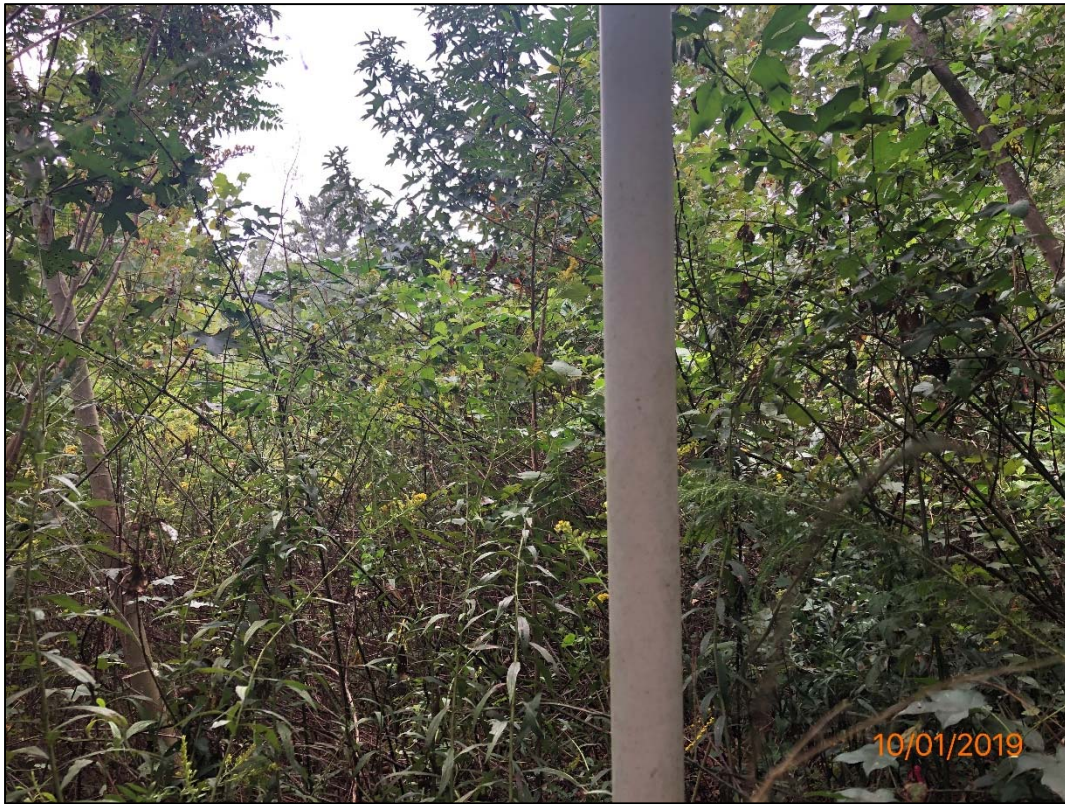
One vegetation problem was identified during the Year 5 monitoring period. This vegetation problem area is documented (**Table 6** and **Table 8**) and mapped on the CCPV (**Figure 3a**) as part of the annual monitoring report. Vegetation problem area 1 (VPA1) is an area where the invasive species mimosa (*Albizia julibrissin*) and Chinese privet (*Ligustrum sinense*) are present along UT1 and Wetland 1. This area is approximately a tenth of an acre in size, and is well vegetated with native trees and native herbaceous cover (VP1 still has 440 planted stems per acre). RES plans to continue treat the invasive species in this area with mechanical and chemical applications. The poor growth and low stem density areas reported in MY4 along UT1 and UT3 were replanted in January 2018.

VPA 1 – Invasives Present UT1 @ Sta. 0+00 (0.13ac)

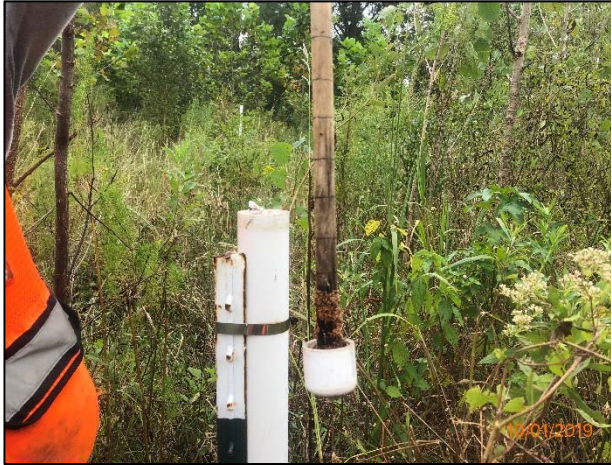
Crest Gauge 1 Reading 0.14'

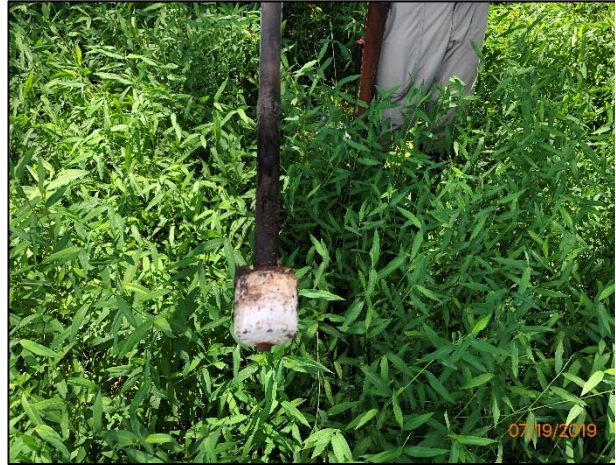
Crest Gauge 5 Reading 0.5'
