**BEST STREAM AND WETLAND RESTORATION PROJECT
MONITORING REPORT
MONITORING YEAR 6
FINAL**

DUPLIN COUNTY, NORTH CAROLINA
CONTRACT No. 004631 - PROJECT No. 95353
USACE Action ID No. 2012-01384 -NCDWR Project No. 13-0865

January 2021

RE: Best Stream and Wetland Restoration Site: MY6 Monitoring Report (NCDMS ID 95353)

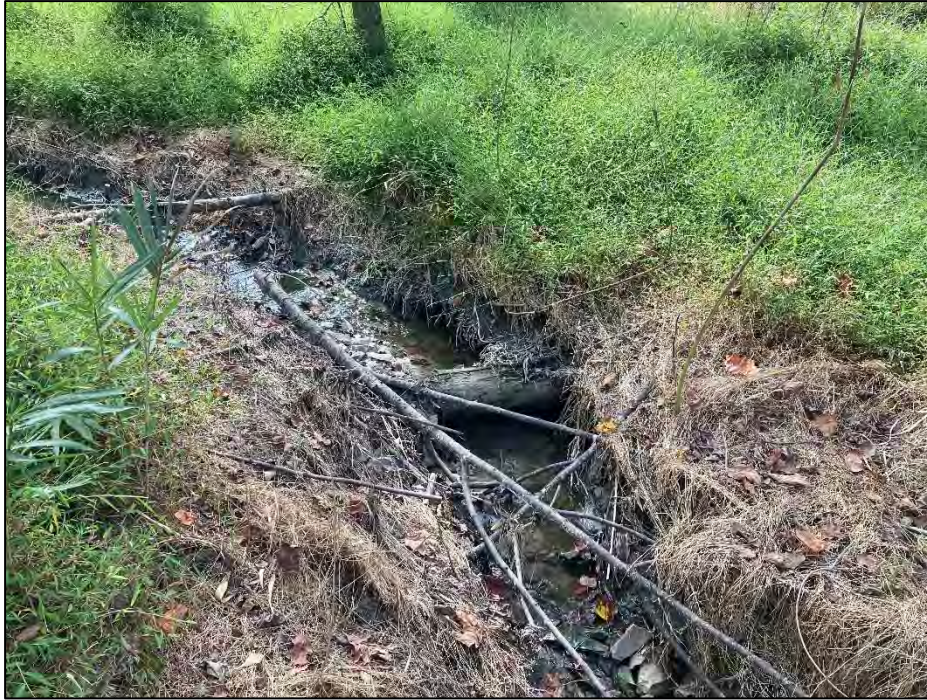
Two minor stream problem areas were found and repaired in October 2020. The first was a piping log sill on UT4 and the second was a piping log sill on UT6. These areas are called out on **Figure 3** and photos are in **Table 8**.

Photo 1 – Piping Log Sill UT4 (Repaired October 2020)

[The piping structures were repaired in October 2020 and are functioning properly, therefore RES does not feel it is appropriate to add them to Table 5.](#)

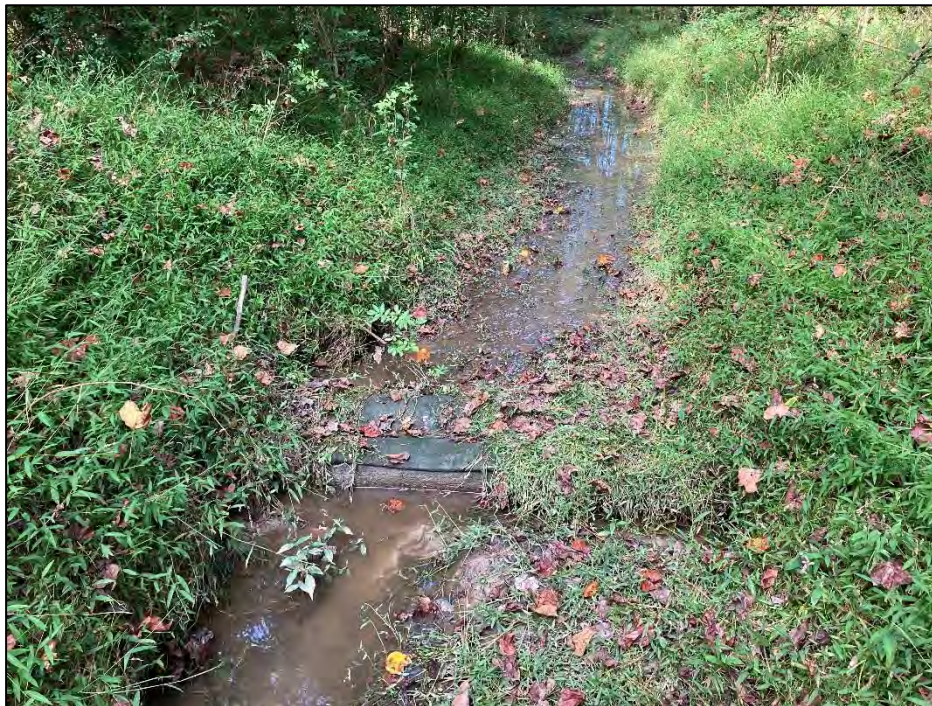
Photo 2 – Piping Log Sill UT6 (Repaired October 2020)

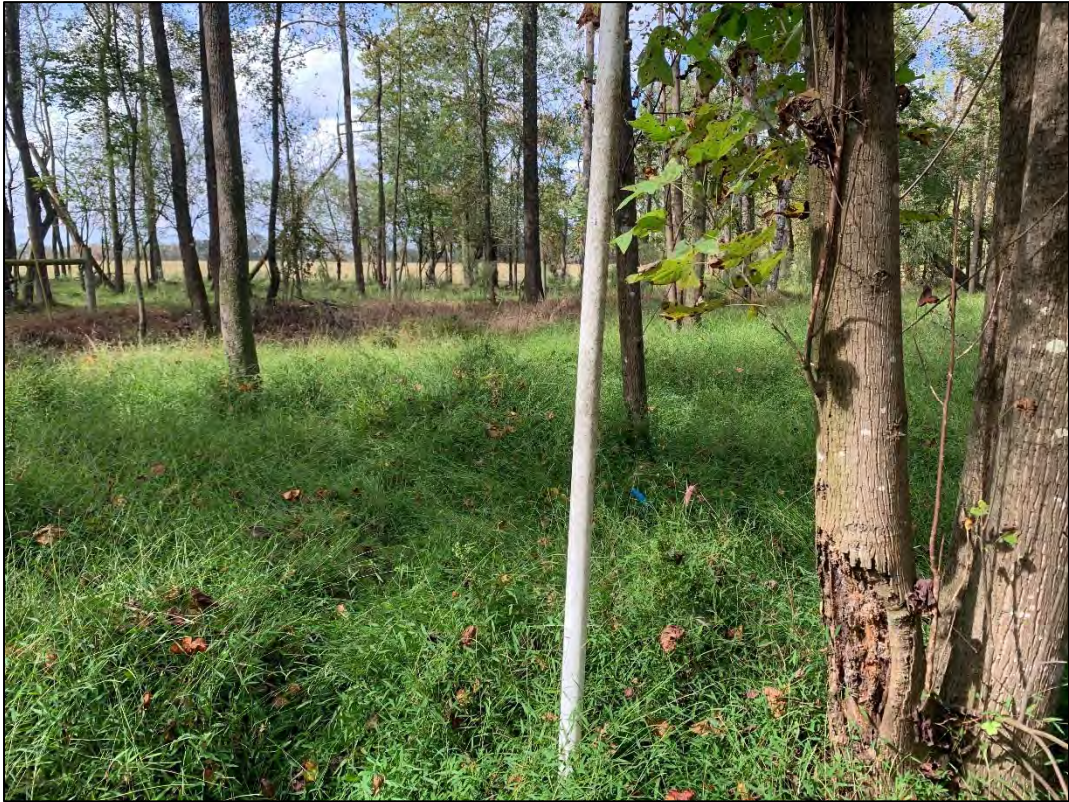
VP18 – Low Stem Density Area UT4 (0.28 acres)

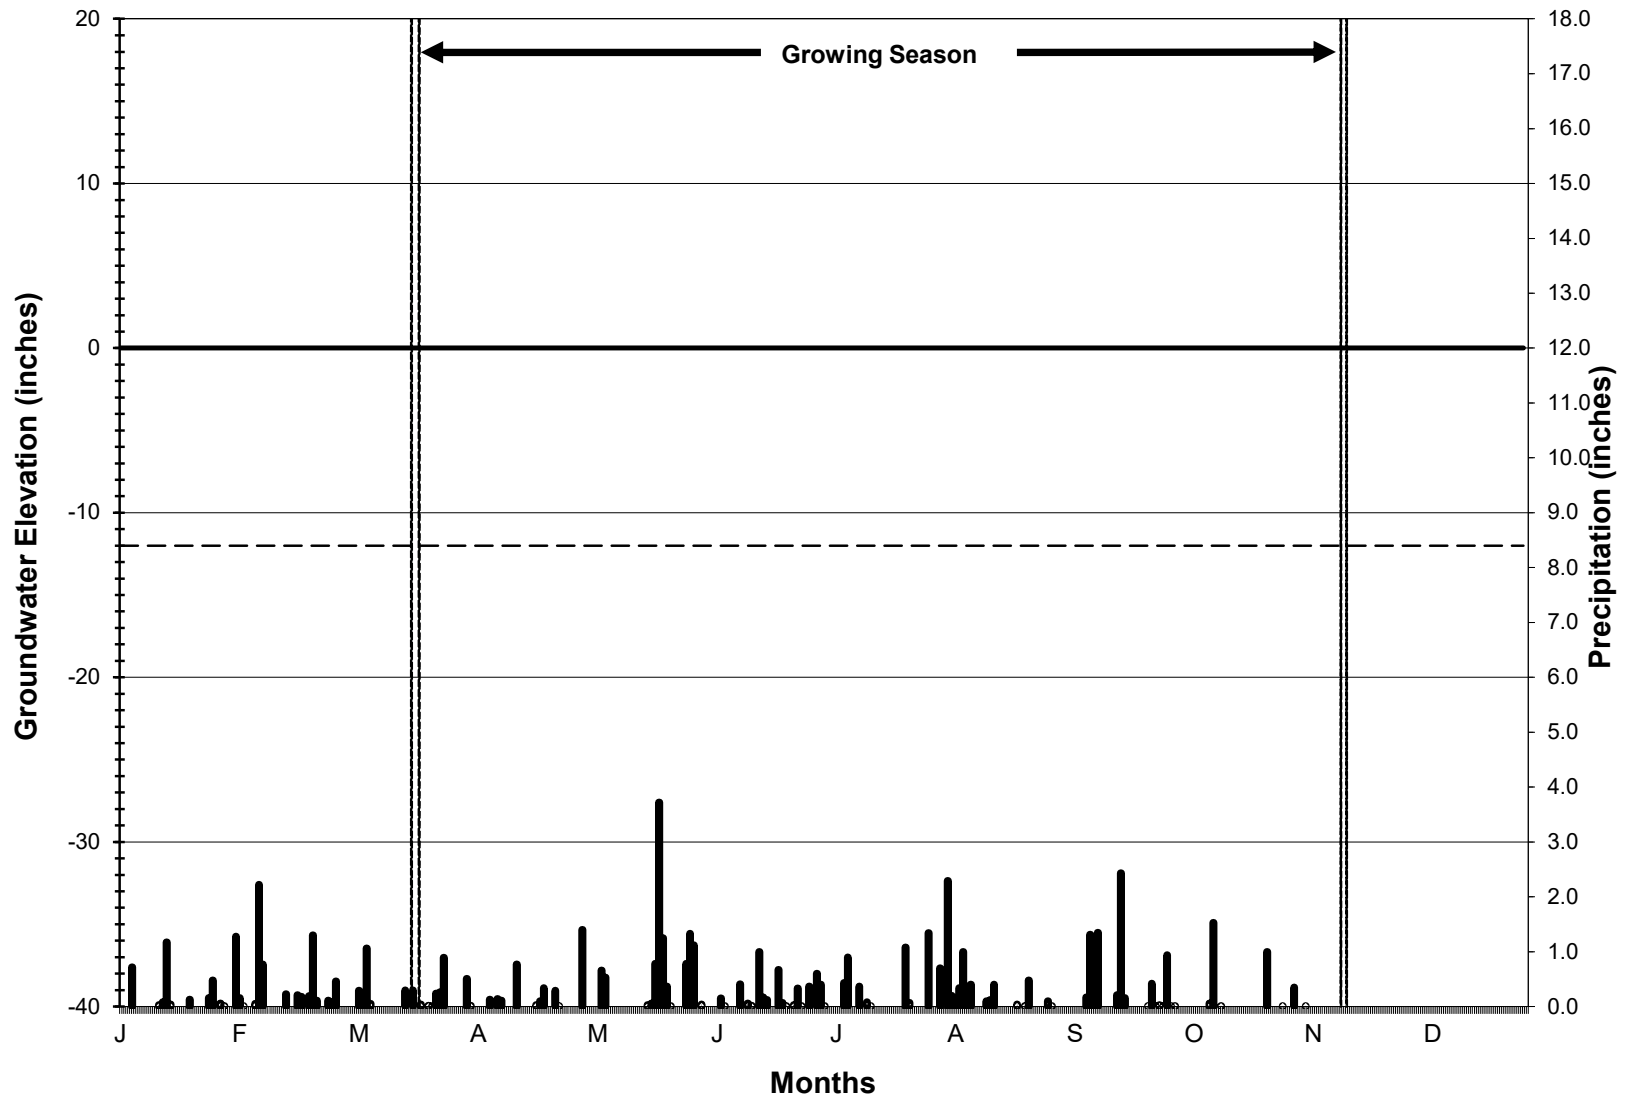
2020 Best Groundwater Gauge AW3 (HOBO failed MY6 2020)

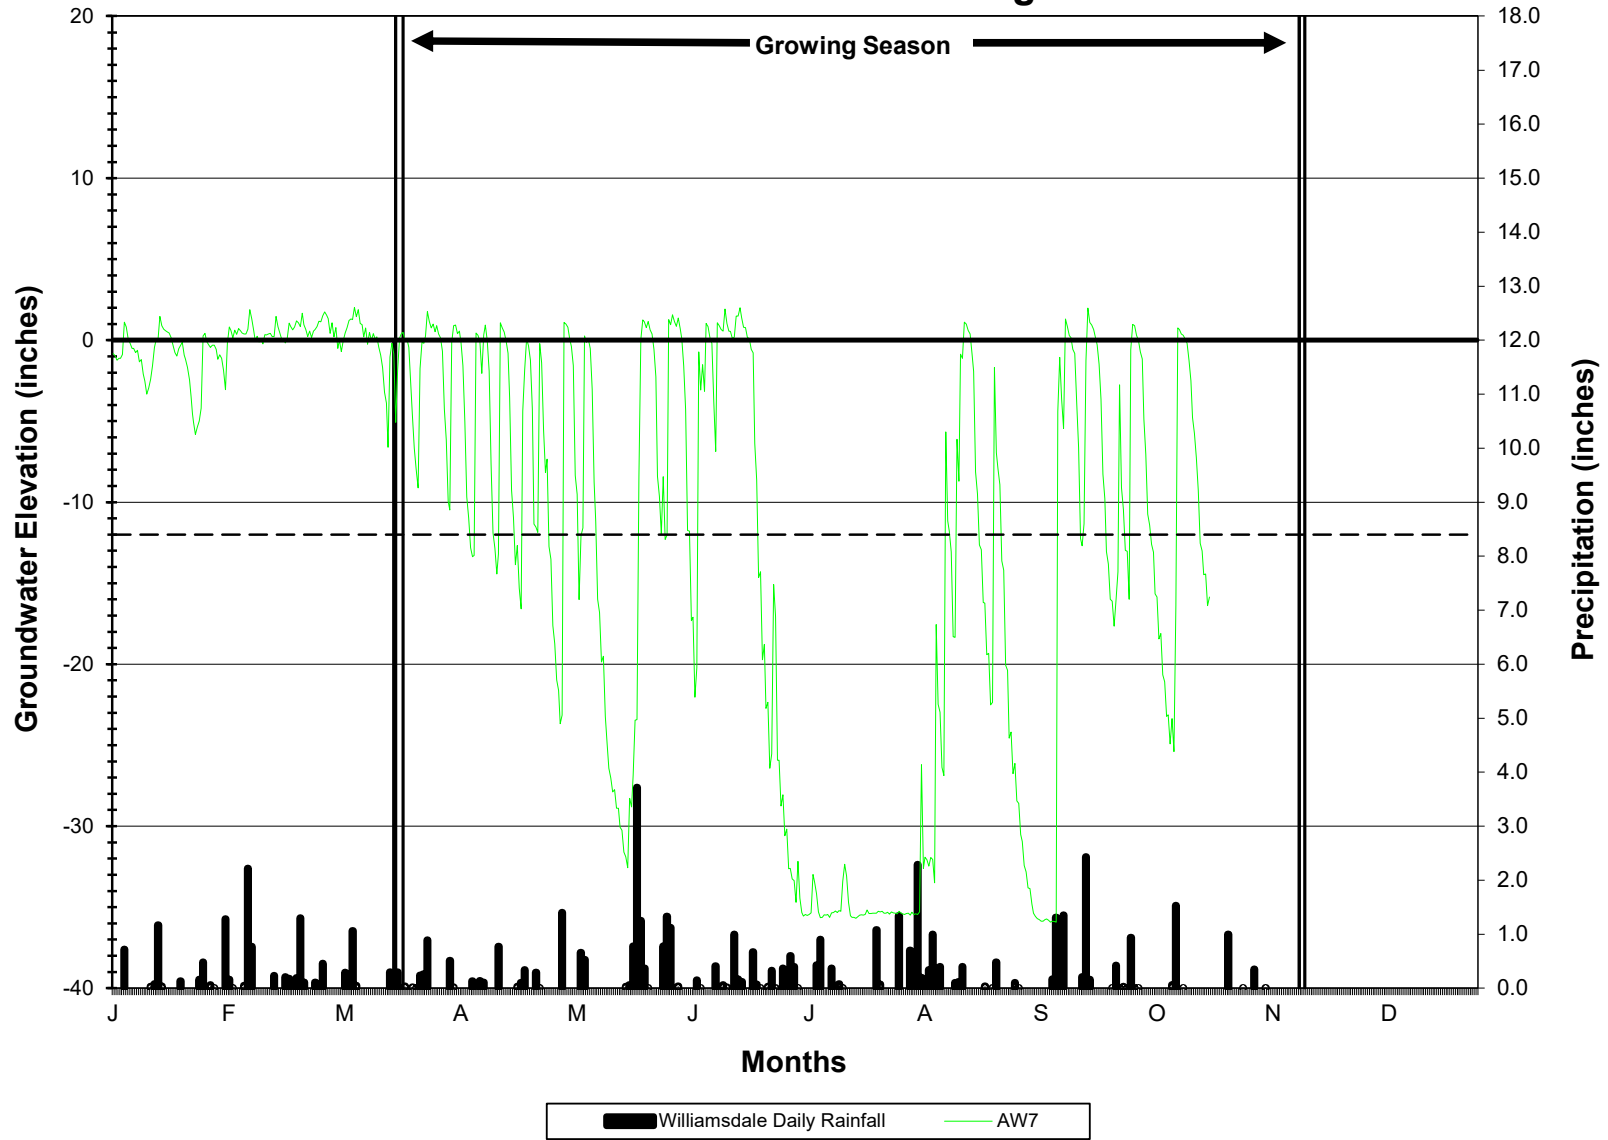
2020 Best Groundwater Gauge AW7

One wetland problem area was noted during the Year 5 monitoring period. AW7 did not meet success for the fourth time in six years, however this year it fell only one percent short. This area, about 0.39 acres, has been considered as at-risk credits. If this well does not meet success again in MY7, RES will perform a wetland delineation and soil development investigation to refine and remove the unsuccessful area from crediting.

1. Section 5.1.5: a. When discussing AW7 and possible loss of wetland credit, please edit language to say that the credit loss area could be up to 0.39 acres and that RES will perform a wetland delineation and investigation of soil development (since the area may delineate as a jurisdictional wetland) to further refine the exact extent of the area that may potentially be removed from credit if the gauge fails to meet success criteria in MY7.
