Big Cedar Creek Stream Restoration Final Year 1 Monitoring Report (2009) Stanly County, North Carolina

EEP Project Number D06054-D

Final Year 1 Monitoring Report (2009)

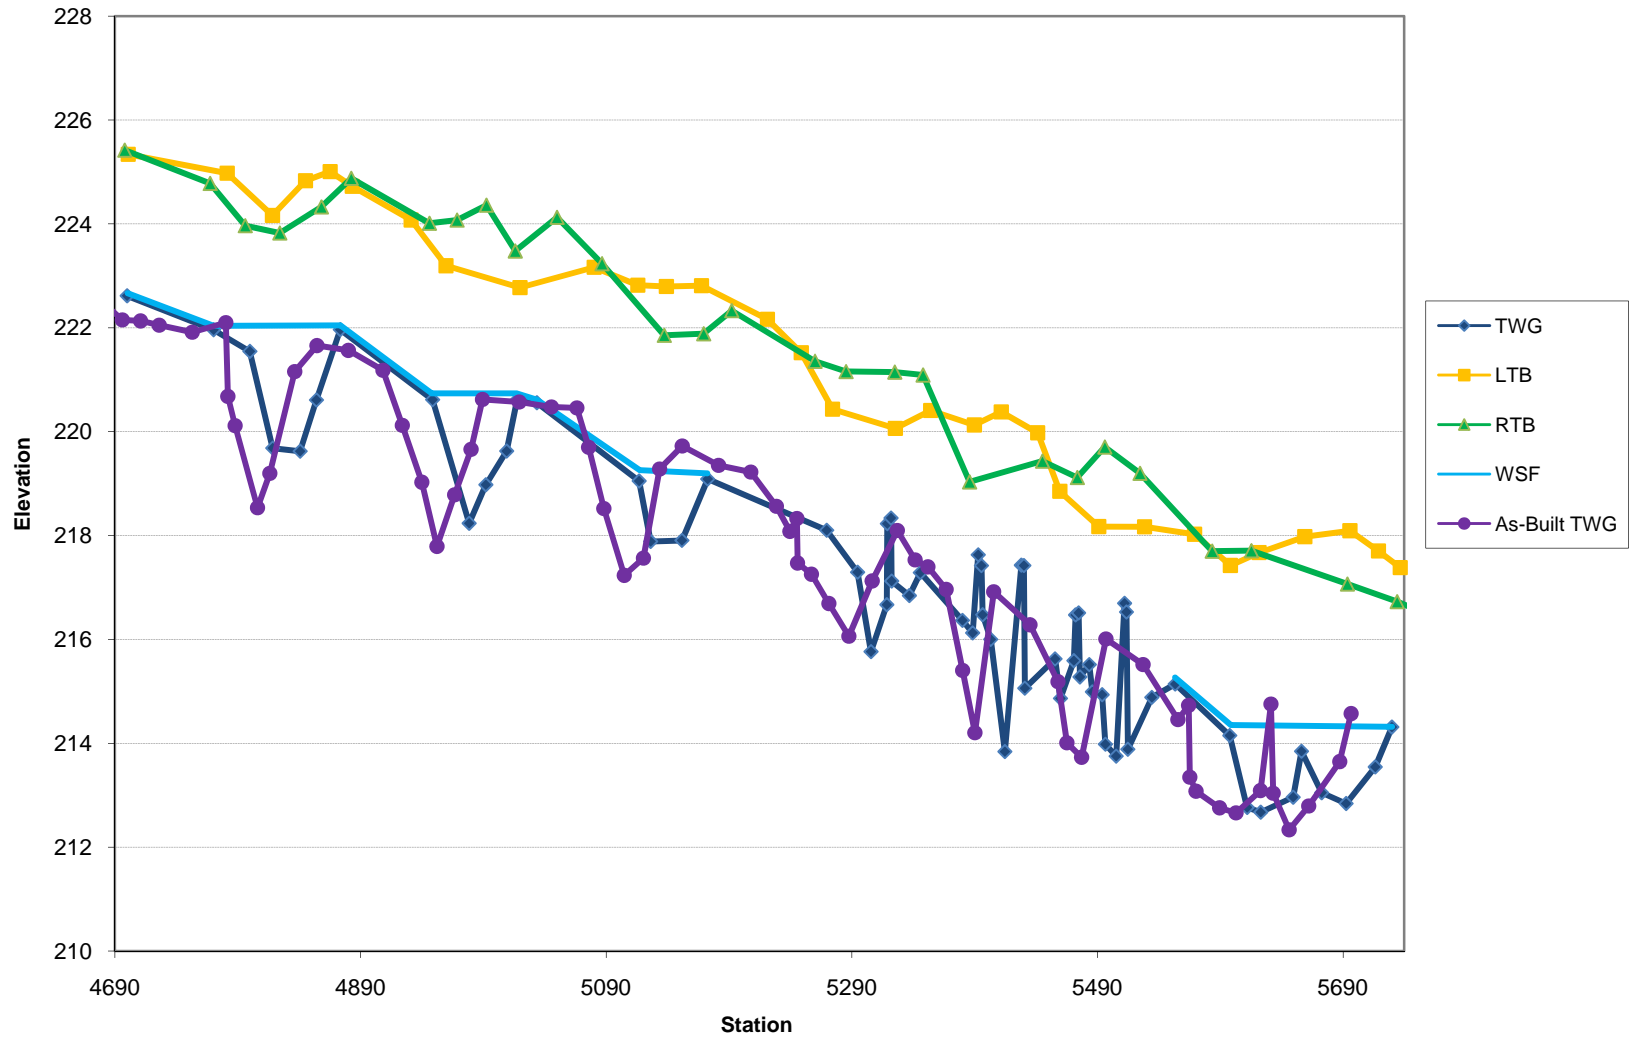
Big Cedar Creek Profile - Stations 4700 to 5730 Year 1 Monitoring

* Dry conditions at the time of data collection (Fall 2009) are reflected in a break in water surface from Station 51+72 to 55+53. Profile changes between Station 53+92 to 55+12 reflect the installation of four J-hook structures. These structures were installed to improve channel stability.
