Big Cedar Creek Stream Restoration Final Year 2 Monitoring Report (2010) Stanly County, North Carolina

EEP Project Number D06054-D

Data Collection Period: November 2010

Submission Date: December 2010

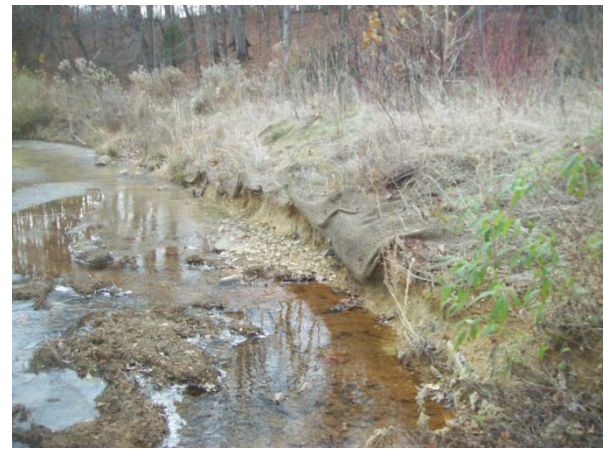
SPA 5 – BCC Toe Erosion from thalweg shift

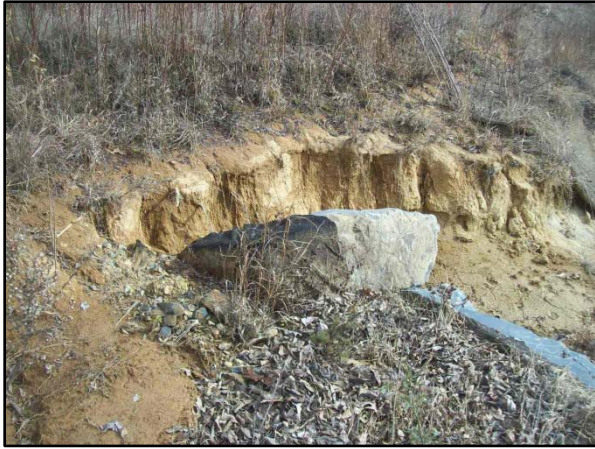
SPA 6 – BCC Bed Degradation

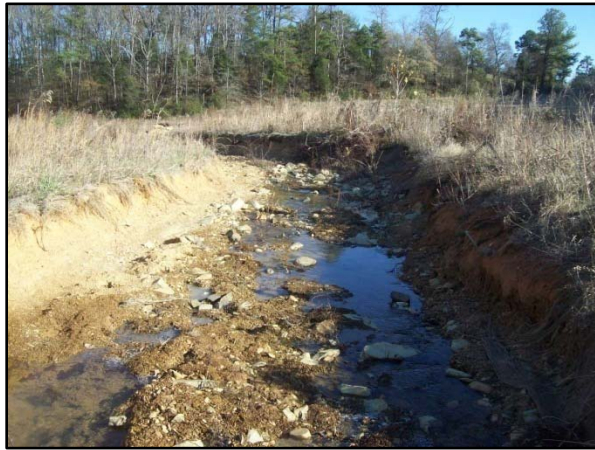
SPA 14 – UT1 Raw Bank

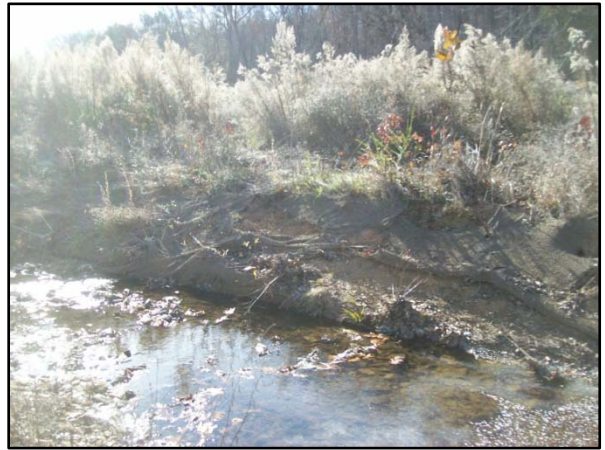
SPA 15 – UT1 Riffle degradation and channel widening

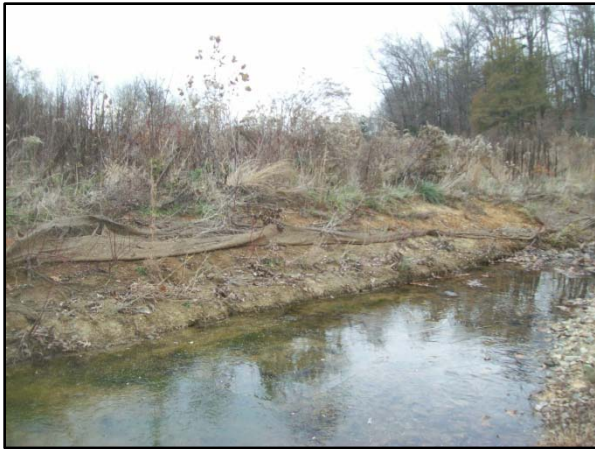
VPA 1 – Bare bank with damaged matting

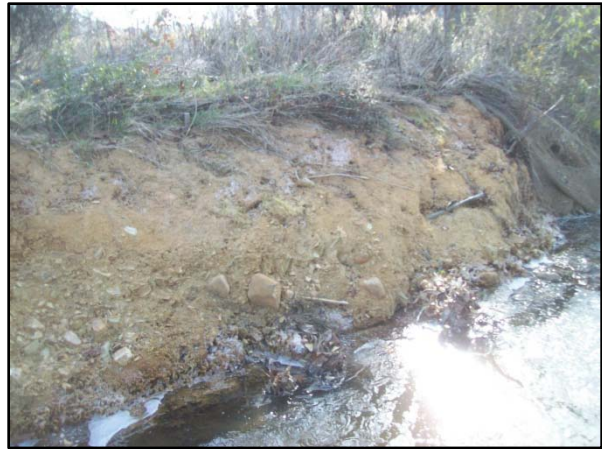
VPA 2 – Bare bank with loss of matting
