Big Cedar Creek Stream Restoration Final Year 3 Monitoring Report (2011) Stanly County, North Carolina

EEP Project Number D06054-D

Data Collection Period: November 2011 – February 2012

Submission Date: March 2012

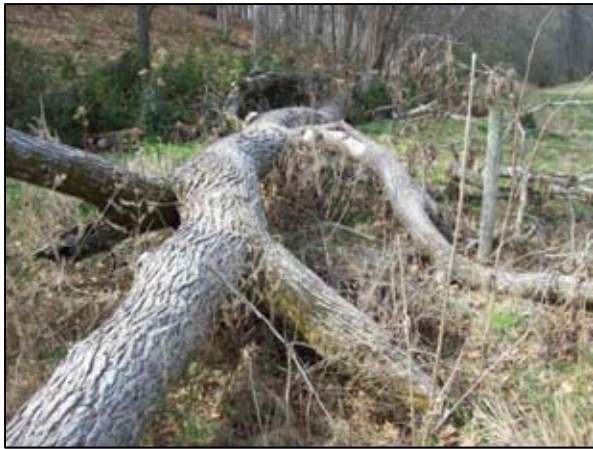
SPA 1 – Conservation easement damage caused by fallen tree

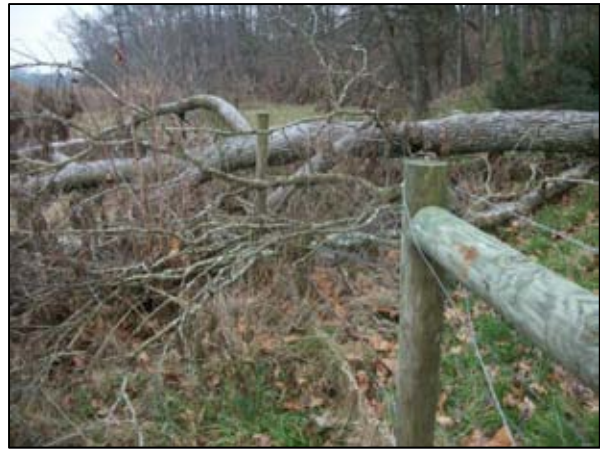
SPA 2 – Conservation easement damage caused by fallen tree

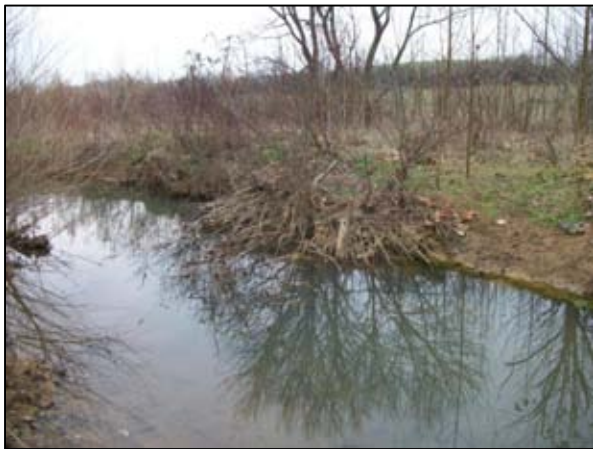
SPA 3 – Bank scour near abandoned beaver lodge
