# Big Cedar Creek Stream Restoration Final Year 4 Monitoring Report (2012) Stanly County, North Carolina

EEP Project ID #92532/EEP Contract #D06054-D

Data Collection Period: November 2012

Submission Date: March 2013

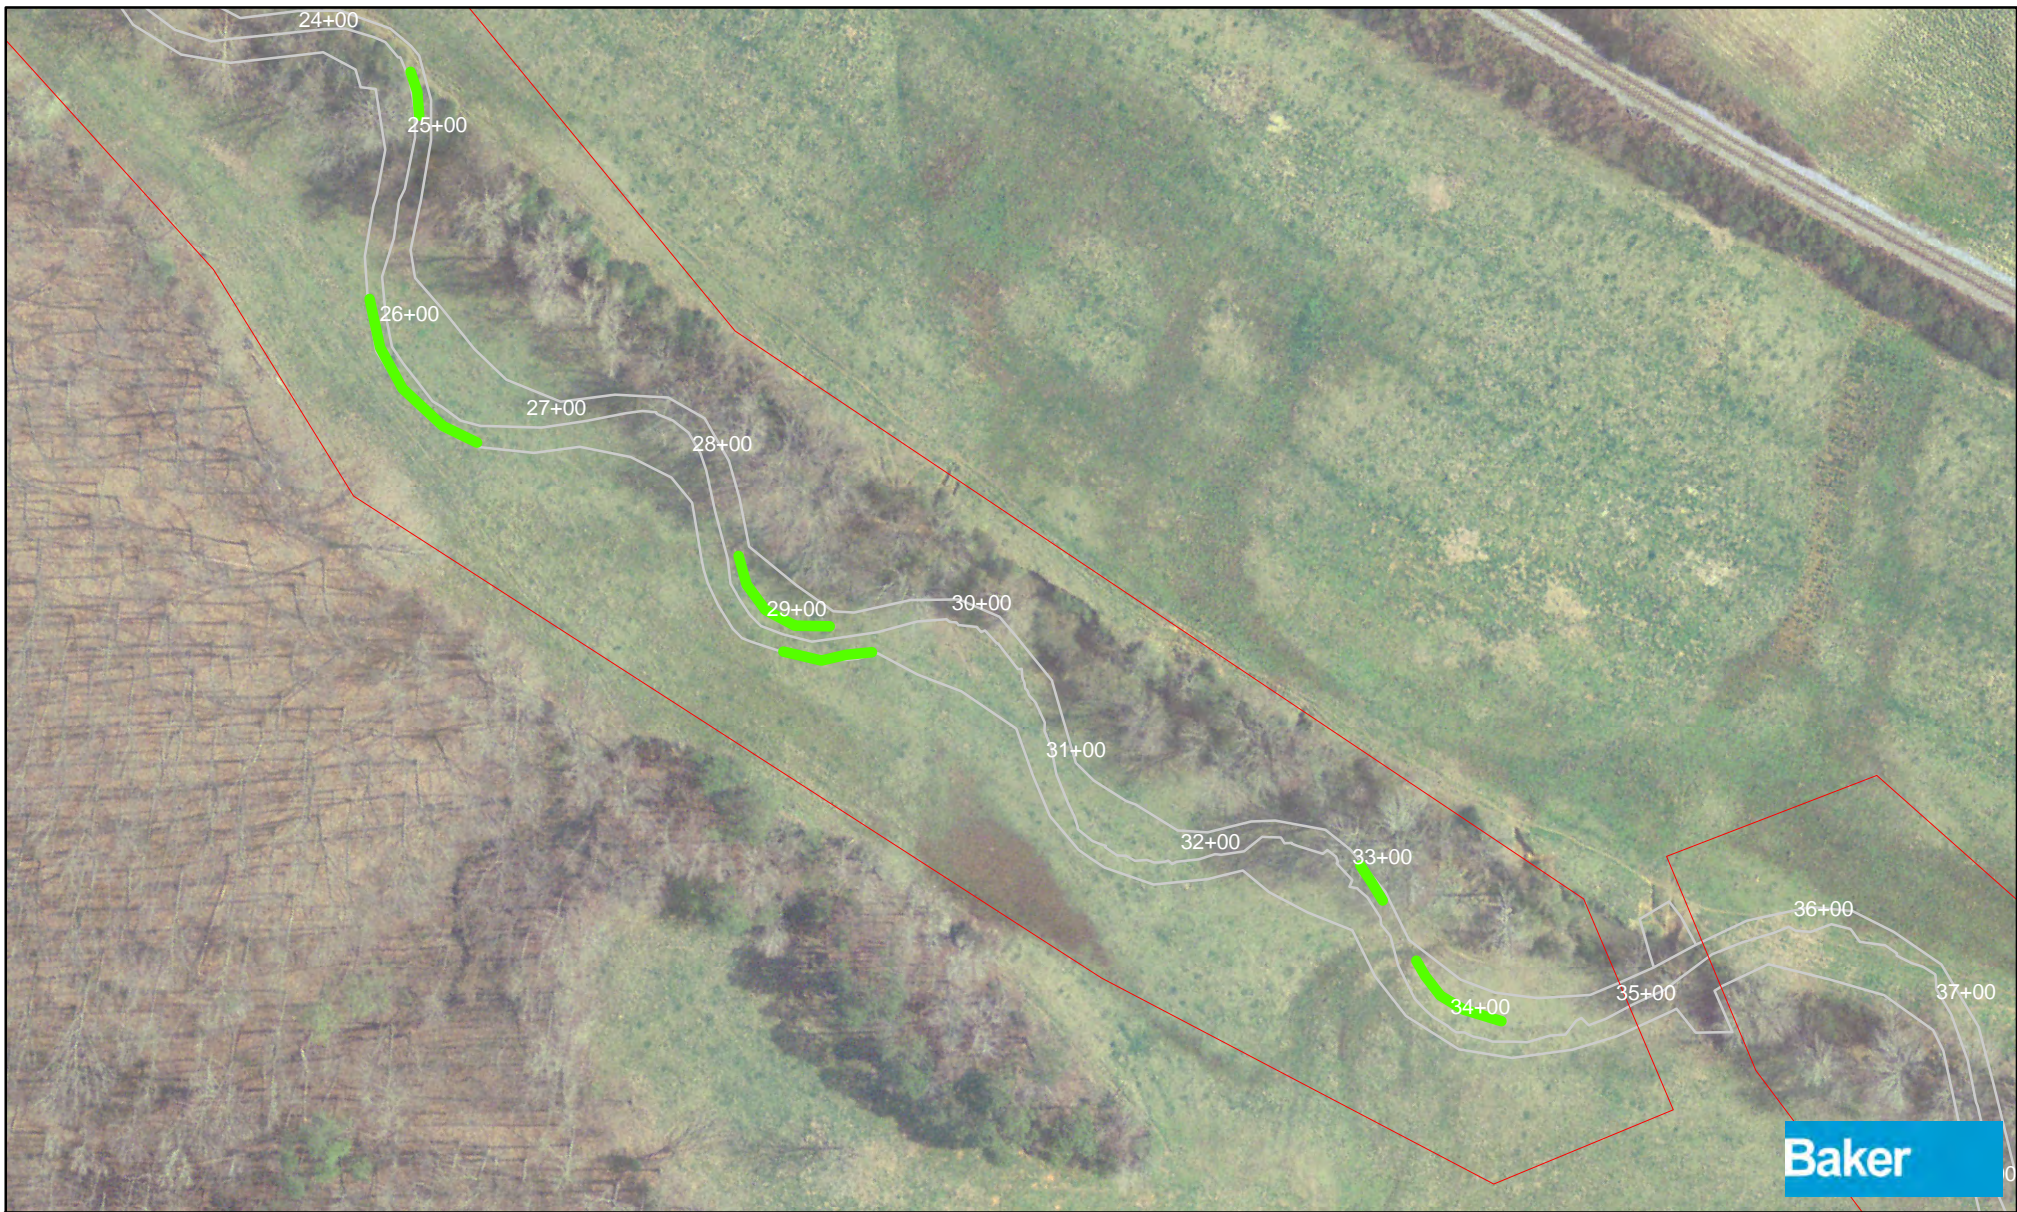
**Figure C1: Vegetation Problem Areas  
BCC (Station 24+00 to 38+00)**

Though the majority of the Site’s floodplain and streambanks have established good vegetative cover, Year 4 monitoring did identify some limited areas within the floodplain and along streambanks that exhibited sparse vegetation and minor areas of erosion. These areas with limited vegetative cover were associated with Reach 2 of BCC in areas that were recently repaired in March 2012 and are located at Station 24+00 and 33+00. UT2 (12+30 and 14+00) also displays some areas of bank erosion. Areas of erosion along BCC are minimal and will be monitored and addressed as needed while areas along UT2 will be re-graded, matted and reseeded to stabilize and limit the potential for additional streambank erosion.
