Big Cedar Creek Stream Restoration FINAL Year 5 Monitoring Report (2013) Stanly County, North Carolina

EEP Project ID #92532/EEP Contract #D06054-D

Data Collection Period: October - December 2013

Submission Date: May 2014

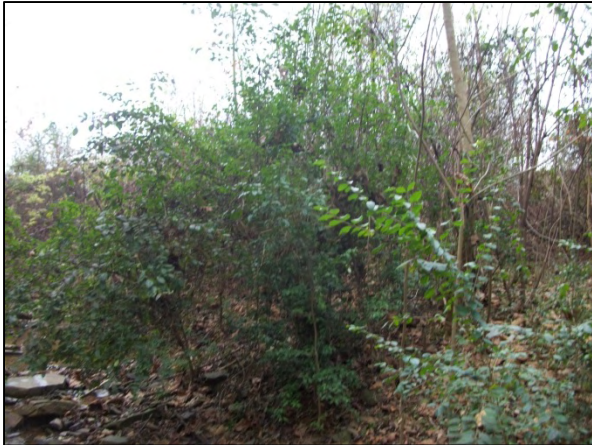
Though a variety of invasive vegetation species are present throughout the Site, the establishment of *Ligustrum sinense* (Chinese privet) infestations are the most dominant. Vegetation Plots 11, 13, 15, 19, and 23 were identified as having a high population density of invasive vegetation species (Figure C1). In order to control invasive species populations throughout the Site, an herbicidal treatment and/or the physical removal of invasive vegetation species will be conducted prior to closeout. See Table C.6 in Appendix C for problem area categories, locations, descriptions, causes, and photo log.

VPA 1 – Privet on Big Cedar

VPA 2 – Privet on UT1
