MONITORING YEAR 1 ANNUAL REPORT

BIG HARRIS CREEK MITIGATION SITE

Cleveland County, NC
DMS Project No. 739
DEQ Contract 006256
DWR 401 Project No. 10-0811
USACE Action ID No. SAW-2009-0475
Broad River Basin
HUC 03050105

Submission Date: February 6, 2019

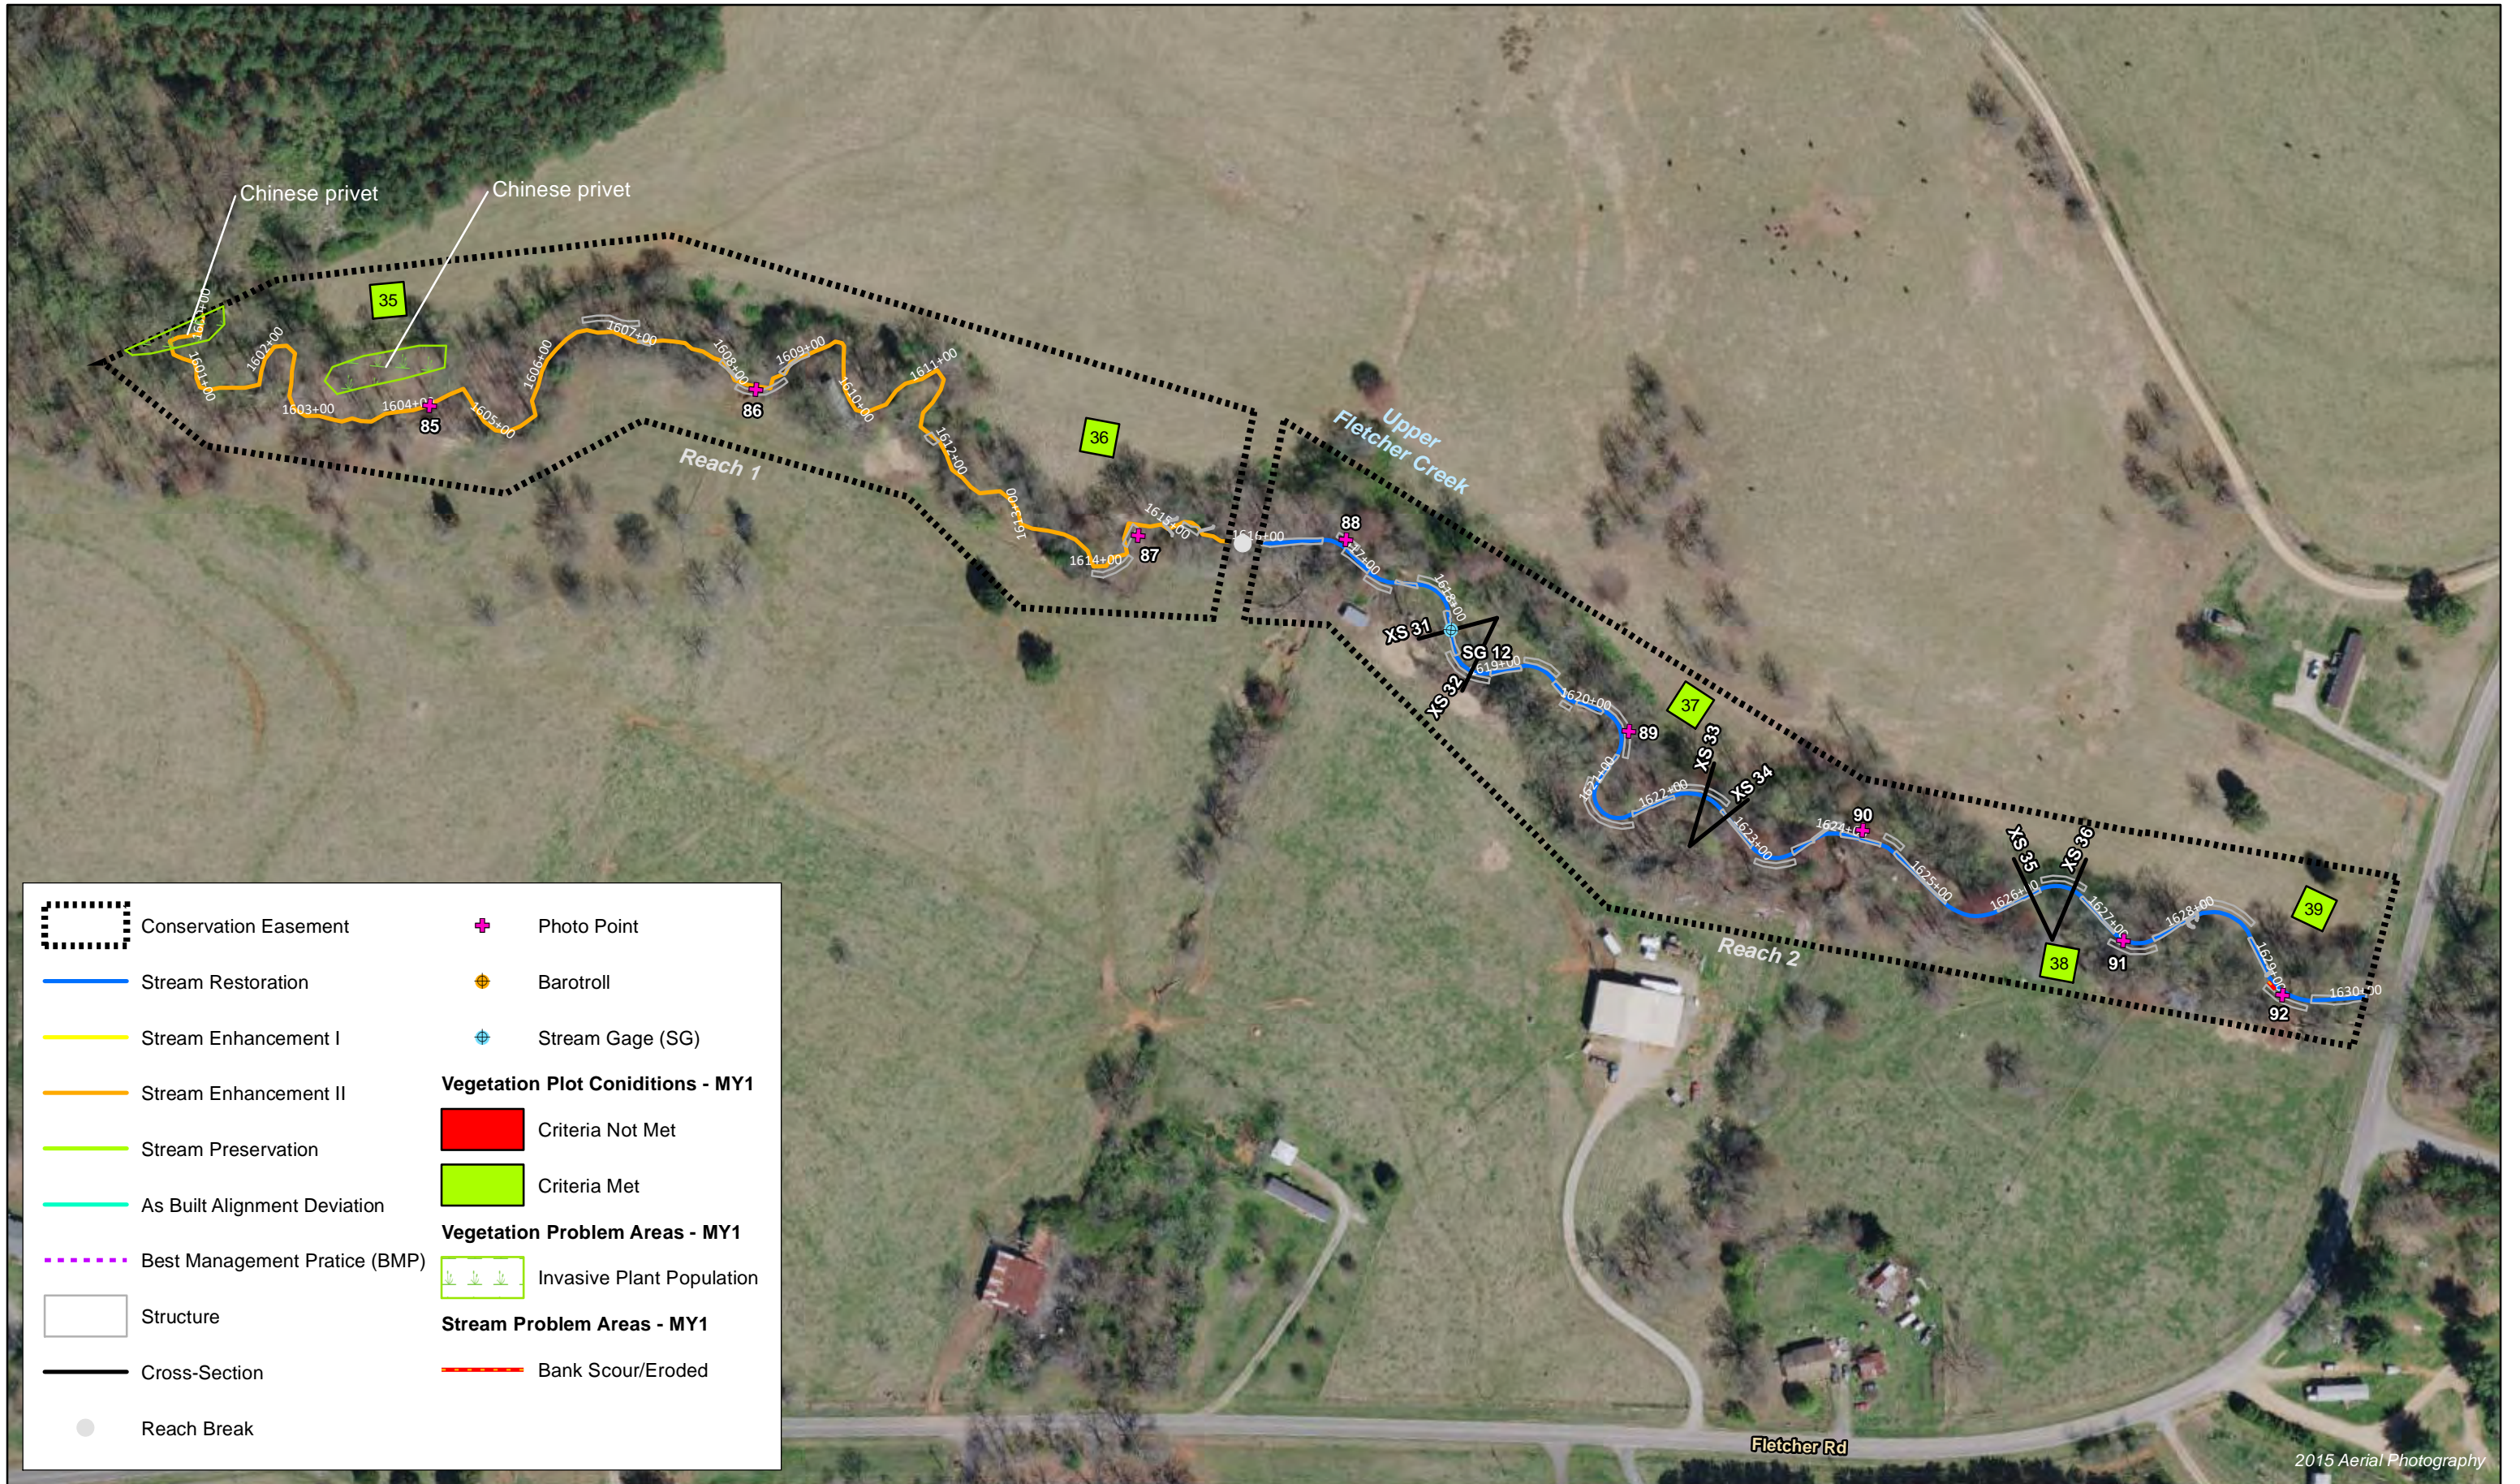
Figure 3.9 Integrated Current Condition Plan View
 Big Harris Creek Mitigation Site - Area A
 DMS Project No. 739
 Monitoring Year 1 - 2018
 Cleveland County, NC

Several areas of erosion in addition to those documented by cross-sections were observed by Wildlands during MY1 assessments. Refer to the CCPV maps in Appendix 2 for bank scour locations. Wildlands will review these areas and implement repairs to stabilize as necessary.

Streams within the Site appear to be stable and functioning as designed with the exception of minor areas of erosion. These areas of erosion will be graded, seeded, matted, and planted to prevent further erosion. Bankfull events were documented on a majority of project streams; therefore, the Site has partially met the stream hydrological success criteria. The average stem density for the Site is 525 stems per acres is on track to meeting the MY5 success criteria however one individual plot (29) currently does not meet the MY5 success criteria as noted in the CCPV. Adaptive management will be implemented as necessary to address areas of stream erosion and invasive plant species.

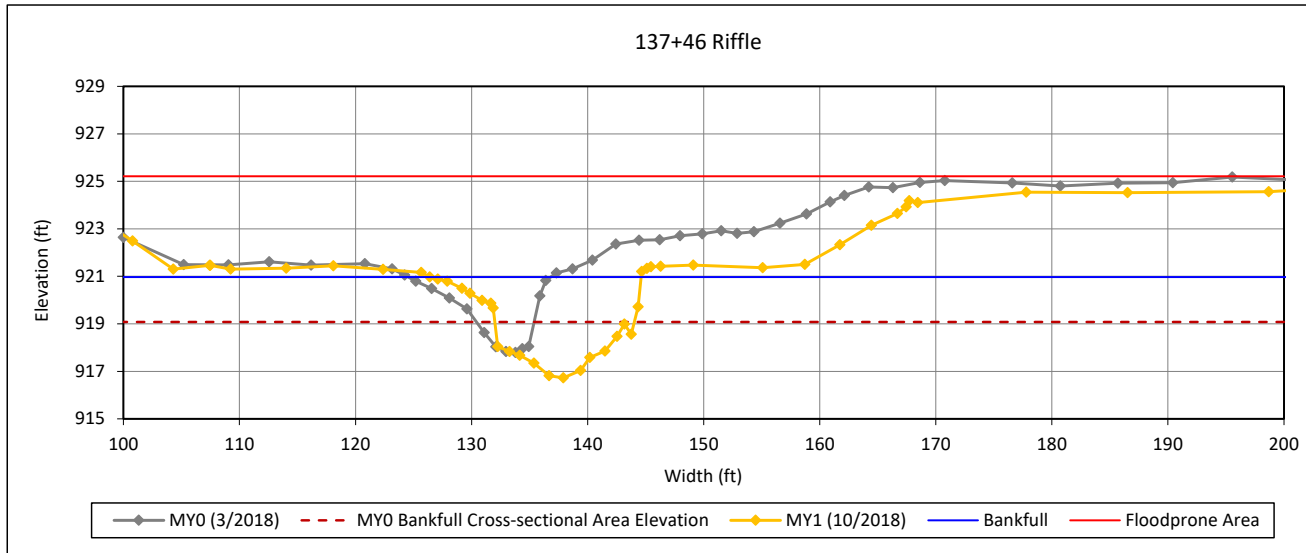
UBHC Reach 2B: Cross-Section 4

DMS Comment; Section 1.2.1 – The second paragraph describes degradation and fining of the substrate at cross-section 4. The description of the changes at this location would be better summarized by adding that the riffle constructed at this location has adjusted/eroded into a pool which helps explain the finer bed material.

Wildlands Response; It is anticipated that repairs at Cross-section 4 will return the channel to a riffle; therefore, the text has not been revised.
