MONITORING YEAR 2 ANNUAL REPORT

BIG HARRIS CREEK MITIGATION SITE

Cleveland County, NC
DMS Project No. 739
DEQ Contract 006256
DWR 401 Project No. 10-0811
USACE Action ID No. SAW-2009-0475
Broad River Basin
HUC 03050105

Data Collection Period: March – October 2019

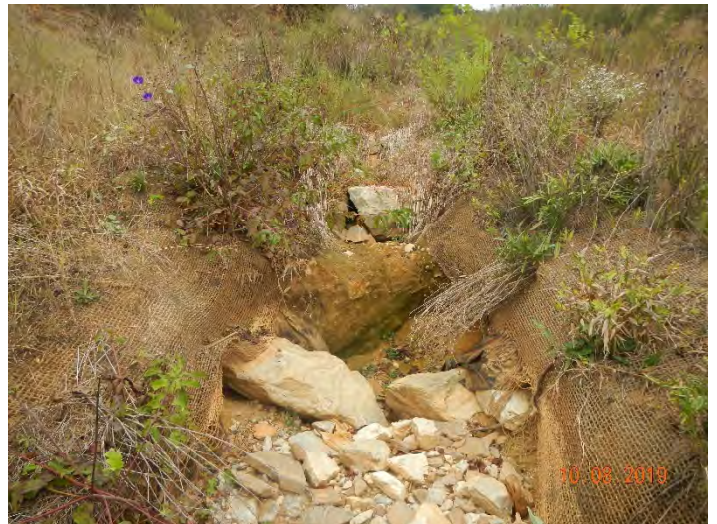
Royster Creek R1 Boulder Sill Failure (Station 806+75) – view upstream (10/8/2019)
