MONITORING YEAR 3 ANNUAL REPORT

BIG HARRIS CREEK MITIGATION SITE

Cleveland County, NC
DMS Project No. 739
DEQ Contract 006256
DWR 401 Project No. 10-0811
USACE Action ID No. SAW-2009-0475
Broad River Basin
HUC 03050105

Data Collection Period: February – November 2020
Final Submission Date: February 15, 2021

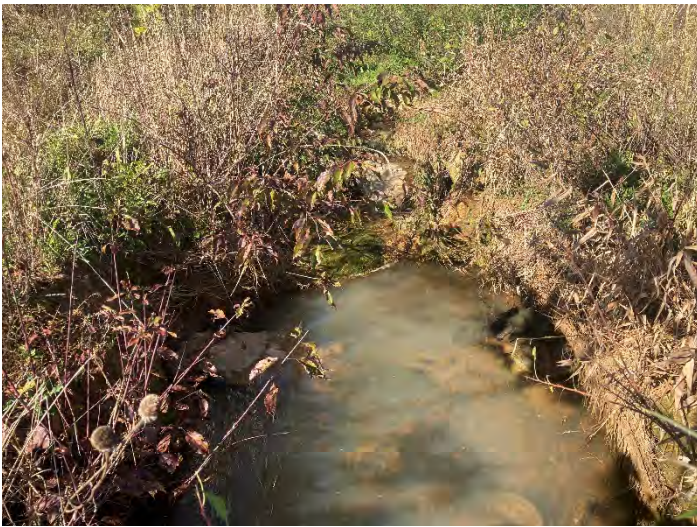
LBHC R2 Log Sill Bypassed (STA 317+45) – view upstream
(10/27/2020)

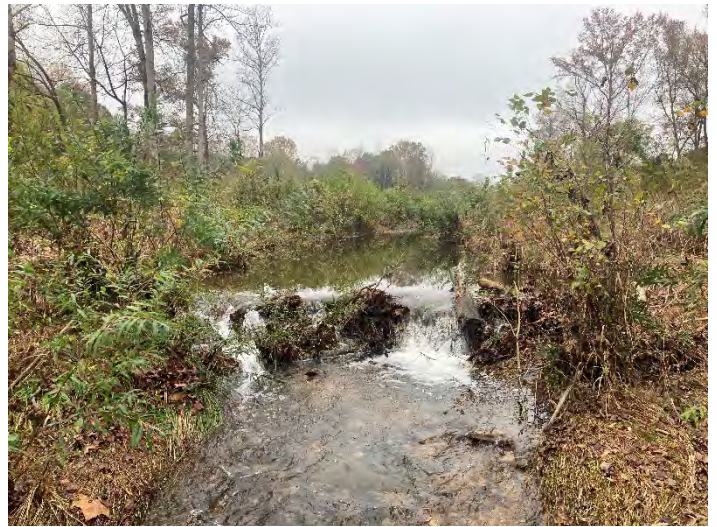
Royster Creek R1 Rock Sill Failed (STA 806+74) – view upstream
(10/27/2020)
