As-built report for the AH&W Mitigation Site Big and Little Warrior Creeks Wilkes County

As-built report for the AH&W
Mitigation Site, Big and Little Warrior
Creeks, Wilkes County

North Carolina Wildlife Resources Commission

February 24, 2003

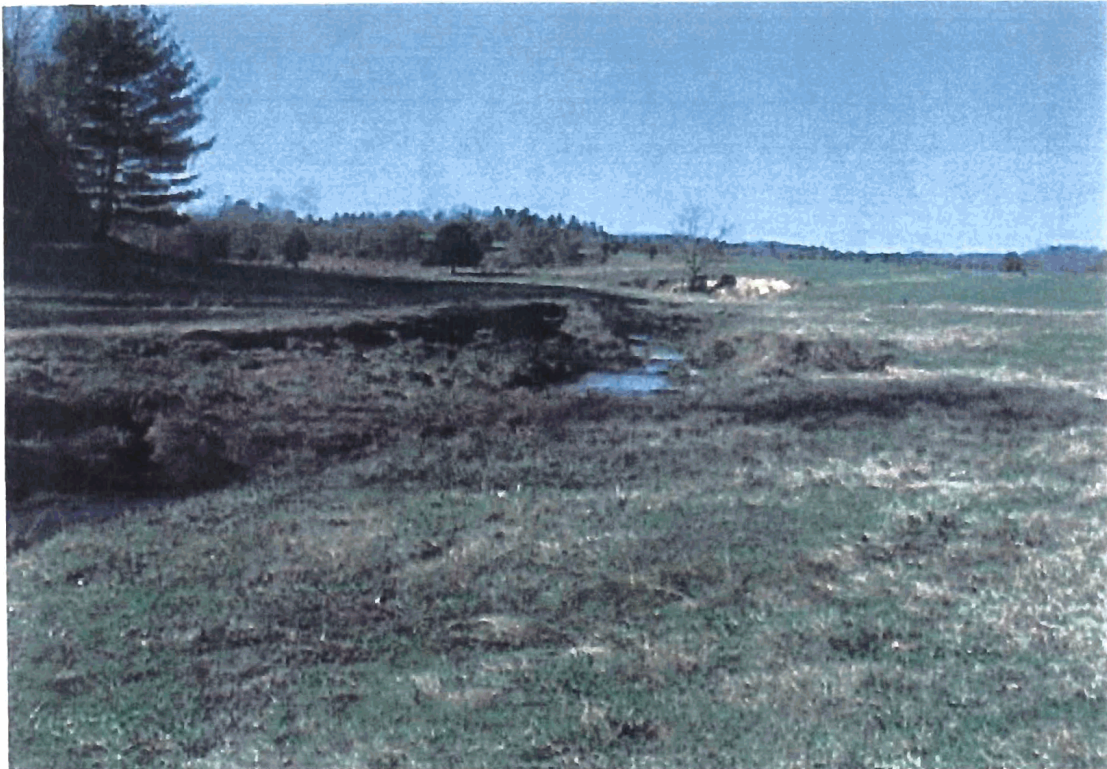
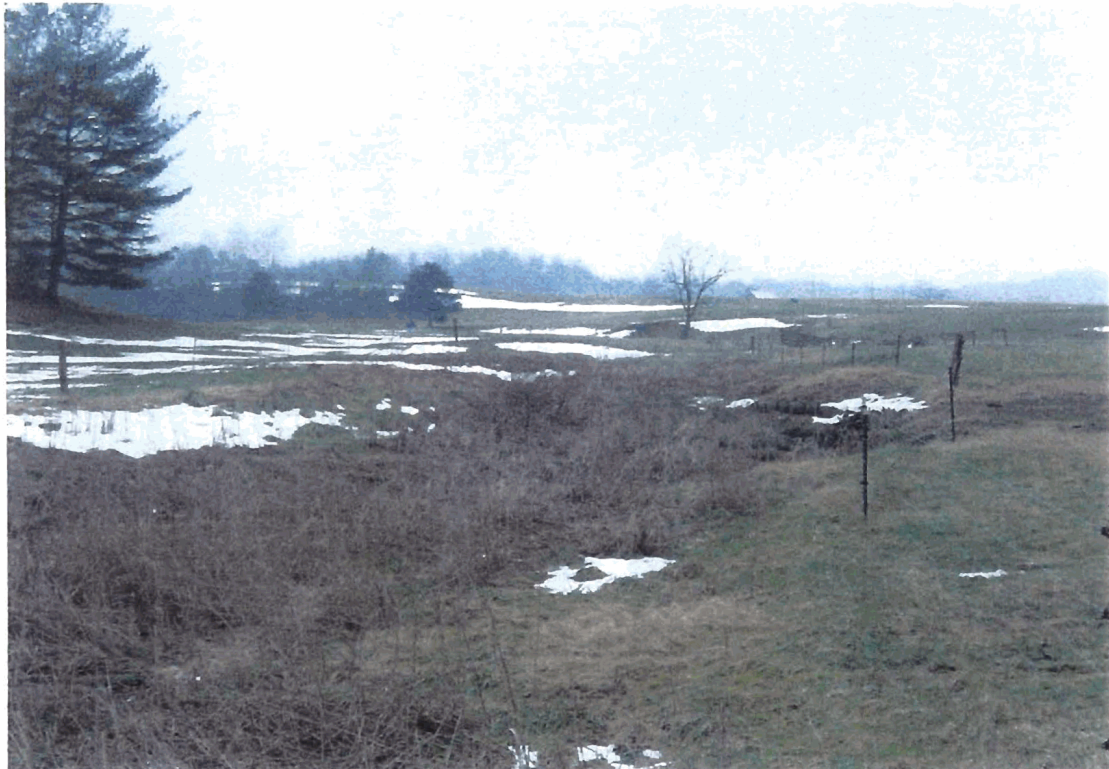
Reach is above the last Left bank meander, in the lower pasture, on Big Warrior Creek. Photo is taken from inside the easement looking upstream. This is series number 3 from the BWC reference photos.

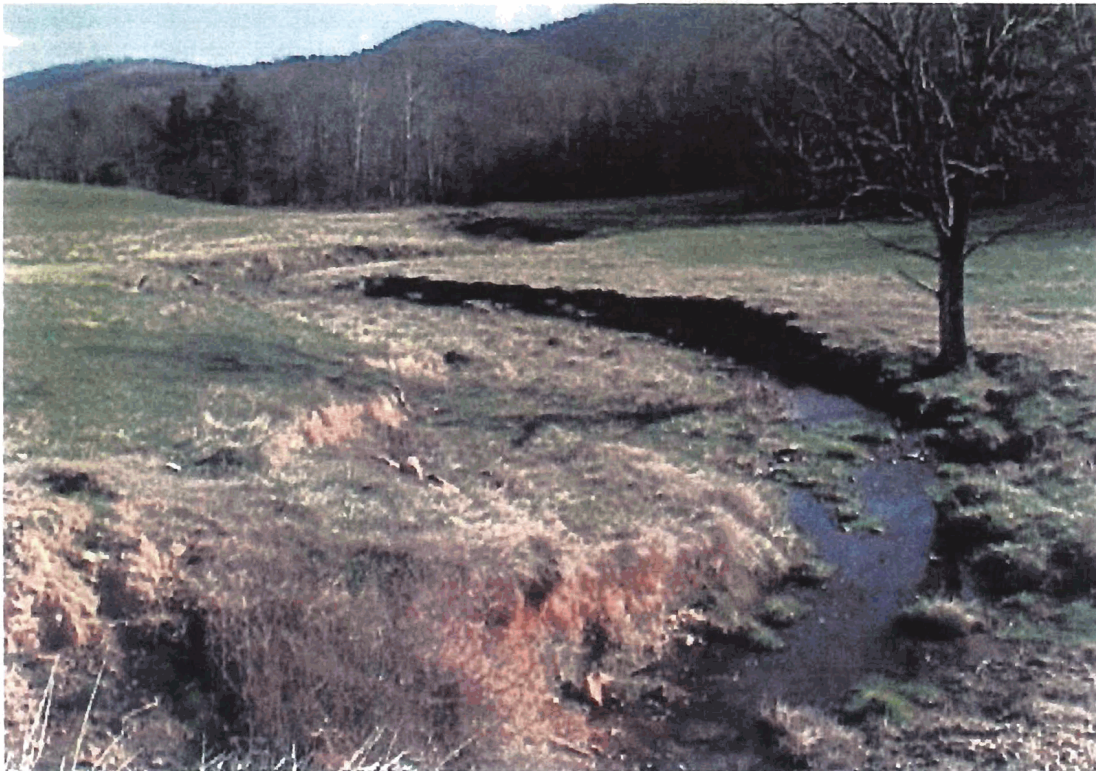
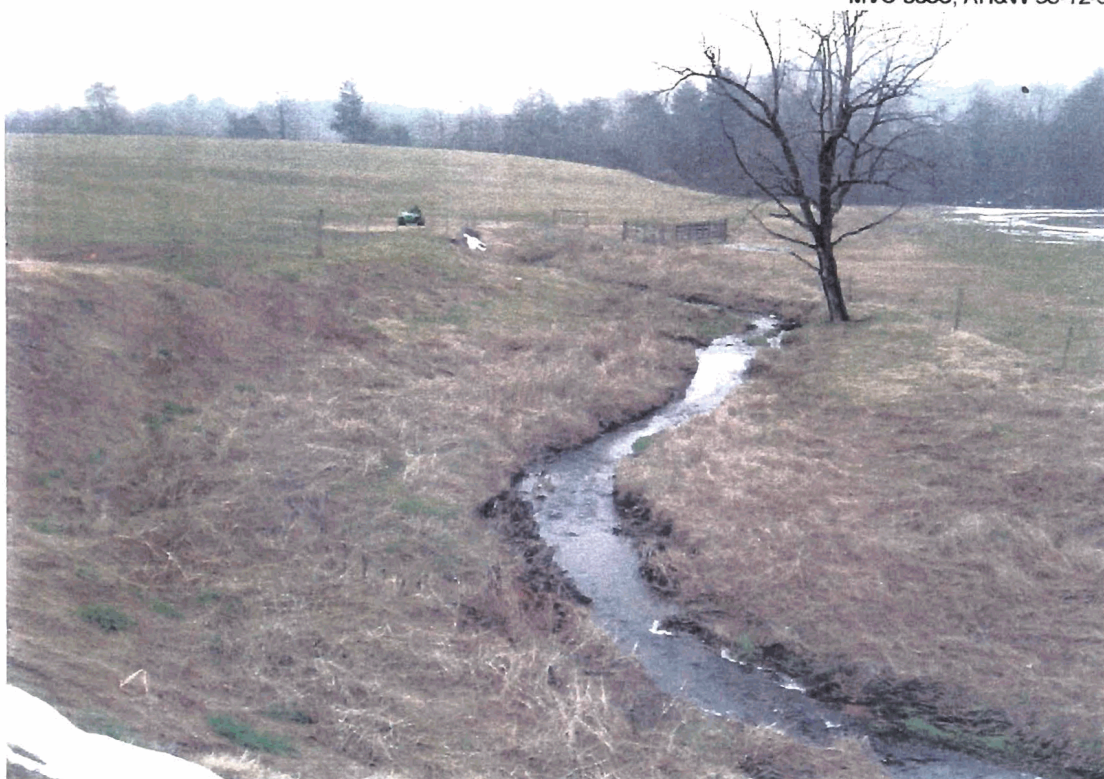
Reach below the high clay bank, in the lower pasture, on Big Warrior Creek. Photo is taken from the top of the bank looking downstream. This is series number 7 from the BWC reference photos.

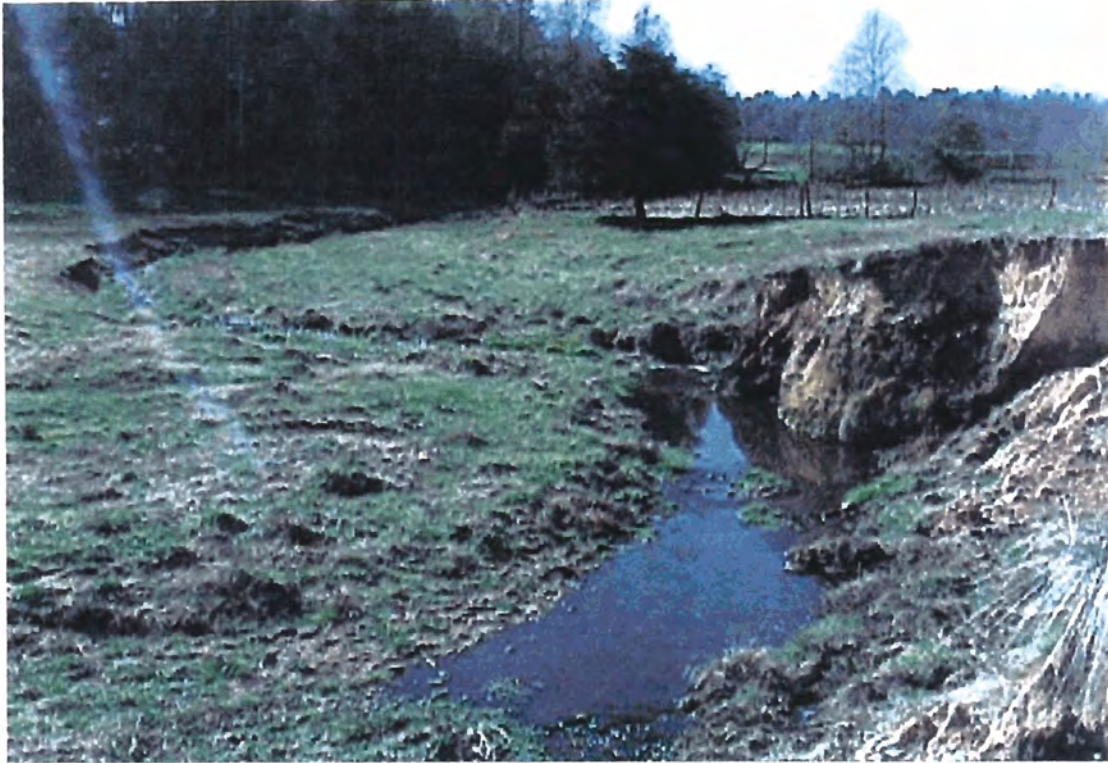
Reach showing the high clay bank and above, in the lower pasture, on Big Warrior Creek. Photo is taken from the top of the bank looking upstream. This is series 8 from the BWC reference photos.

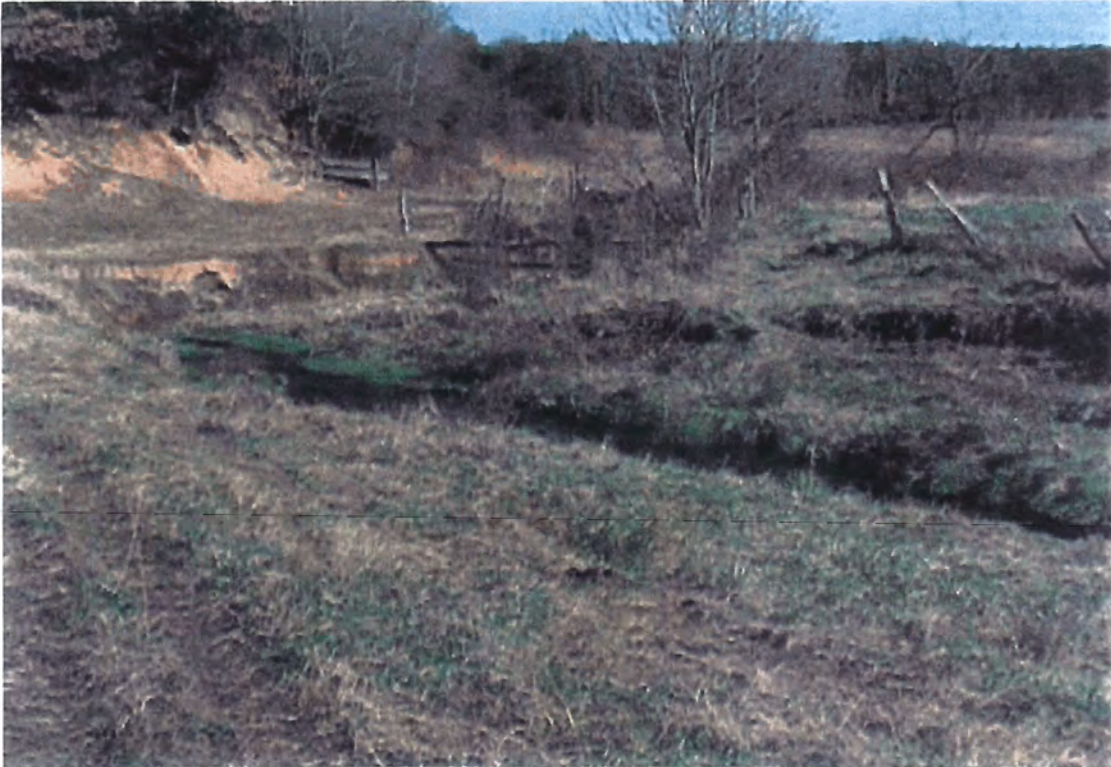
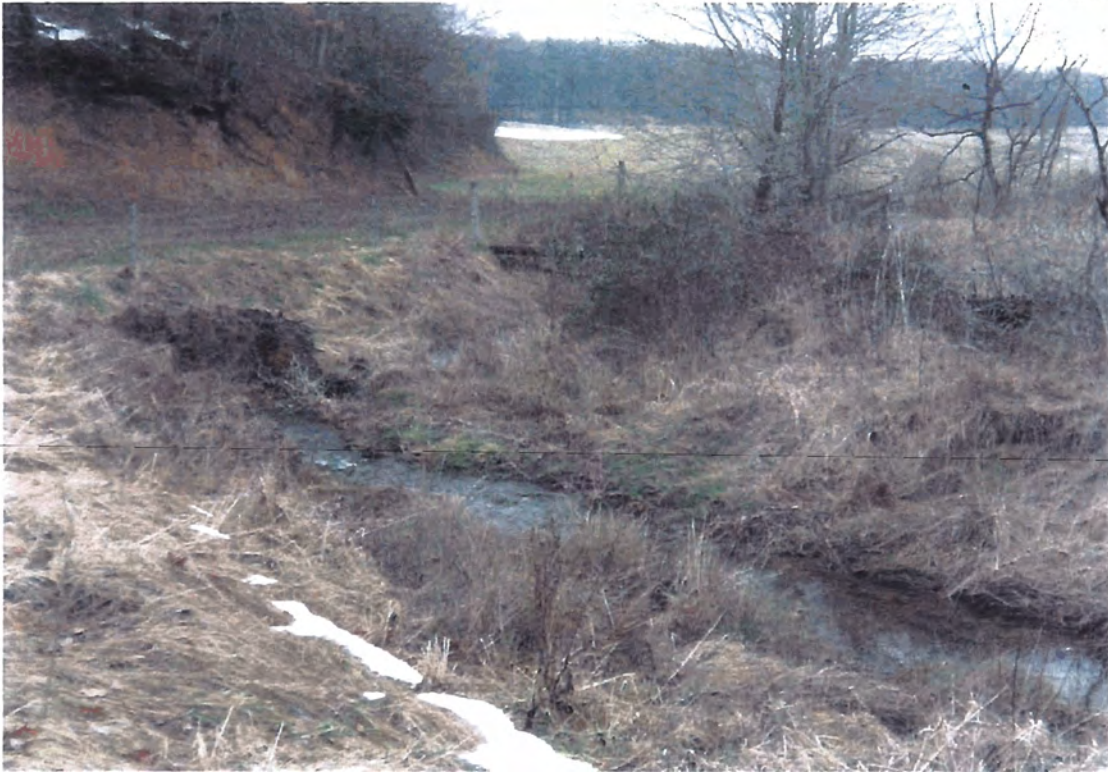
**Bend at the end of the middle pasture, on Big Warrior Creek.
Photo is taken looking downstream from just above the bend. This
is series number 13 from the BWC reference photos.**

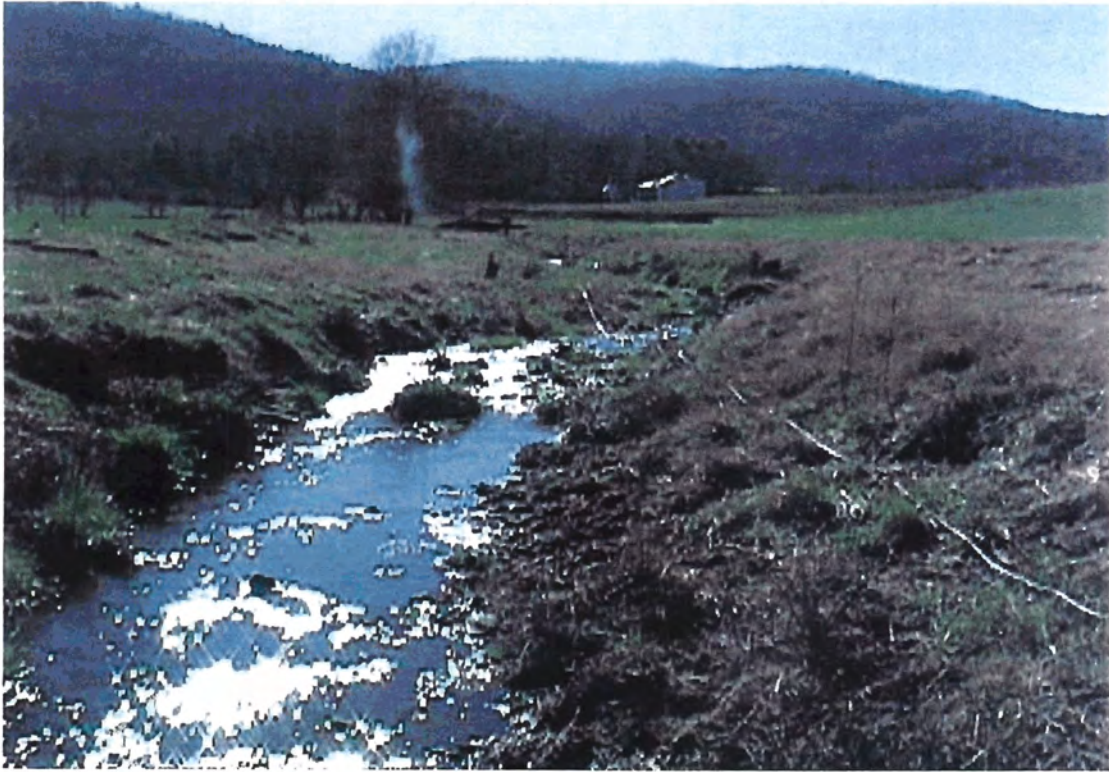
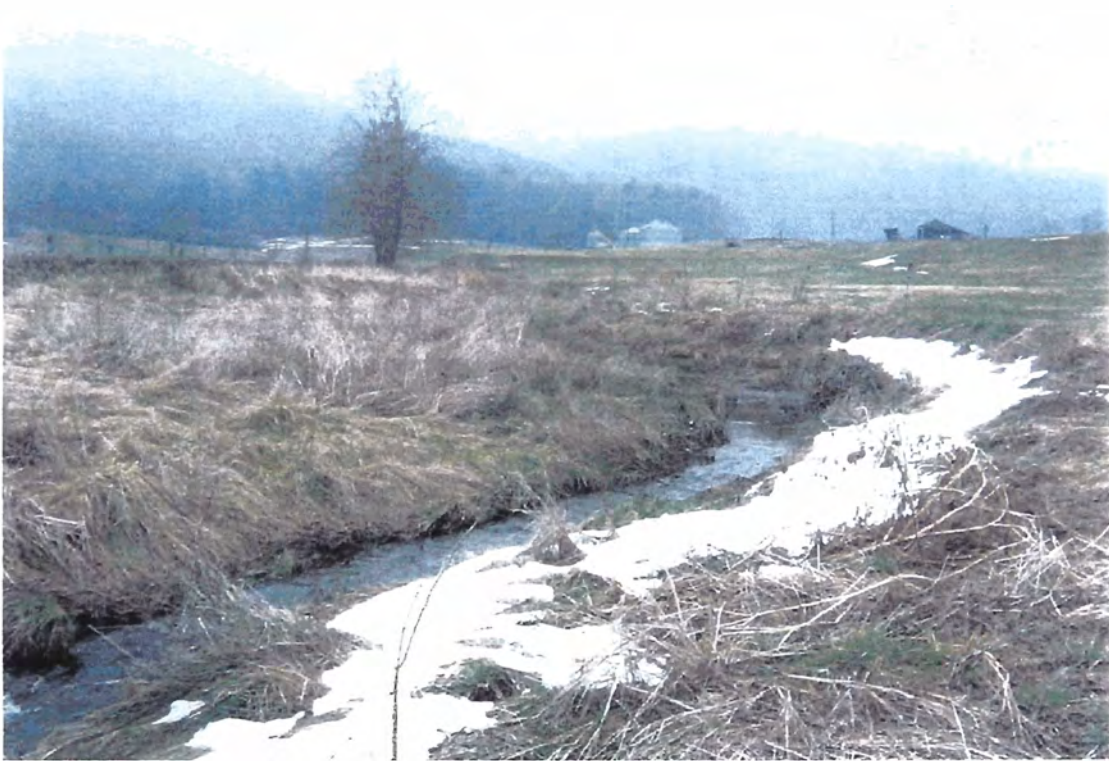
Reach is in the middle of the middle pasture, on Big Warrior Creek. Photo is taken from a point bar looking upstream. This is series number 15 from the BWC reference photos.

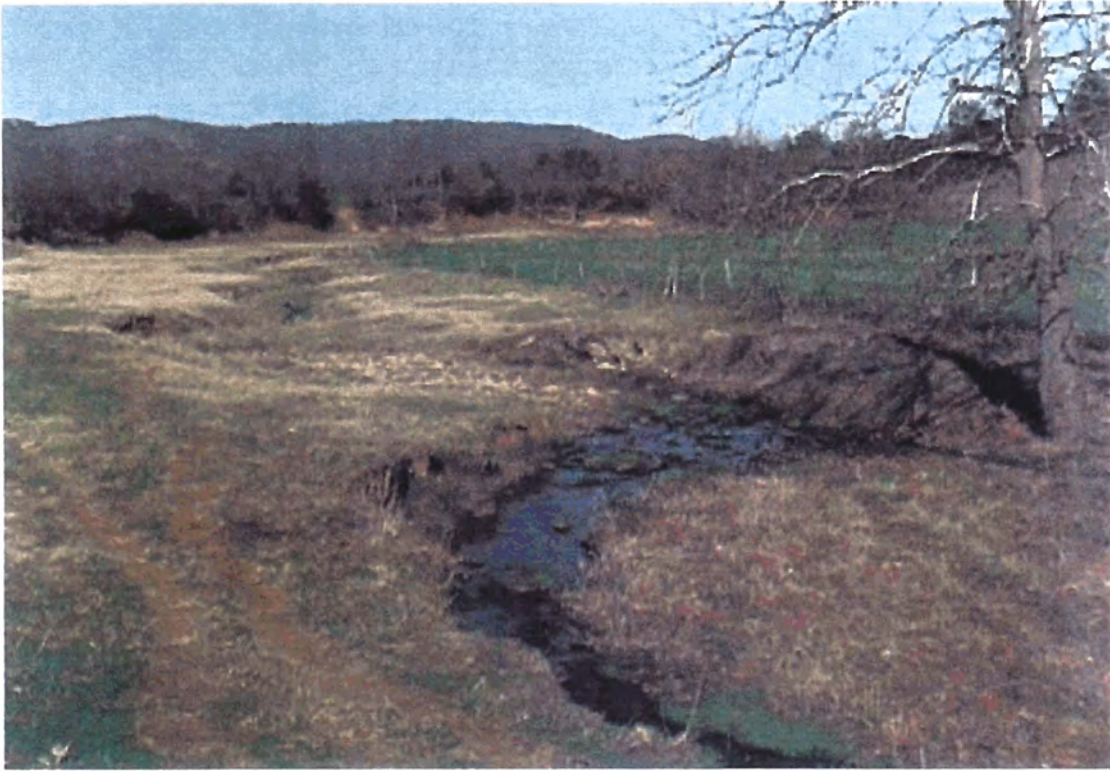
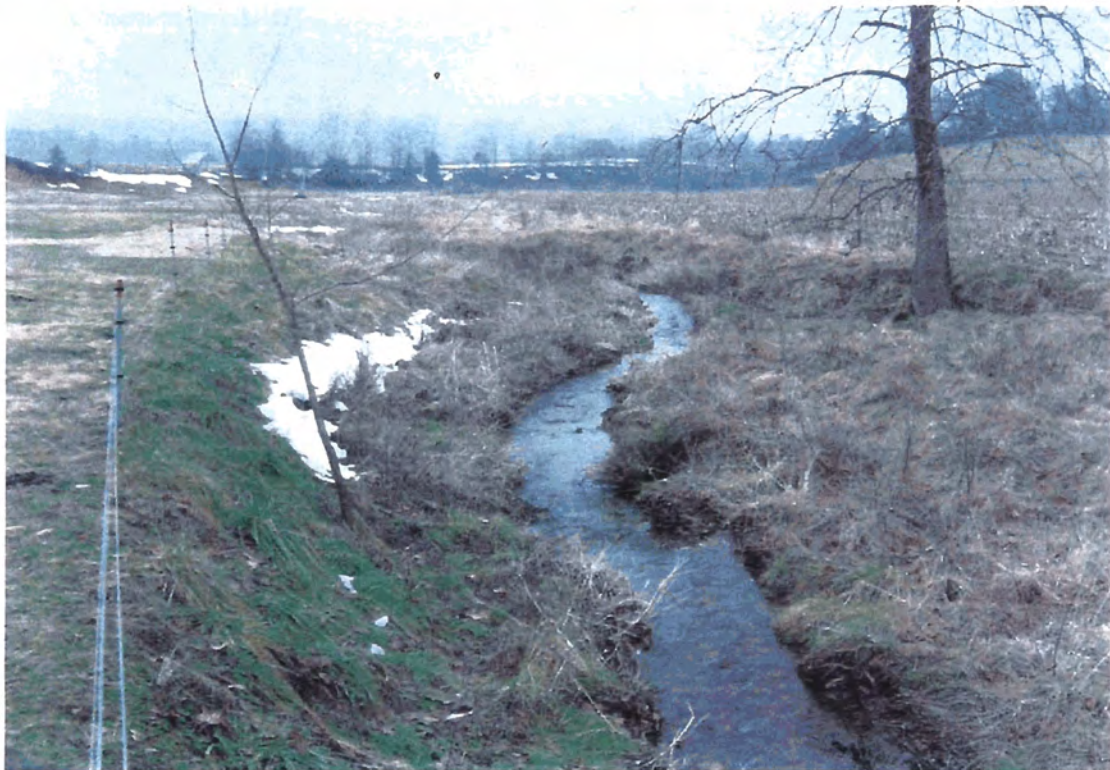
Reach below the Feed Barn, in the middle pasture, on Big Warrior Creek. Photo is taken from the property line survey point looking downstream. This is series number 17 from the BWC reference photos.

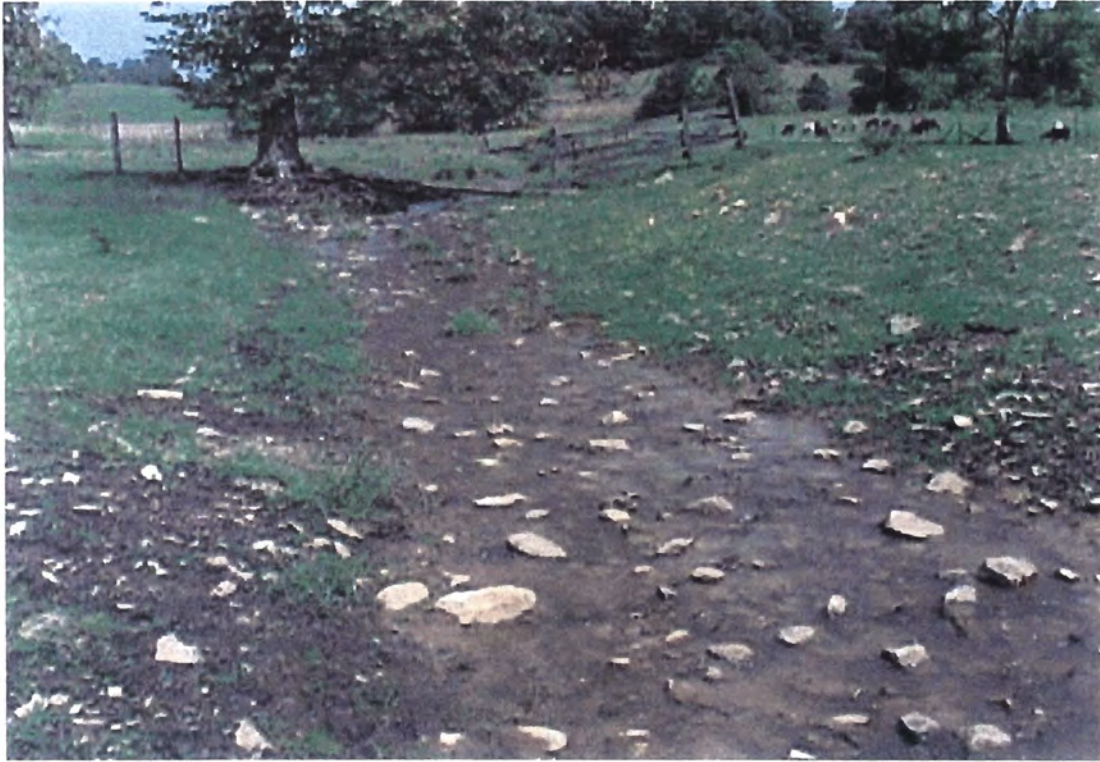
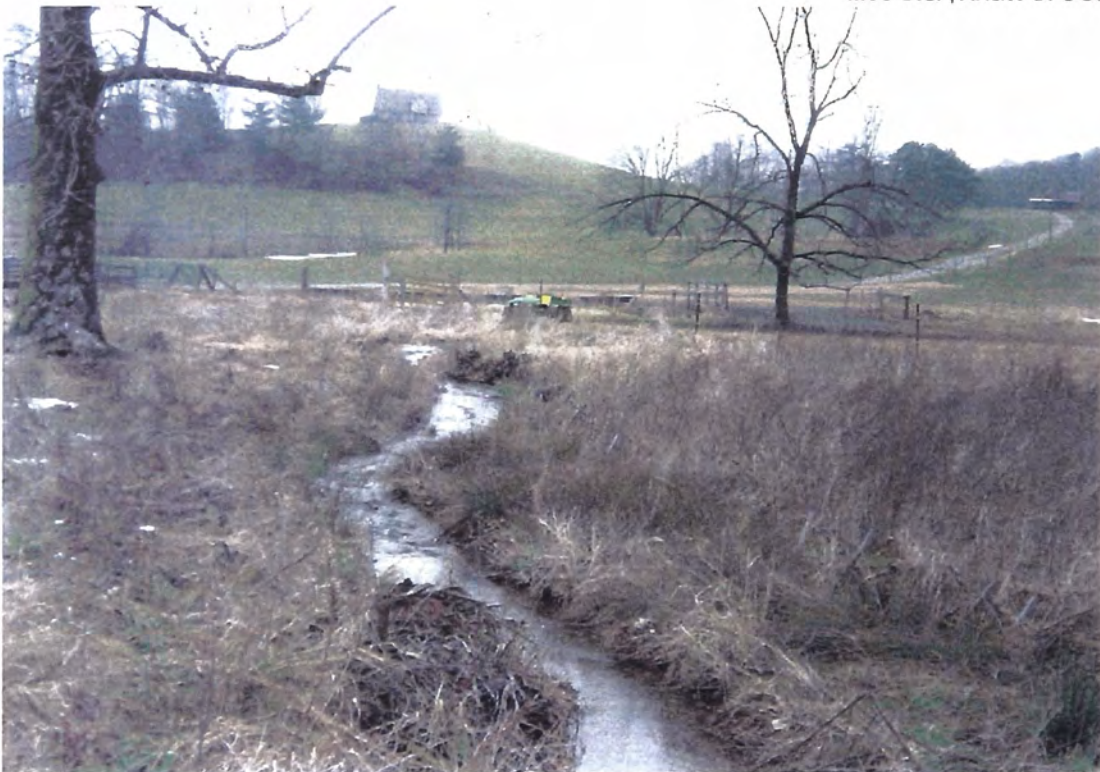
Reach above the bridge in feedlot, on Big Warrior Creek. Photo is taken from the left bank just above the first sycamore, looking downstream to bridge. This is series number 24 from the BWC reference photos.

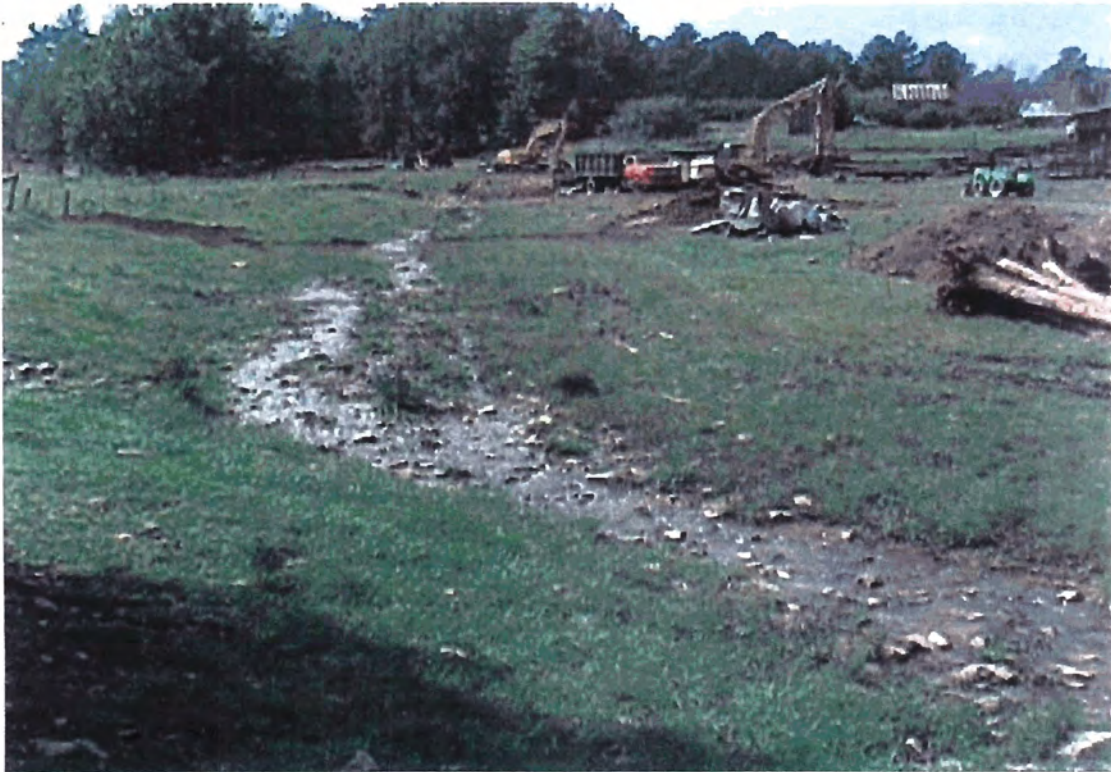
Reach is in the middle of the feedlot, on Big Warrior Creek. Photo is taken from the right bank, just below survey point 1A44, looking upstream. This is series number 27 from the BWC reference photos.

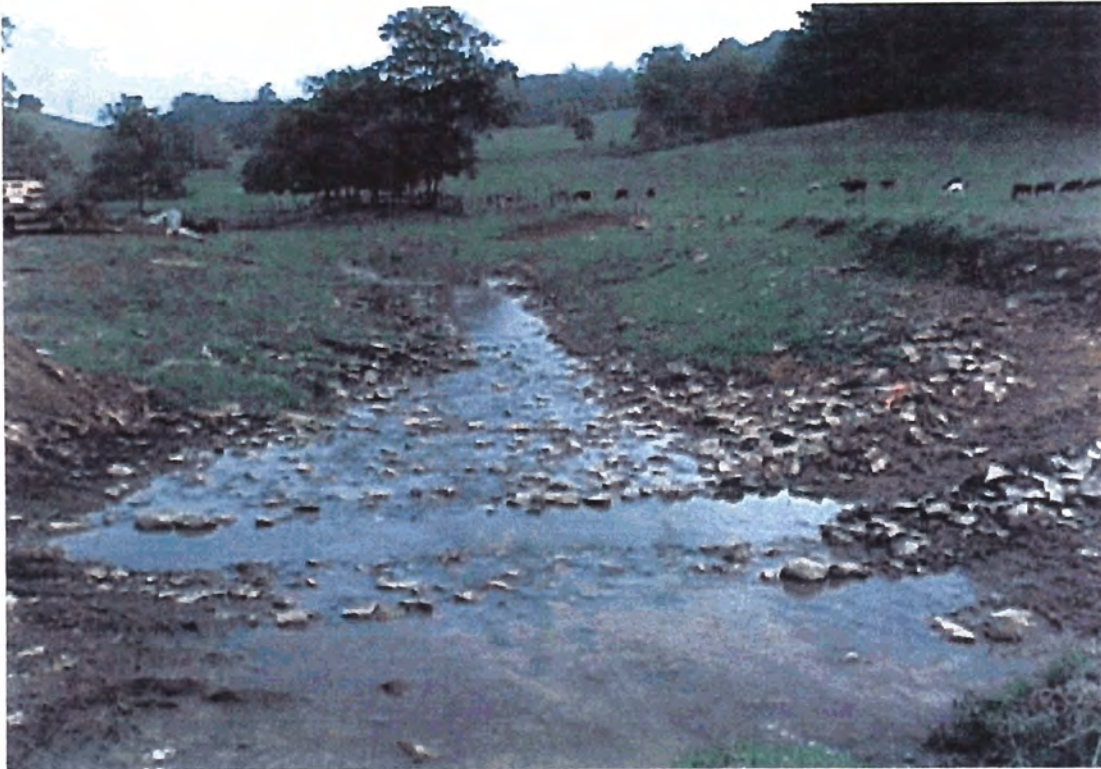
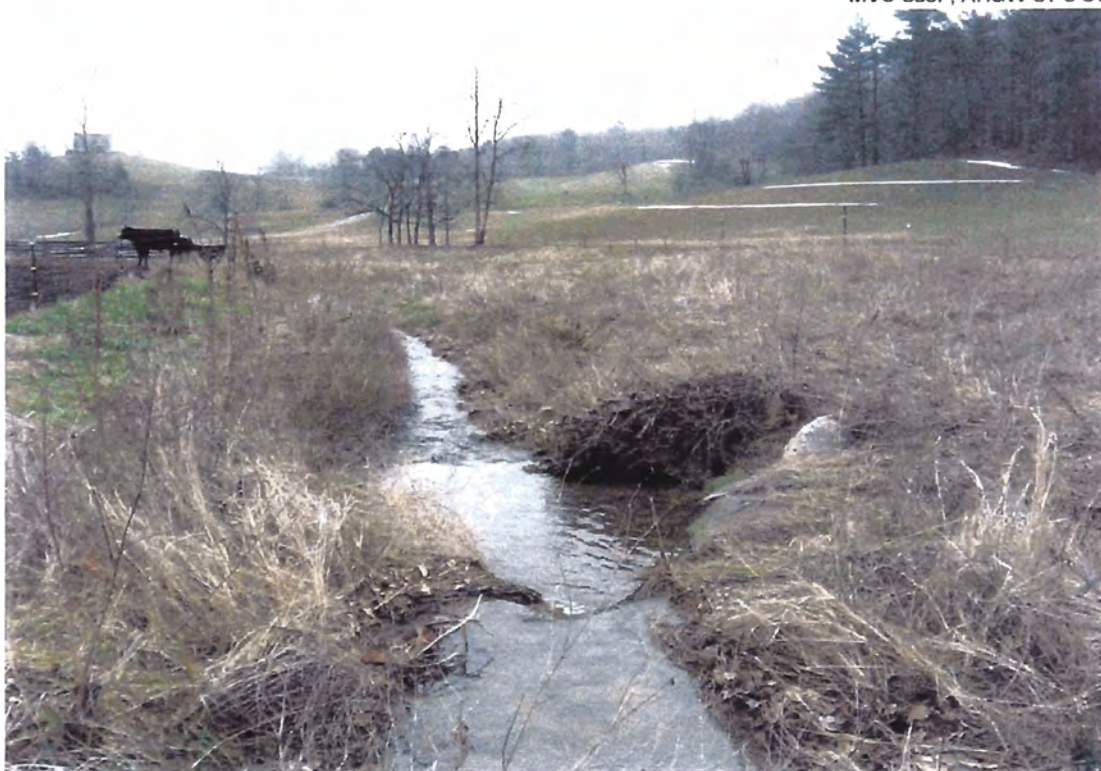
Reach is in the middle of the feedlot, on Big Warrior Creek. Photo is taken from the mid-channel, at the old cross-fence just below survey point 1A45 looking downstream. This is series number 28 from the BWC reference photos.

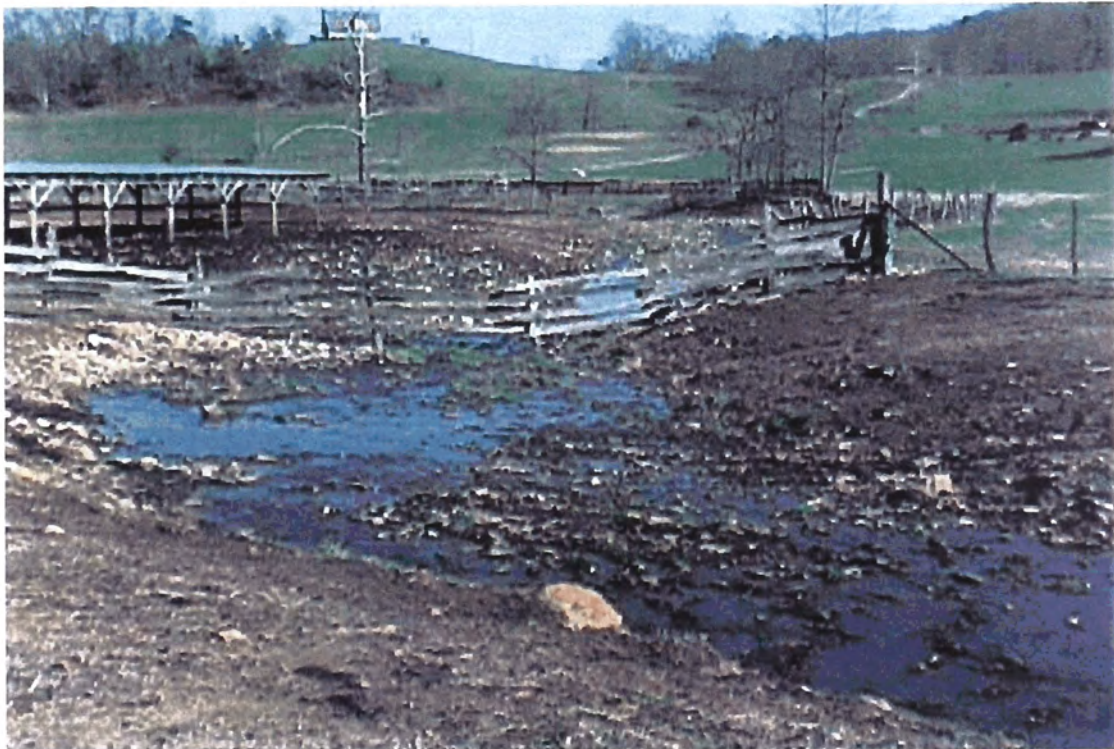
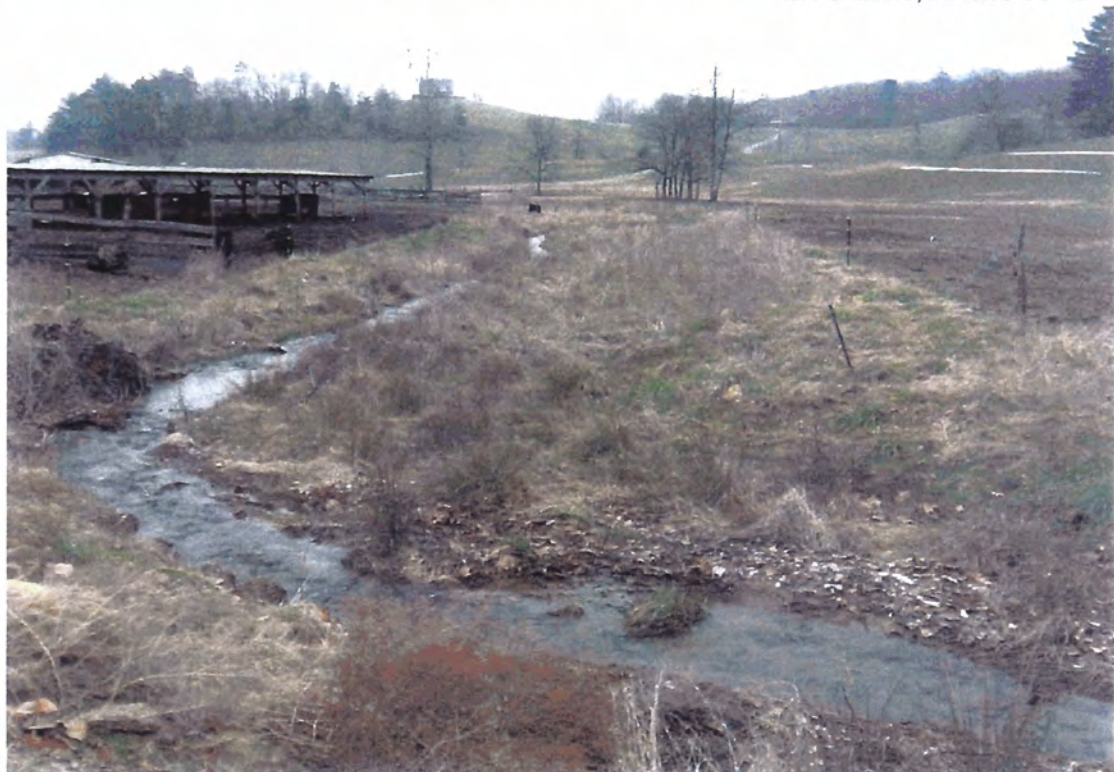
Reach is in the upper end of the feedlot, on Big Warrior Creek. Photo is from the left bank, just above the old cross-fence at survey point 1A45 looking downstream. This is series 30 from the BWC reference photos.

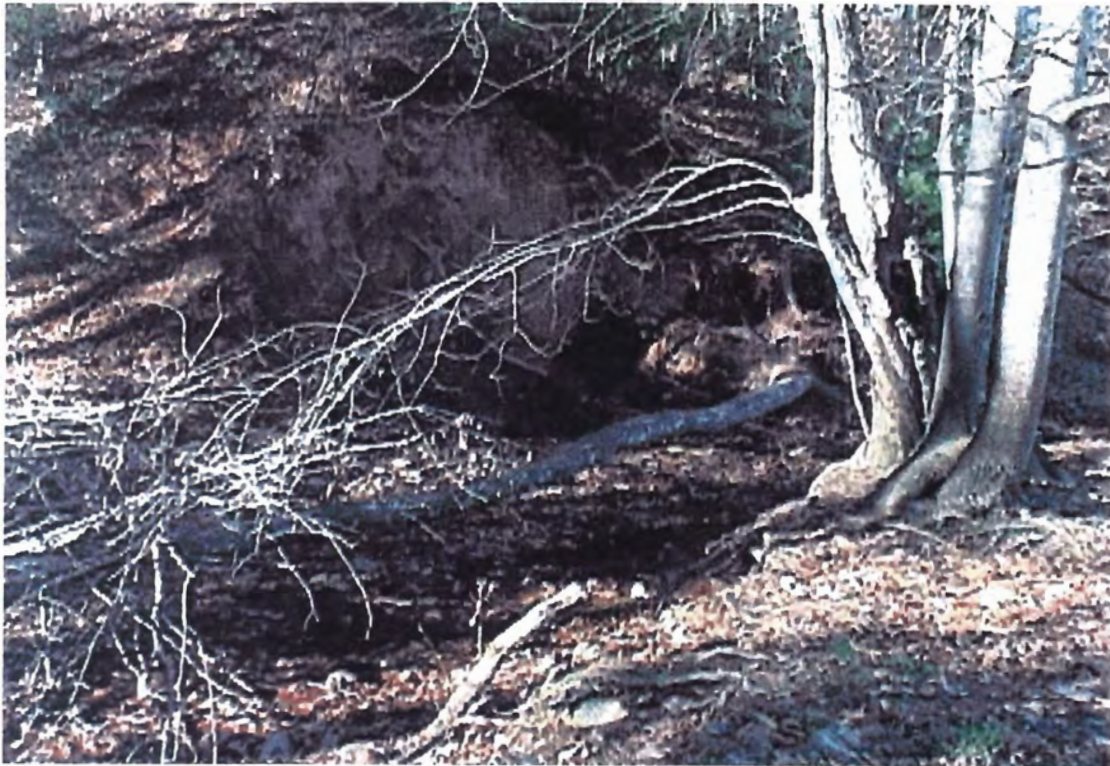
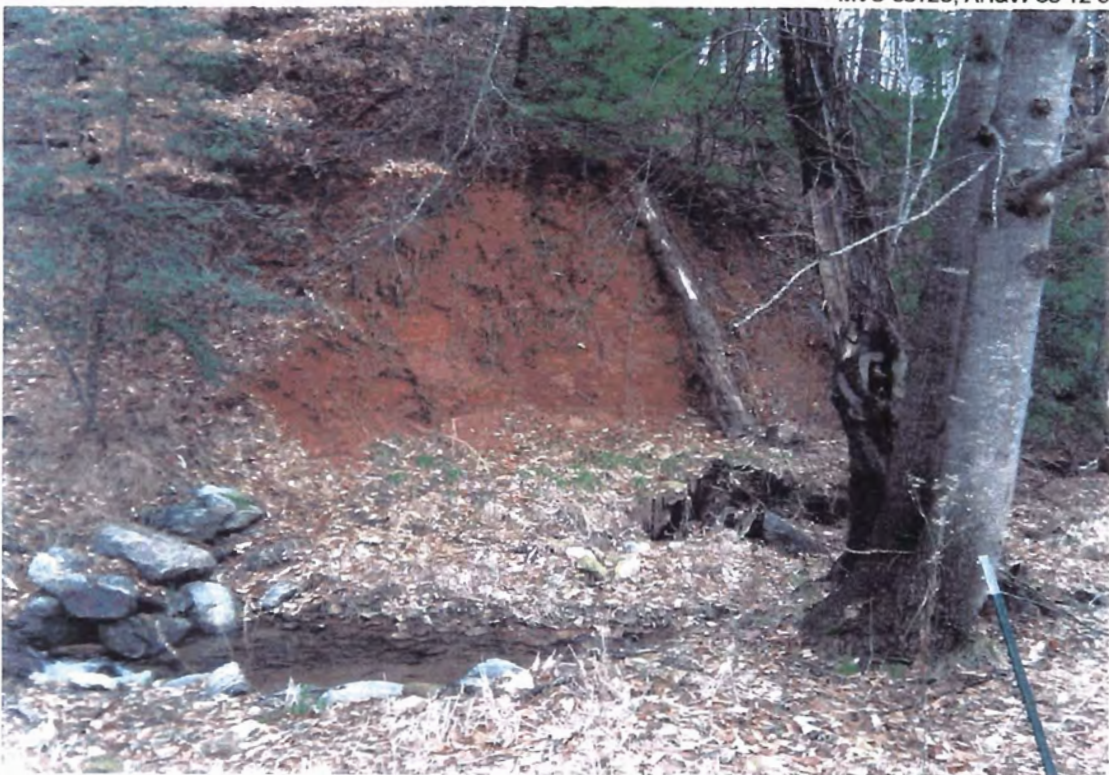
Reach is in the middle of the upper pasture, on Big Warrior Creek. Photo is taken from the right bənł just below s.p. 1A65 looking downstream to eroding clay bənł area. This is series 52 from the BWC reference photos.

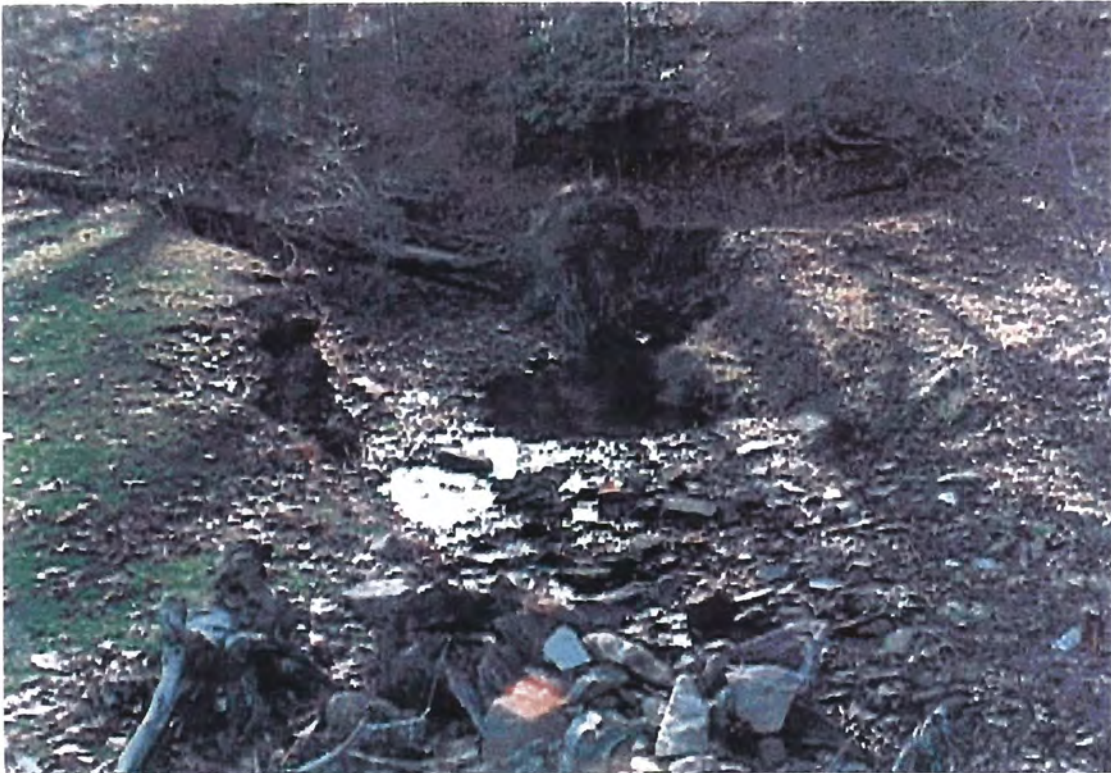
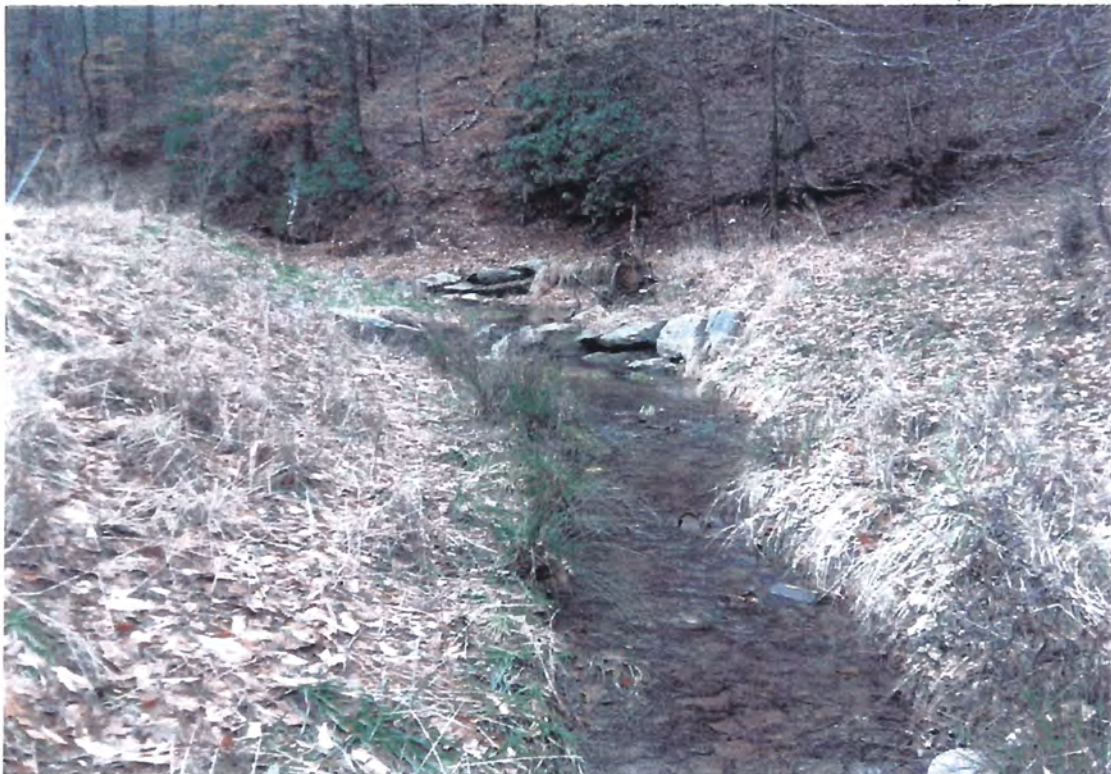
Reach is in the middle of the upper pasture, on Big Warrior Creek. Photo is taken from the right bank just below survey point 1A63 looking upstream to site of old headcut area. This is series number 49 from the BWC reference photos.

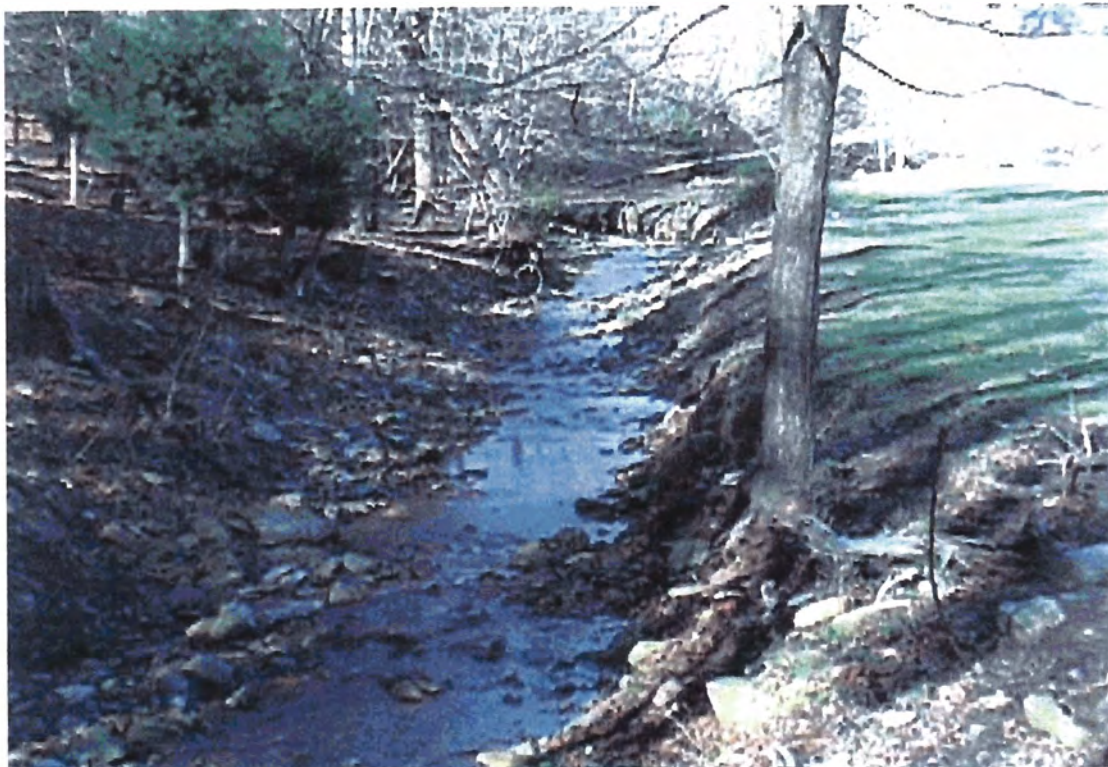
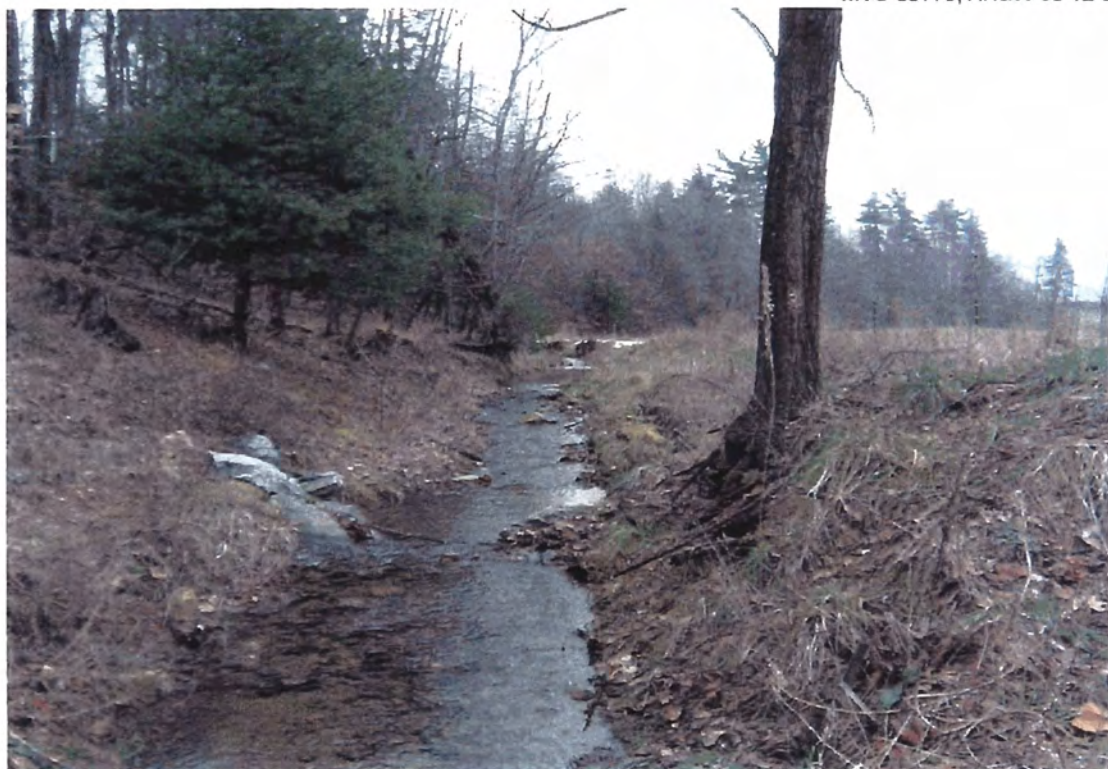
Reach is at the upper end of the upper pasture, on Big Warrior Creek. Photo is taken from the left bank looking downstream to the single locust tree and cross-vane. This is series 58 from the BWC reference photos.

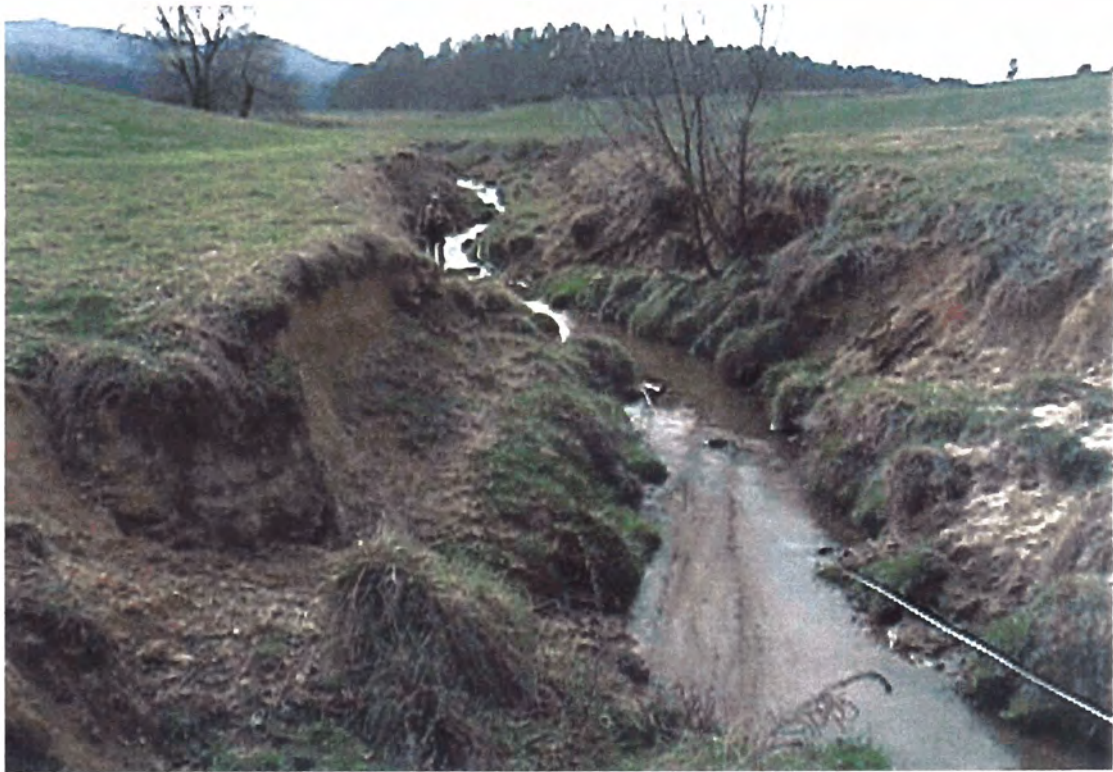
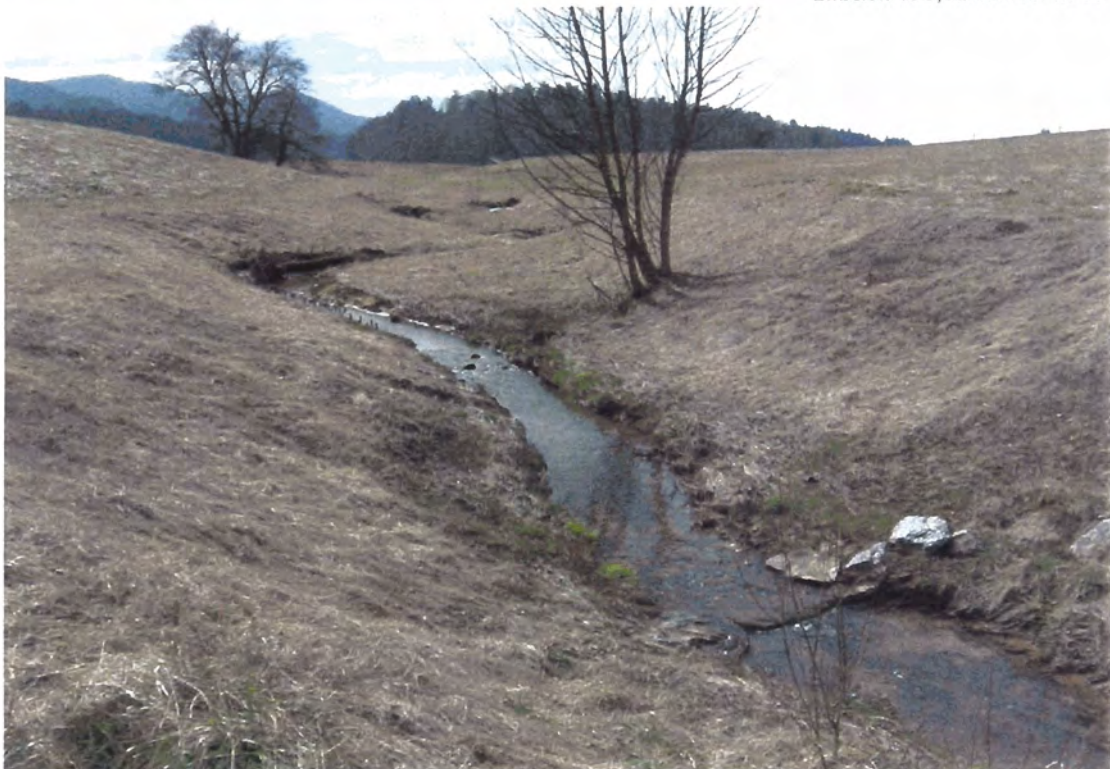
Reach is the lower end of the lower pasture, on Little Warrior Creek. Photos are from the end of the project looking upstream to the lower large willow. This is series number 1 from the LWC reference photos.
