As-built report for the AH&W Mitigation Site Big and Little Warrior Creeks Wilkes County

As-built report for the AH&W
Mitigation Site, Big and Little Warrior
Creeks, Wilkes County

North Carolina Wildlife Resources Commission

February 24, 2003

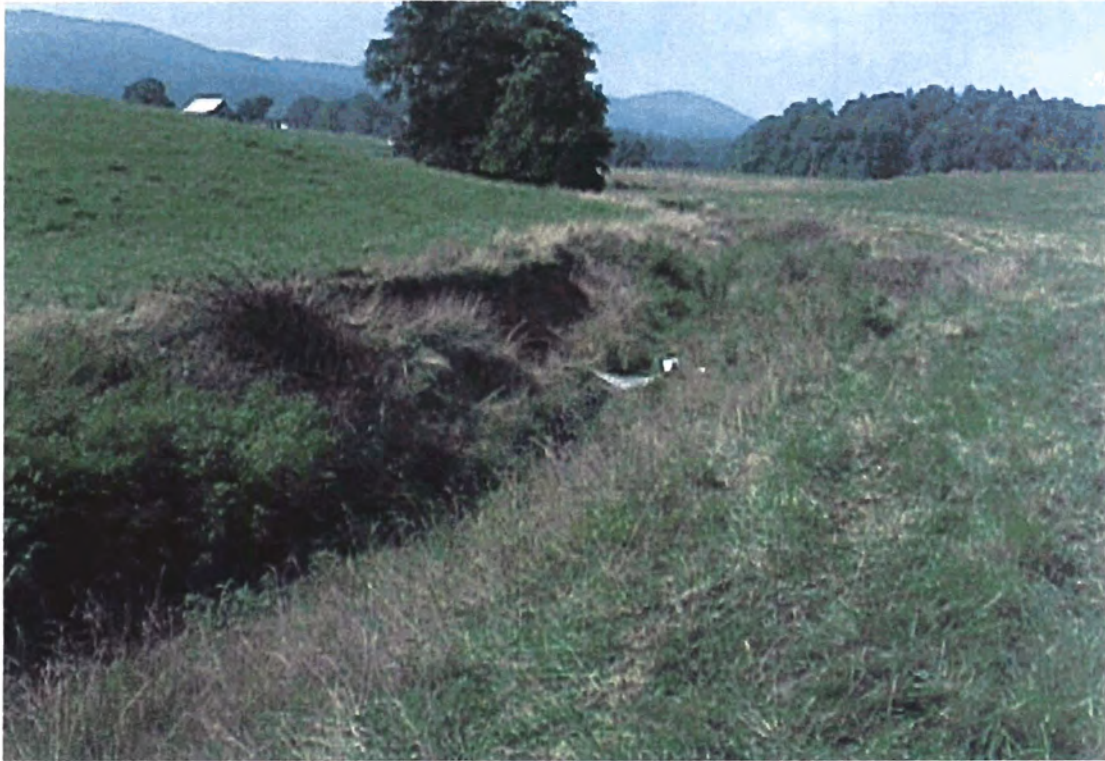
Reach is **the** lower end of the lower pasture, on Little Warrior Creek. Photos are taken from just upstream of survey point 2A38 looking upstream. This is series number 4 from the LWC reference photos.

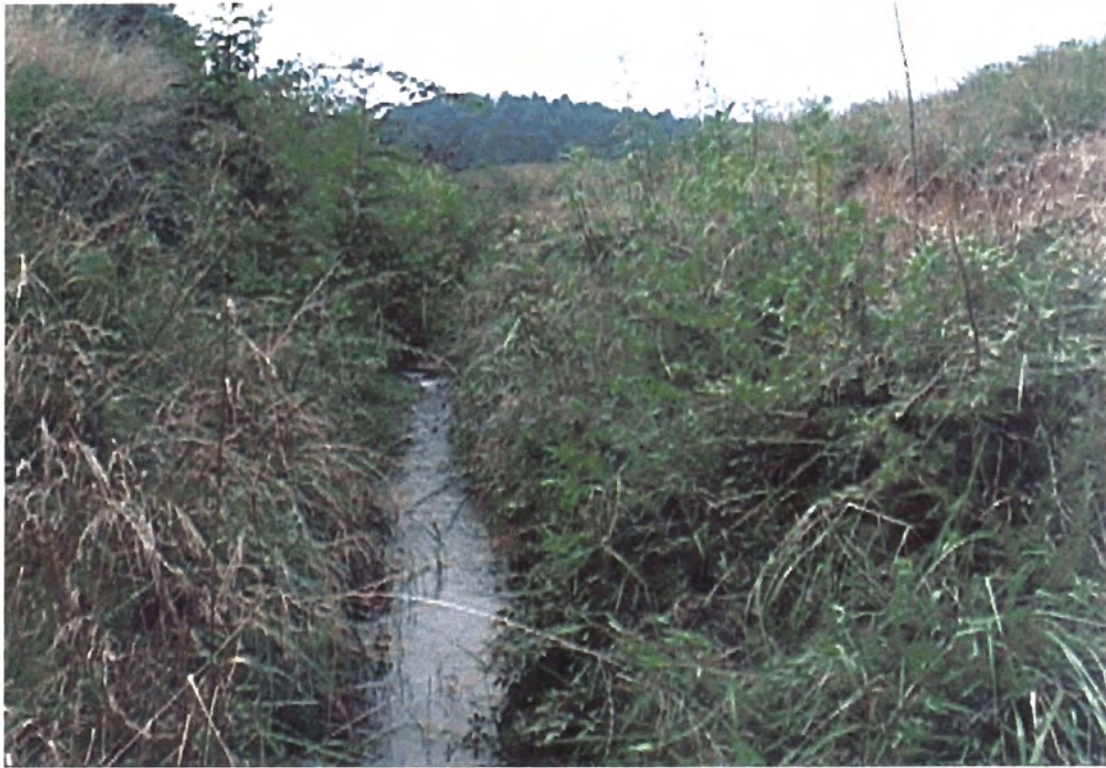
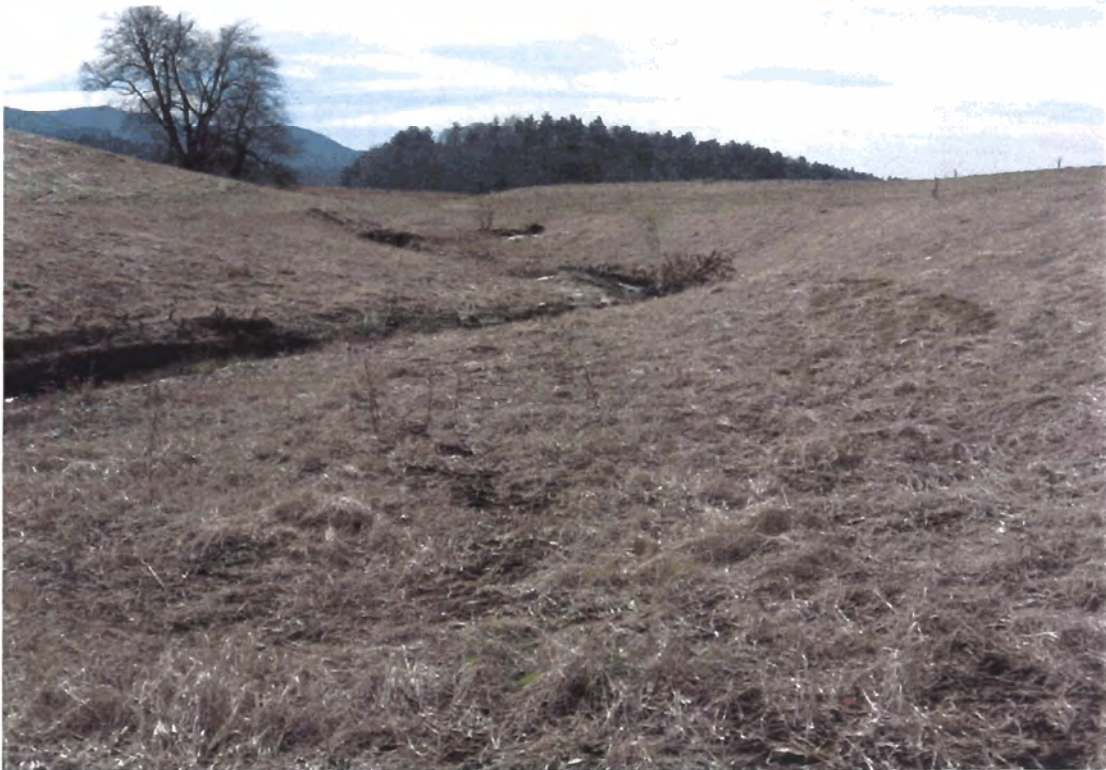
Reach is at the lower end of lower pasture below Hwy 18, on Big Warrior Creek. Photo is taken from just above the large willow looking upstream. This is series number 3 from the LWC reference photos.

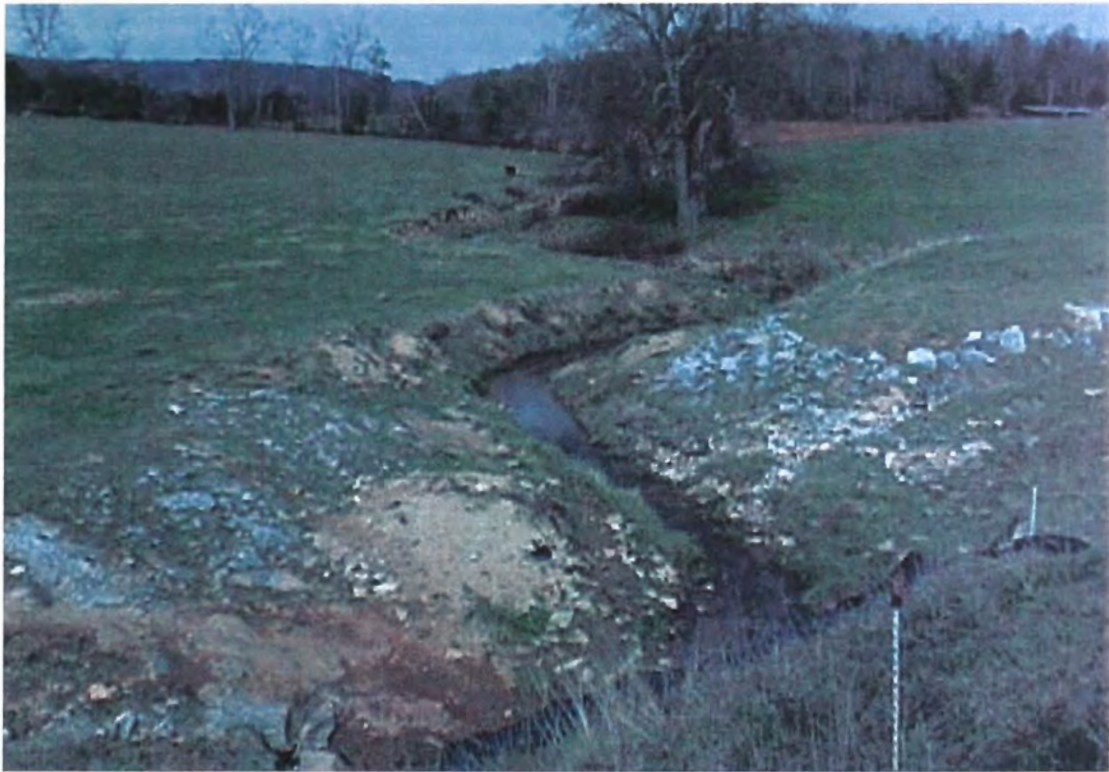
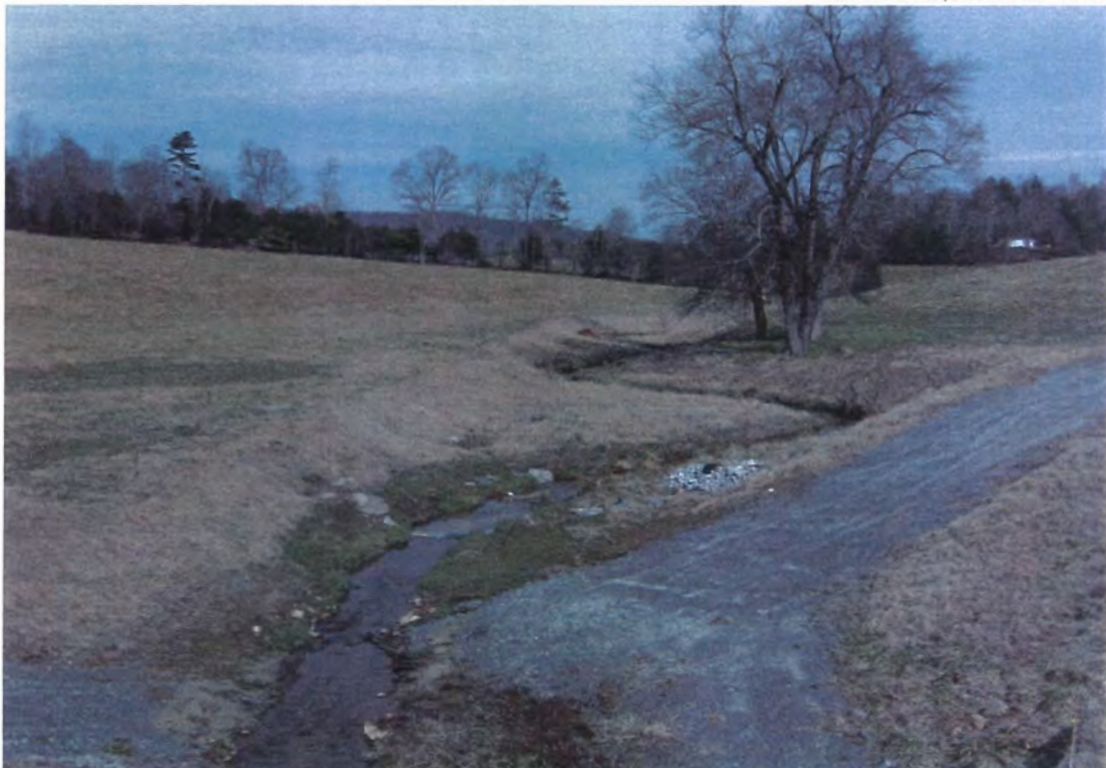
Reach is the upper end of lower pasture below Hwy 18, on Big Warrior Creek. Photo is taken from on top of the culvert under Hwy. 18 looking downstream. This is series number 8 from the LWC reference photos.

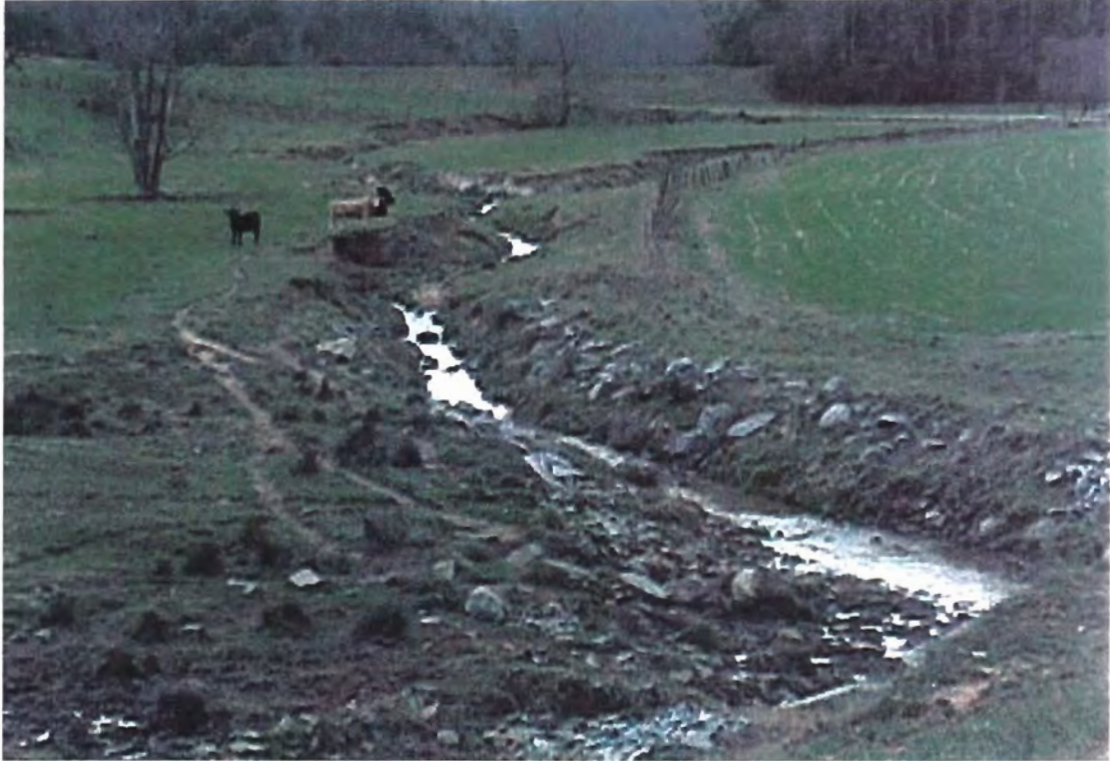
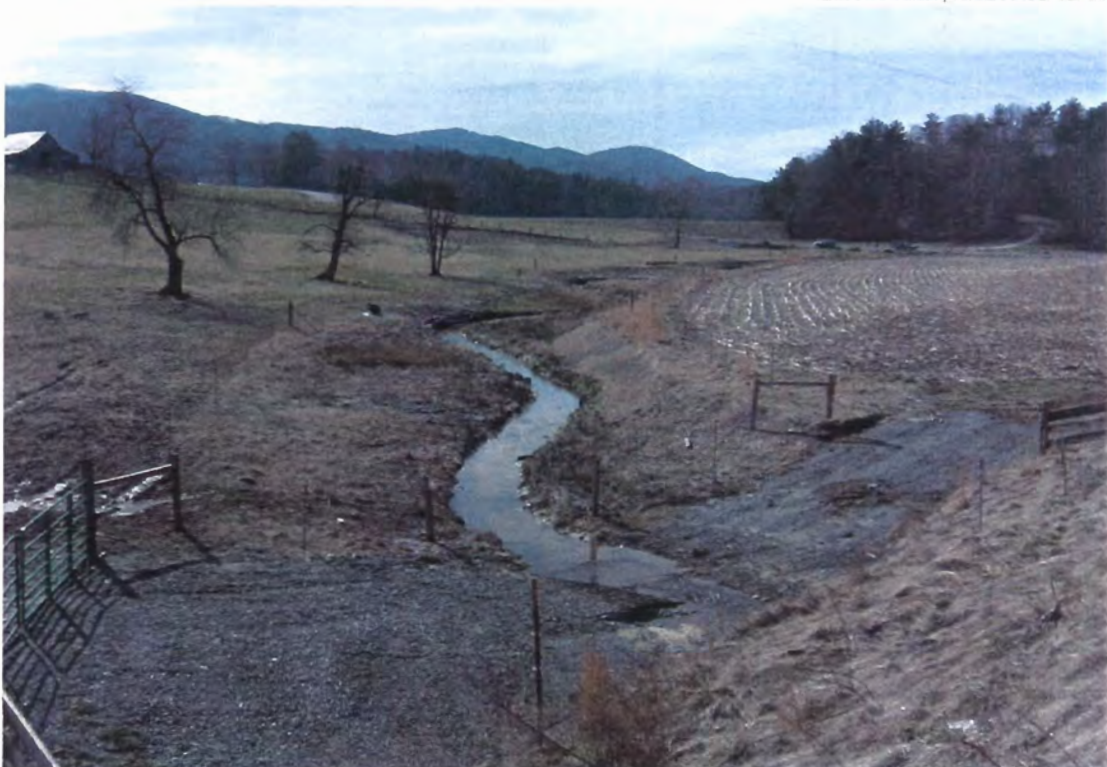
Reach is above the Hwy 18 culvert, on Big Warrior Creek. Photo is taken from slope below Hwy. 18, looking upstream towards Andrews Road. This is series number 10 from the LWC reference photos.

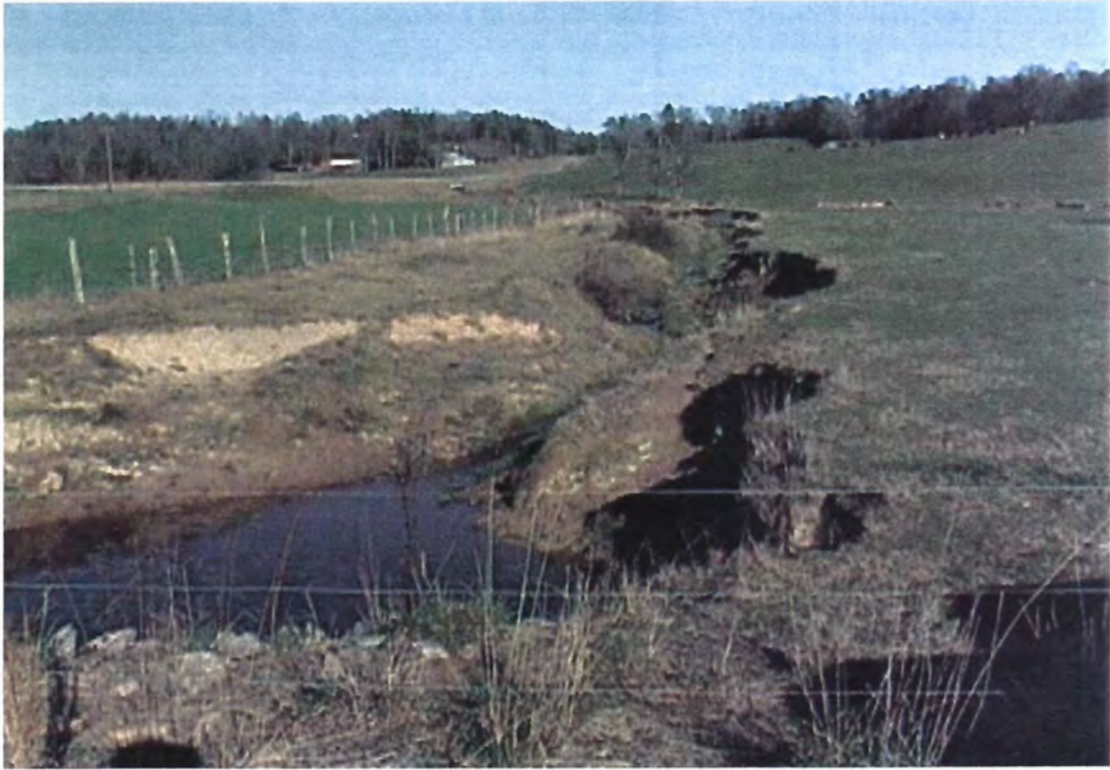
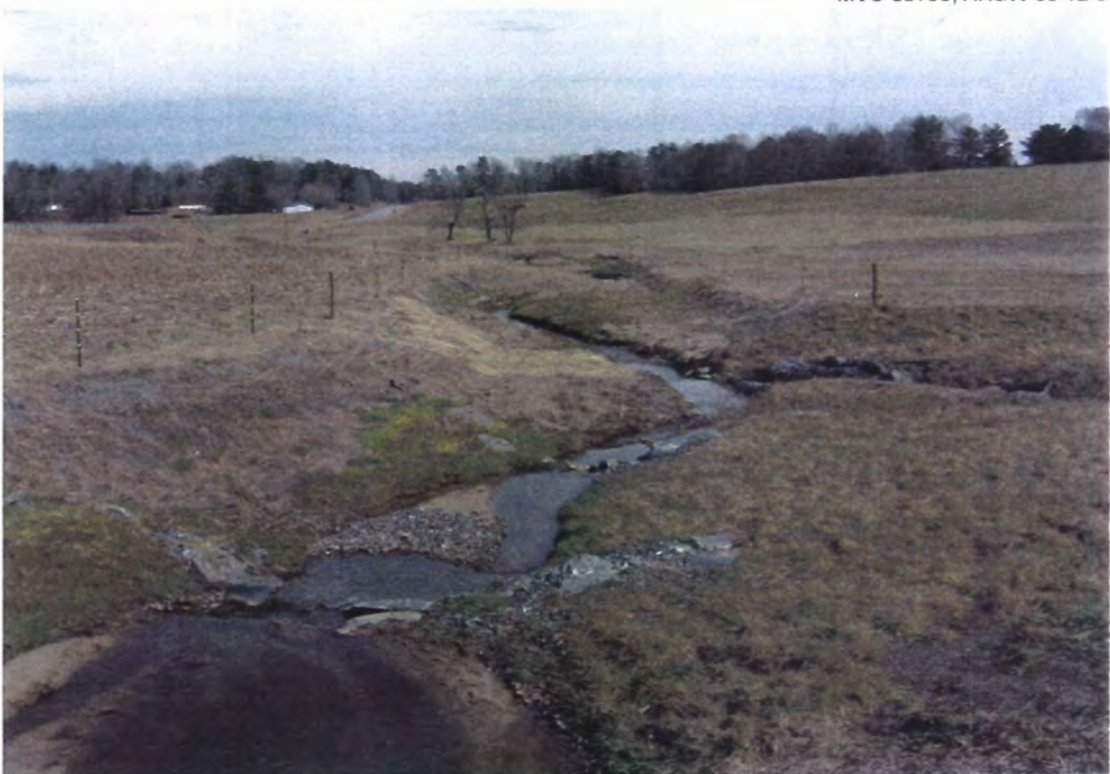
Reach is below the culvert on Andrews Road, on Little Warrior Creek. Photo is taken from the right side of the culvert looking downstream towards Hwy. 18. This is series number 17 from the LWC reference photos.

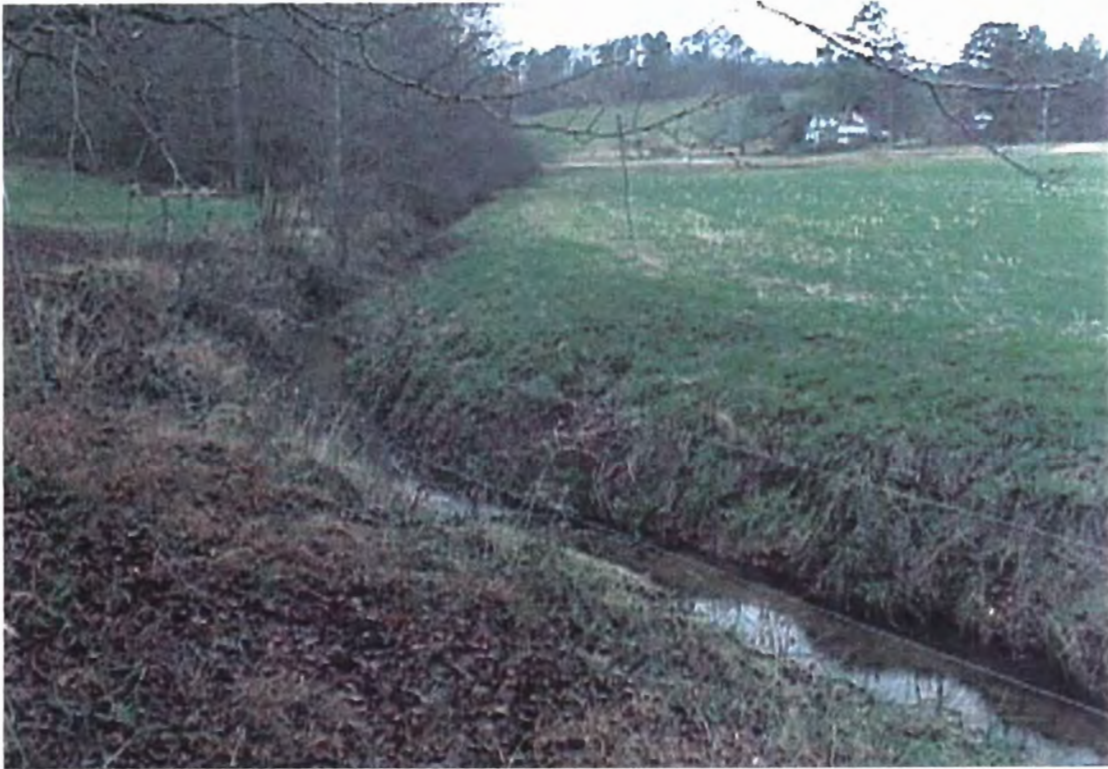
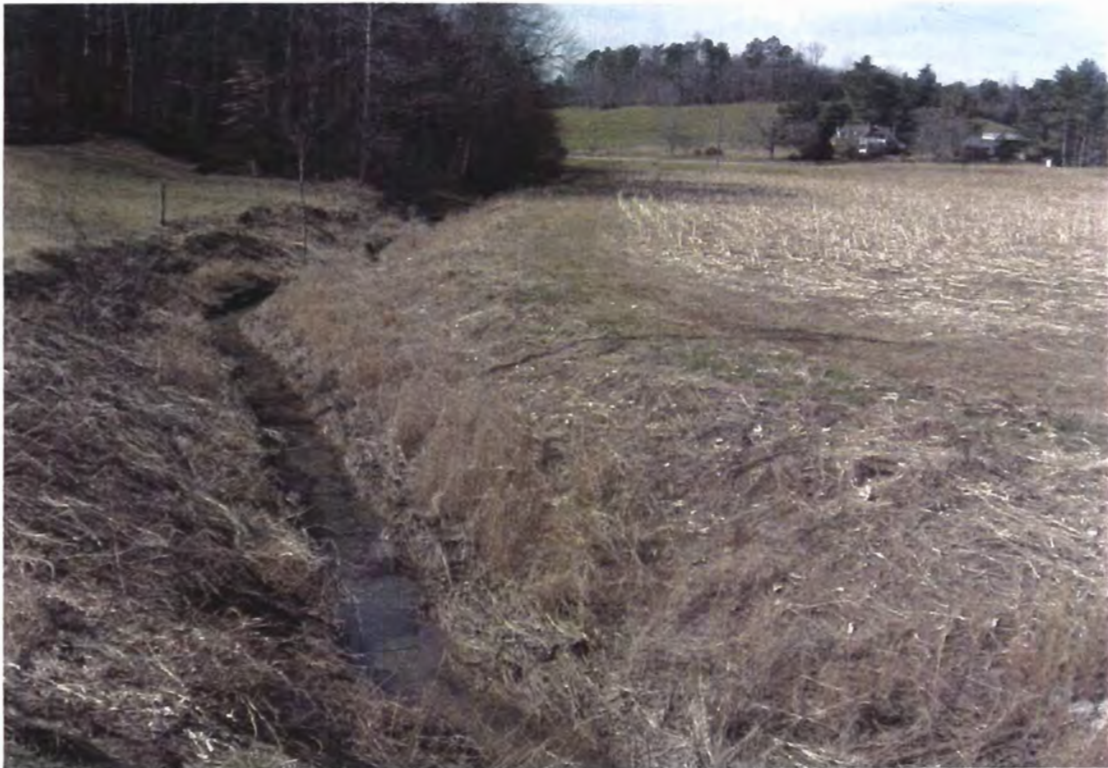
Reach is above the culvert on Andrews Road, on Little Warrior Creek. Photo is taken from the right side of the culvert looking upstream towards Hwy. 18. This is series number 22 from the LWC reference photos.

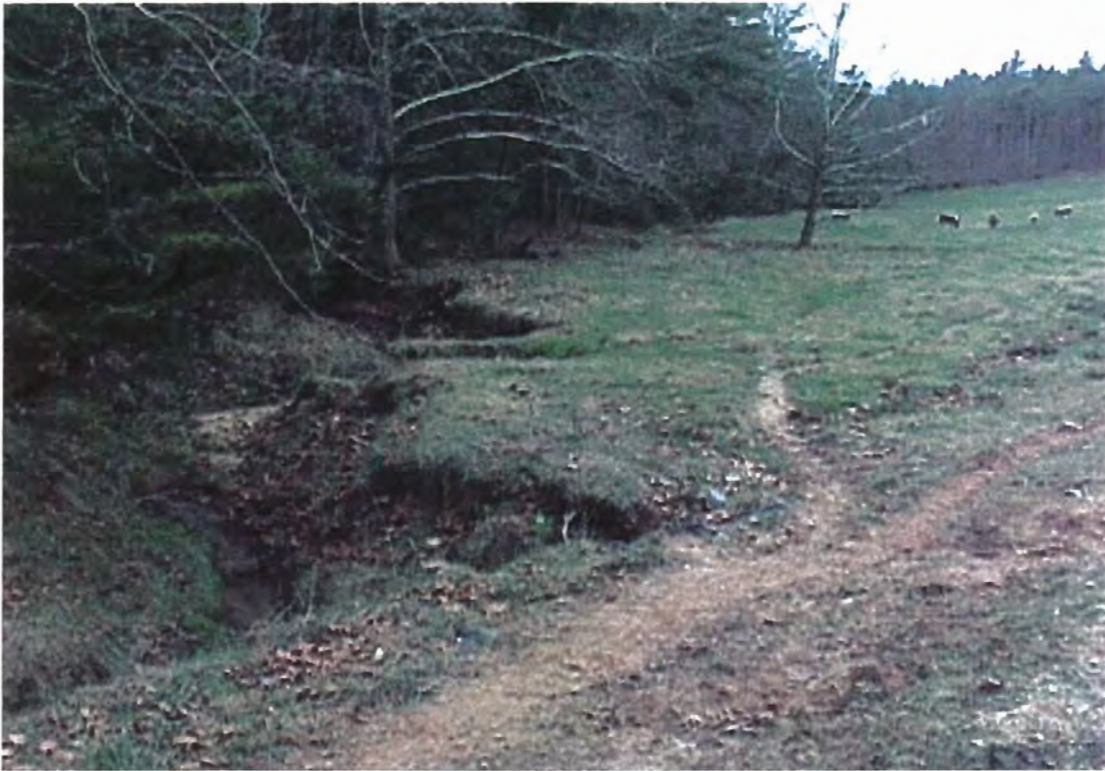
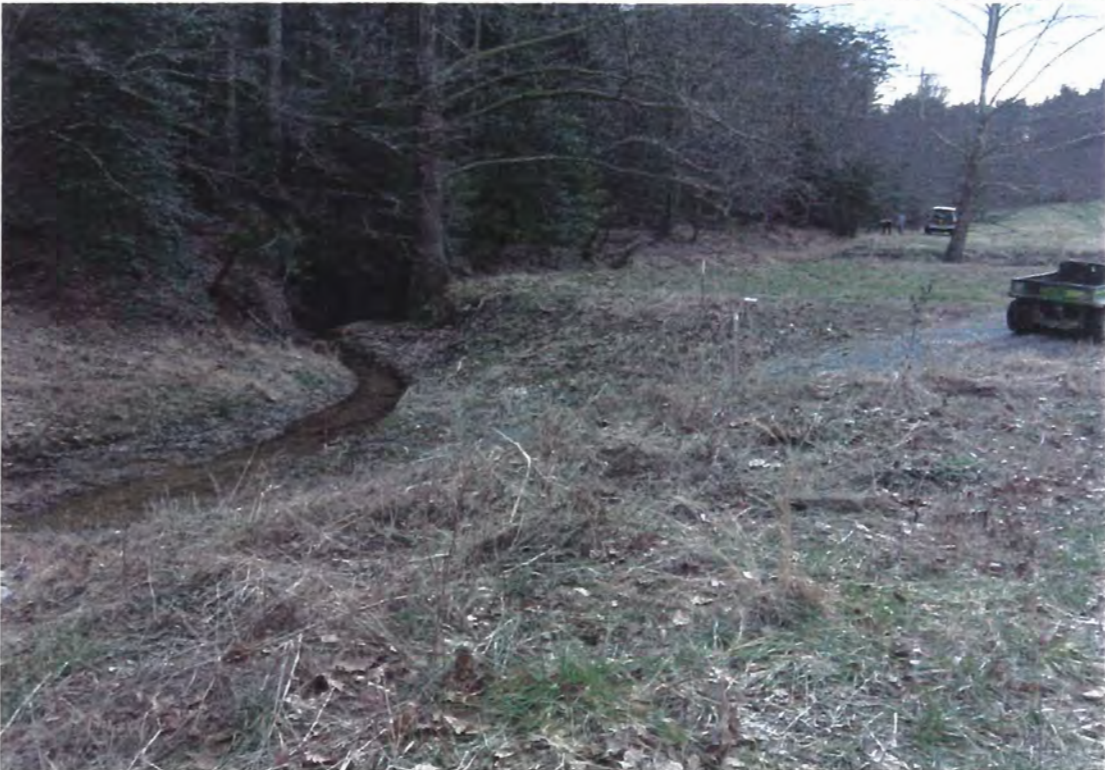
Reach is in the upper pasture south of Hwy 18 on Little Warrior Creek. Photo is taken from the left side of the channel looking upstream towards upper end of cattle crossing. This is series number 32 from the LWC reference photos.

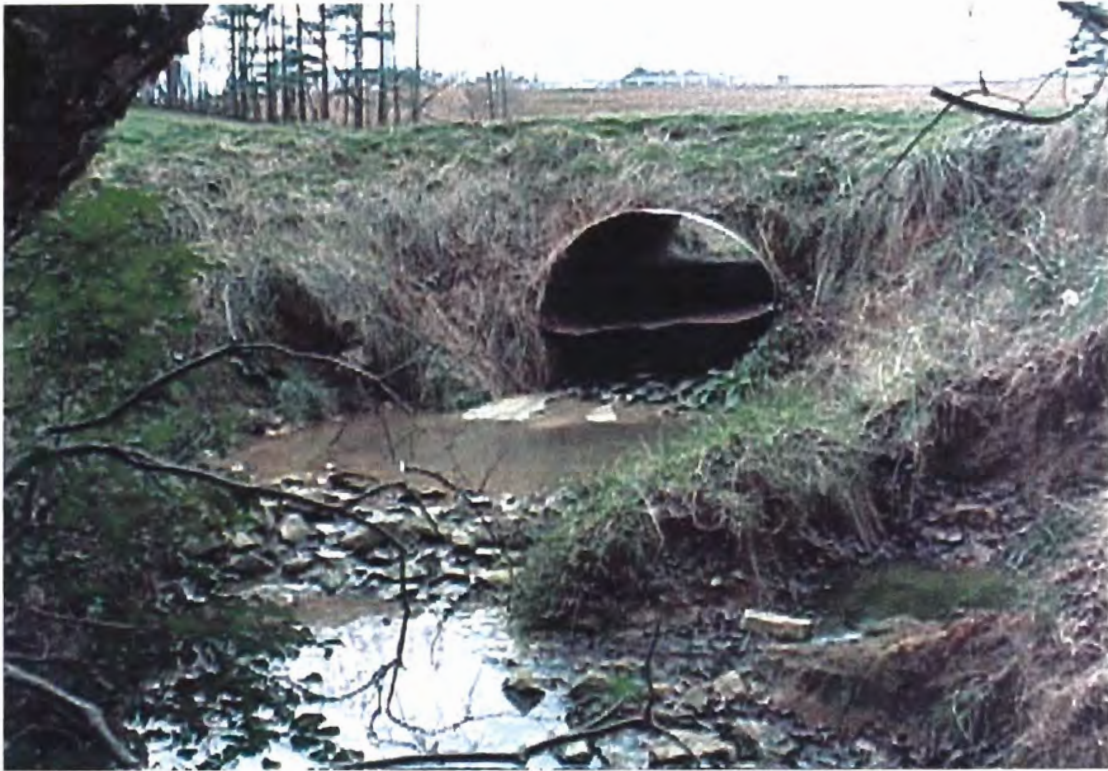
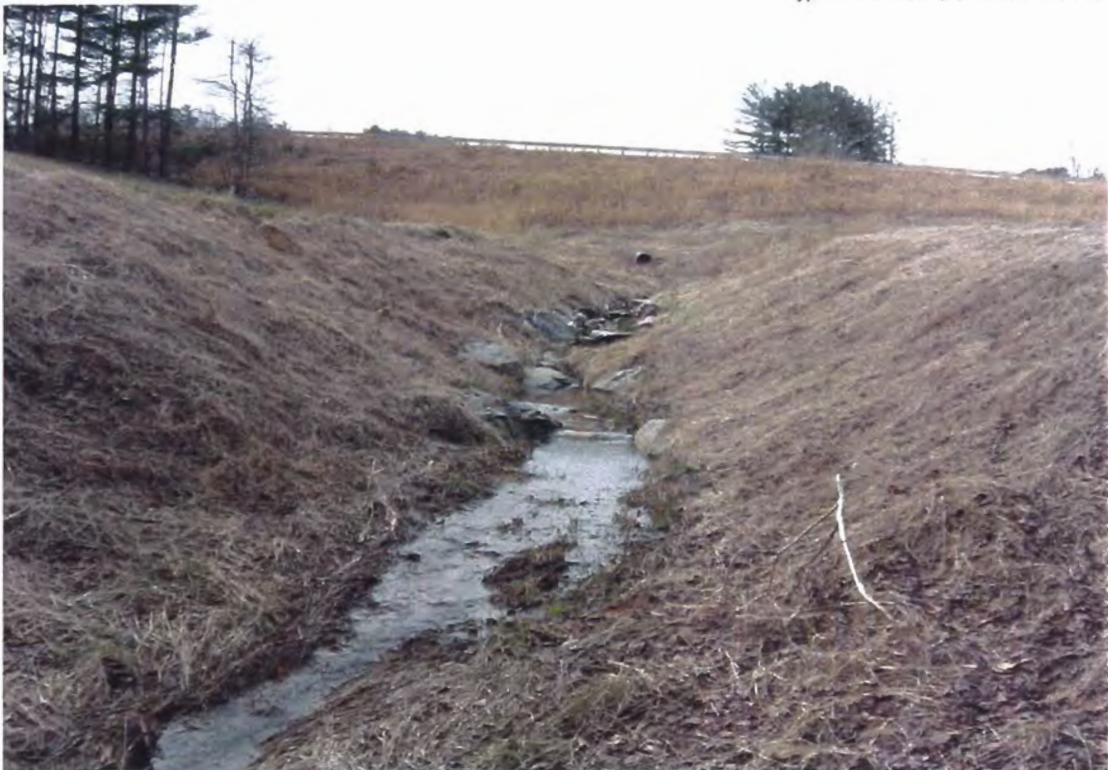
Reach is the upper tributary the crosses Hwy 18 on Little Warrior Creek. Photo is taken from the confluence looking upstream towards the highway. This is series number 38 from the LWC reference photos.
