# ANNUAL REPORT FOR 2004

**Big Warrior and Little Warrior Creek Mitigation Site**  
**Wilkes County**  
**WBS Element 34404.4.1**  
**TIP No. R-2239 B**

Prepared By:  
Office of Natural Environment & Roadside Environmental Unit  
North Carolina Department of Transportation  
January 2005

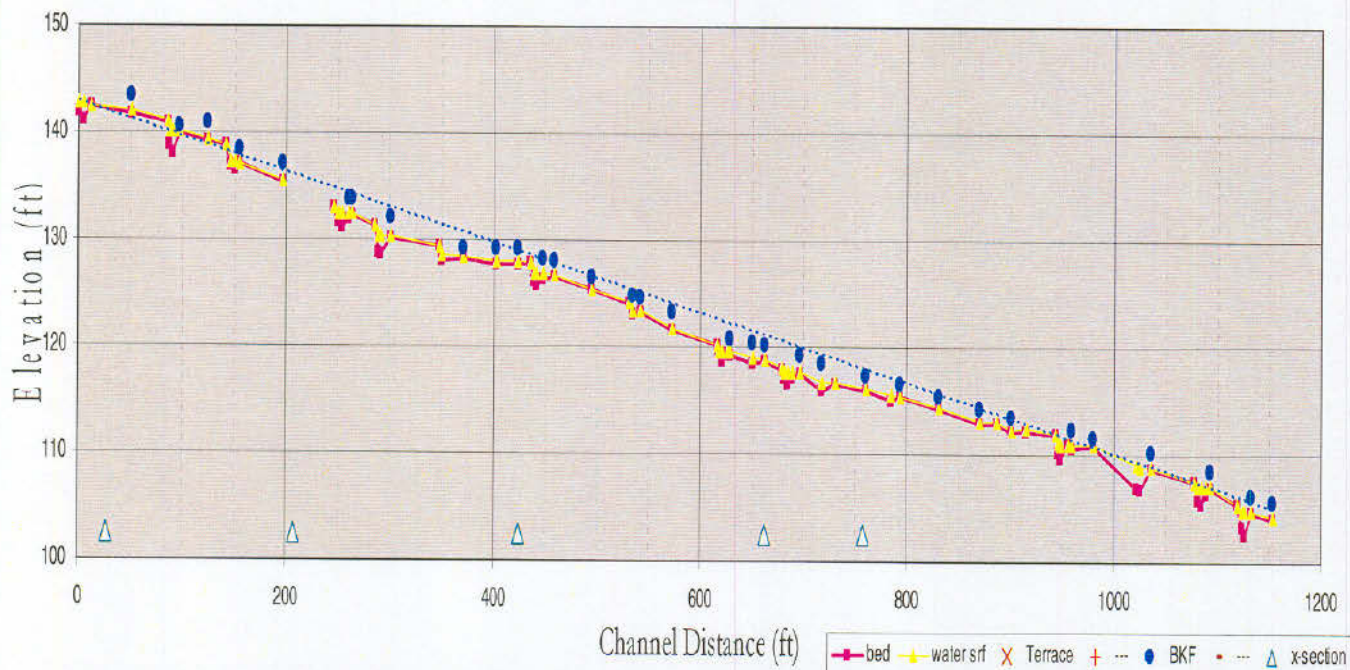
### Big Warrior Creek - Upper Pasture

- ◆ A large number of the structures within this segment of profile appear unstable. Water was noted either flowing around the structures or underneath the header rocks. In turn, this is causing erosion of the adjacent streambanks in several areas.

Big Warrior Creek remains stable; however, there are isolated areas of degradation and instability. A number of the structures are not functioning properly throughout the Upper Pasture and Feed Lot Sections. These areas should be assessed during the next monitoring period to determine if remedial actions are necessary.
