**UT to Billy's Creek Stream Restoration  
Final 2006 Monitoring Report  
Monitoring Year One**

**Ecosystem Enhancement Program Project Number 36**

Submitted: January 19, 2007

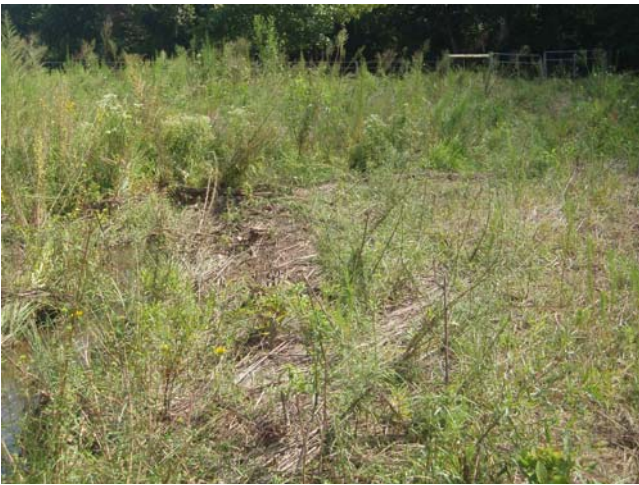
<b>Table AI. Vegetative Problem Areas UT to Billy's Creek EEP Project Number 36</b>			
<b>Feature/Issue</b>	<b>Station #/Range</b>	<b>Probable Cause</b>	<b>Photo #</b>
Bare Bank	31+10	Storm damage	VPA1
Bare Bank	30+65	Cattle damage	VPA2
Bare Floodplain	30+65	Cattle damage	VPA3
Bare Floodplain	29+40	Cattle damage	VPA4
Bare Floodplain	28+90	Cattle damage	VPA5
Bare Bank	23+85	Cattle crossing	VPA6
Bare Bank	24+25	Cattle damage	VPA7
Bare Bank	22+45	Cattle crossing	VPA8
Bare Bank	22+27	Cattle crossing	VPA9
Bare Bank	22+12	Cattle crossing	VPA10
Bare Bank	21+35	Cattle crossing	VPA11
Bare Bank	21+35	Cattle crossing	VPA12
Bare Bank	19+00	Cattle crossing	VPA13
Bare Bank	18+75	Cattle crossing	VPA14
Bare Bank	17+45	Cattle damage	VPA15
Bare Floodplain	13+00	Cattle damage	VPA16

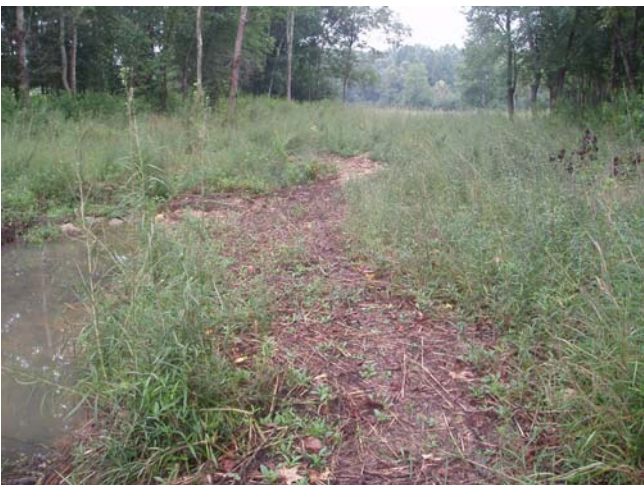
Despite fencing, cattle paths were present along both sides of the banks throughout the project reach, and these paths no longer support vegetation. Planted vegetation was sparse along the project reach, especially on the banks. However, the site appeared to be stabilizing. Since the June storm event and the exclusion of cattle, site conditions have improved. The site was observed on July 21, 2006, August 18, 2006, and again during the monitoring effort on September 6, 2006. Site conditions appeared to improve with each subsequent visit. Grazed seedlings are re-leafing and rushes (*Juncus* spp.) are populating the streambanks.

Cow path along streambank

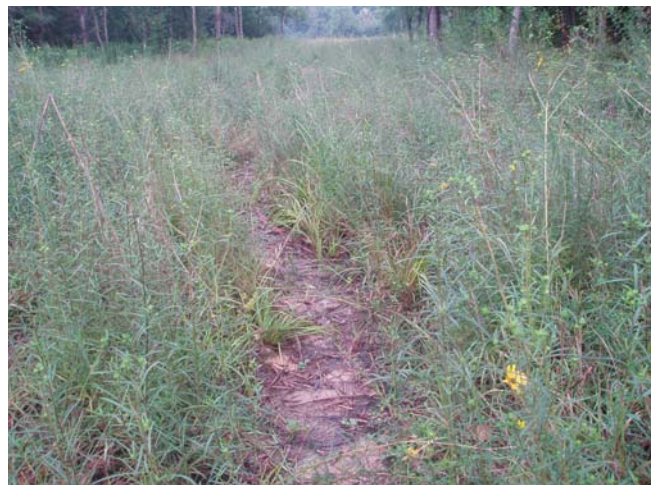
Cow path in upland zone

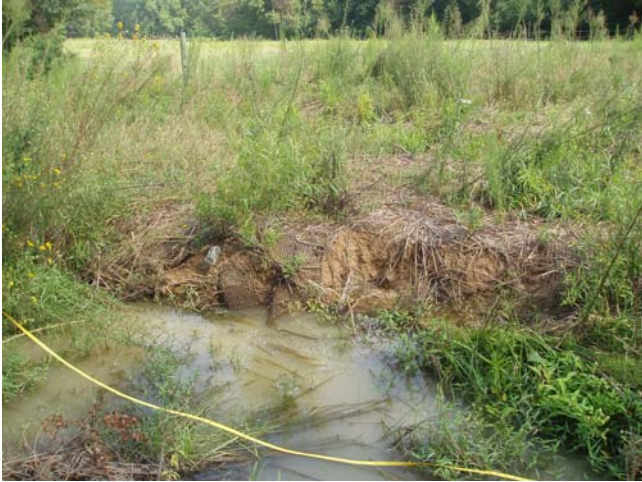
<b>Table BI. Stream Problem Areas UT to Billy's Creek EEP Project Number 36</b>			
<b>Feature Issue</b>	<b>Station</b>	<b>Suspected Cause</b>	<b>Photo #</b>
Bank scour	28+80*	Hoof shear	PA1
Bank scour	21+35*	Matting issues	PA2
Bank scour/aggradation	19+50*	Hoof shear and sedimentation	PA3-1 and PA3-2
Abandoned channel	19+15 to 19+35	Matting issues	PA4-1 and PA4-2
Engineered structure stressed	16+08*	Scour behind structure	PA5
Sedimentation	10+00 to 12+00	50-year storm event	PA6-1 and PA6-2

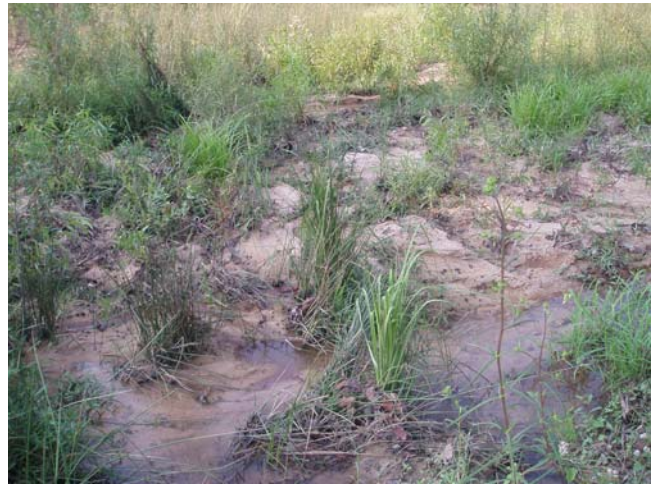
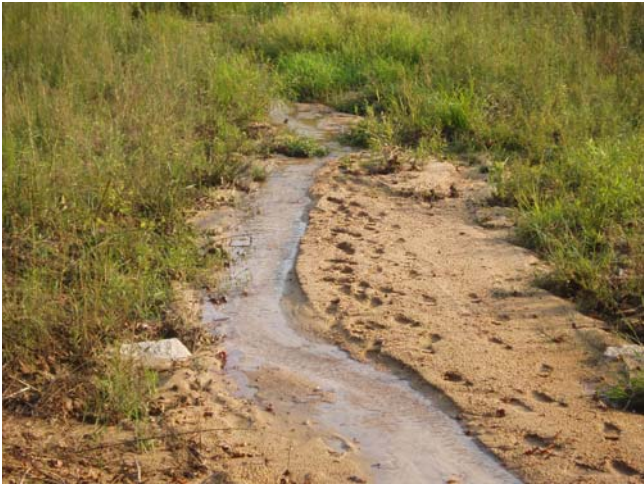
Overall, the site was observed to be functioning well. Instream structures appeared to be stable, and the stream has maintained a defined channel. The most notable problem observed was the accumulation of sediment within the first 100 feet of the project reach. The sediment accumulation is most likely the result of a 50-year storm event associated with Tropical Storm Alberto that occurred during June of this year (2006). The Year One Monitoring channel length is 2,025 linear feet.
